**NIST NCSTAR 1-1C**

**Federal Building and Fire Safety Investigation of the  
World Trade Center Disaster**

# **Maintenance and Modifications to Structural Systems**

David A. Fanella  
Arnaldo T. Derecho  
S. K. Ghosh

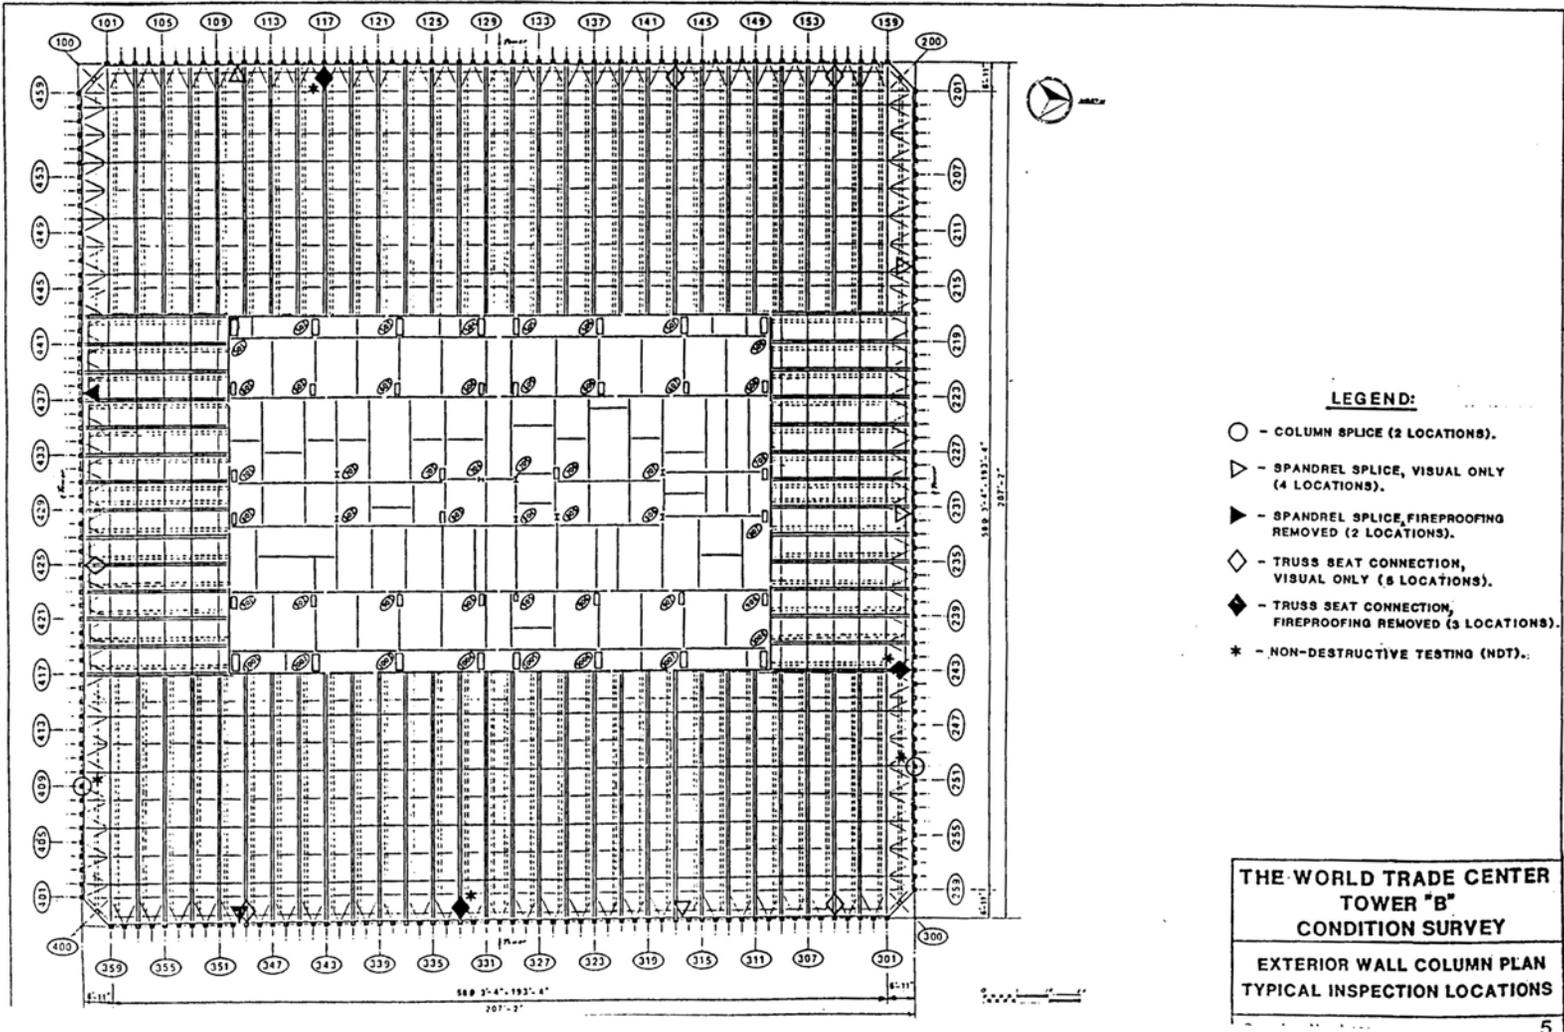
Figure 3-1. Typical inspection locations of exterior wall per 1990 Condition Survey Report of WTC 2.

Inspection of the exterior walls was made from inside the building. Inspection locations are indicated in Fig. 3–1, which is Drawing 5 from the report (PANYNJ 1990).

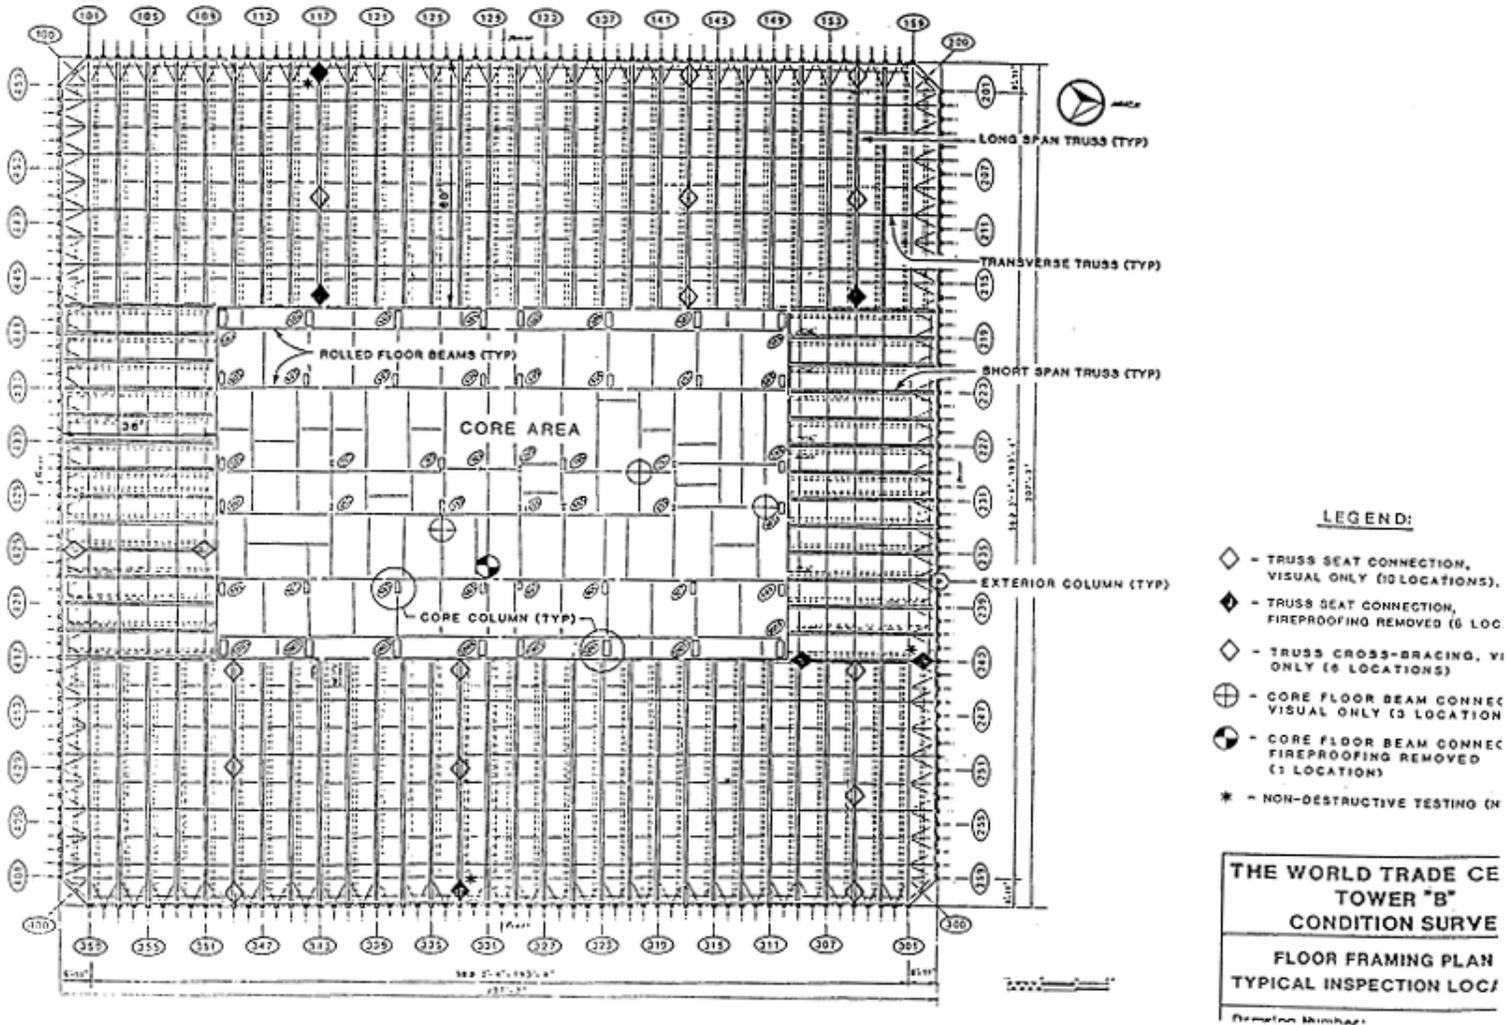
Figure 3-3. Typical inspection locations of floor framing per the 1990 Condition Survey Report of WTC 2.

**Floors 9 through 41**—Floor framing inspected in this zone was found to be in good condition. Light corrosion was observed on all core beams and beam connections, and on main truss connections on floors 28 and 37.

According to the report, the most significant deficiencies in this zone were found at the damping units (see Table C-1 in the survey report). Damping units on floors 18 and 37 were observed to be missing one fastener at each unit. Two fasteners were found to be missing in one damping unit on floor 29, as well as on floor 38. Also, at floor 38, a damping unit was observed to be missing four fasteners. According to the structural drawings (WSHJ 1967a), four fasteners were required to connect the damping unit to the member attached to the bottom chord of the floor truss, and two fasteners were required to connect the damping unit to the exterior column.

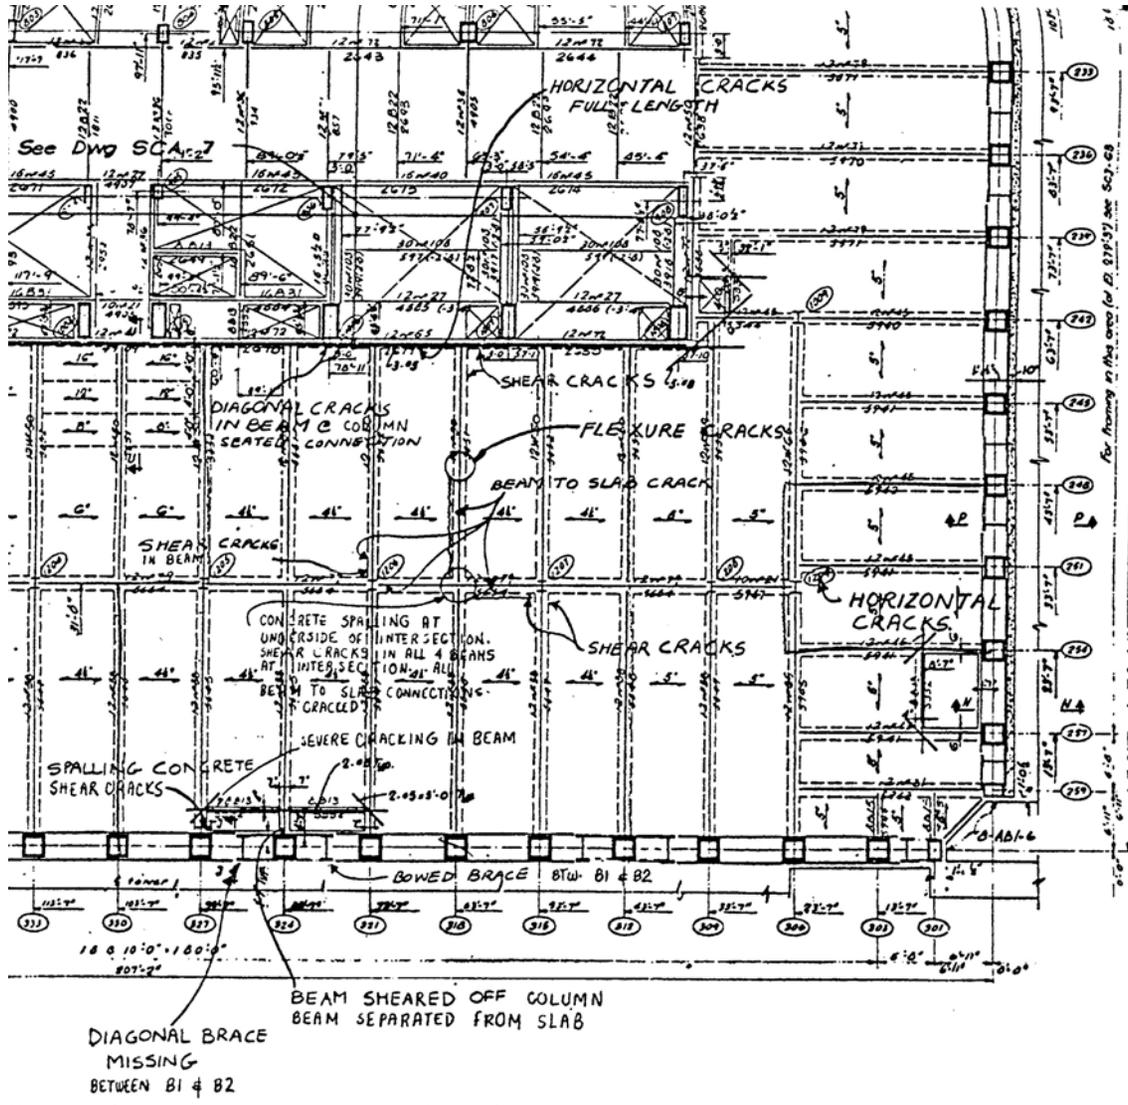
Figure 4-2. Damage assessment for WTC 1 at Level B2.

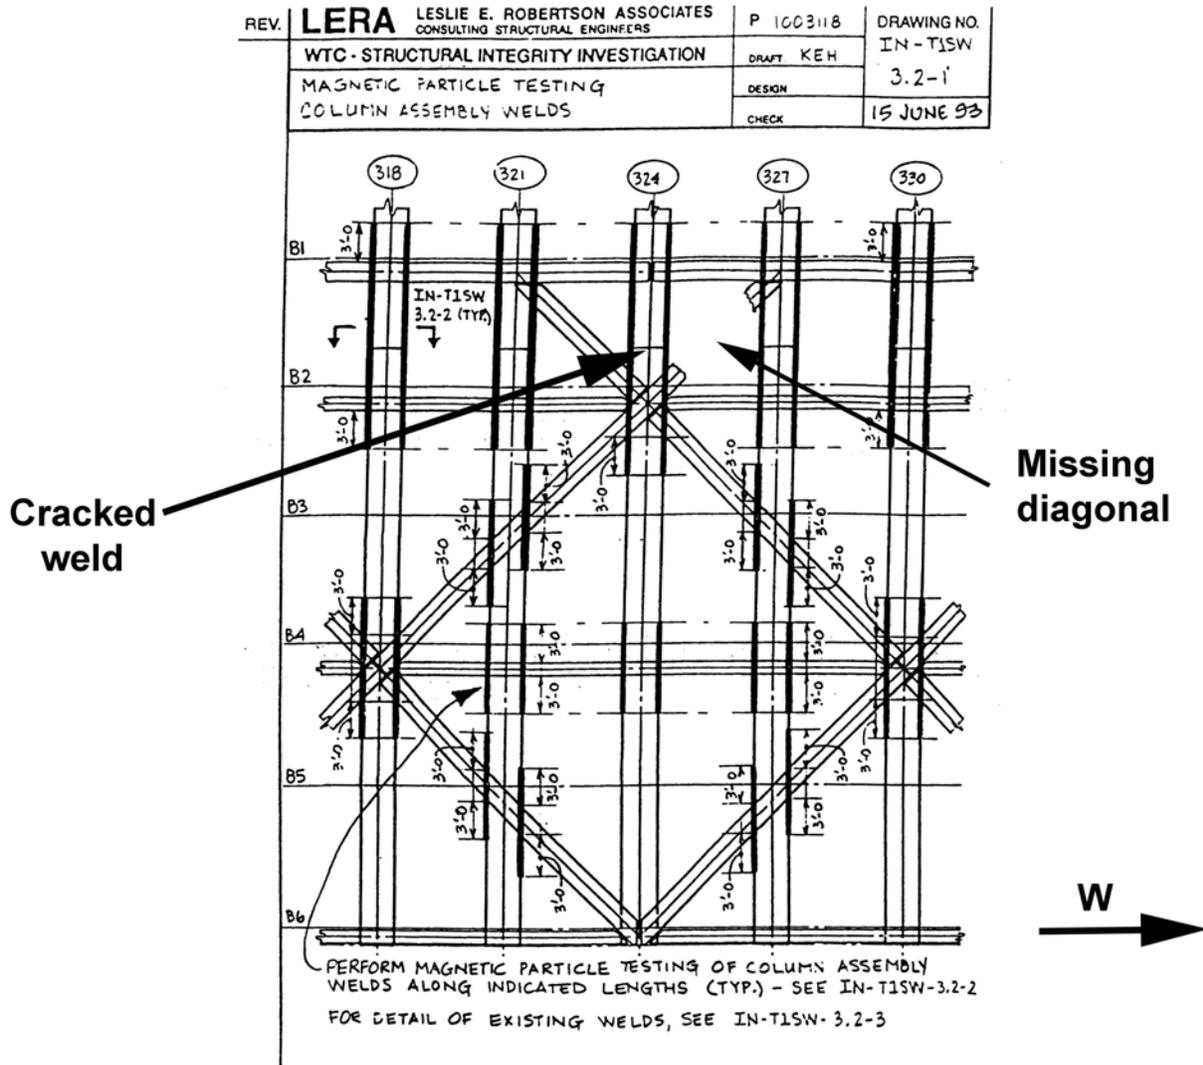
**Figure 4-3. Bracing on south face of WTC 1 damaged by blast.**
