NIST NCSTAR 1-3

**Federal Building and Fire Safety Investigation of the
World Trade Center Disaster**

Mechanical and Metallurgical Analysis of Structural Steel

September 2005

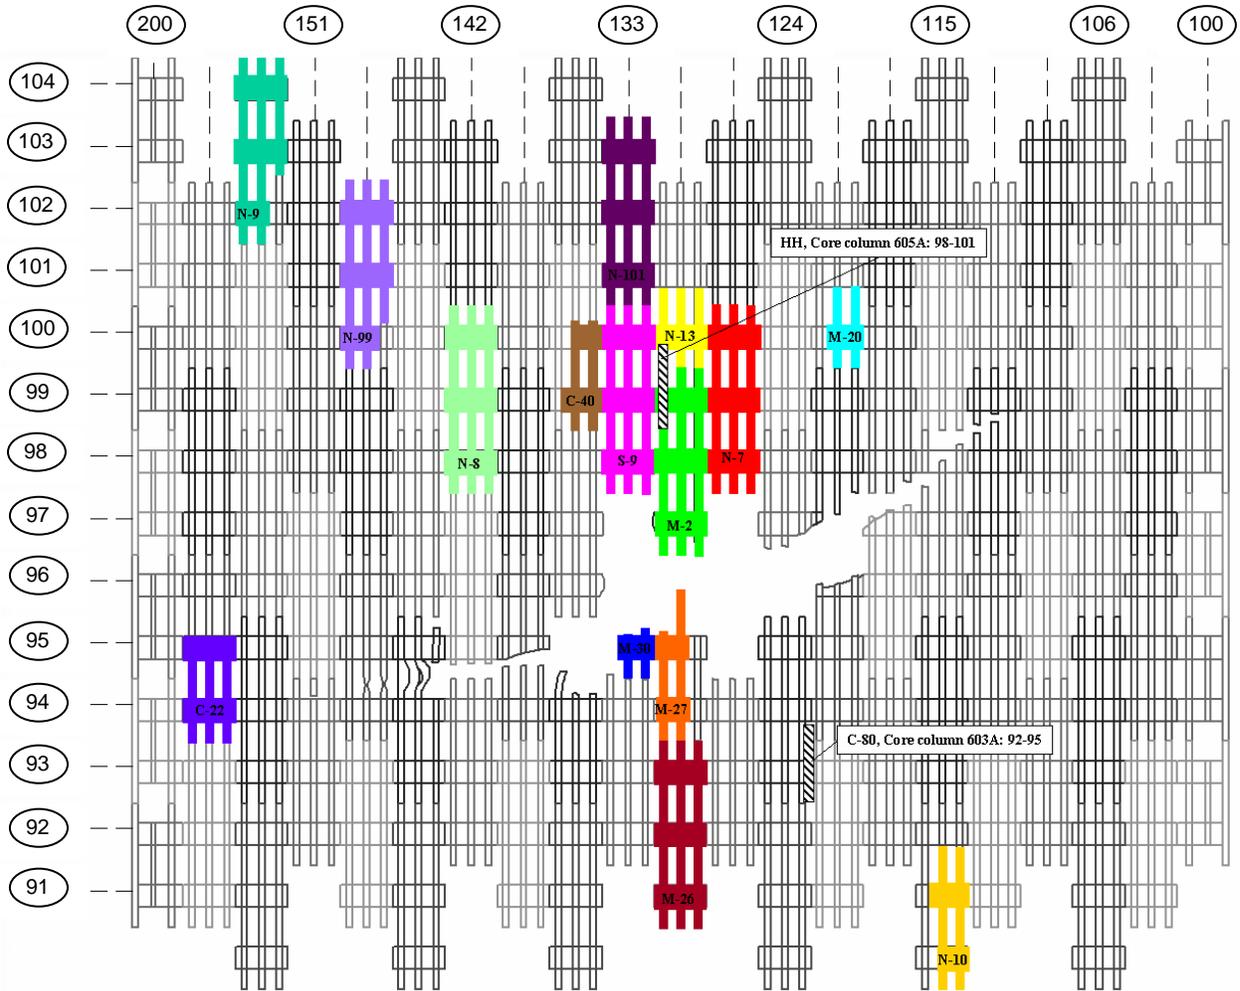
Figure 5–5a. Interpreted column damage, from photographic evidence, to north face of WTC 1, with overlay of recovered steel identified by NIST. Colored regions represent recovered portions. Both core columns (#603 and #605) are in the second row from the north face of WTC 1.

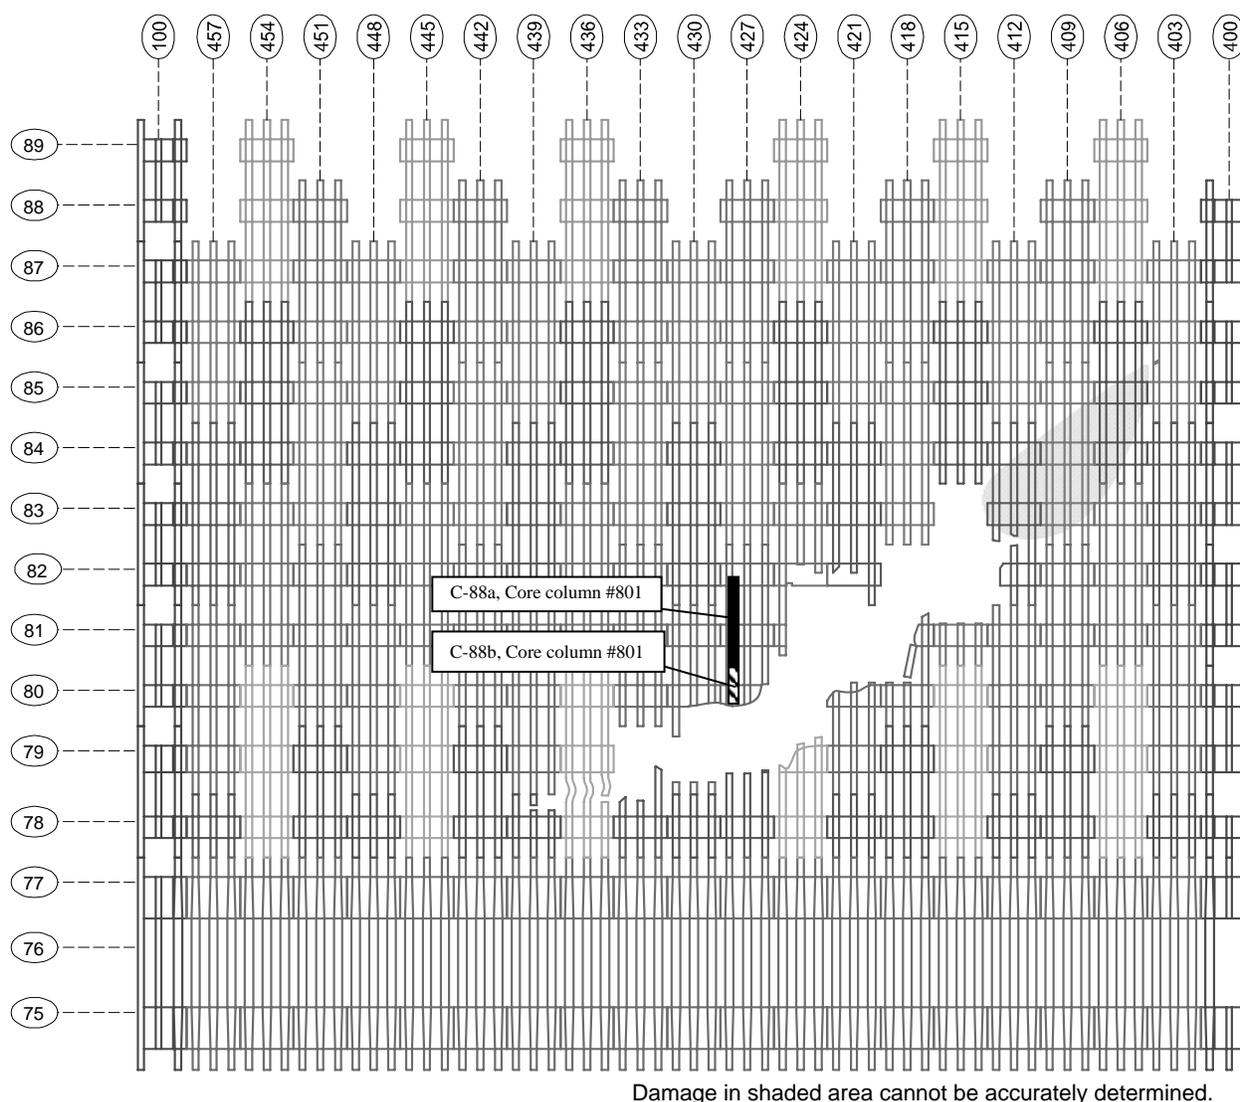
Figure 5–5b. Interpreted column damage, from photographic evidence, to south face of WTC 2, with overlay of recovered steel identified by NIST. Samples shown represent recovered portions. Core column line 801 is in the row closest to the south face of WTC 2.

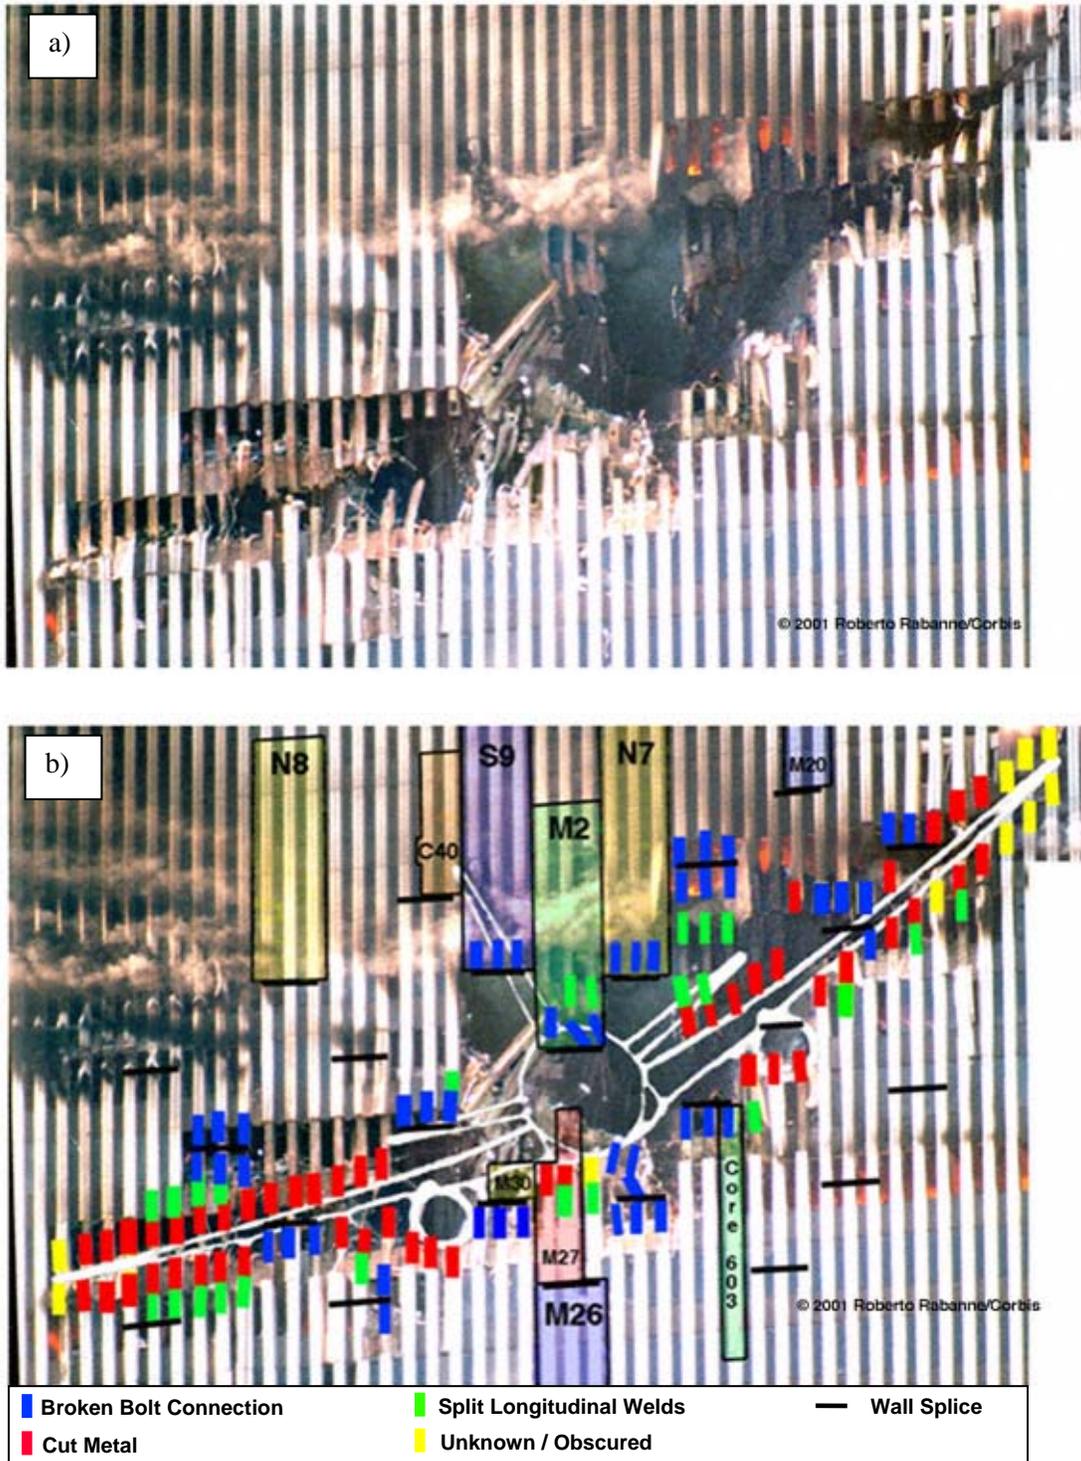
Figure 6–1. (top) Enhanced image showing the impact hole in the north face of WTC 1, and (bottom) overlay of an outline of a Boeing 767 that has been distorted to get a best approximate fit with damage to WTC 1. The location and type of localized damage has been indicated.

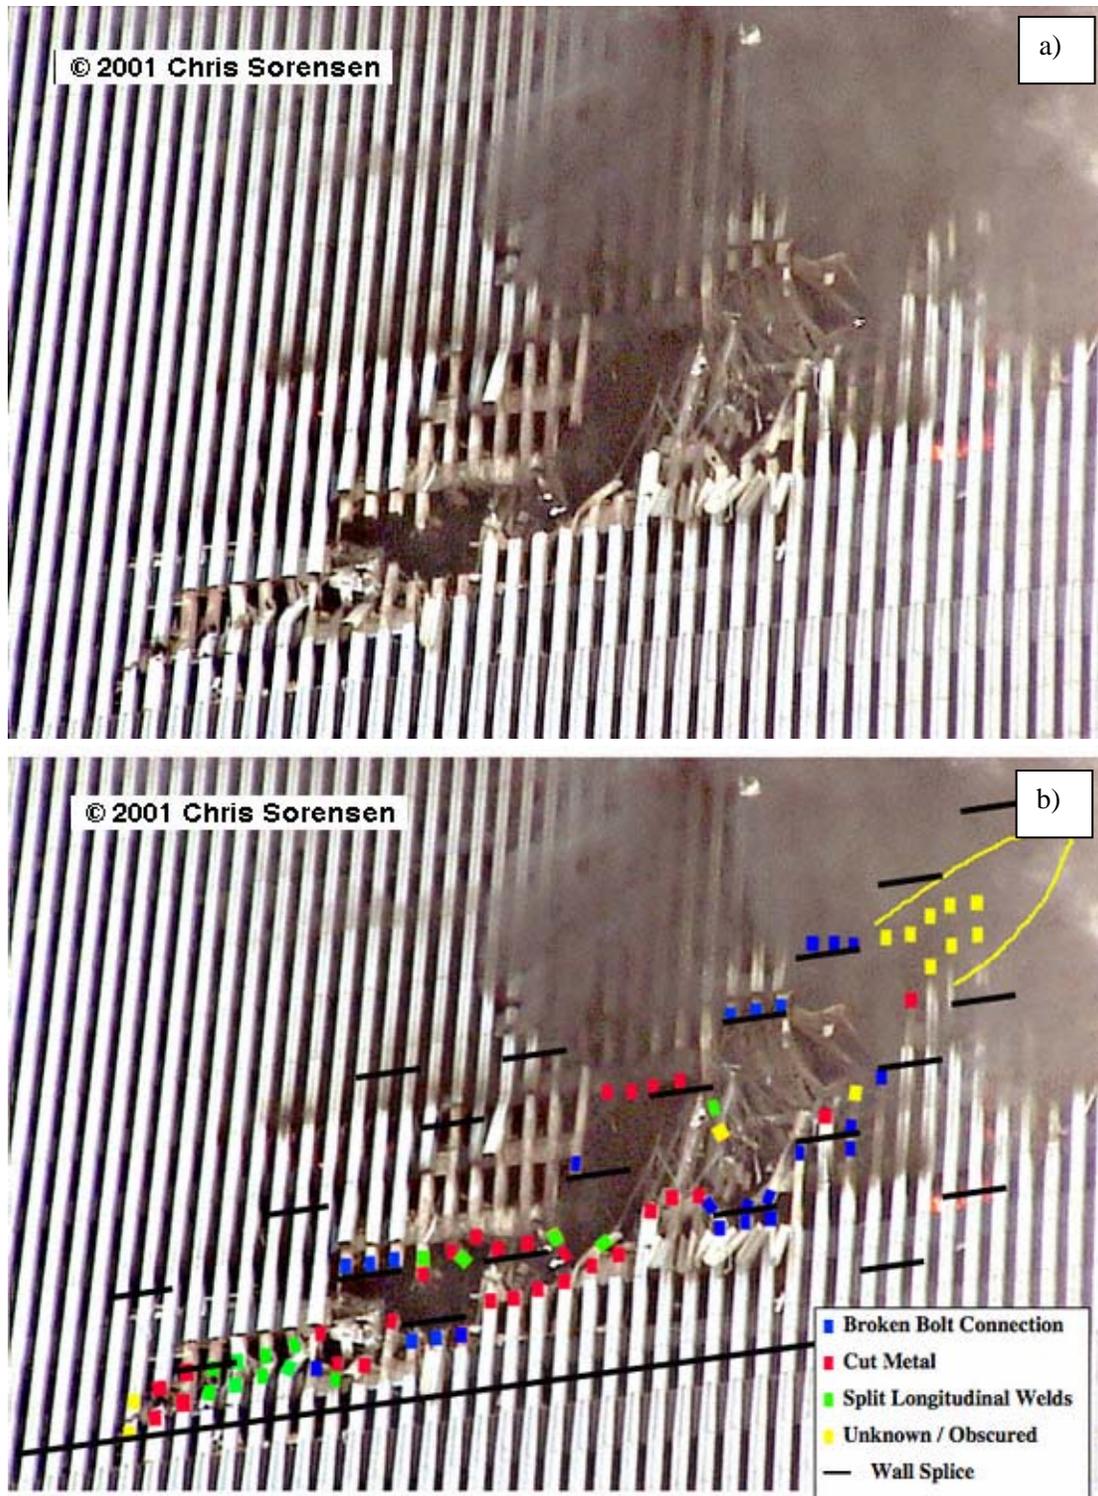
Figure 6-2. (top) Enhanced image showing the impact hole in the south face of WTC 2 and (bottom) overlay of the location and type of localized damage.

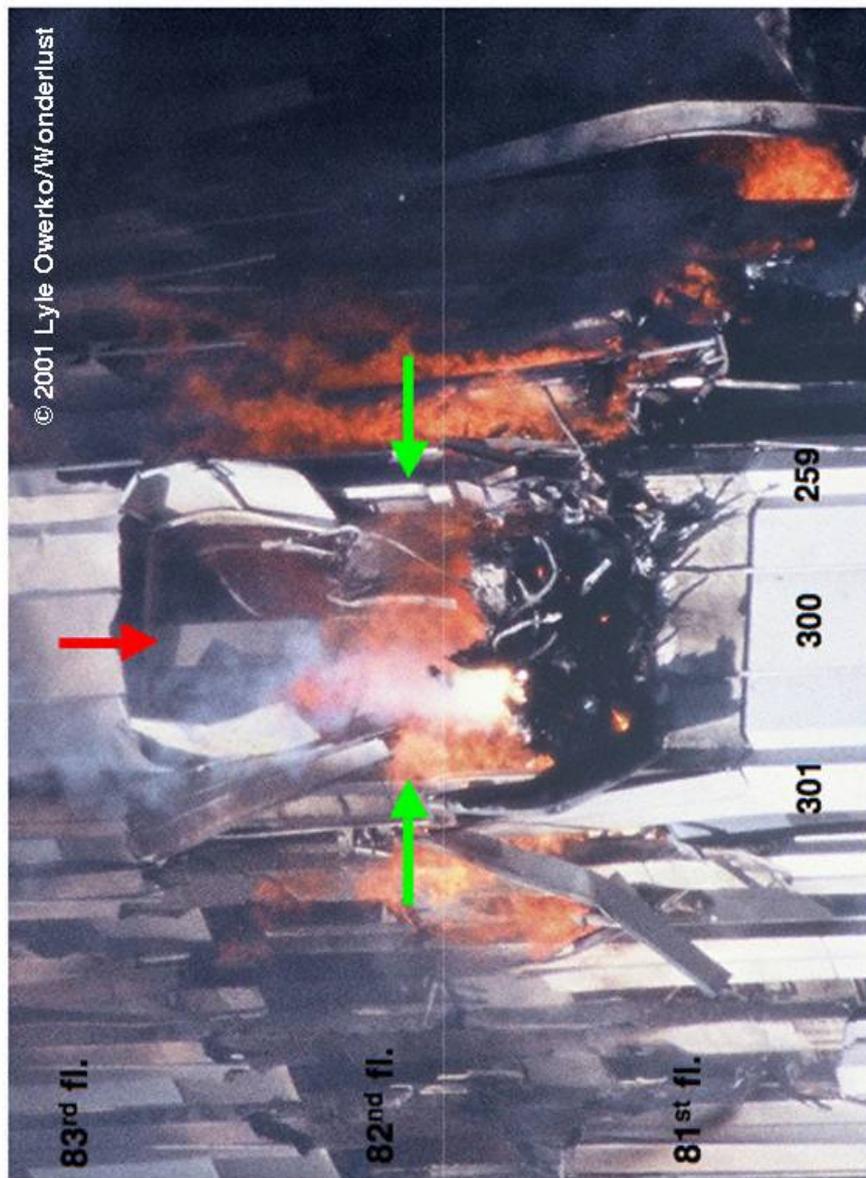
Figure 6-3. Damage to northeast corner of WTC 2 at 81st floor. The red arrow indicates an intact column 300 at the 82nd floor. Other photographs confirm that the spandrel connecting column 300 to columns 259 and 301 is also intact (location indicated by green arrows).

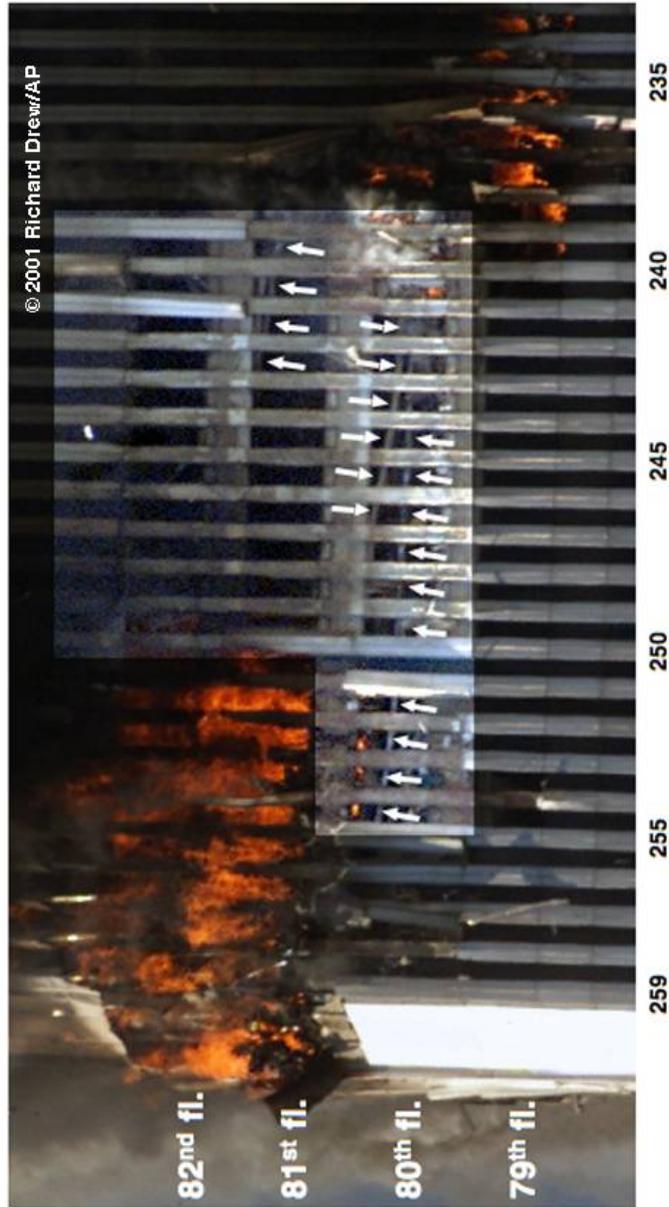
Figure 6-5. Dropped floors on north face of WTC 2.

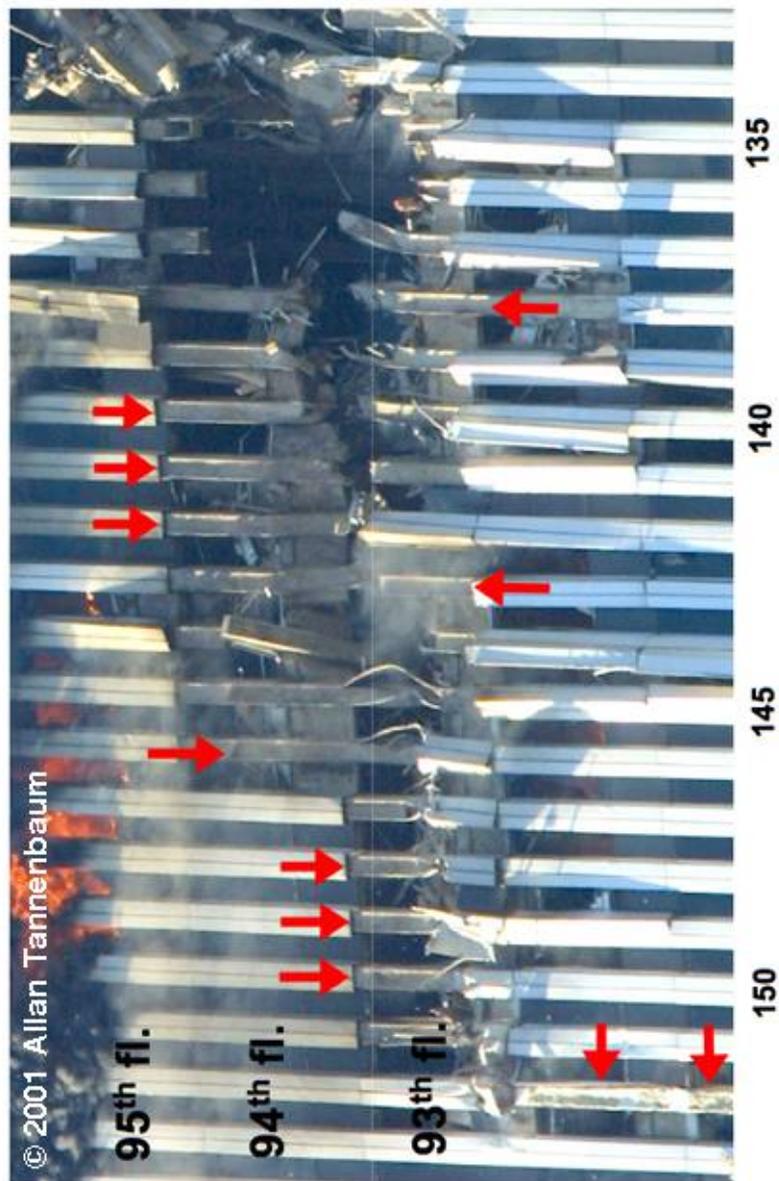
Figure 6-8. Port side of impact hole in north face of WTC 1 showing missing fireproofing. The red arrows indicate a few of the many instances of missing fireproofing around the impact hole. The region roughly approximated as the area where the aluminum panels were dislodge has been digitally enhanced for clarity.

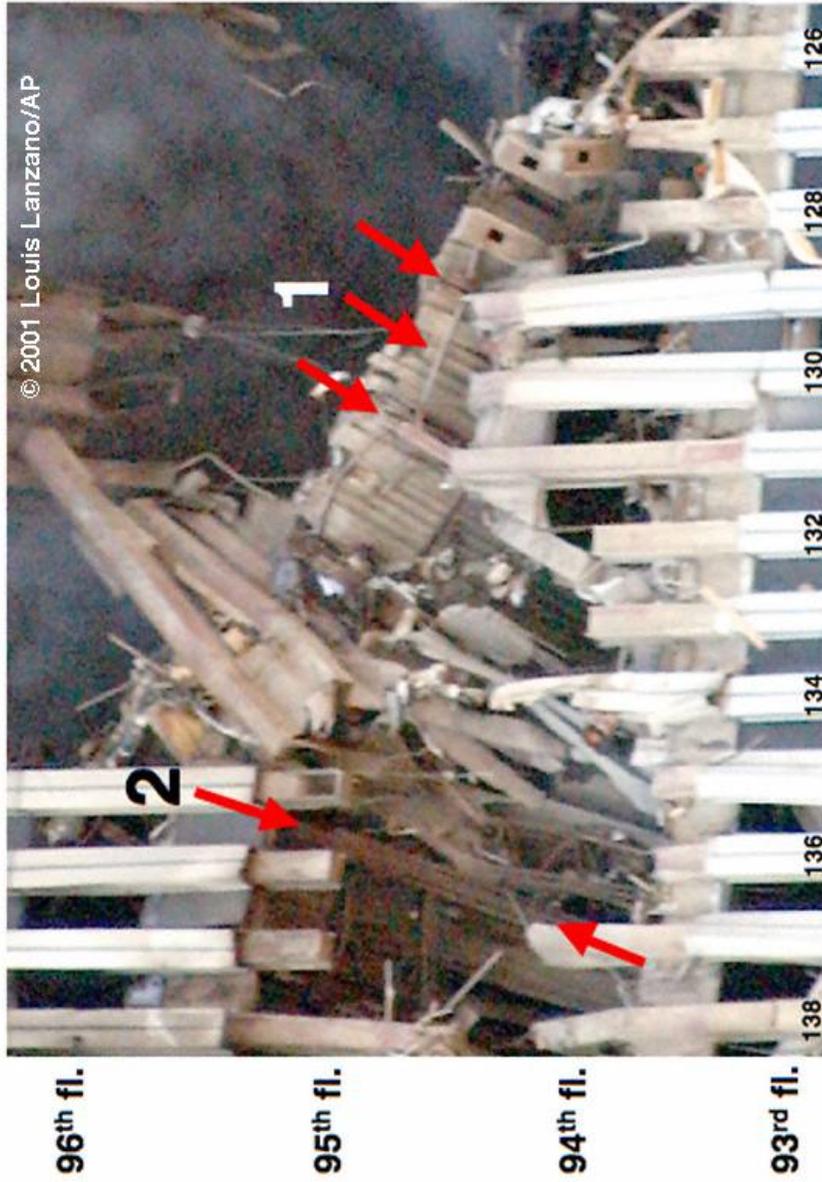
Figure 6-9. Missing fireproofing on floor trusses that fell into impact hole on north face of WTC 1. The arrows labeled "1" are three trusses where the lower or upper chords can be seen, and can distinguish the line that separates the two angle iron components. The arrows labeled "2" lie at either end of a lower chord of a truss that fell farther inside the building, and is made up of four angle irons (a double truss). The red paint color being visible and the fact that the line between the angle iron can be seen indicated that the fireproofing was displaced.

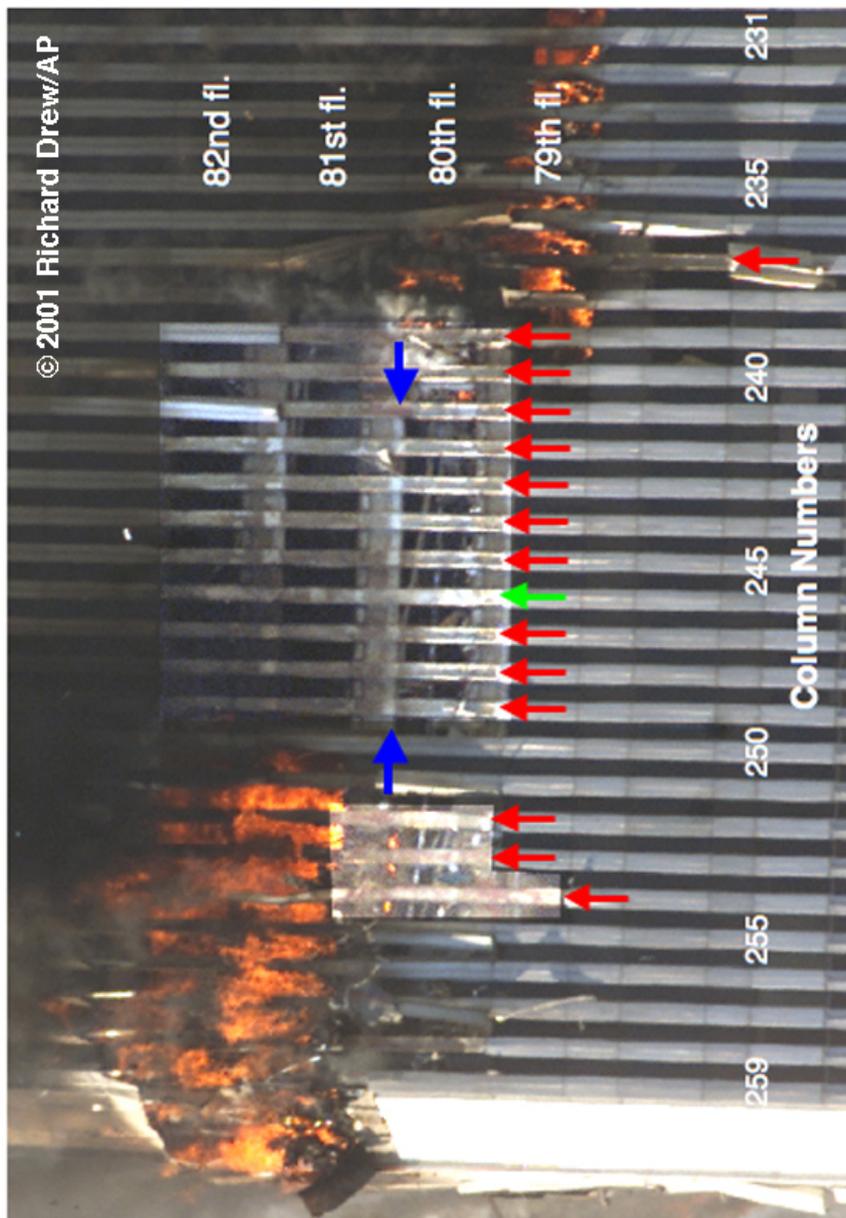
Figure 6–10. Missing façade and fireproofing on north face of WTC 2. Two regions have had contrast and gamma adjusted to enhance visibility of the features. Red arrows indicate columns with missing or damaged fireproofing. Missing or damaged fireproofing determinations were made from this and several other photos taken at different times and angles. Blue arrows indicate white features where some sort of coating has preserved the fireproofing in place.

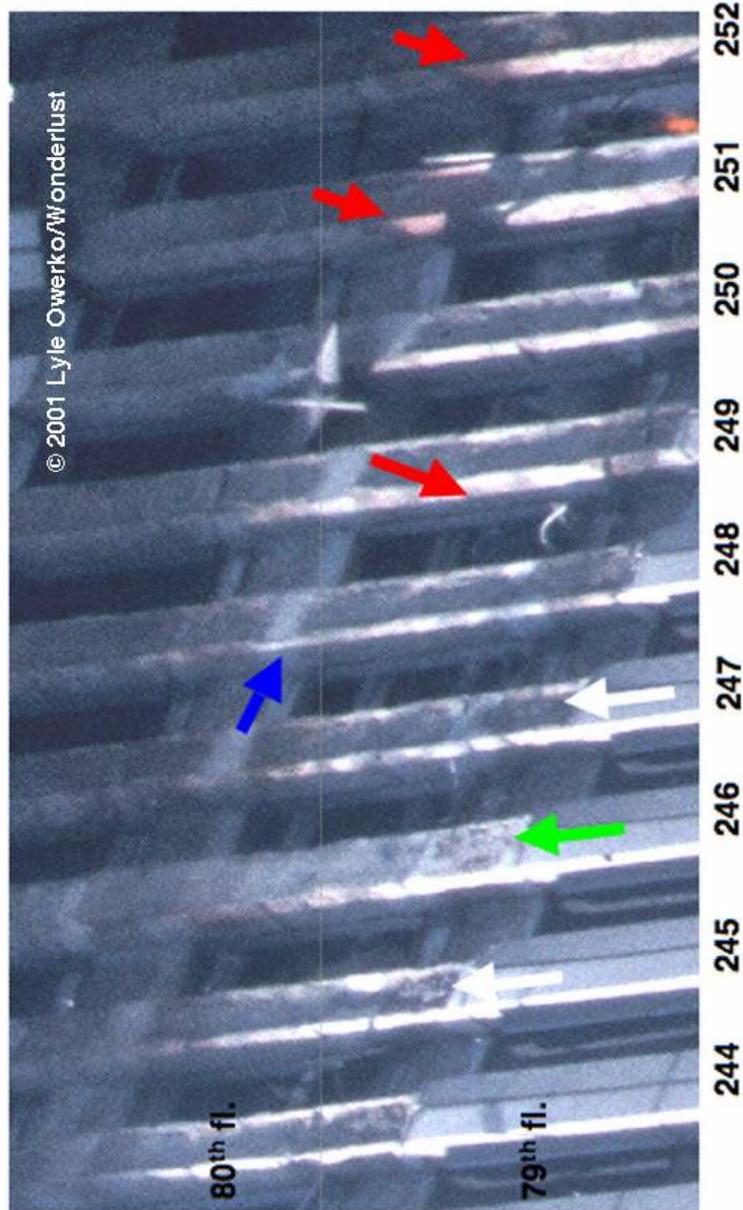
Figure 6-11. Missing fireproofing on flanges of exterior columns of north face of WTC 2. Fireproofing has come off, revealing red Tnemec paint of the column (red arrows). This image also shows how the outer web regions have been partially or completely denuded of fireproofing. Damage is evidenced by shading by sunlight - compare green (undamaged fireproofing) and white (damaged fireproofing) arrows. Blue arrow indicates same type of white coated area of fireproofing as previous figure that adhered when material above and below was dislodged.

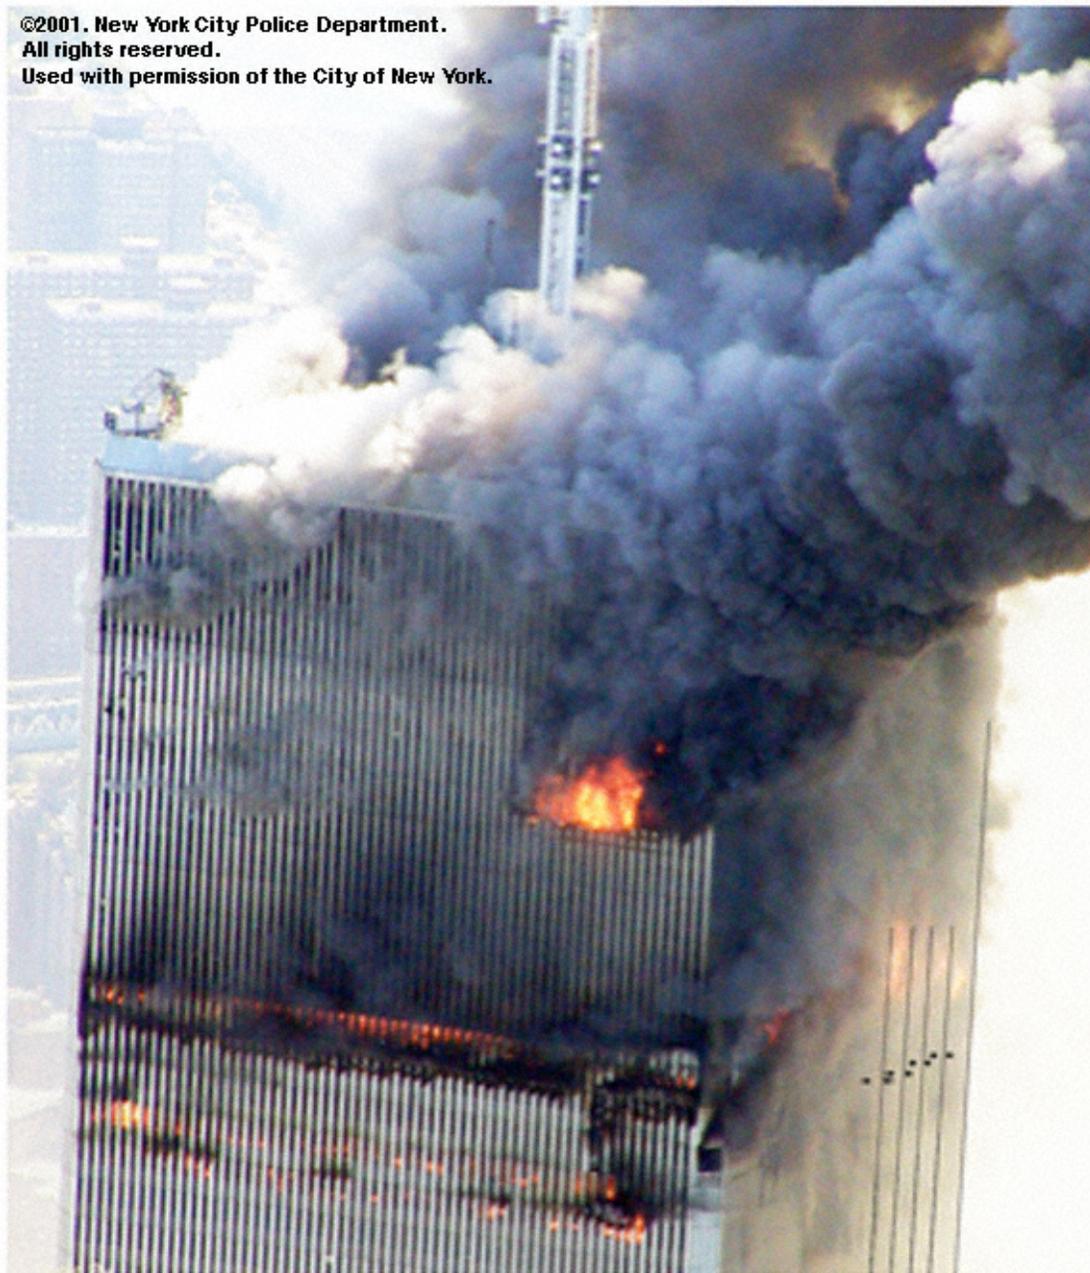
Figure 6–14. Inward bowing of south face (at right, with dark lines overdrawn) of WTC 1. Taken at 10:23 a.m. from an NYPD helicopter.

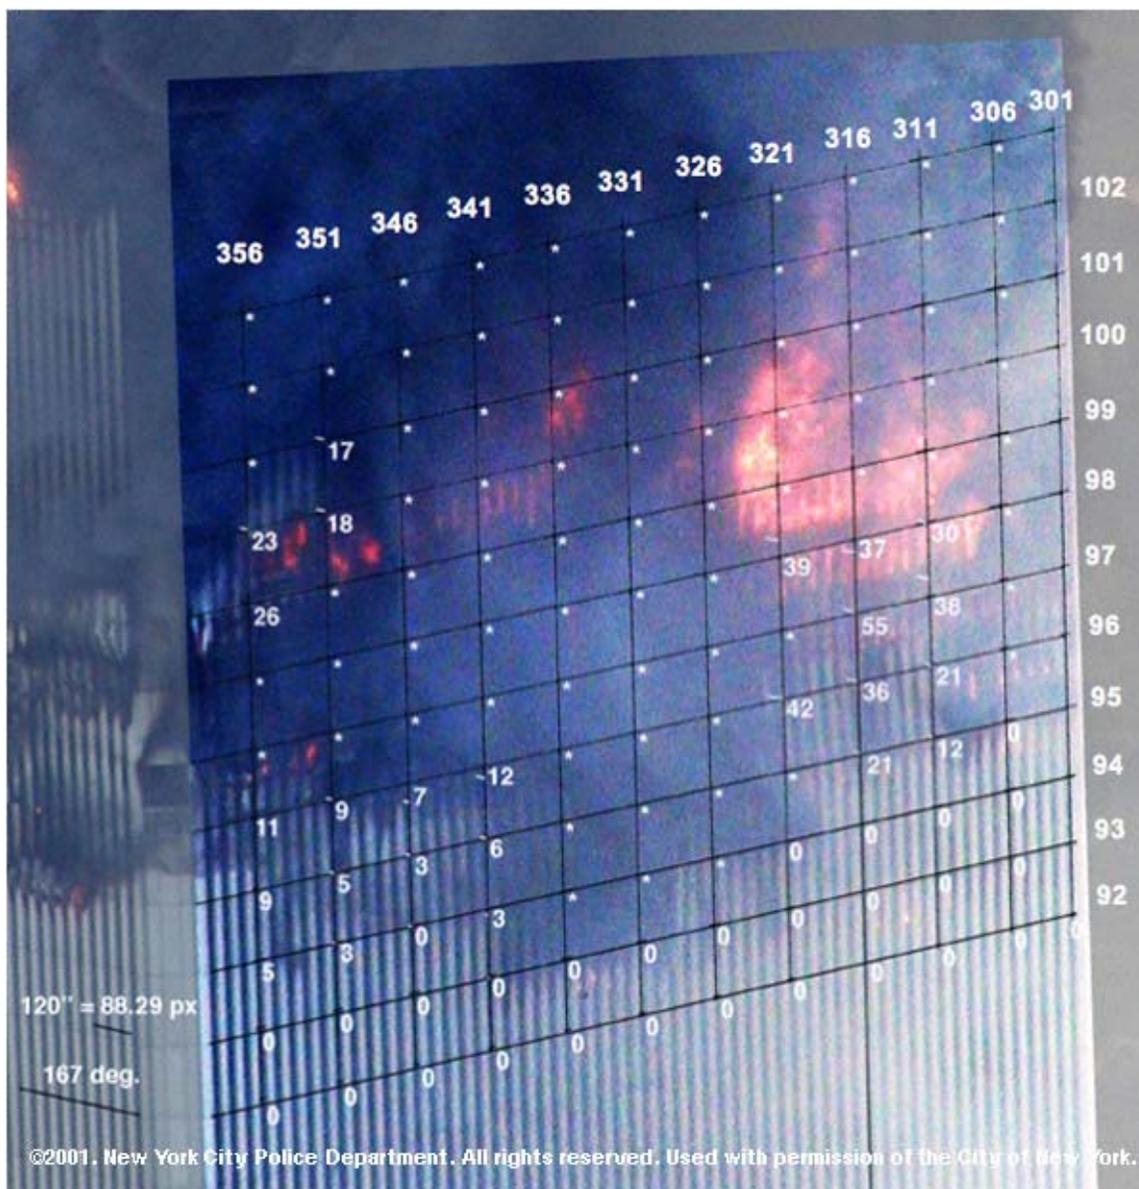
Figure 6–15. Pull in of south face of WTC 1 at 10:23 a.m. showing considerable displacements of outer columns into the building. Faint white vertical features are the aluminum façade of the exterior. Maximum visible inward displacement of the columns is 55 in. +/- 6 in. Poor resolution leads to large uncertainties in measurements; a large fraction of the south face of the building is obscured by smoke.

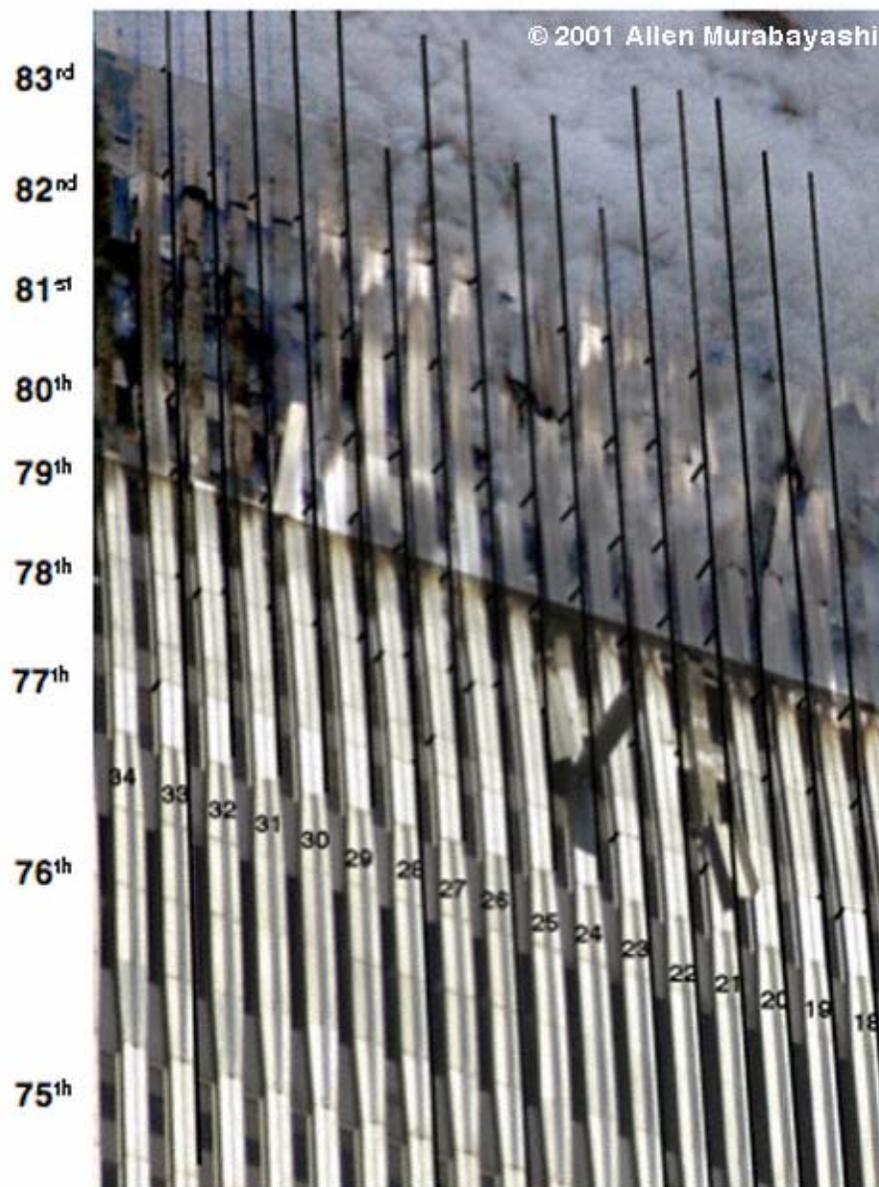
Figure 6–16. East face of WTC 2 at 9:53:04 a.m. showing a larger amount of pull in. The vertical black lines were drawn to establish the original line of the exterior wall columns, and the shorter line segments are drawn at the same angle as the nearest observable joint in the exterior aluminum panels to establish the inward bowing distance. For actual column numbers, add a “3” to the front of the two-digit designations in the image.

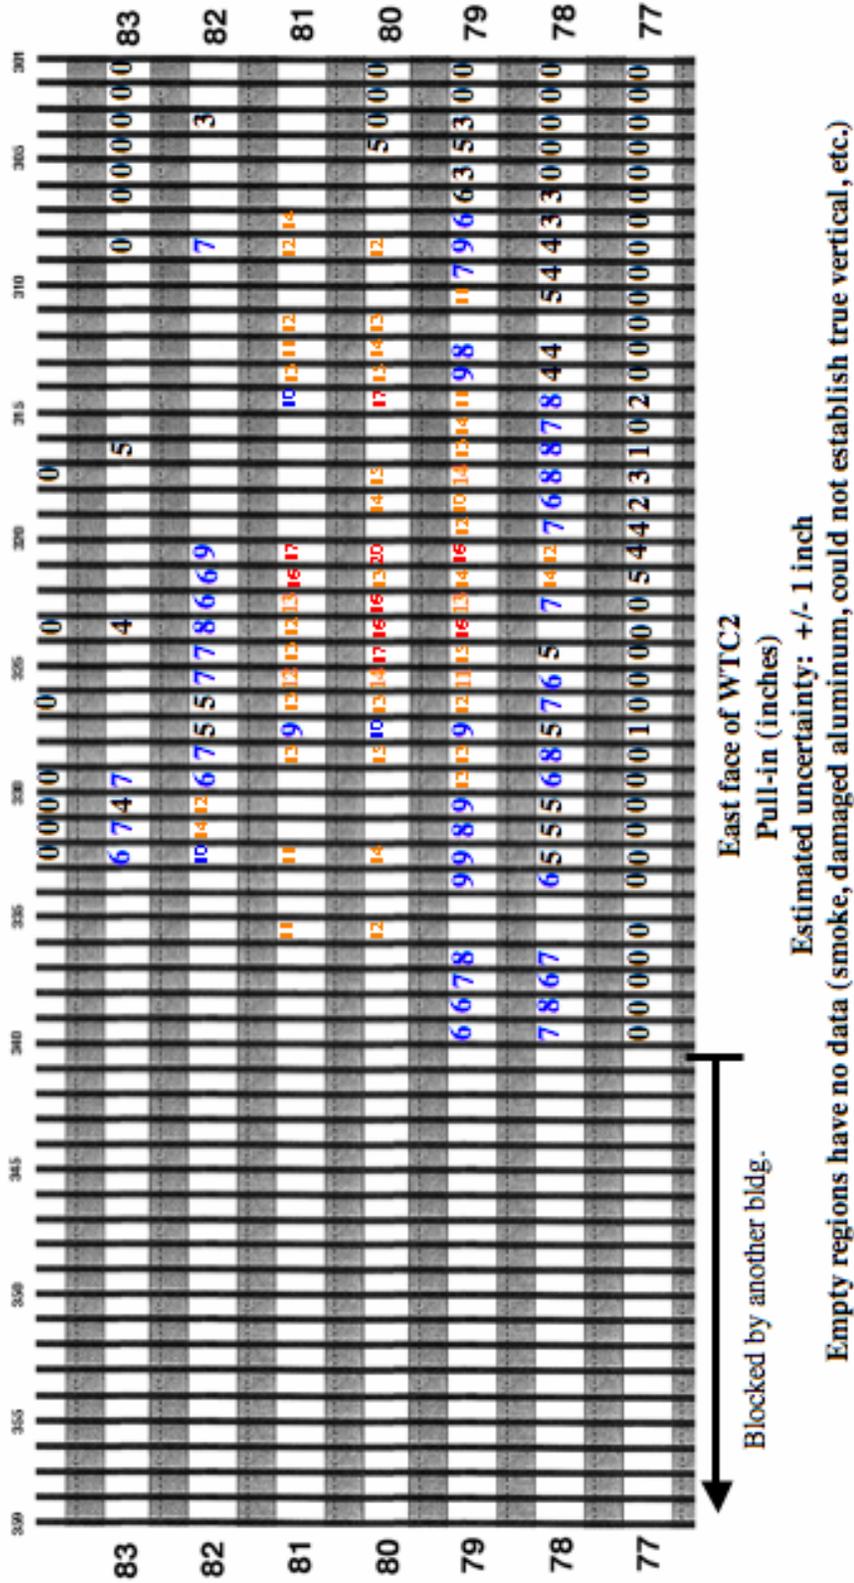
Figure 6-18. Map of pull in displacements of the east outer face of WTC 2 inward shortly before collapse. Each measurement refers to the upper left corner of the window within which the number resides. Measurements were in inches. The colors refer to groups of 5 in. displacements (0-5: black, 6-10: blue, 11-15: orange, 16-20: red) for easier visualization. This data was combined from two images taken by the same photographer at nearly the same location 10 s apart, and it is assumed that the inward deflection did not change appreciably during this time.

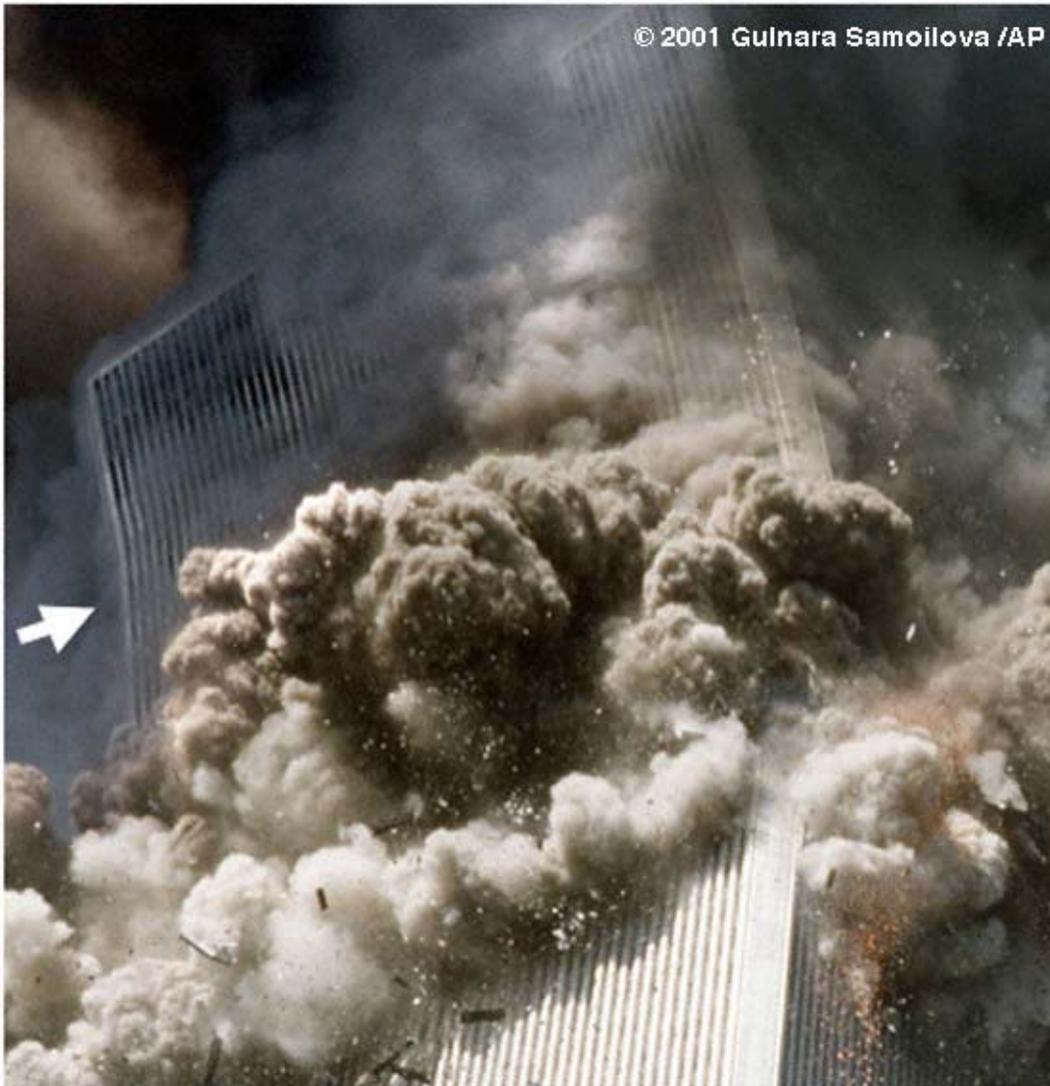
Figure 6–19. Initial seconds of collapse of WTC 2 viewed from the east-northeast, and kink in the southeast edge of the building near the 106th floor (arrow).

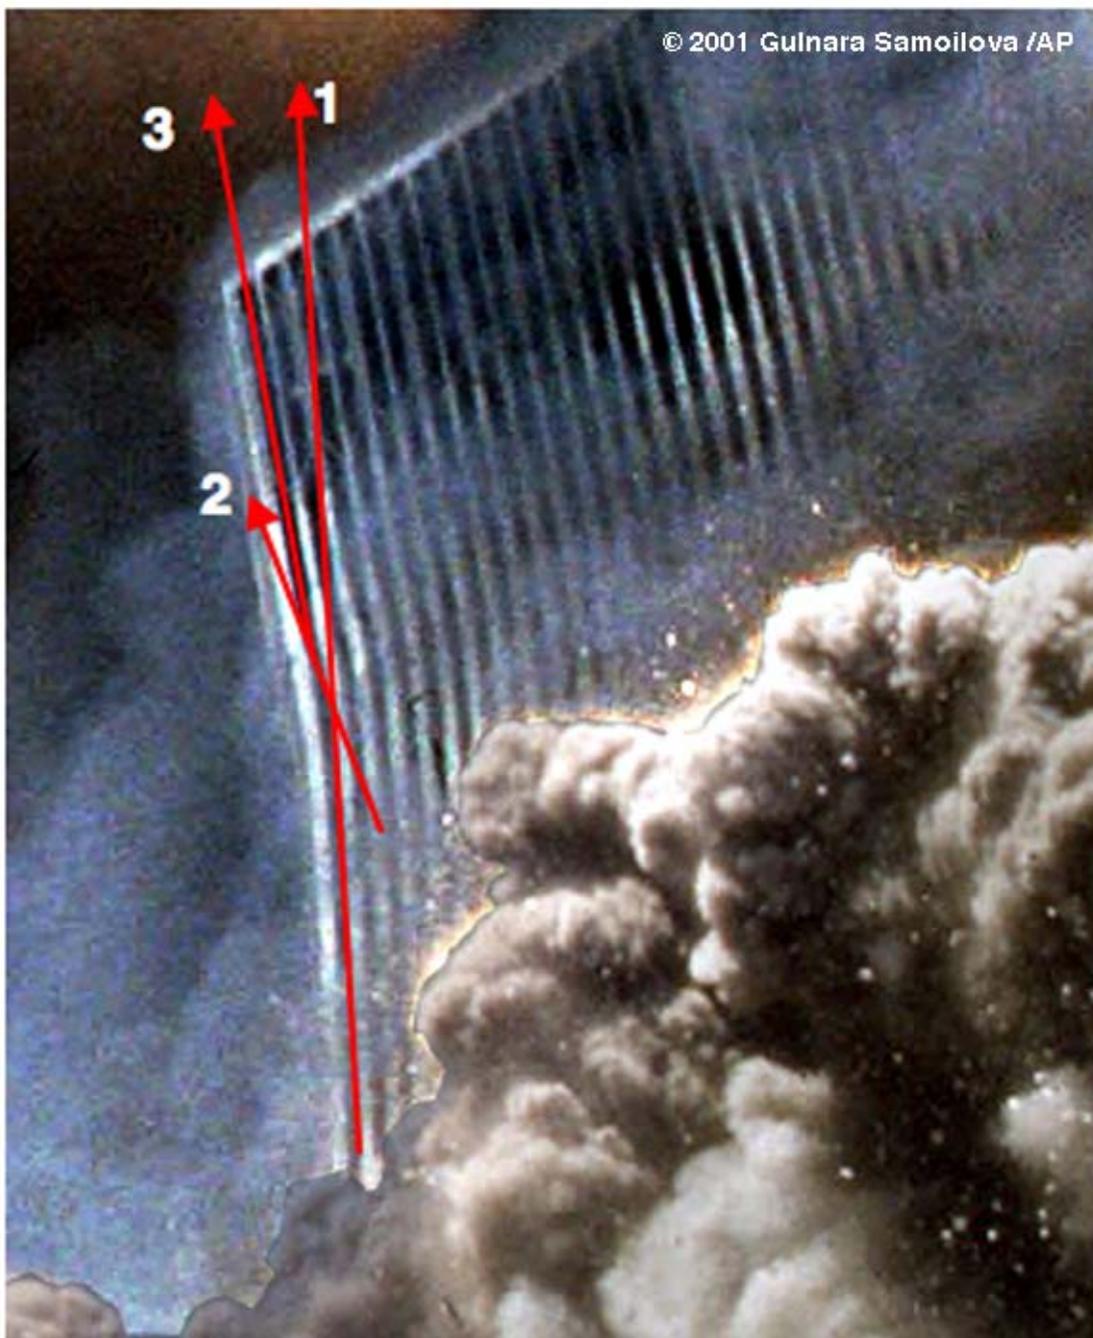
A more detailed analysis of the geometry has been made of this distortion, shown in Fig. 6–20. The kink was in fact a double-kink, and the directions of the axes of bending are shown in the figure. It was believed that this distortion was formed by the sideways shift of loads transmitted via the hat truss and rigid, beam-framed floors of floors 107 to 110, and a more detailed structural analysis can be found in NIST NCSTAR 1-6E. Examination of the right side of the image, after considerable image processing, shows that the NE corner of the building bent, but had no sharp discontinuity. Thus, the sharp kink had not propagated across the face of the building. An image taken approximately 2 s before collapse (Fig. 6–21) shows no bending, so it is believed that the kink developed at either the moment of collapse initiation or during the earliest moments of the collapse process.

Figure 6–20. A close-up of the kink area in the previous figure (southeast corner, WTC 2), with overlaid lines to highlight the details of the kink geometry. The edge of the building (1) bends an angle to another direction (2), then bends back somewhat toward the original direction (3).

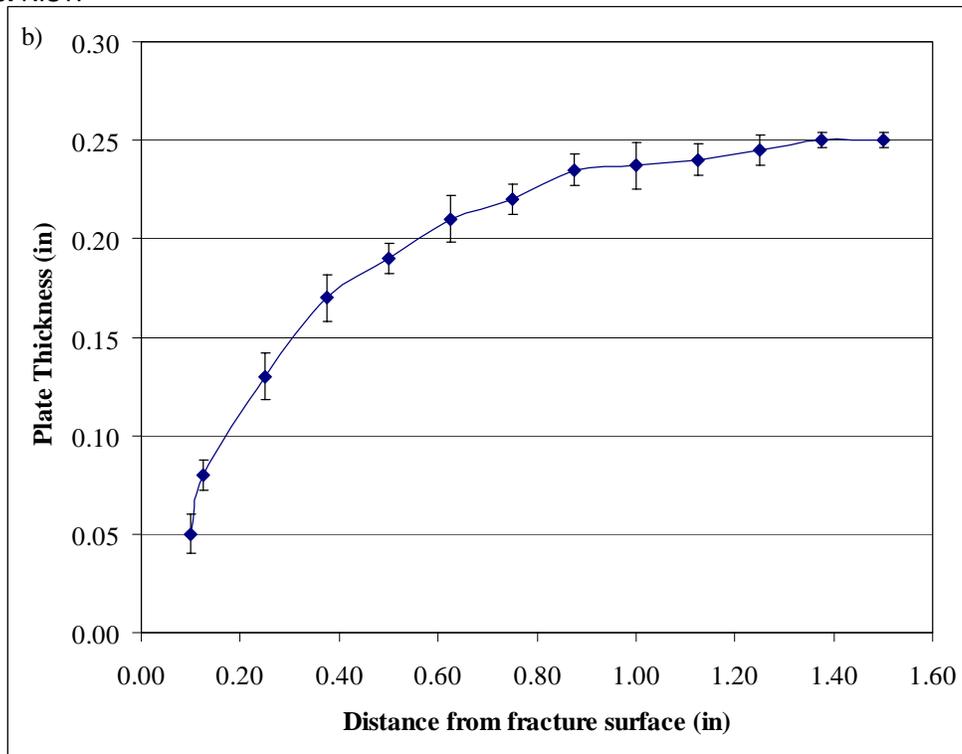
**Figure 6–23. Thinning of outer web from column 130 of panel M-2 (A130: 96-99).
a) Photograph showing thinning, b) graph indicating plate thinning near fracture surface.**

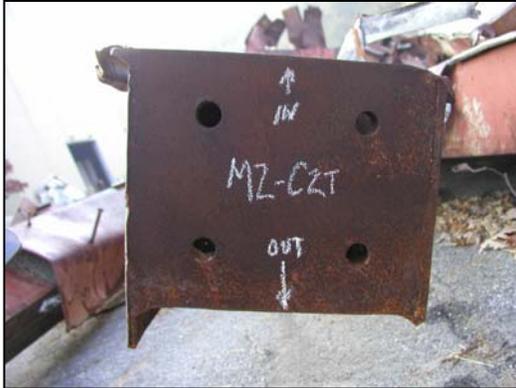
No change in bolt hole shape

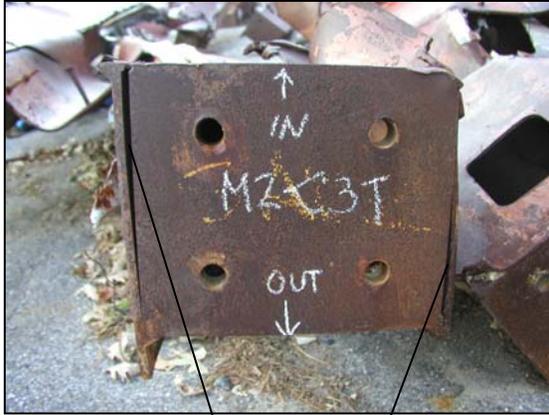
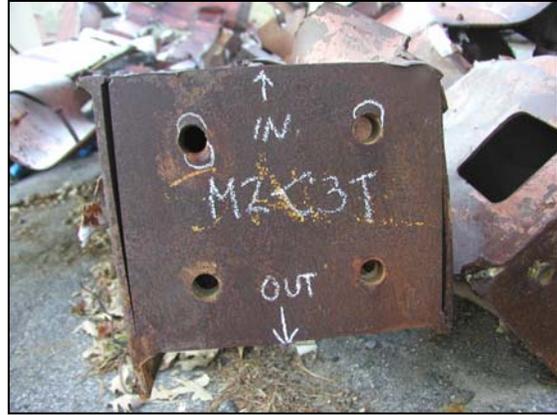
Separation between flange plates and butt plate
