NIST NCSTAR 1-3

**Federal Building and Fire Safety Investigation of the
World Trade Center Disaster**

Mechanical and Metallurgical Analysis of Structural Steel

September 2005

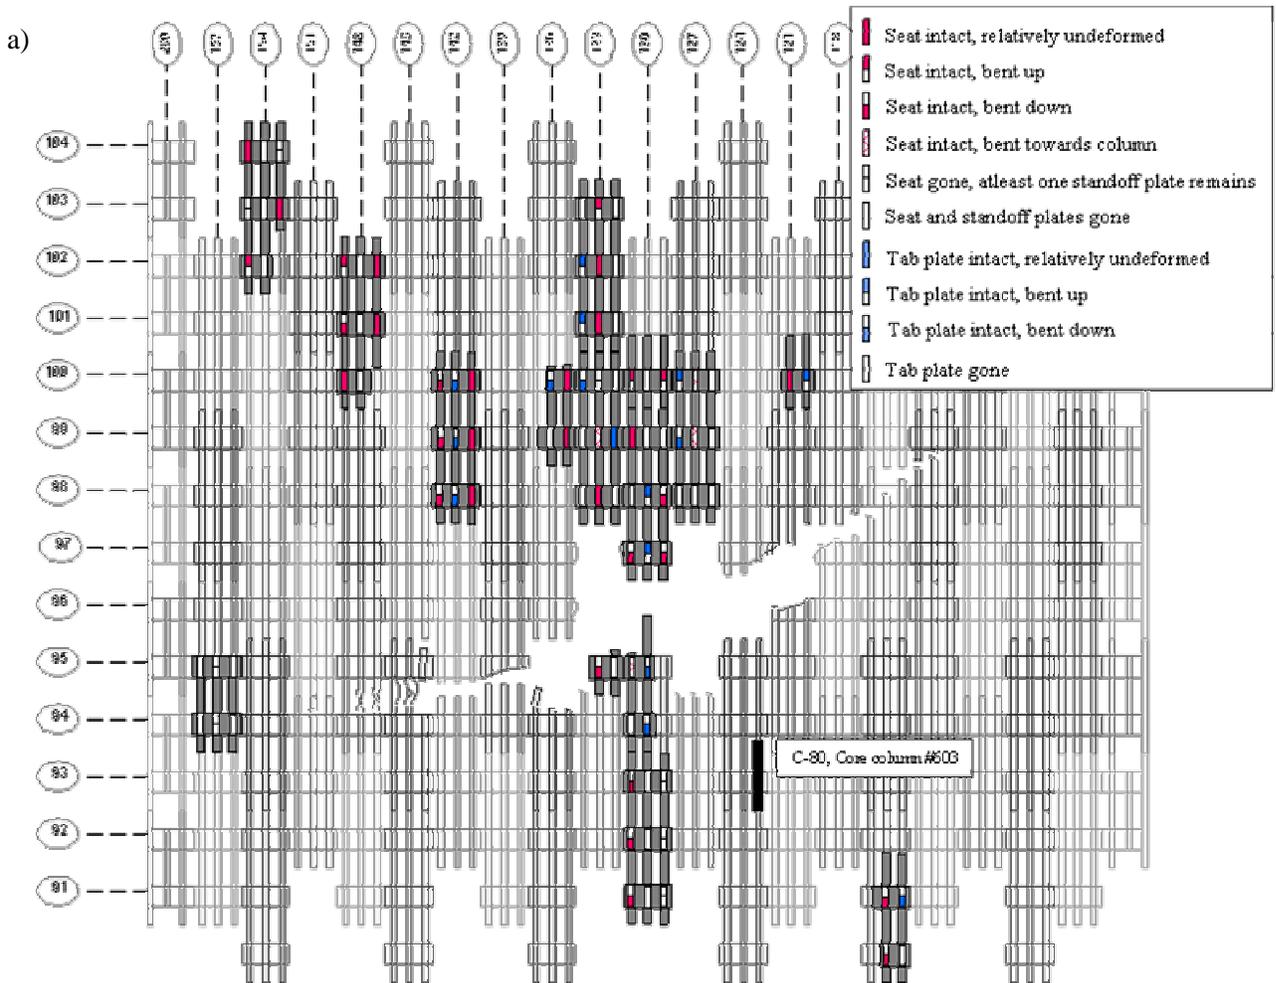
Figure 6–28a. Damage diagram overlaid with recovered samples and damage of connectors.

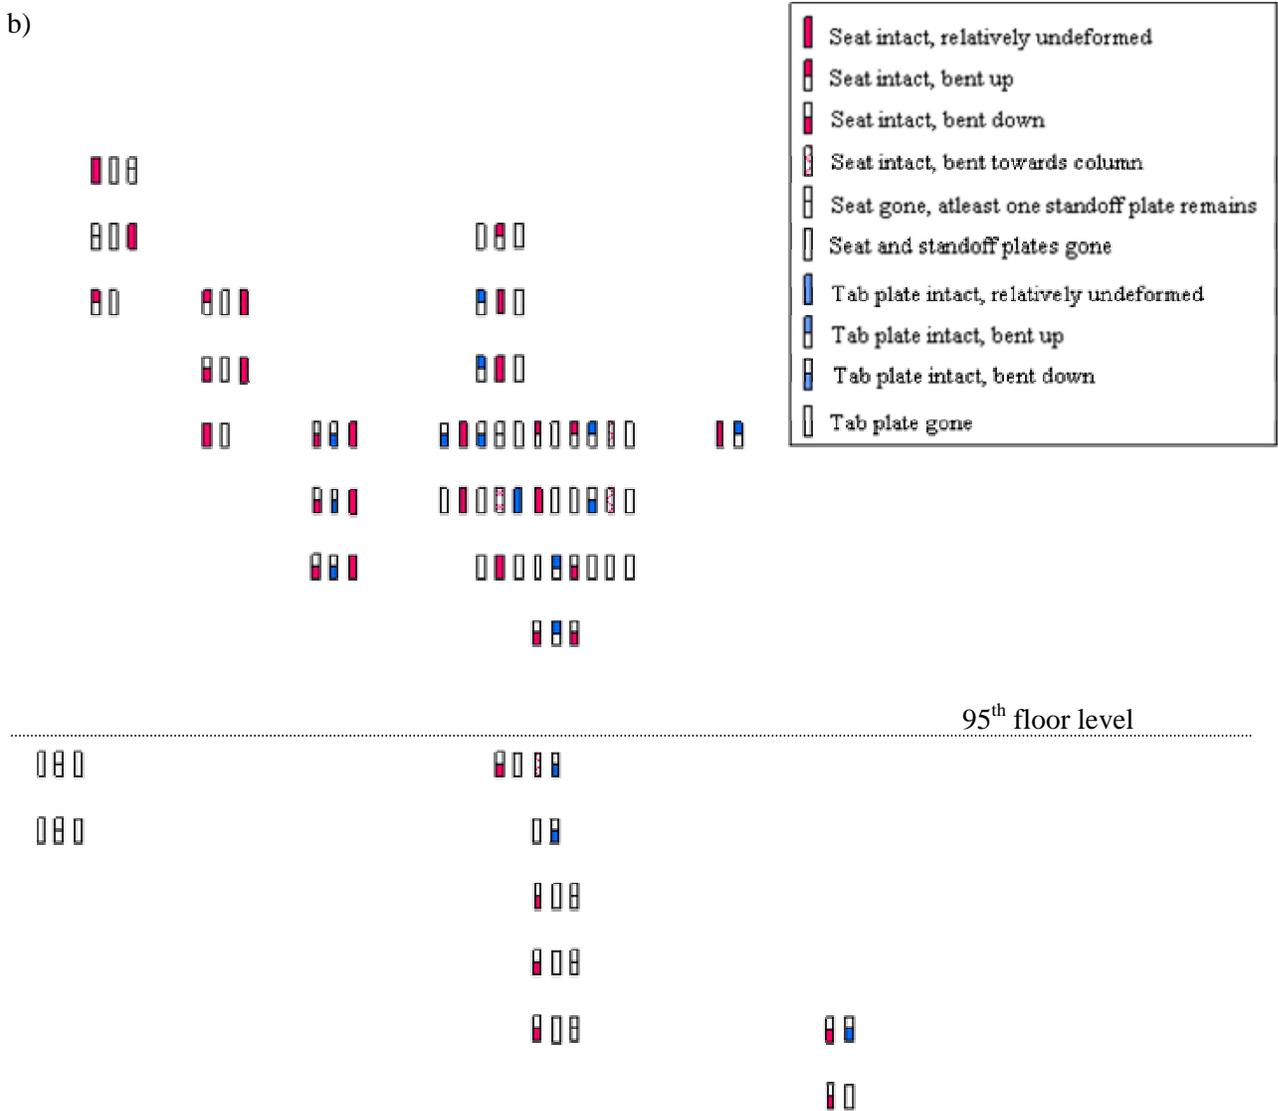
Figure 6–28b. Damage of connectors. At or below the 95th floor, all connectors are either bent down or missing.

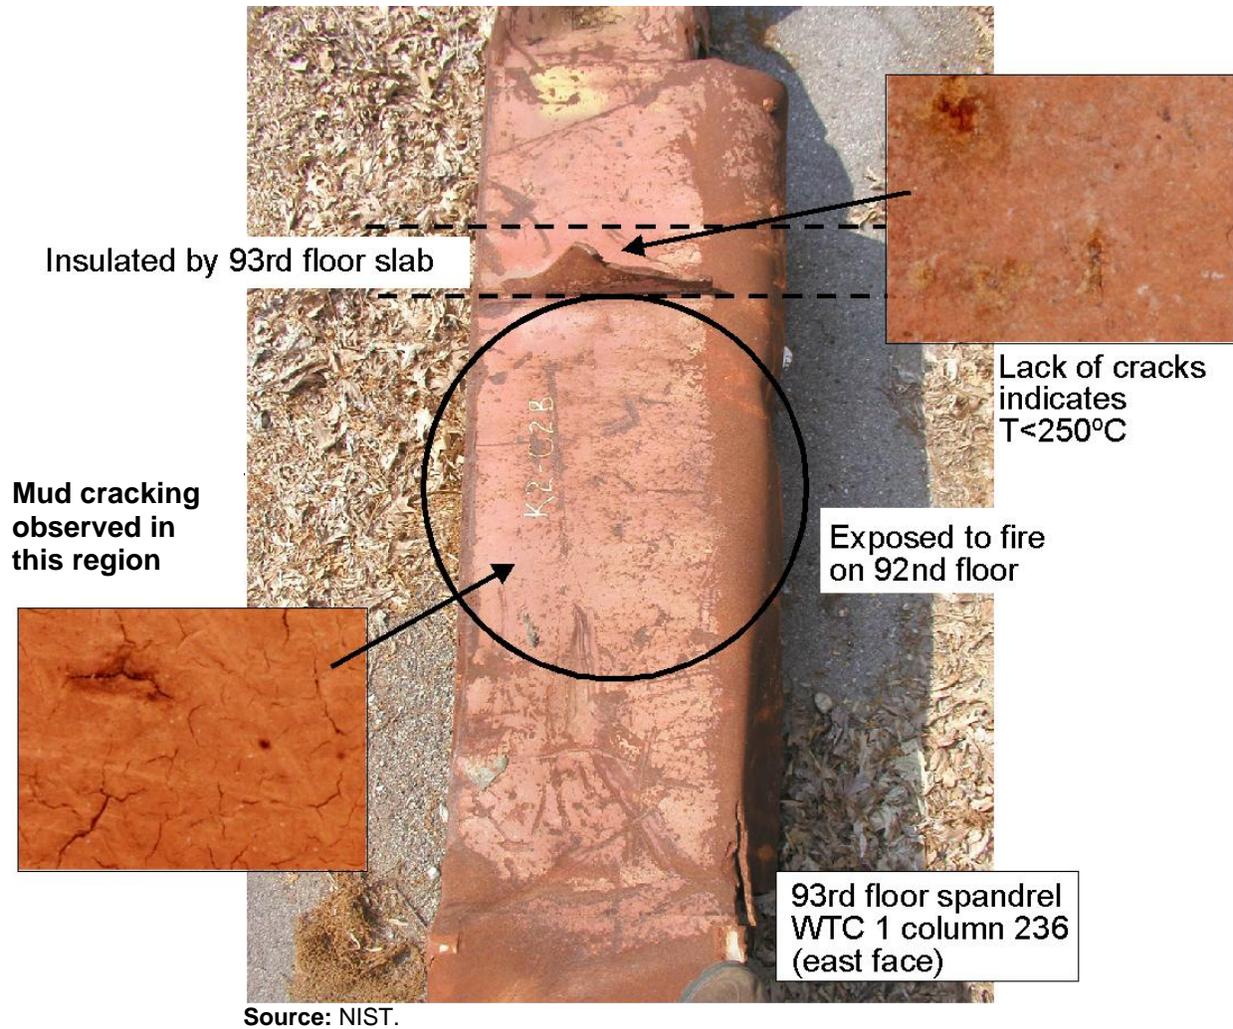
Figure 6–37. Spandrel at the 93rd floor of column 236 from sample K-2 (A236: 92-95). Paint mud cracking was found below the 93rd floor line, no evidence of paint mud cracking was found above floor line.
