ICLP 2000

SOME ENLIGHTENING CASE HISTORIES ON LIGHTNING DAMAGE

Thomas Key

EPRI PEAC, Inc.

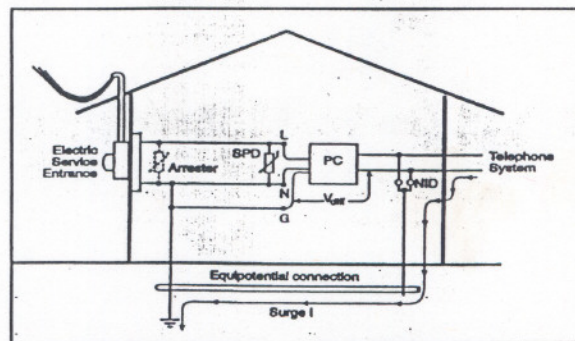
Figure 1 – Scenario for shifting reference potentials between power and telephone systems

The visit revealed a case of the incorrect but frequent practice of two uncoordinated providers – the cable TV company and the power company – installing their service entrance at opposite ends of the house (Figure 1). The consequences of such practice are briefly described in the following.

In the scenario of Figure 1, a personal computer (PC) is connected to both the power system and the telephone system. The surge current "Surge I" flows from the telephone system toward the common grounding point via the protective device "NID" at the point of entry, and the equipotential conductor. This current produces a magnetic field which couples into the loop formed by the power branch circuit, the telephone premises wiring lines to the PC, and the equipotential conductors. The voltage thus induced in the loop appears across the telephone and power ports, with upsetting or damaging consequences.

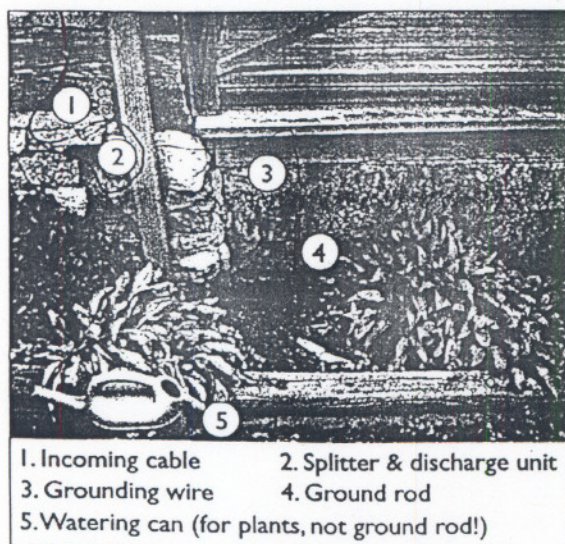
Figure 2 — Cable TV entrance

In the Cozy Cabin installation, the power service entrance was located at one end of the house, while the cable TV service entrance was located at the opposite end. Furthermore, a visit to the site revealed that the cable TV shield was grounded only by a questionable ground rod next to the house foundation (within the drip line, and thus in dry soil, see Figure 2). This cable TV grounding electrode was not bonded to the grounding electrode of the power service entrance, a clear violation of the U.S. National Electrical Code ("NEC", NFPA 70, 1999) [4].

Following the visit to the site by the authors, the local cable TV company was informed of this situation and took what they believed an appropriate action: the incoming cable was first routed under the house, in the crawl space, to allow bonding the shield to the power service grounding connection. From there, the cable was returned to its original point of entry into the house, at the opposite end. This modification did correct the NEC violation but left the arrangement in the topology shown in Figure 1.

However, the interaction was not pursued further with the cable company. A recommendation was made to the owner, to install a surge reference equalizer [5] for each piece of video equipment. After that was done, no damage occurred during the next lightning season. Of course, it is still too early to declare victory over Zeus and Murphy, but encouraging when compared to a previous history of two incidents within a few months.

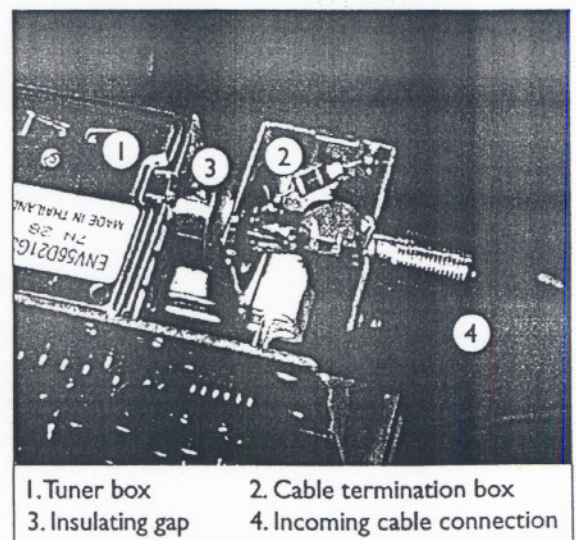
Figure 3 — Insulating gap at signal input

One of the failed TV receivers from the Cozy Cabin was made available to the authors for examination. No evidence of damage was found on the power side of the chassis and the related components, but a clear indication of surface flashover was observed along the insulation of the gap intended to isolate the cable input 'ground' termination (connected to the incoming cable shield) from the shielding can of the tuner (connected to one of the power cord conductors, see Figure 3).

After cleaning the carbonized path of the flashover, a 0,5 μ s – 100 kHz Ring Wave was applied in incremental steps between the two conductors of the power cord, bonded together, and the shield connector of the cable input: flashover occurred at 2 kV. By removing the material to a greater depth and covering it with epoxy, the gap did withstand a greater level, and failed at 2,5 kV. That flashover occurred at another part of the original insulation, thus providing valid information on the original withstand capability.

This case study illustrates the classic situation of separate service entrances, compounded with incorrect bonding. The examination and test demonstrate that at least 2,5 kV were developed across the power port and the cable TV port of the receiver under a condition of distant or nearby lightning strike.

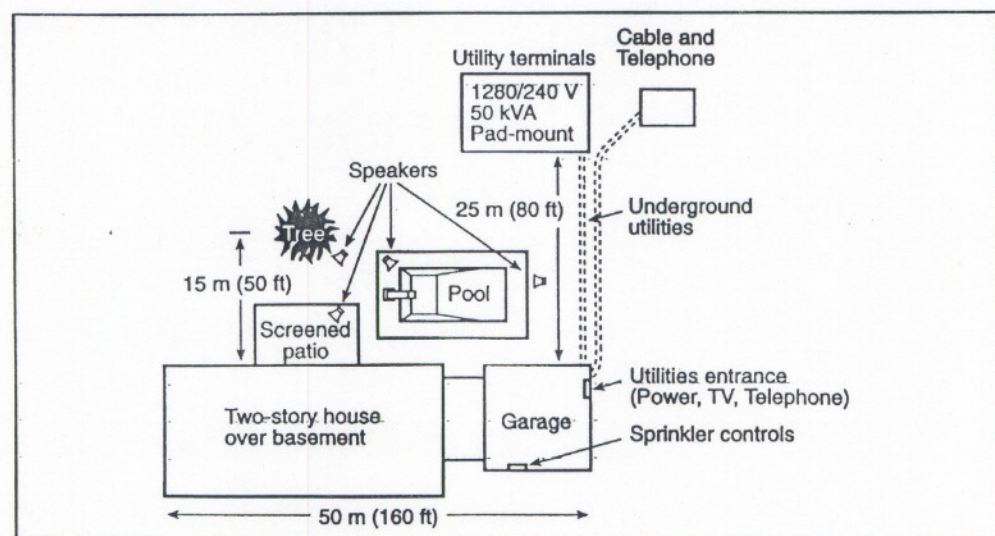
Figure 4
Schematic configuration of the Rambling Residence

The overall physical layout of the house, damaged tree, and electronic equipment are shown in Figure 4. The tree that was struck is much taller than the house and is the tallest of the trees in the immediate area. The bark was stripped from the tree trunk for most of its height. The tree trunk is only approximately 15 m from the house and even closer to the patio, where some of the audio speakers were installed. Outdoor speakers are also located in the pool area and connecting walkways.

In the audio amplifiers, as noted above, the power supplies of the units were not damaged, but their output transistors that drive the speakers and the speakers themselves were damaged. Thus, it was speculated that the surge energy had been coupled into the speaker wires, which are probably very long and very near to the lightning strike, rather than as a "power-line surge."

The visit to the installation verified this theory. The home entertainment equipment, including amplifiers, is centrally installed in the basement of the house. Speakers are located throughout the house, the patio, and the swimming pool area. The wire length between the outdoor speakers and the central amplifier is about 30 m, and some of the wires run within 10 m of the tree trunk.

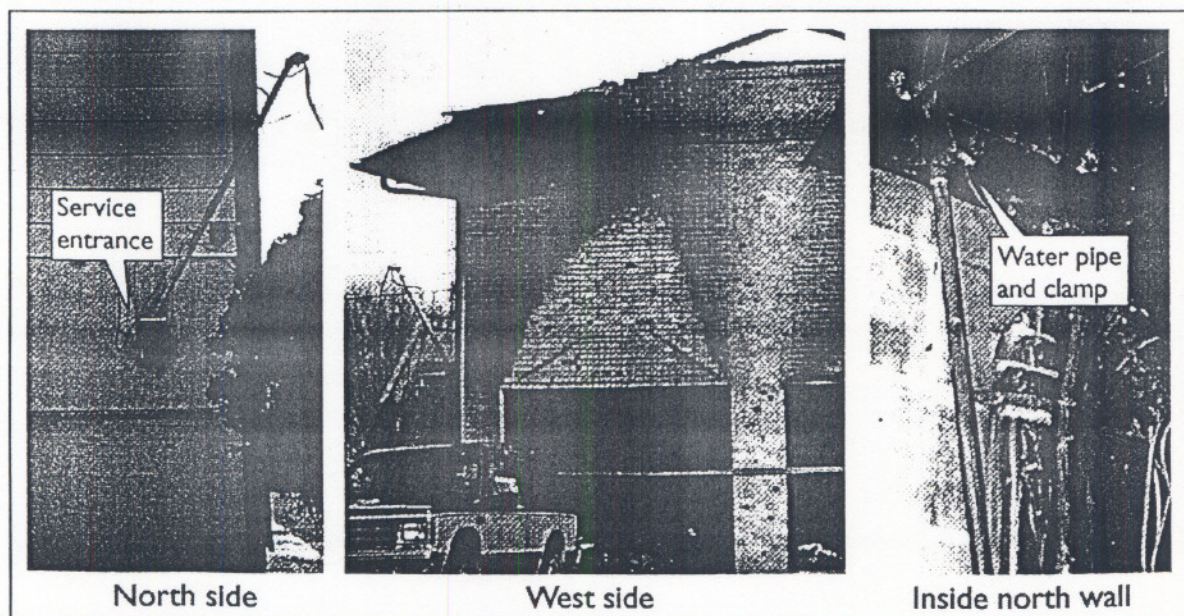
Figure 5 — The Standard Suburban aftermath

In this case, which occurred in a suburban, semi-rural hilly area, the post-strike investigation revealed that the overhead service drop to the house (involving a span of about 20 m across the street) had been severed by melting at the point of strike. From there, the current traveled to the revenue meter (typically on the outside wall in U.S. practice), where a ground conductor is normally installed with a short run to the earthing electrode of the house. Instead, according to the practice when constructed in the 1970s, a cold water pipe was allowed to be the main earthing electrode. In this case, the conductor for the earthing electrode entered the garage and was routed upward near the ceiling with several bends before it was bonded to a copper water pipe. Without any better path to earth, the lightning current had apparently followed the same route, severing the bare conductor while seeking the well-grounded water pipe (see Figure 5).

As shown in the photographs of Figure 5, the service entrances were overhead and without any direct path to earth. This type of installation would not be approved by current US practice, which requires a direct connection to a driven ground rod in addition to any other supplemental electrodes such as the cold water pipe. One of the main reasons that the practice was modified is the growing use of PVC or plastic water pipe.

On a later visit, the engineers who made the first visit were allowed to visit the repaired house. Indeed, the new service grounding point includes not only the electric power but also the telephone and cable company. The new water piping is PVC, and a driven ground rod has been installed as the primary grounding electrode.
