Update on a Consumer-Oriented Guide for Surge Protection

Thomas Key, Doni Nastasi, Kermit Phipps
EPRI-PEAC
10521 Research Dr.
Knoxville, TN 37932

François Martzloff
National Institute of Standards
and Technology*
Gaithersburg MD 20899-8113

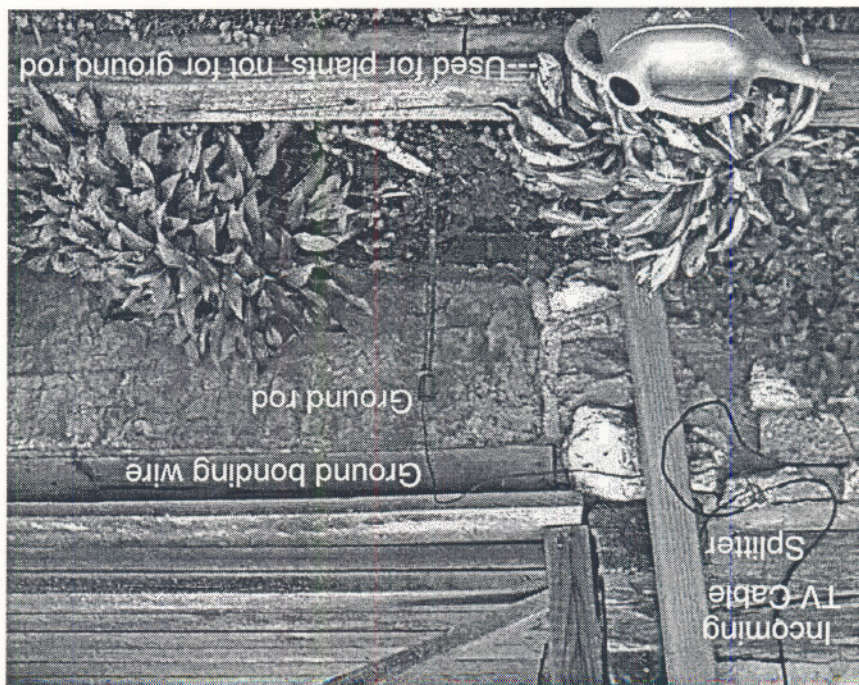
The power service entrance is located at one end of the house, while the cable TV service entrance is located at the opposite end. A visit to the site revealed that the cable TV shield was grounded only by a questionable ground rod next to the house foundation (within the drip line, and thus in dry soil, see Figure 1). Furthermore, this grounding connection was not bonded to the grounding connection of the power service entrance, a clear violation of the National Electrical Code, according to the current edition as well as several, if not all, earlier editions [NFPA 70, 1999].

Figure 1
Cable TV service entrance and 'ground bonding'

The local cable TV company was informed of this situation and took what they believed an appropriate action: the incoming cable was first routed under the house, in the crawl space, to allow bonding the shield to the power service grounding connection. From there, the cable was returned to its original point of entry into the house, at the opposite end. It would seem that under such a configuration, a lightning current surge traveling along the cable shield (instead of a proper bonding conductor), might create sufficient voltage drop along the path under the house to create problems. However, the interaction was not pursued further with the cable company. A recommendation was made to the owner of the house to install a surge reference equalizer near each of the video equipment in the house.

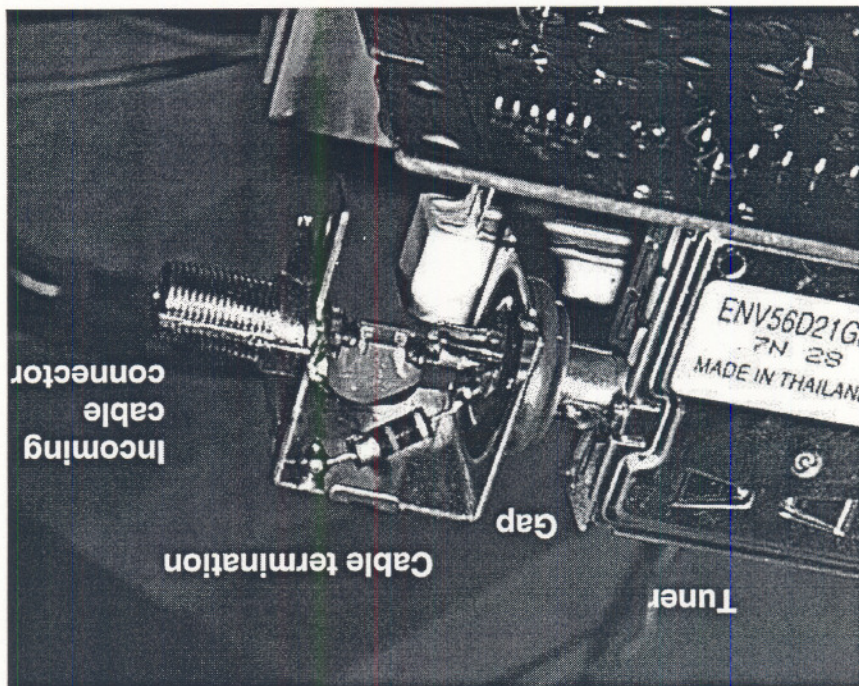
One of the failed TV receivers was made available to PEAC for examination. No evidence of damage was found on the power side of the chassis, but a clear indication of surface flashover was observed between the cable input 'ground' termination (connected to the incoming cable shield) and the shielding can of the tuner (Figure 2). After cleaning as best as possible the carbonized path of the flashover, a surge voltage was applied between the power cord of the receiver and the 'ground' of the cable input: flashover occurred for a 2 kV Ring Wave. By removing the material to a greater depth and covering it with epoxy, the gap did withstand a greater level, and failed at 2.5 kV. That flashover occurred at another part of the original insulation, thus providing valid information on the original withstand capability.

Figure 2
Cable TV input termination and UHF tuner
at rear of TV receiver

This case study illustrates the classic situation of separate service entrances, compounded with incorrect bonding. The examination and test demonstrate that at least 2.5 kV can be developed across the power port and the cable TV port of the receiver under a condition of distant or nearby lightning strike. This finding is consistent with the results of other tests reported under Section 4.

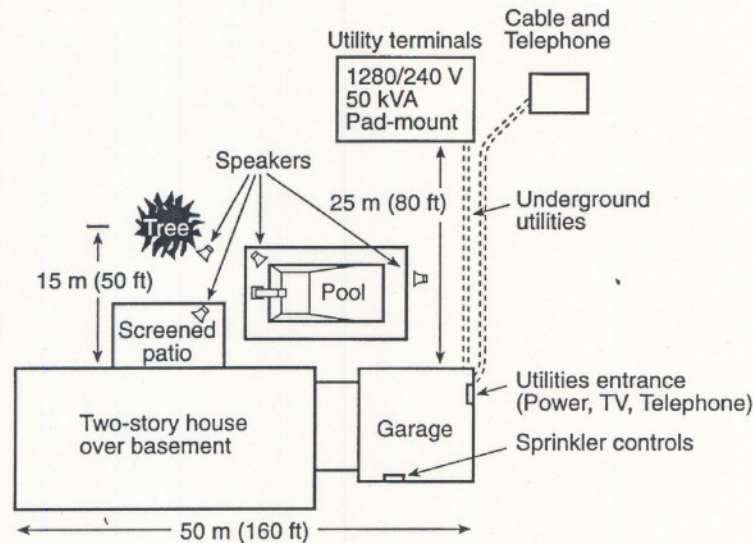
The overall physical layout of the house, damaged tree, and electronic equipment are shown in Figure 3. The mature tree that was struck is much taller than the house and is the tallest of the trees in the immediate area. The bark was stripped from the tree trunk for most of its height. As shown in the figure, the trunk is only approximately 15 meters from the house and even closer to the patio, where some of the audio speakers were installed. Outdoor speakers are also located in the pool area and connecting walkways.

Figure 3
Schematic configuration of the Rambling Residence

From this informal examination, it appears that no electrical codes were violated. Furthermore, the cable TV and telephone entered the residence together with the electrical service at the same location (garage), as is the practice recommended in the engineering report.

One of the observations during the laboratory inspection of the audio amplifiers was that the power supplies of the units were not damaged, but their output transistors that drive the speakers and the speakers themselves were damaged. Before arrangements could be made for the site visit, it was speculated that the surge energy had been coupled into the speaker wires, which are probably very long and very near to the lightning strike, rather than as a "power-line surge." The visit to the installation verified this theory. The home entertainment equipment, including amplifiers, is centrally installed in the basement of the house. Speakers are located throughout the house, the patio, and the swimming pool area. The wire length between the outdoor speakers and the central amplifier is about 30 meters, and some of the wires run within 10 meters of the tree trunk.

Since the visit to the residence was motivated, as stated, by the curiosity of PEAC engineers rather than by a customer complaint, there was no need to offer a prescription for protection. Instead, the visiting engineers offered the general statement that for a direct strike such as the one that had occurred, providing a high level of protection confidence by a comprehensive retrofit would probably cost more than the equipment that was damaged. In contrast, the dead tree was the one irreplaceable loss that was most painful for the owners. Techniques for protecting trees exist (an extensive array of grounding cables along the limbs, [NFPA 780, 1997] and are sometimes applied to trees recognized as having great historical or esthetic value, but the cost is generally a deterrent for typical residential surroundings.
