## **FORENSIC STUDY OF THE STEEL IN THE WORLD TRADE CENTER**

Thomas A. Siewert<sup>1</sup>, J. David McColskey<sup>1</sup>, Chris McCowan<sup>1</sup>, Frank W. Gayle<sup>2</sup>, William E. Luecke<sup>2</sup>, Stephen W. Banovic<sup>2</sup>, Tim Foecke<sup>2</sup>, and Richard F. Fields<sup>2</sup>

<sup>1</sup>National Institute of Standards and Technology, Materials Reliability Division, Boulder, CO 80305, <sup>2</sup>Metallurgy Division, Gaithersburg, MD 20878, siewert@boulder.nist.gov

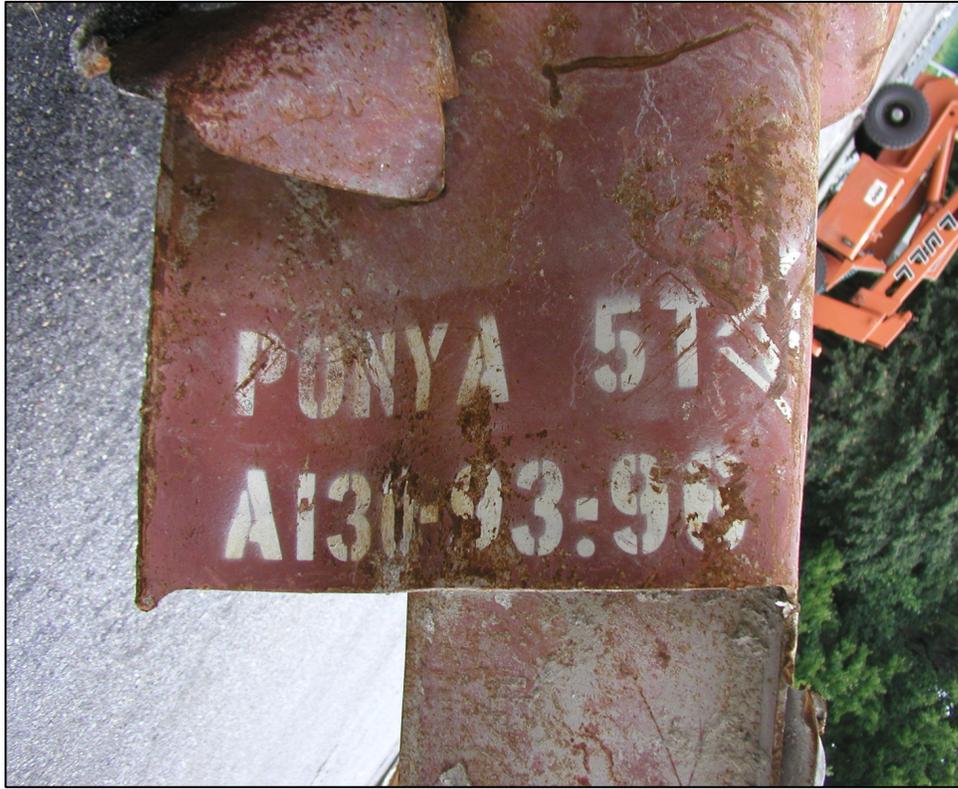
Figure 2. Characteristic stenciling found on the lower portions of the perimeter column panels. Markings indicate this piece was in WTC 1 (“A”), column number 130, spanning floors 93-96 (colored orange in Figures 3 and 4): this is the panel hit by the nose of the first aircraft. (NIST)

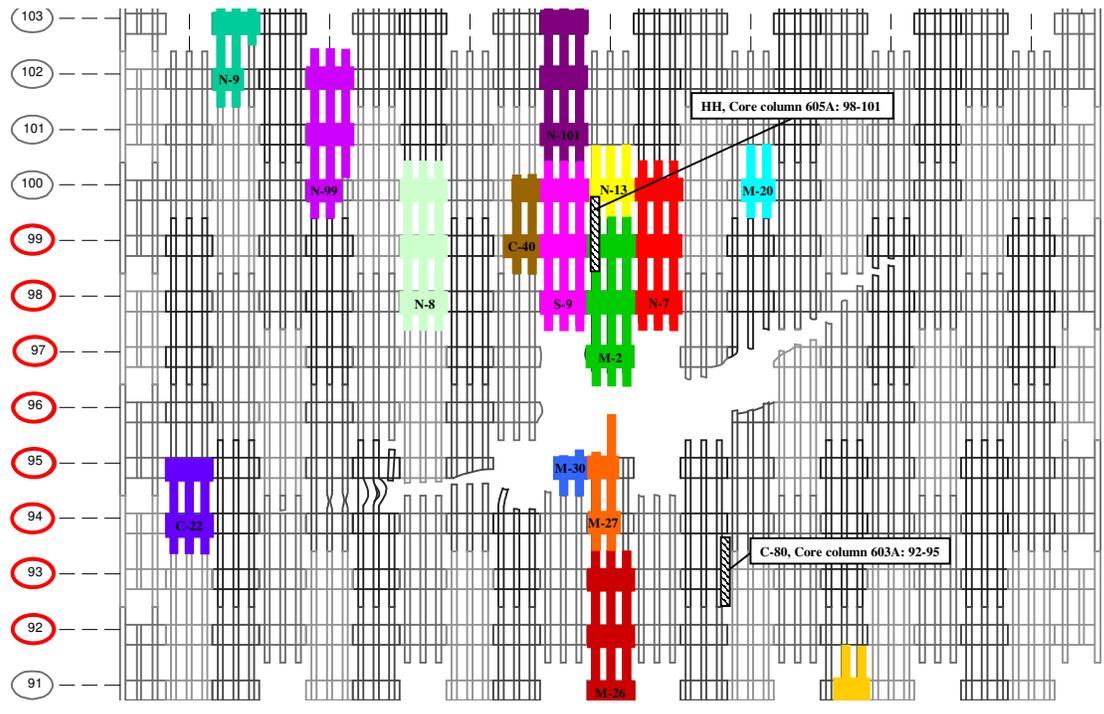
- WTC1 - 4 perimeter panels directly hit by the aircraft (Figure 3),
  - 22 perimeter panels from critical floors (91-101),
  - 2 core columns from the fire-affected floors,

Figure 3: North face of WTC 1. Impact damage to the perimeter columns with location of structural elements recovered for the NIST investigation shown in color. Note that fires were observed on floors 92 to 99 and 104. (FEMA BPAT 2002 as modified by NIST 2004)

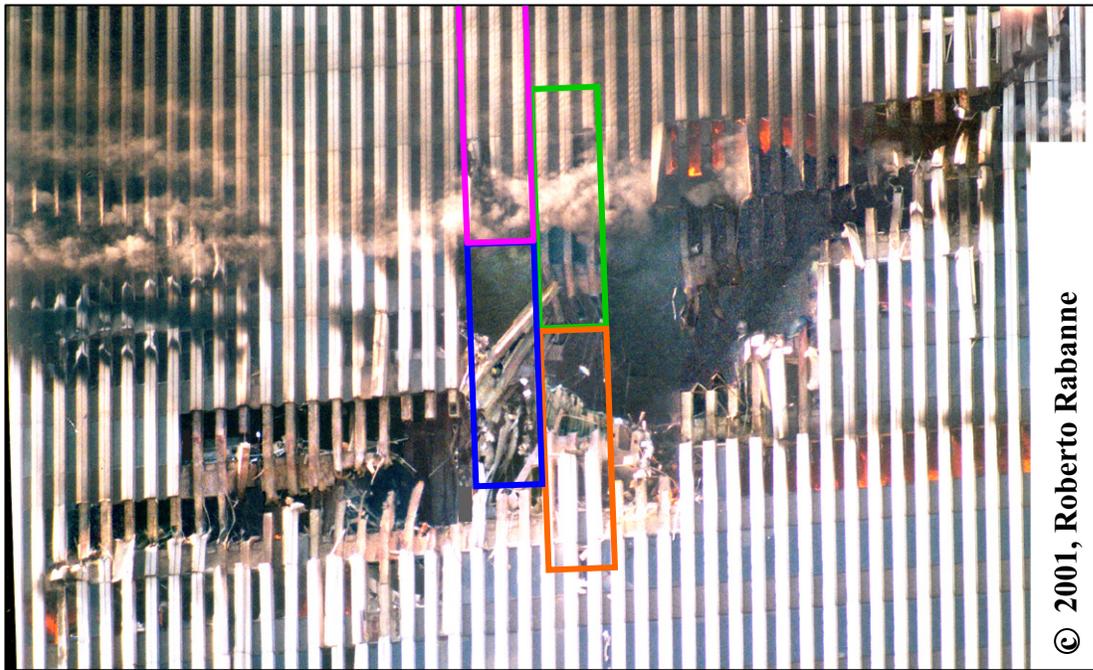
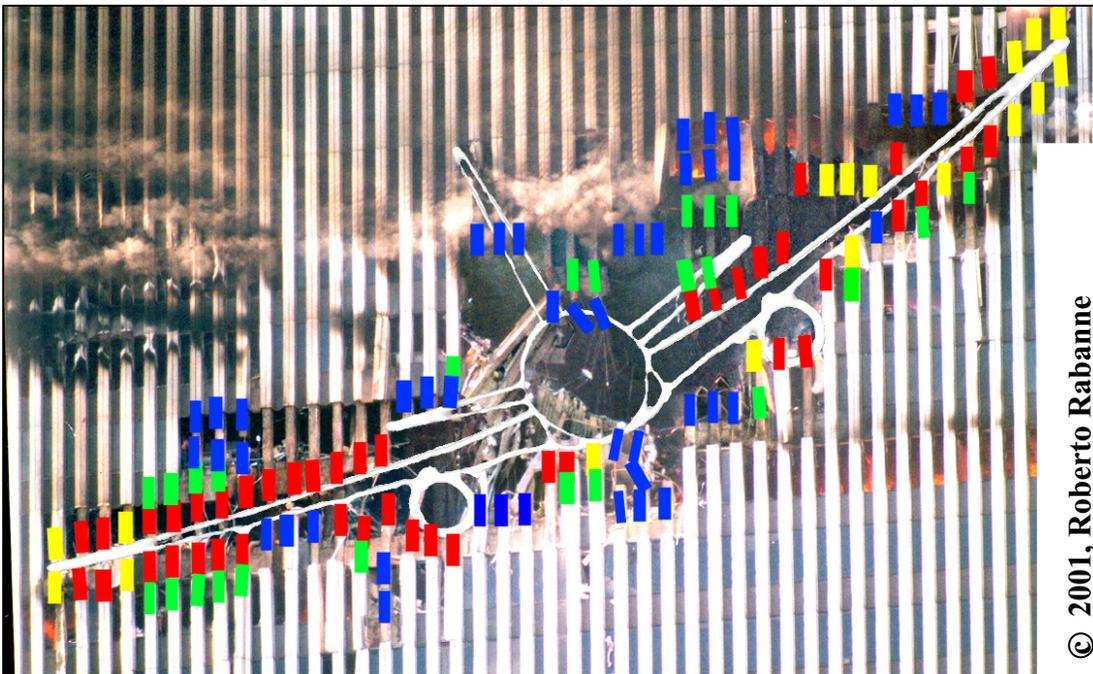
Extensive image processing was used on photographs received from news organizations and the public to determine pre-collapse damage to the perimeter panels. Figure 4 shows the impact image used to extract perimeter column failure mode information from WTC 1. The four panels highlighted by colored boxes correspond to those in Figure 3. These panels were damaged by the aircraft impact. Superimposed onto this figure is the outline of the aircraft (Figure 4b). Careful examination of such images has allowed the characterization of the types of columns failures as indicated.

Comparisons were made between such observed pre-collapse damage and the present condition of the four recovered panels that were hit. This analysis indicated that two of the impact-damaged panels are in a condition similar to that before the collapse. Some of the extraneous damage can be attributed to the events during and after collapse, but the general shape and appearance of the recovered pieces correspond well with the damage photographs. An example is shown in Figure 5 showing panel M-2 (WTC 1, column line 130, floors 96 to 99; green panel in Figures 3 and 4). Damage to the lower columns was clearly associated with impact, which caused columns 129 and 130 to bend inward at the 97th floor level, very similar to what was revealed by the photographic observations. With this type of knowledge, the response of the materials used in the buildings' construction can be ascertained with respect to the impact of the aircraft, and the ability of the aircraft impact models to reproduce the event can be validated.

Figure 4: Enhanced photographs used to determine pre-collapse damage to the perimeter panels of WTC 1. a) Colored boxes indicate location of recovered panels that were damaged as a result of aircraft impact, b) Outline of airplane overlaid on impact damage with indications of location and type of localized damage. Red boxes - cut metal components, blue - broken vertical column connection bolts, green - failure of longitudinal welds in the box columns, and yellow – indeterminate damage.

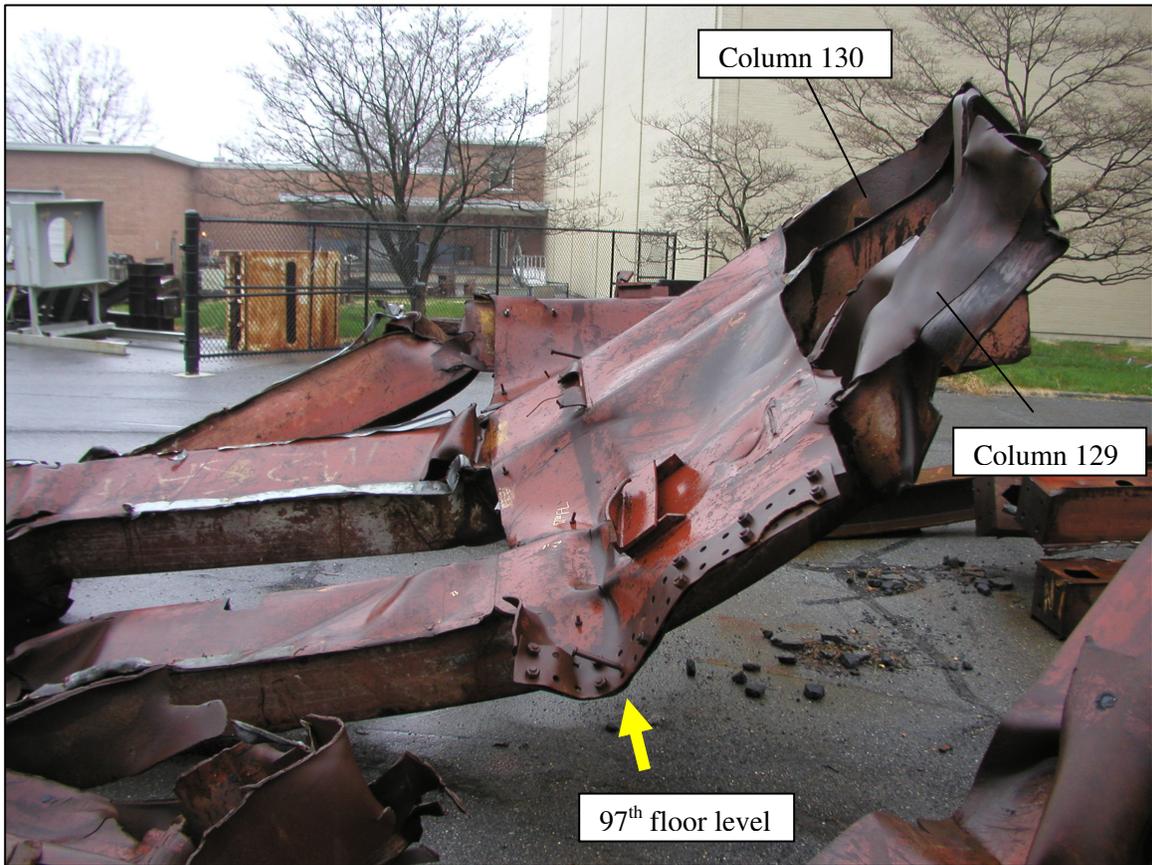
Figure 5: View of panel M-2 (WTC 1, center panel (column line 130), floors 94 to 97; green in Figures 3 and 4). The bottom of panel is on the right-hand side of the picture, and the outside of the panel is facing down. A major bend in the panel is located at the 97th floor level. (NIST)

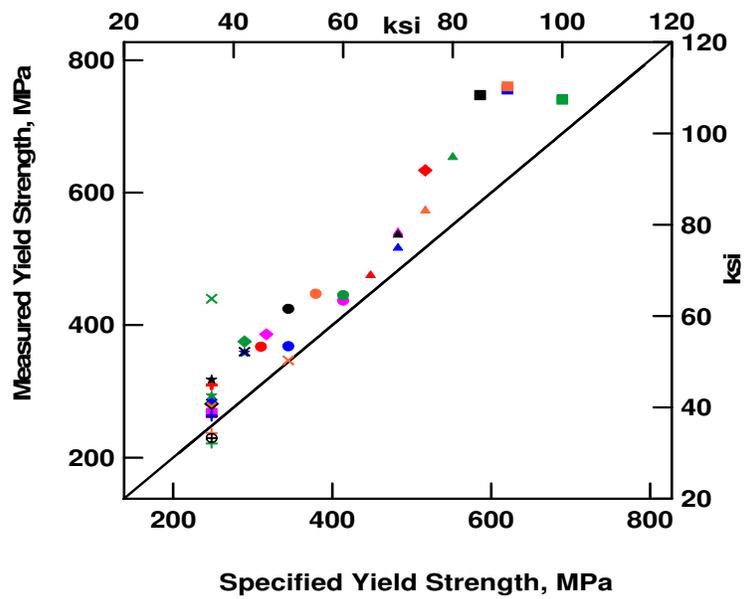
Mechanical property tests indicate that all the steels likely met all required minimum test requirements. A plot of measured versus specified yield strength is given in Figure 6.

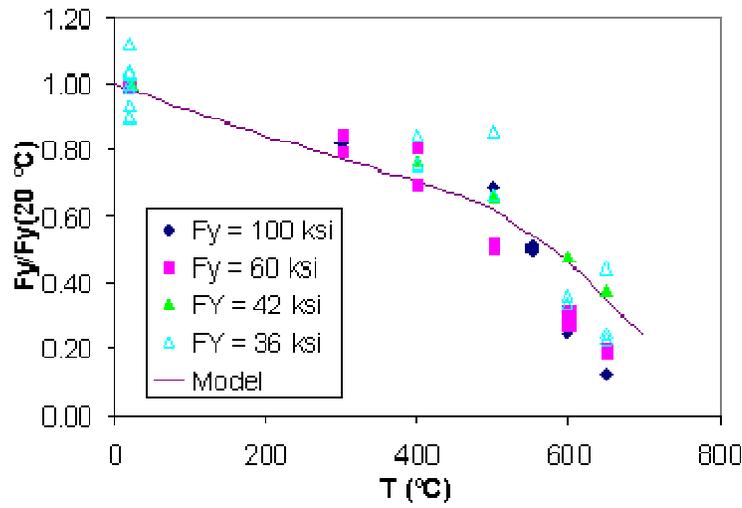
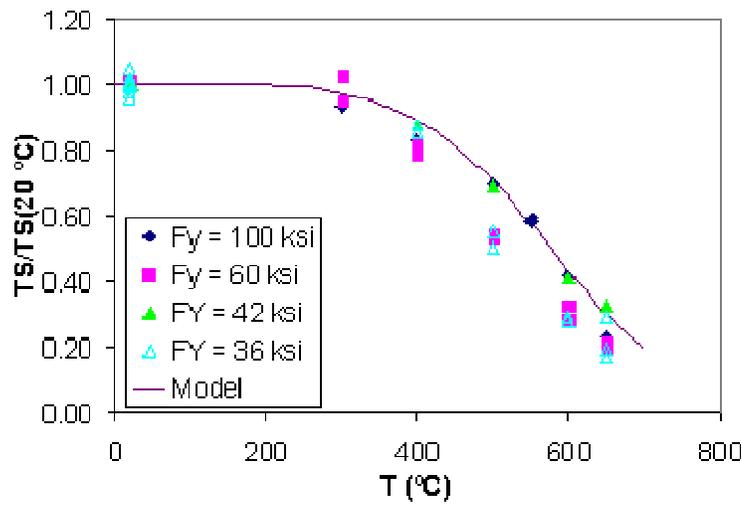
In addition to room temperature properties, data were generated on the effects of high temperature on the mechanical properties of the steels and on the effects of high strain rates on the mechanical properties of the steels. Figure 7 demonstrates the effects of temperature on yield and tensile strengths of some of the WTC steels. As expected, the strengths decrease with increasing temperature.

Figure 7. Normalized yield strength and ultimate tensile strength measured as function of temperature. Model curve is based on historical data for WTC era steels.

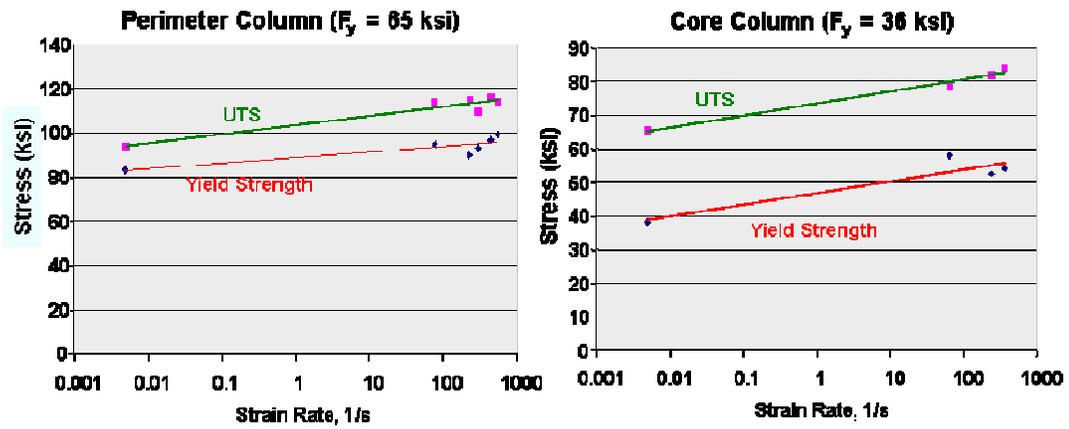
The mechanical properties of steel are sensitive to strain rate, and can exhibit significantly enhanced strength at high strain rates, with important effects on building response to impact. A higher strength of a column should lead to increased energy absorption and reduction in momentum of the aircraft after impact, thereby reducing further damage done to the interior of the building. Measured strain rate effects are given in Figure 8 for a 65 ksi perimeter column and a 36 ksi core column steel. As expected, the yield and ultimate strengths increase with increasing strain rate.

Figure 8. Ultimate and yield strengths measured as a function of strain rate for two column steels. It is estimated that strain rates during the airplane impact ranged as high as  $500 \text{ s}^{-1}$  to  $1000 \text{ s}^{-1}$ .
