# **Deterioration of Iowa Highway Concrete Pavements: A Petrographic Study**

Paul E. Stutzman

December, 1999

Building and Fire Research Laboratory  
National Institute of Standards and Technology  
Gaithersburg, MD 20899

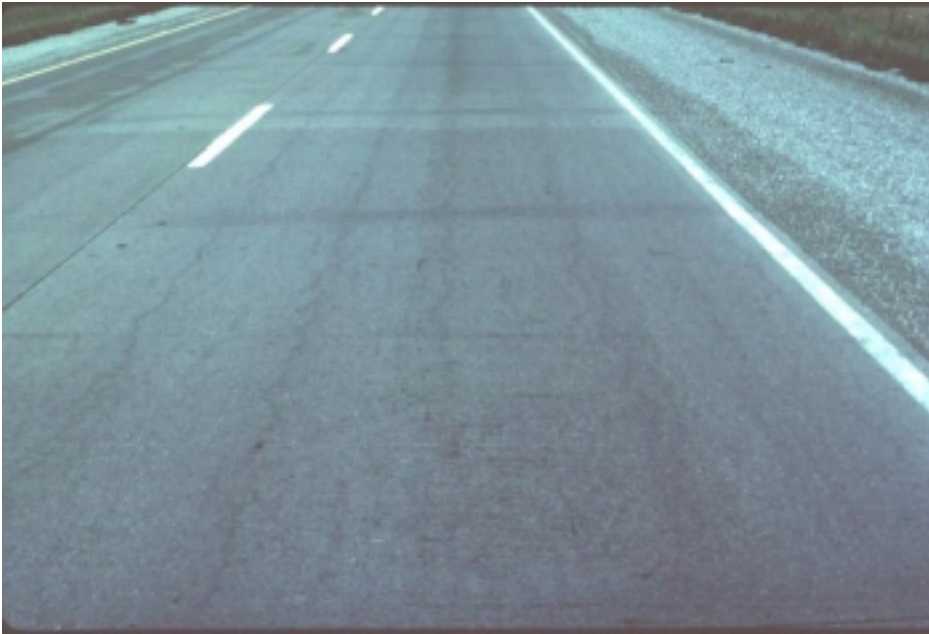
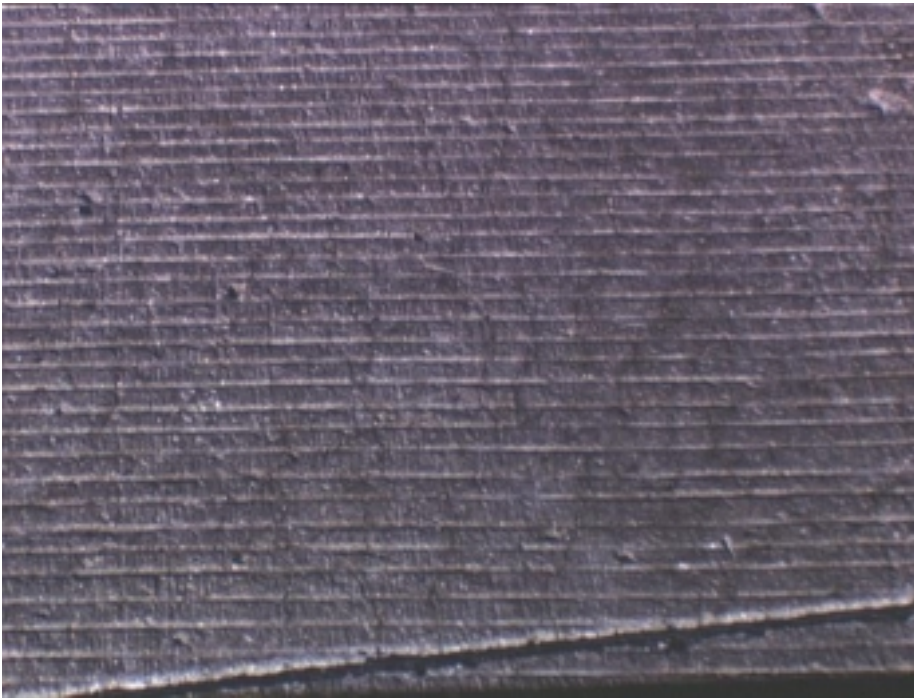
Figure 1. Onset of pavement deterioration is visible as a slight darkening of the concrete in the transverse joint region (top, I-80) and in pavements with advanced deterioration, a tightly-closed pattern cracking (bottom, US 20). Some of these pavements also have vibrator trails.

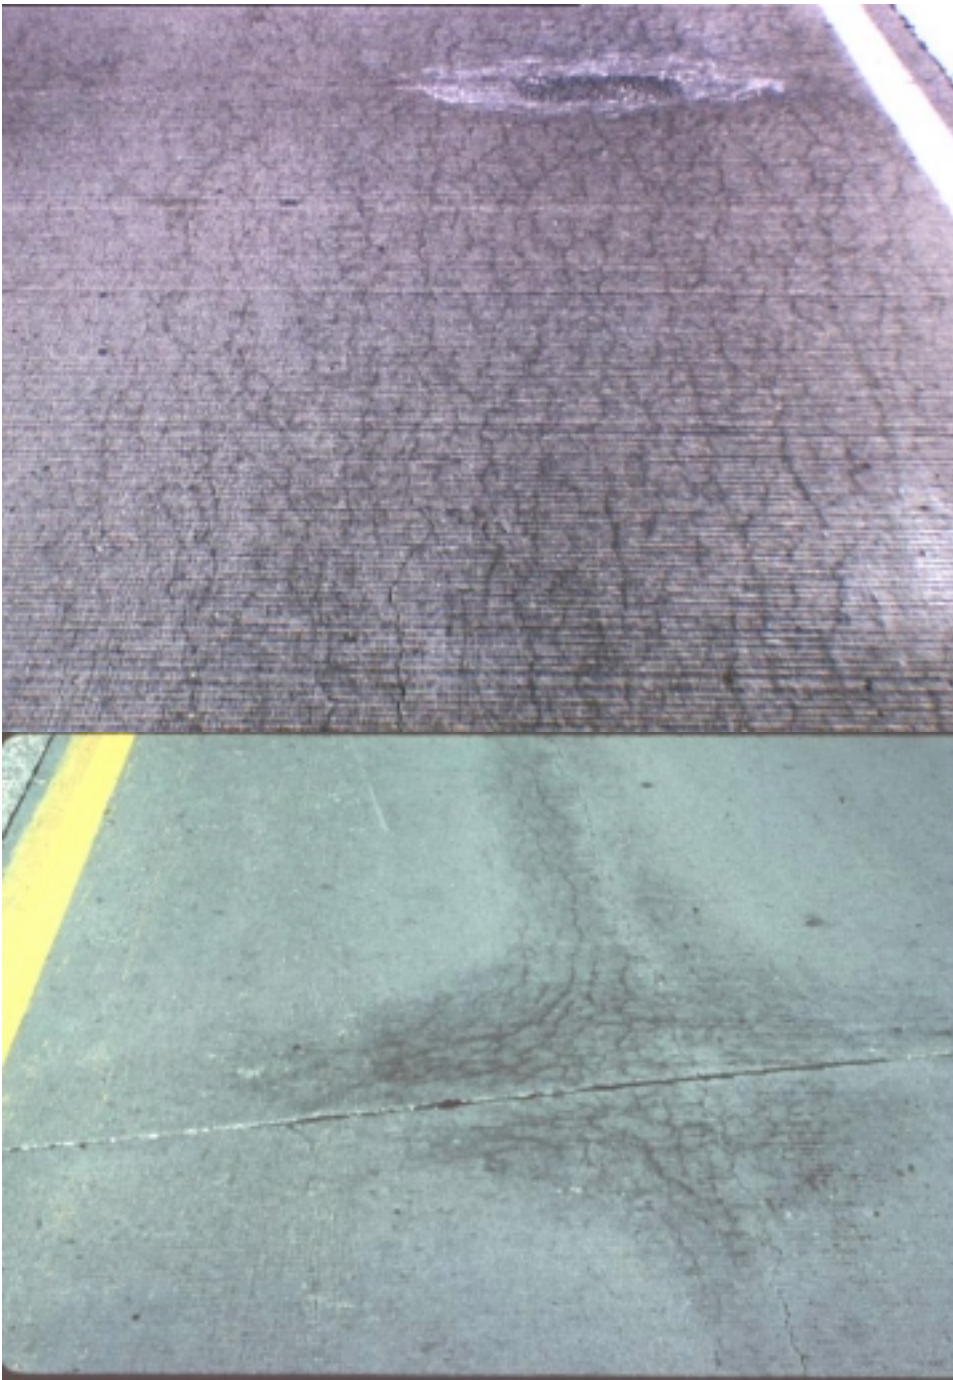
Figure 2. Map cracking oriented in the longitudinal direction of the pavement, interconnected by slightly finer cracks perpendicular to pavement direction becomes more prominent with progression of deterioration (top). Advanced degradation shows cracking paralleling the transverse joint and road edge, and along cracks within vibrator trails. The degradation would be characterized initially as “low” severity according to the SHRP Distress Identification Manual [17] and “moderate” as the deterioration progresses.

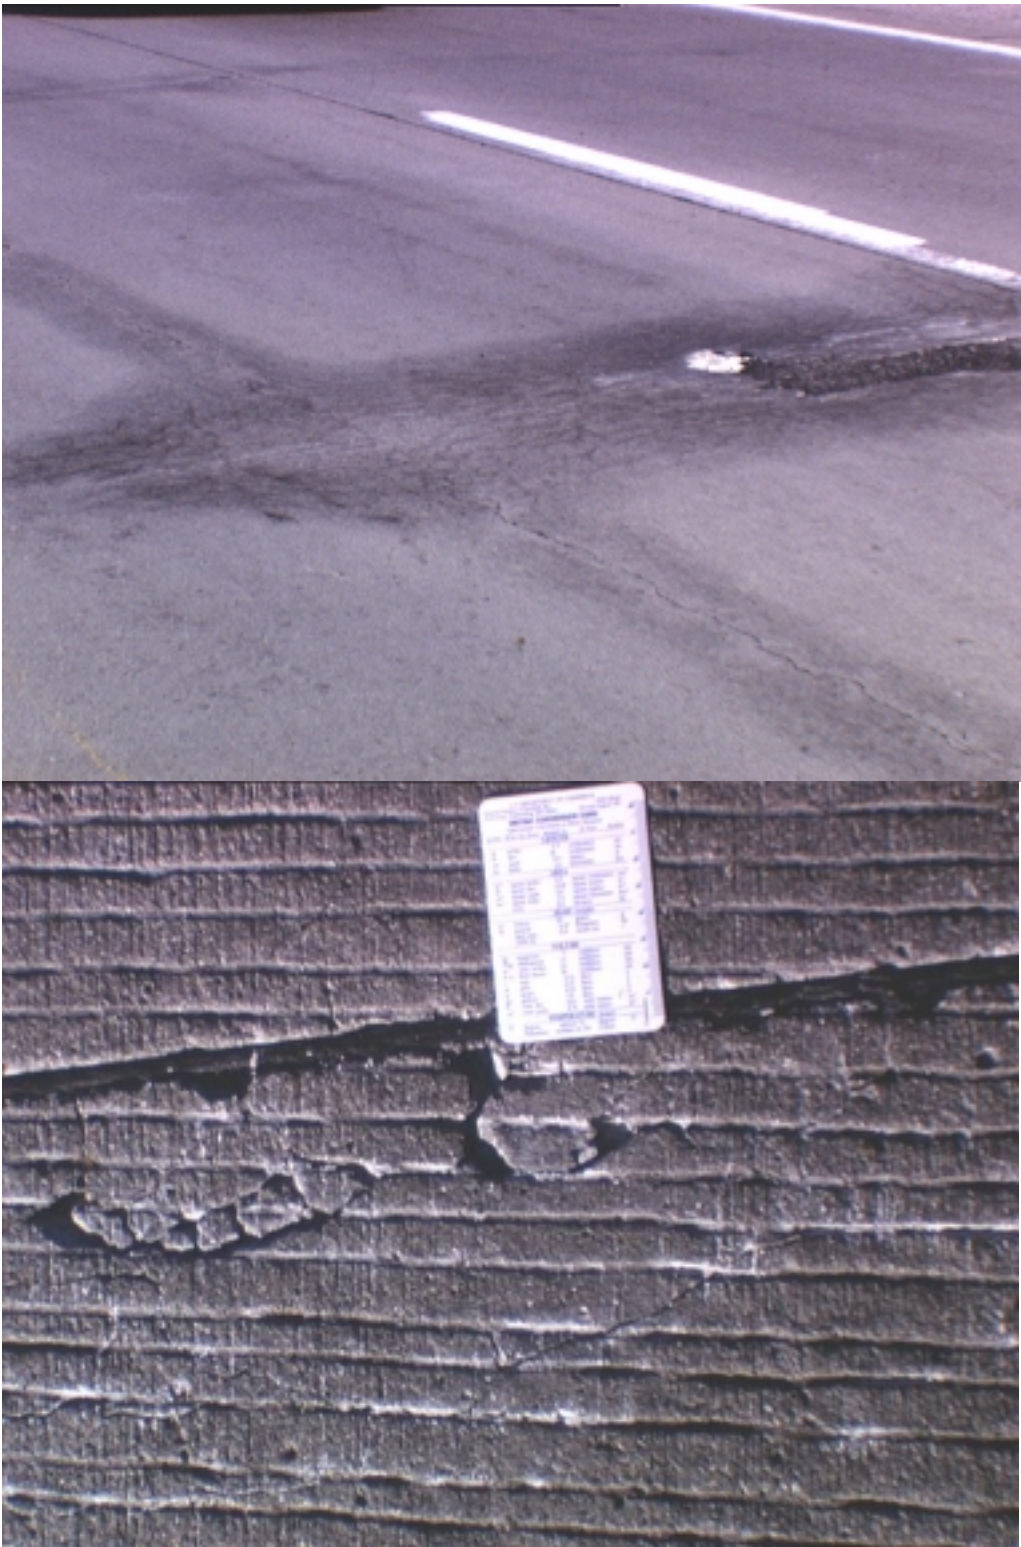
Figure 3. Pavements exhibiting severe deterioration show significant pattern cracking (here accentuated by moisture along the crack), cracking along joints, spalling along joint edges and white efflorescence. Open joints and lack of displacement along pavement slabs provides evidence against permanent expansive processes such as alkali-aggregate reaction and sulfate attack.

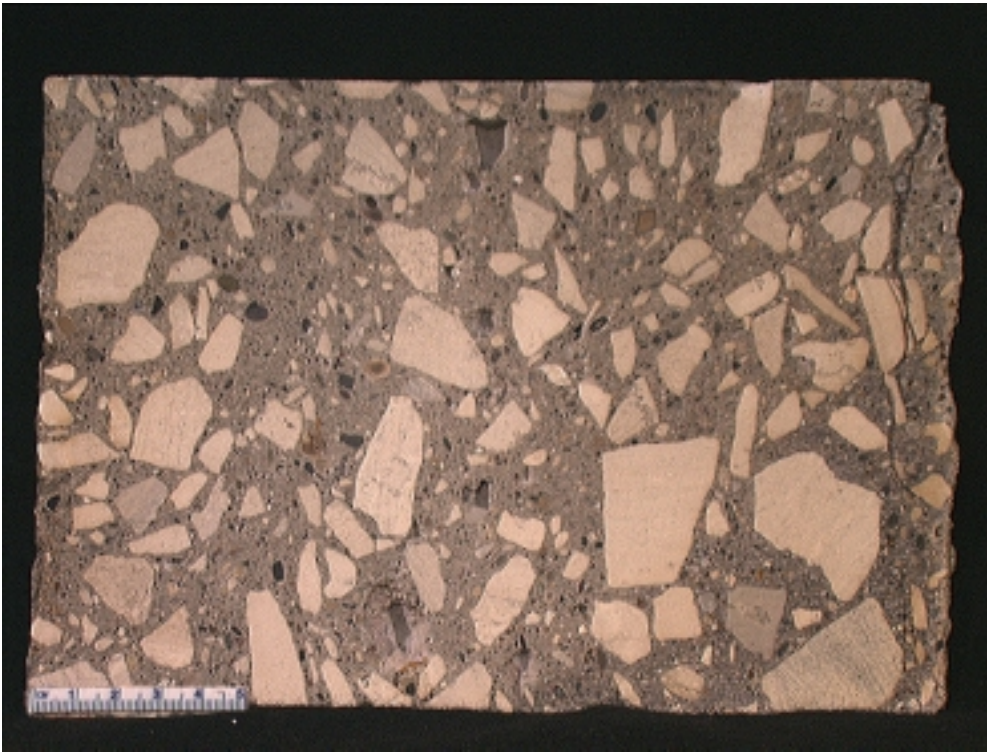
Figure 9: Iowa 175 Core 2 shows some aggregate / mortar segregation and cracking located near the core base (base to the right).

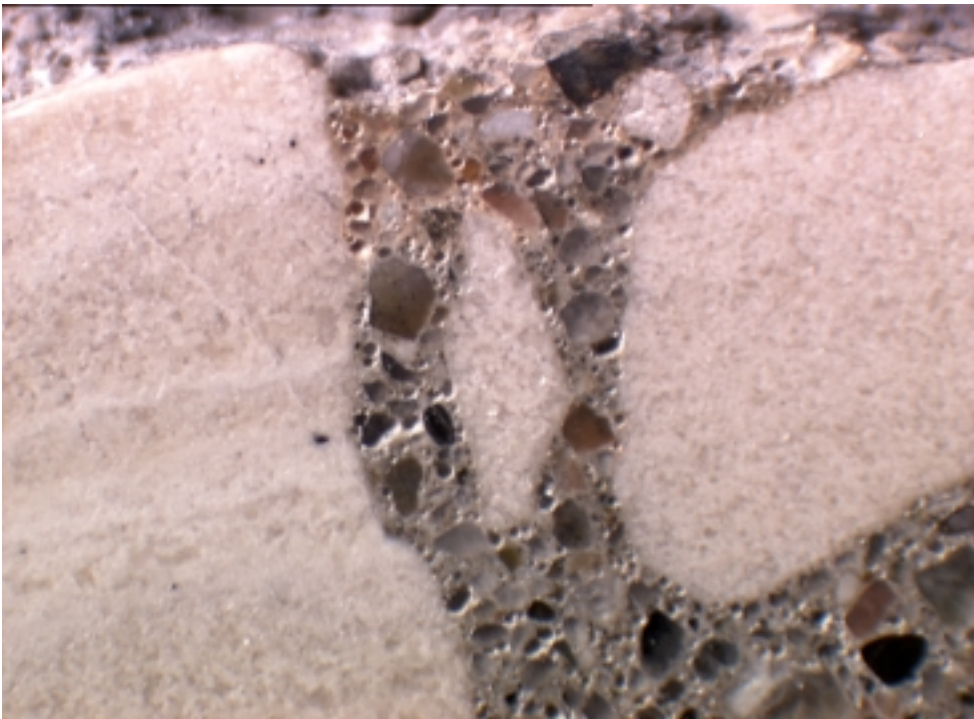
Figure 10. Iowa 175 Core 2 surface microstructure. Slight discoloration in the upper mortar indicates approximate depth of carbonation. Micrograph field width: 14 mm

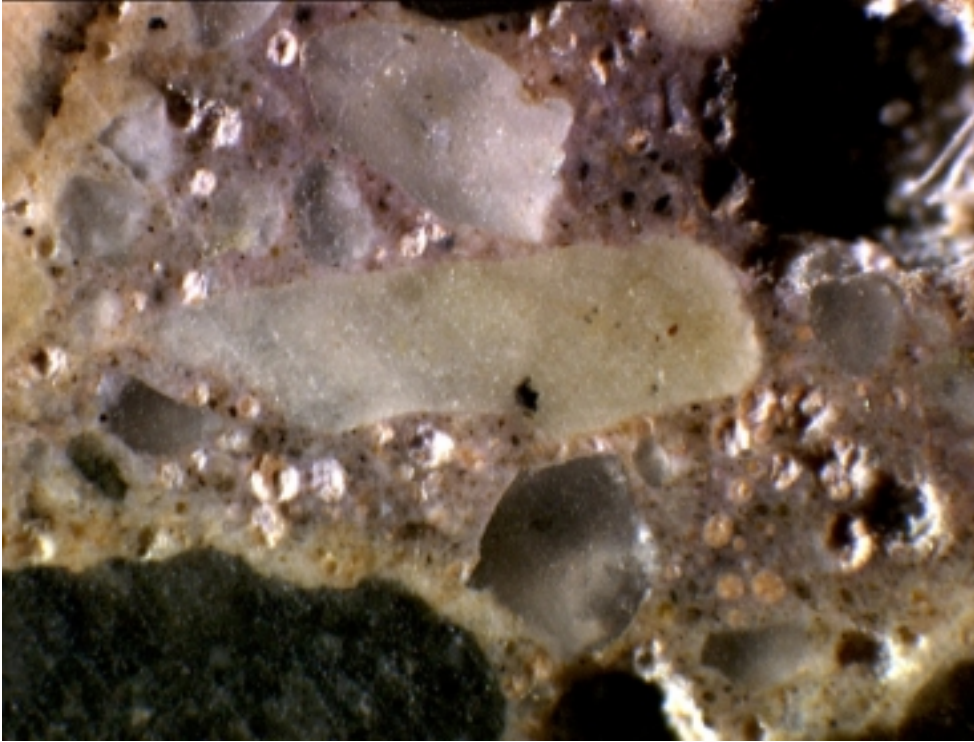
Figure 11. Iowa 175 Core 2 base mortar microstructure exhibiting partial filling of the entrained air void system. Micrograph field width: 4 mm

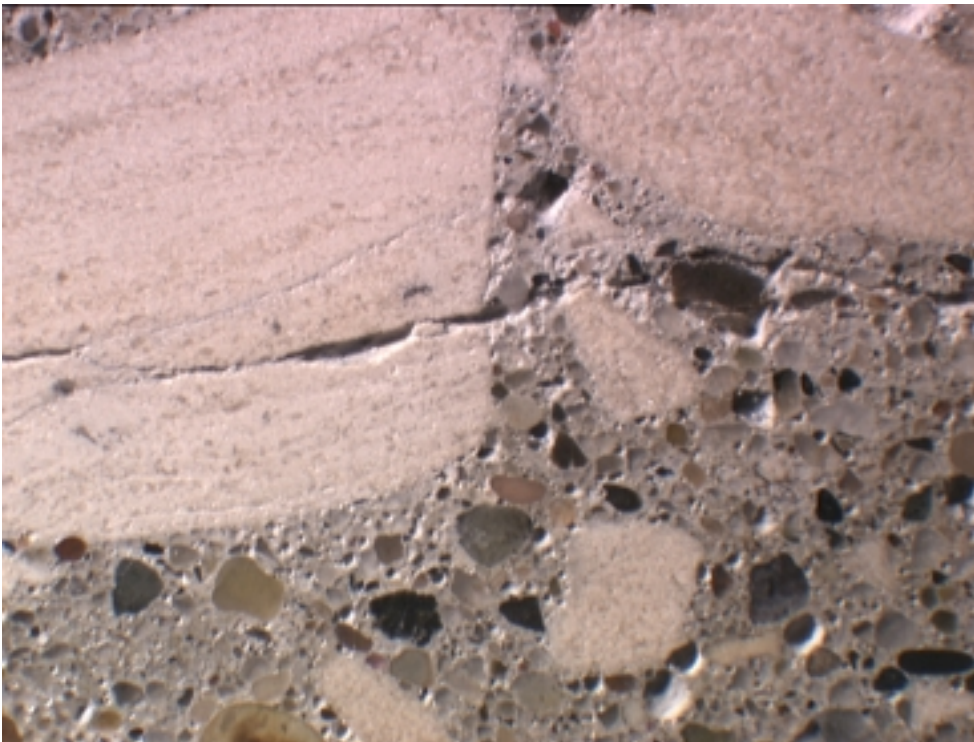
Figure 12. Iowa 175 Core 2 base microstructure exhibits cracking in the mortar and coarse aggregate. Micrograph field width: 14 mm.

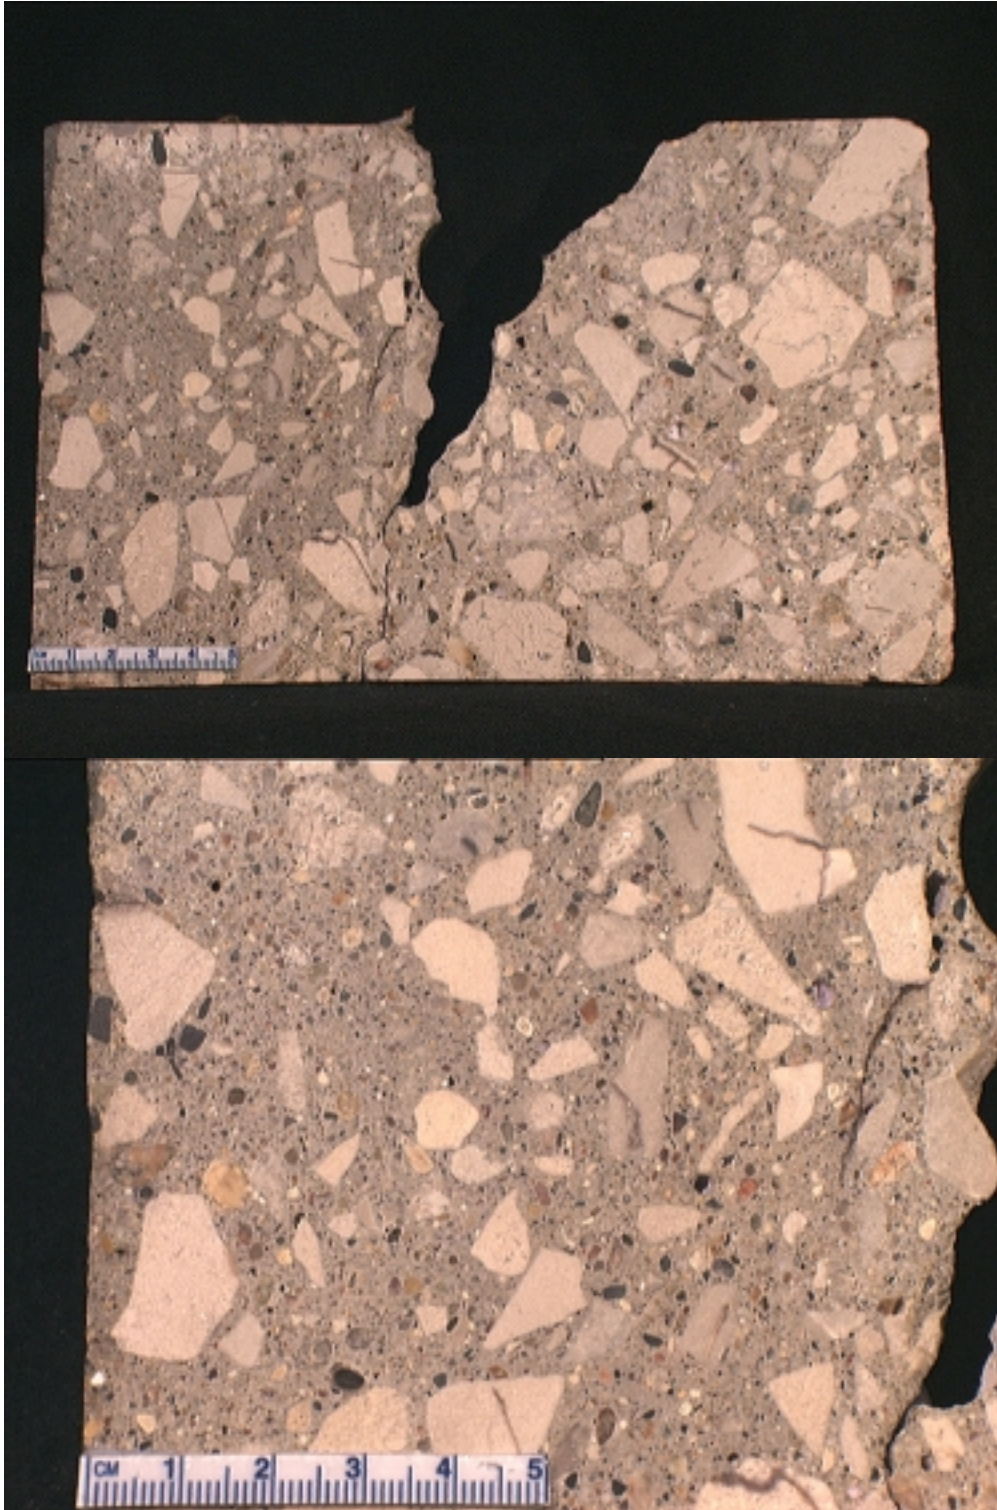
Figure 14. Core 7 (road surface is to the left) exhibits cracking of coarse aggregate, vertical cracks from the surface that are either drying shrinkage or freeze thaw-related. Segregation of mortar and coarse aggregate is visible in the whole core cross section (upper image) and the upper-core microstructure (lower).

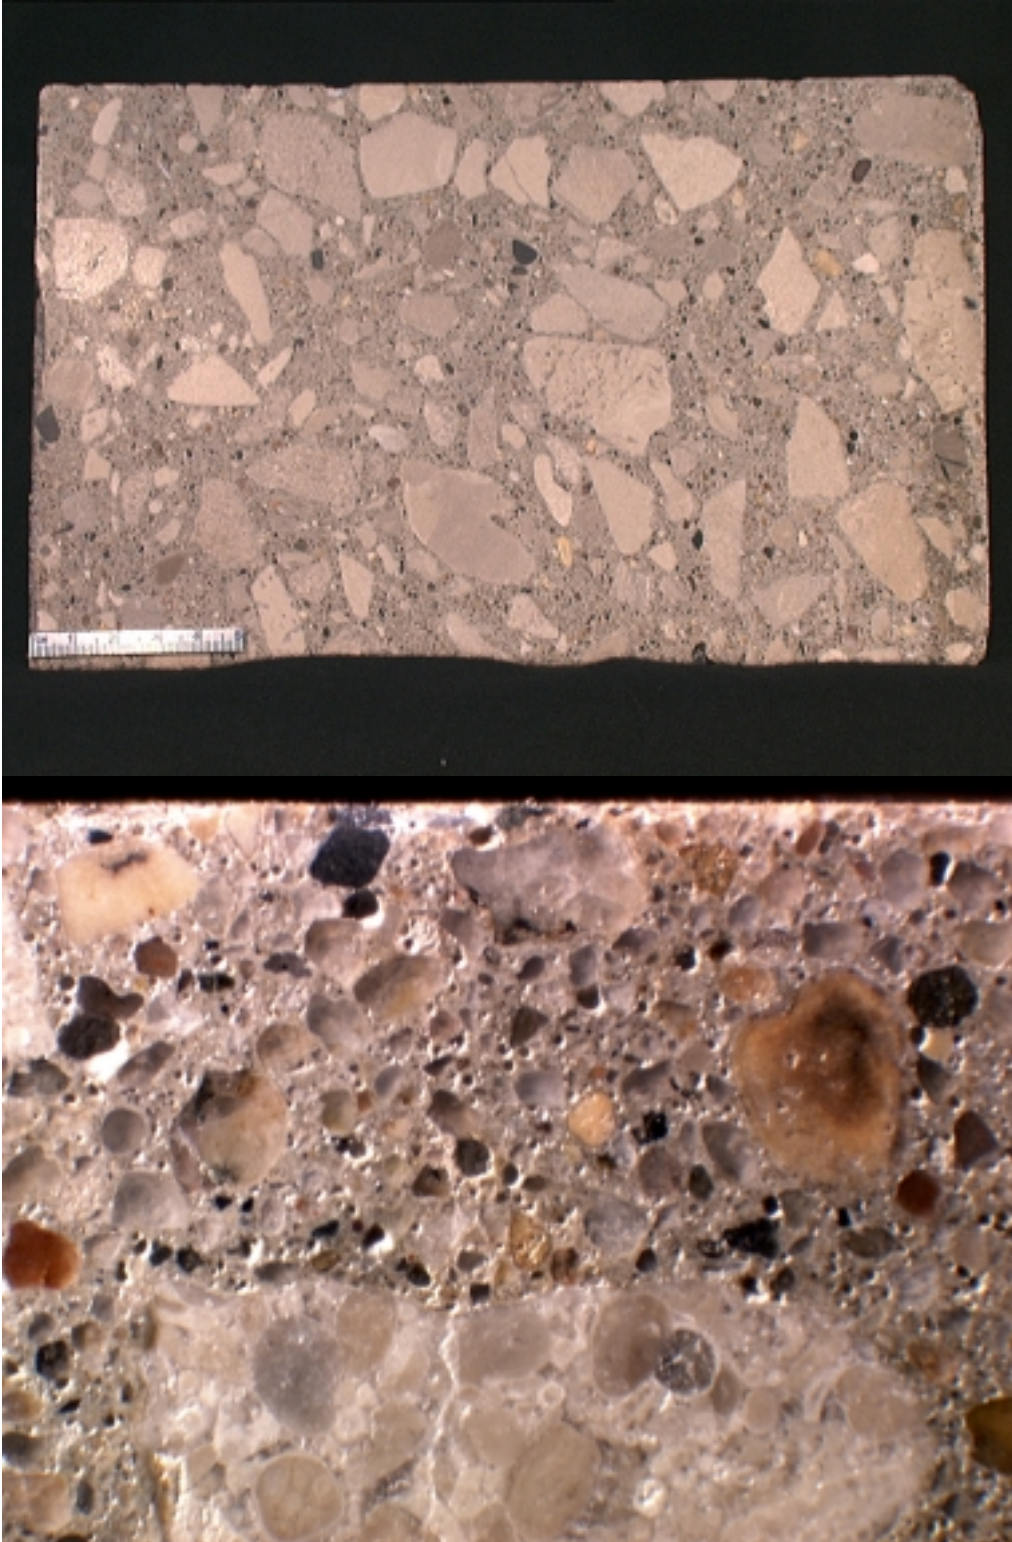
Figure 15. Core 8 exhibits less cracking but does have surface cracking to depths of 20 mm. Some of these cracks as seen in the lower image (13 mm field width) are associated with cracking within the coarse aggregate.

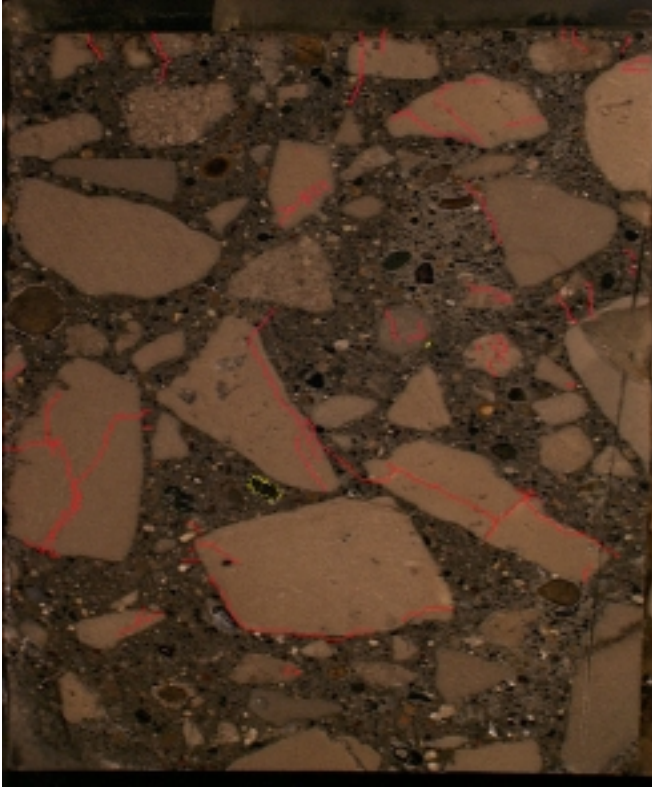
Figure 16. Cracking (red) and ASR (yellow) in Core 7 as observed using SEM. Cracking of aggregate is common. Surface cracks appear carbonated and terminate in both the mortar and the coarse aggregate. Micrograph field width is approximately 10 cm.

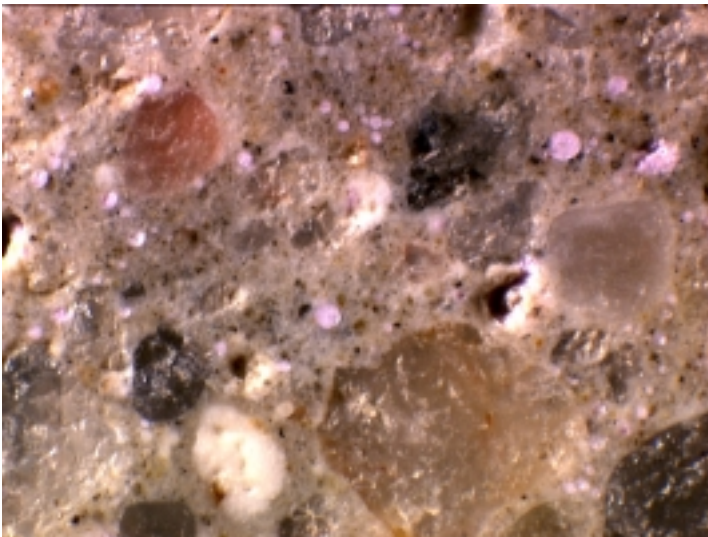
Figure 17. Filling of the smaller entrained air voids (purple) has significantly increased the air void spacing factor while only slightly decreasing the total entrained air void volume for both Cores 7 and 8. Field width: 4 mm.

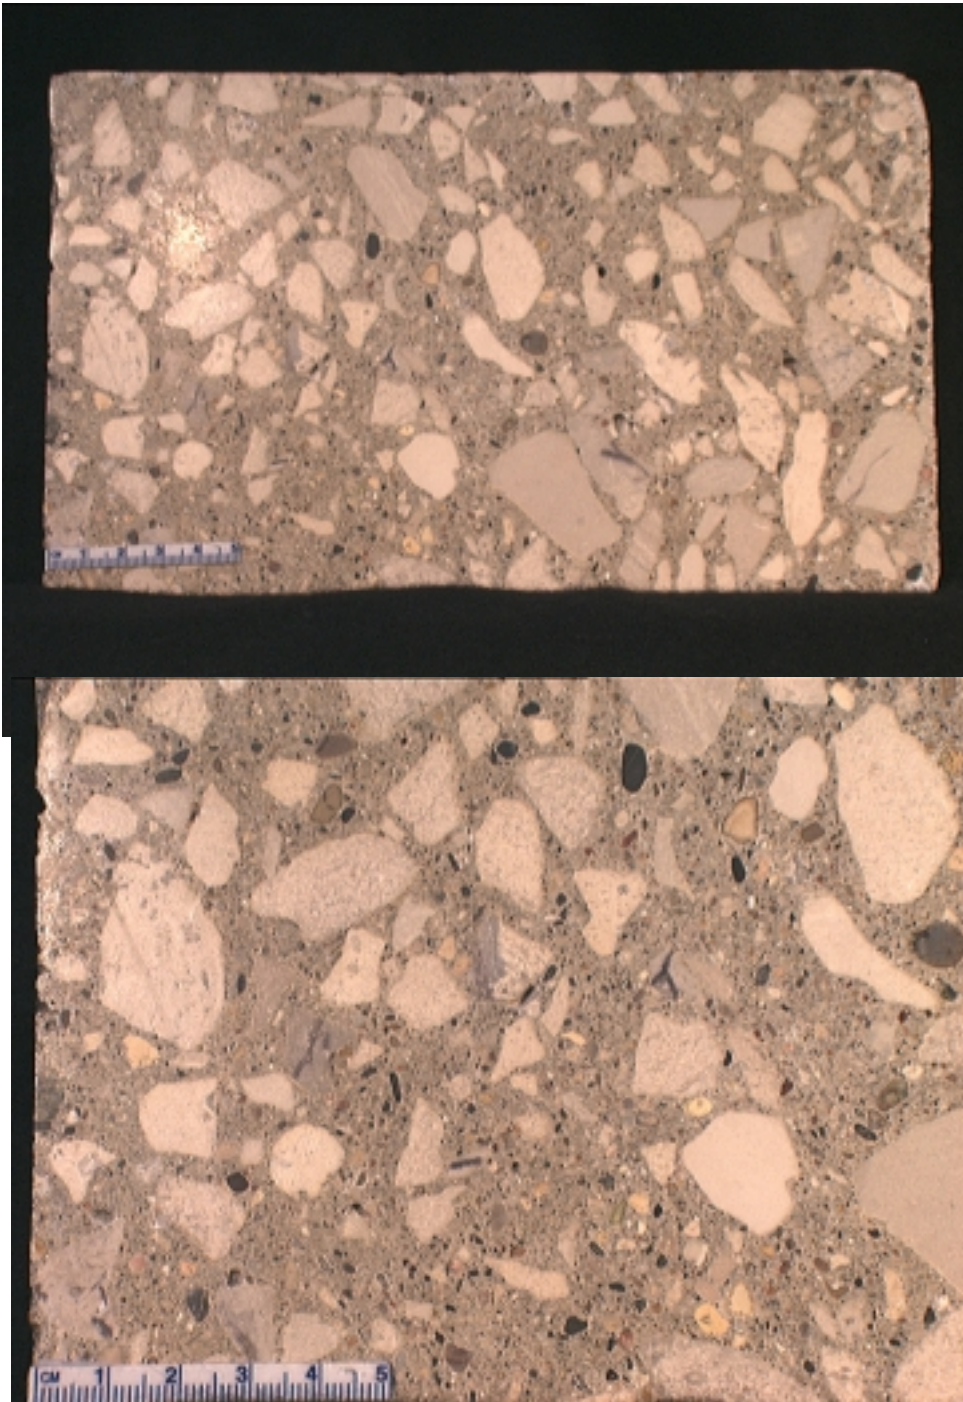
Figure 20. Core 13 cross sections show segregation within the concrete and only minor cracking of the mortar and coarse aggregate.

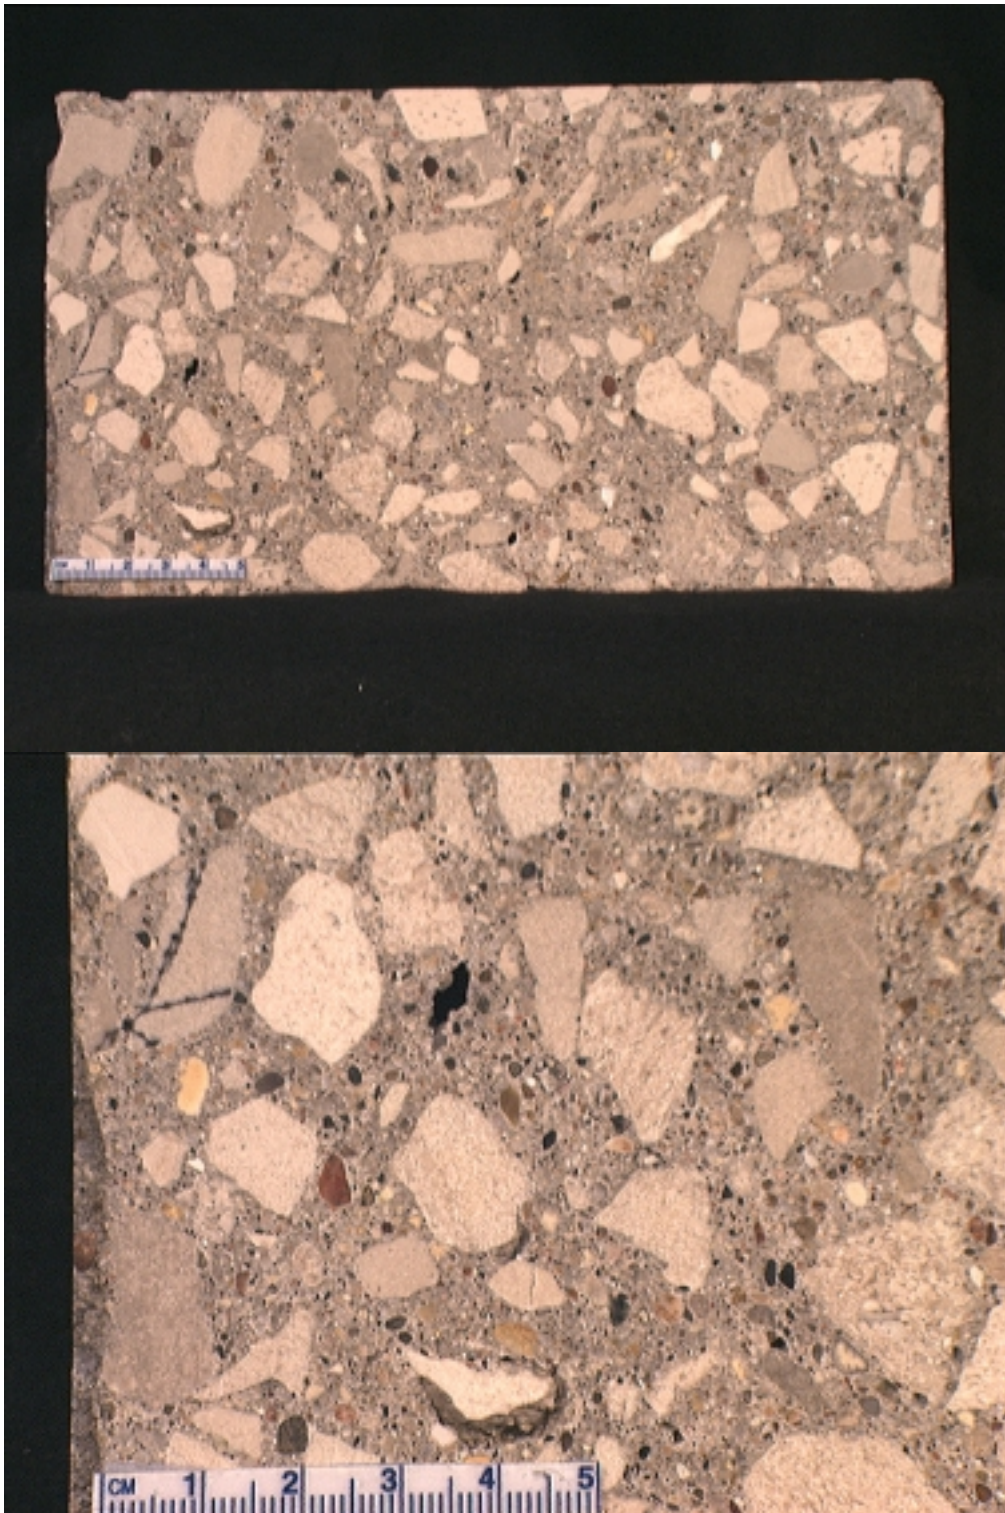
Figure 21. Core 14 exhibits some cracking of both the paste and coarse aggregate and some mortar / aggregate segregation in middle.

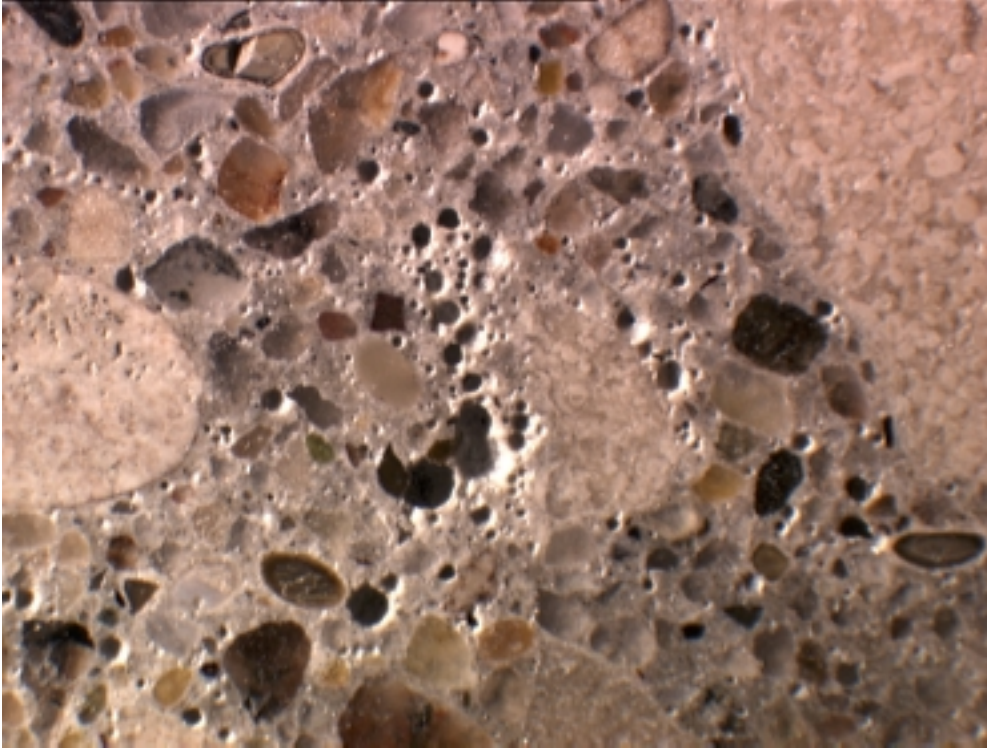
Figure 22. Clustering of air voids may indicate difficulties in mixing and development of a properly sized, disseminated entrained air void system. Field: 7 mm.

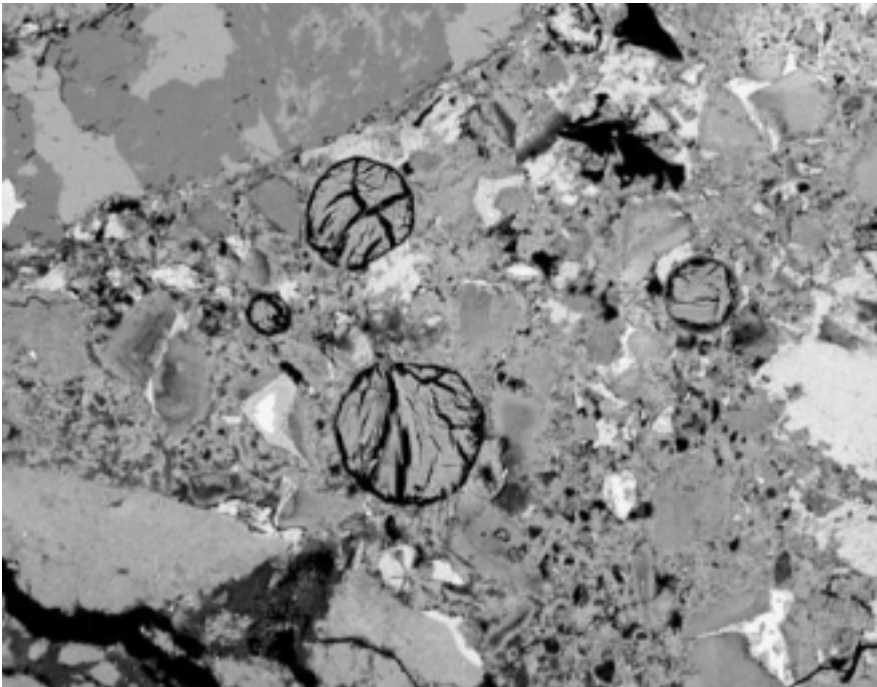
Figure 23. A SEM image of Core 13 paste shows ettringite-filled entrained air voids, the irregularly-shaped capillary voids (black), and a reactive shale grain in the lower-left. Note absence of cracking outside of this shale grain and lack of paste / aggregate gaps that would be typical of an overall paste expansion. Field: 200  $\mu\text{m}$ .

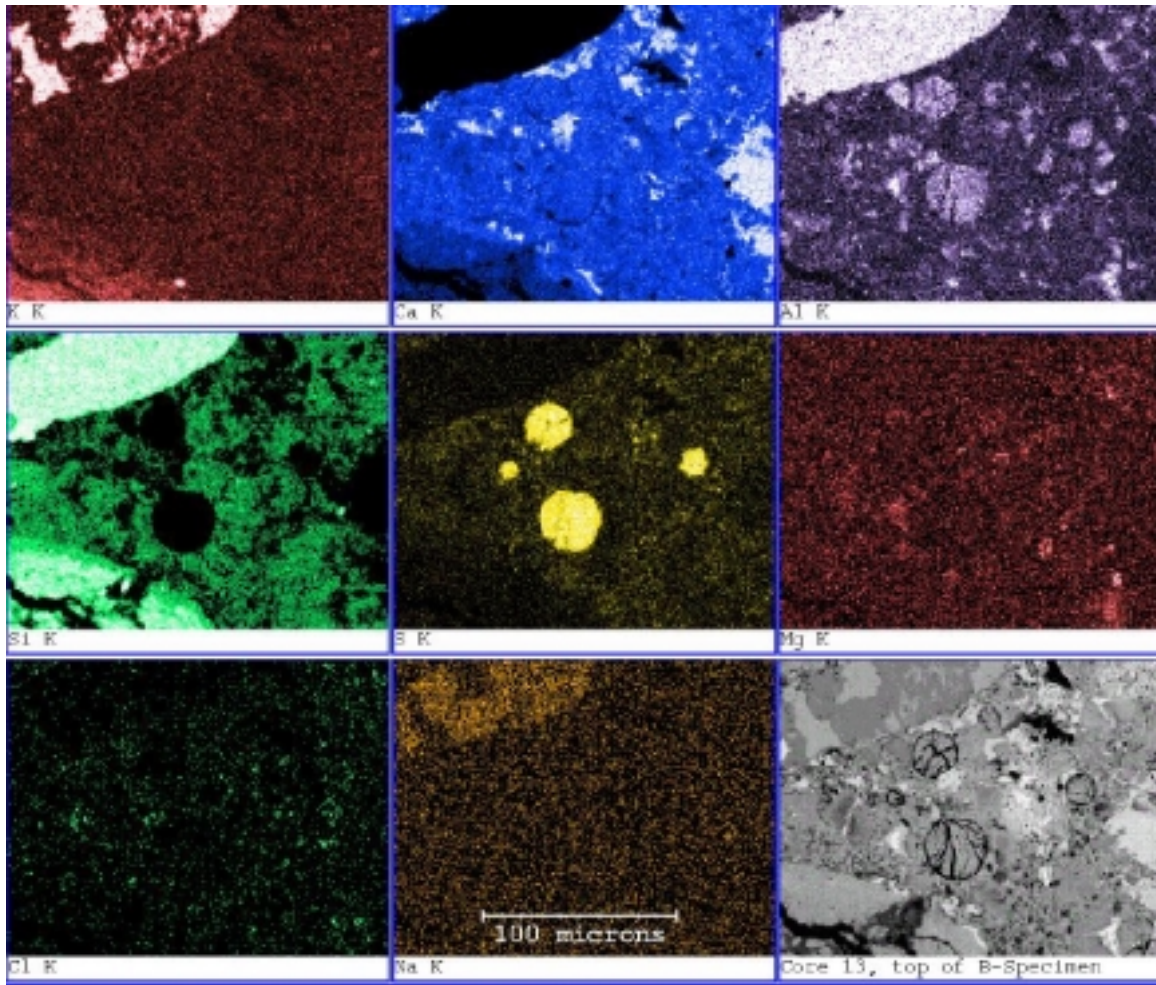
Figure 24. X-ray images corresponding to image in Figure 23. While the shale has undergone alkali-silica reaction, no cracking is apparent within the paste. Common locations of aluminum, sulfur and calcium in the X-ray images delineate ettringite.

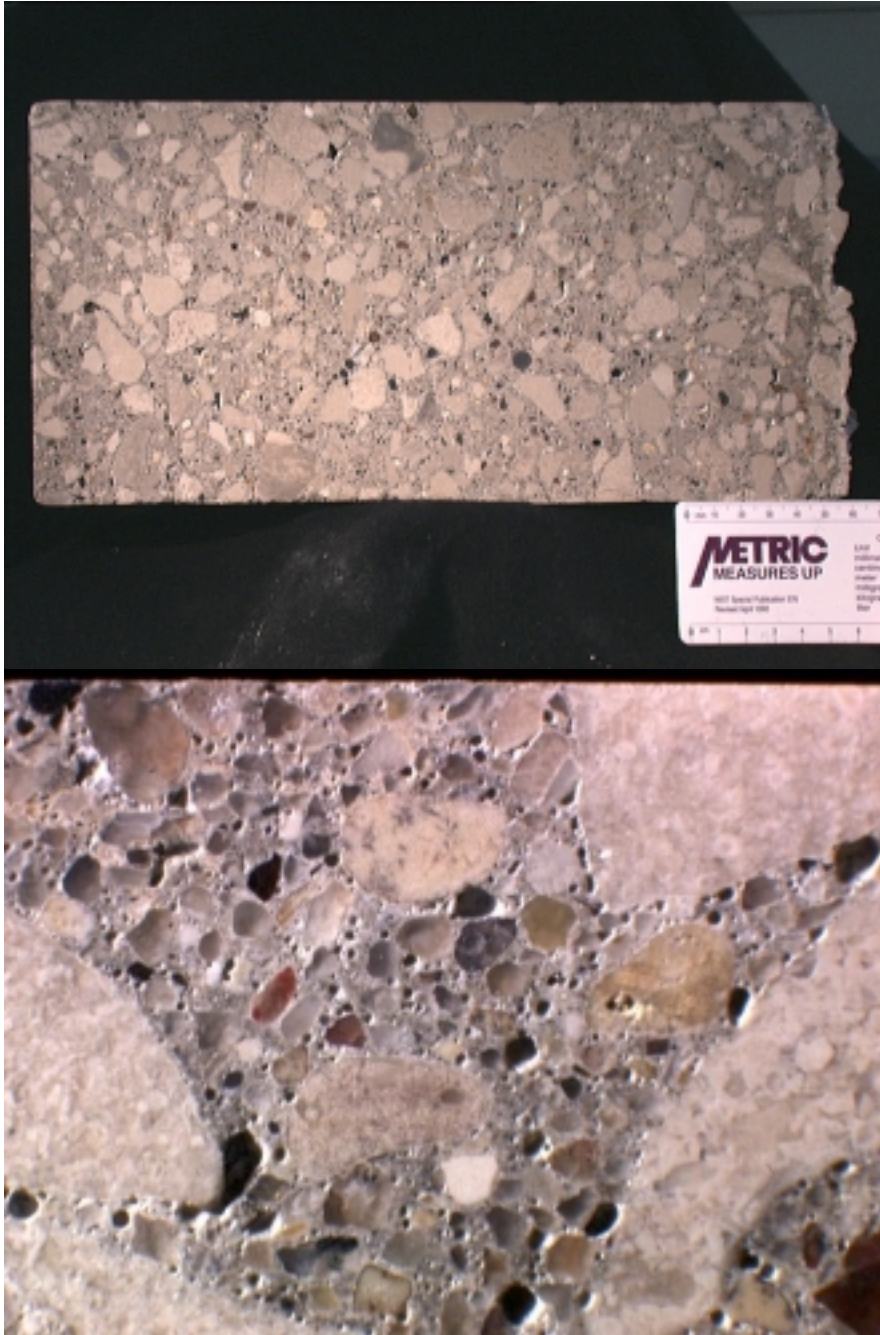
Figure 27. Core 18 contains about 12 % entrained air volume and a spacing factor of 0.08 mm. Aggregate gradation appears more uniform, and possibly smaller maximum size than the degraded pavement concretes. Low specific surface and common entrapped air voids are features common to other cores in this study.

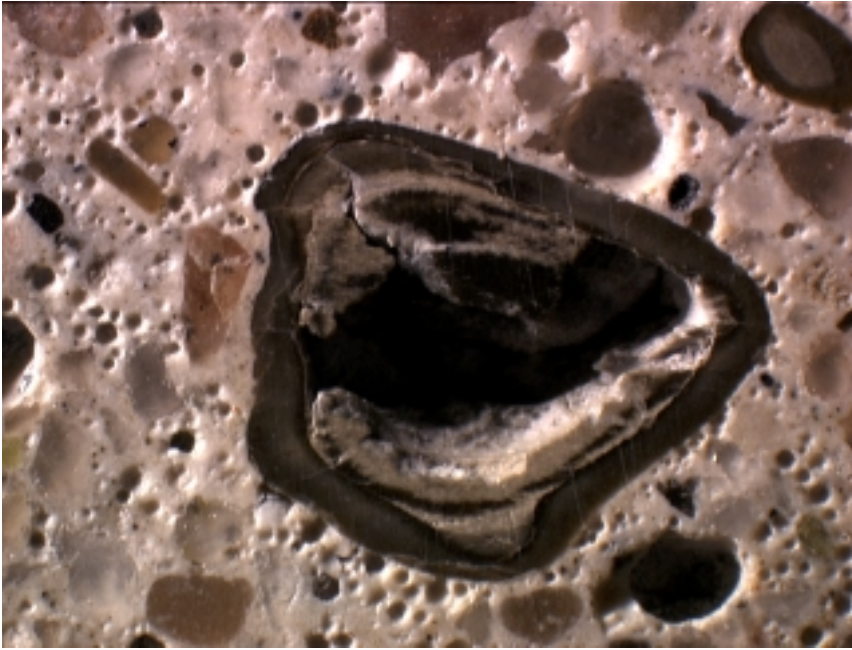
Figure 29. Core 18 mortar microstructure includes numerous shale fragments that appear to have undergone alkali-silica reaction, however little cracking of the mortar was evident. SEM examination indicated that some of the reaction product permeated the paste filling the capillary voids adjacent to the shale. Field width: 10 mm.

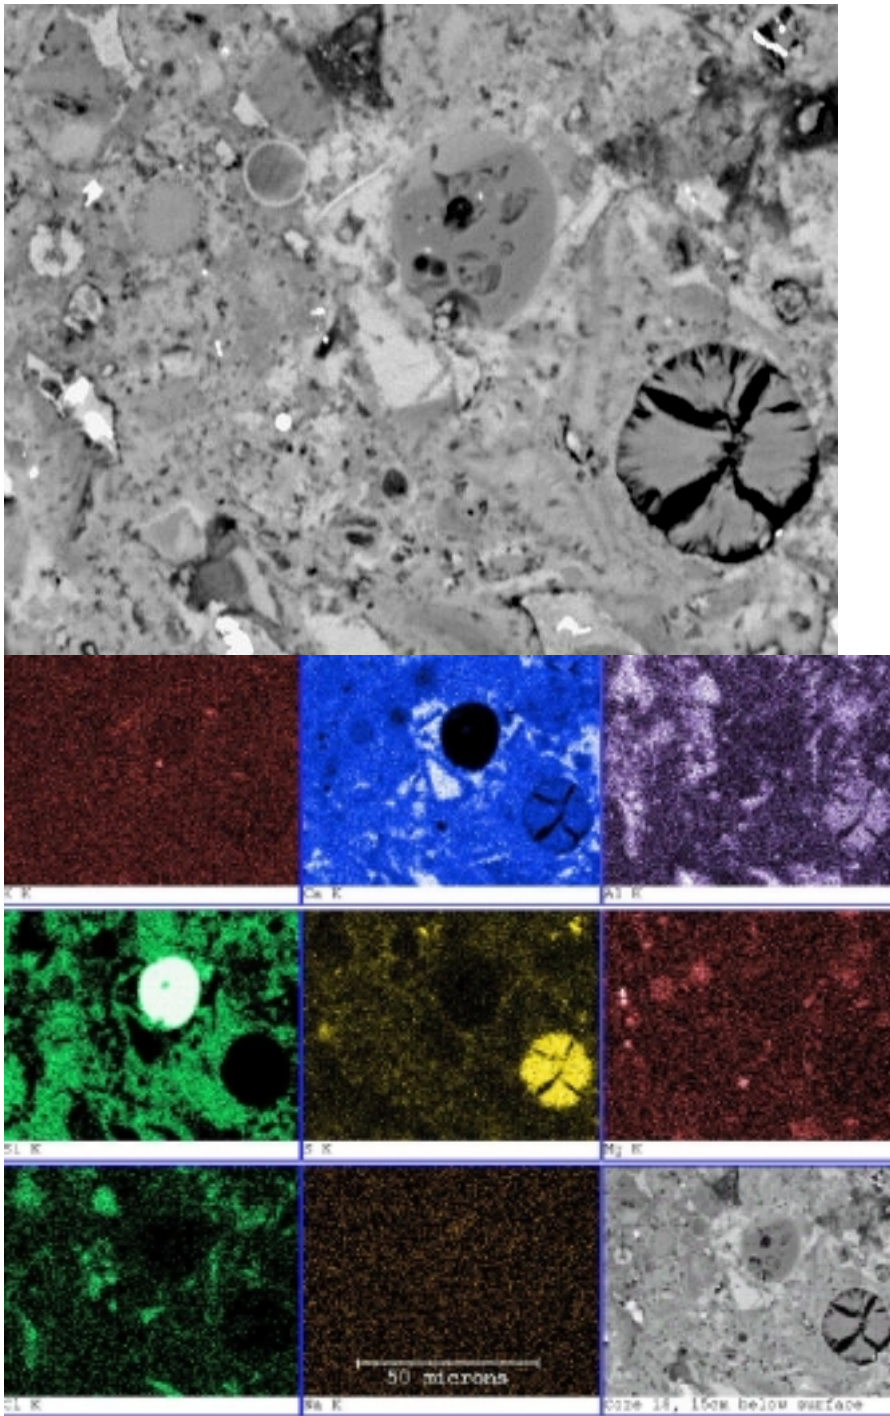
Figure 31. SEM of Core 18 shows an air void partially filled with ettringite (lower-right) and partially reacted fly ash particles (circular). X-ray element distribution (lower image) shows regions of high sulfur and aluminum that delineate locations of ettringite. Regions of chlorine and aluminum delineate regions of chloroaluminate. Field width: 75  $\mu\text{m}$ .

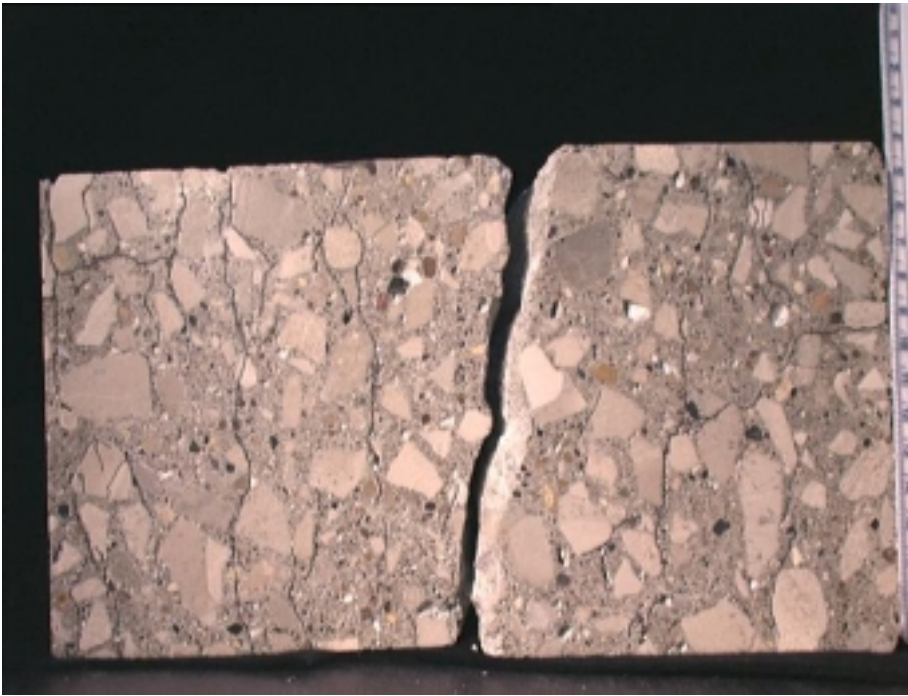
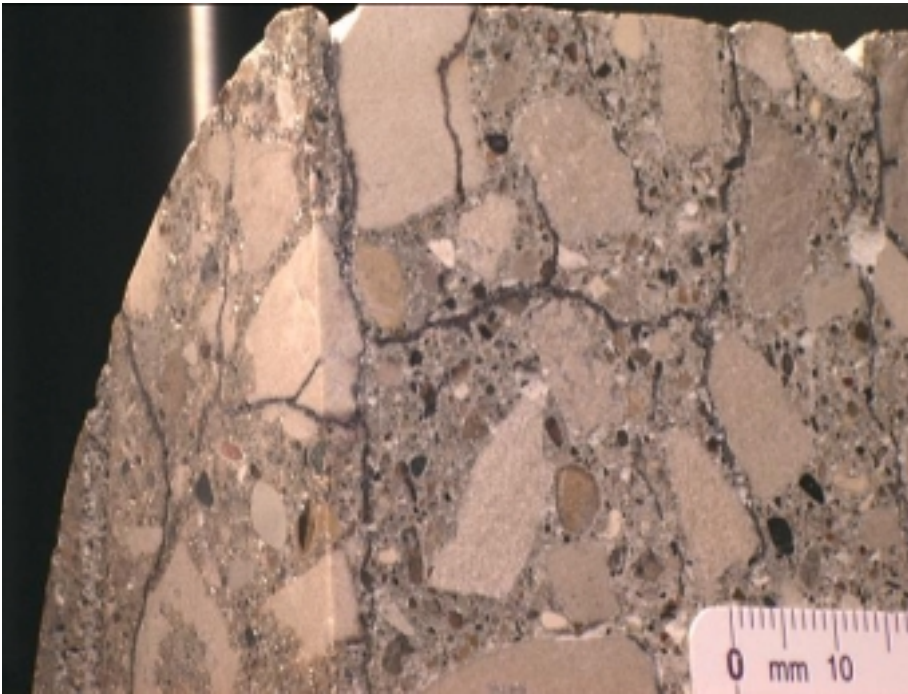
Figure 32. Core 19 exhibits extensive cracking of both the paste and coarse aggregate. Cracks trending parallel to the pavement surface (to the left) intersect perpendicular cracks; features typical of freeze-thaw cracking. The oblique view of the upper portion of core 19 shows cracking in both the surface (polished for clarity) and cross-section orientations.
