# **Deterioration of Iowa Highway Concrete Pavements: A Petrographic Study**

Paul E. Stutzman

December, 1999

Building and Fire Research Laboratory  
National Institute of Standards and Technology  
Gaithersburg, MD 20899

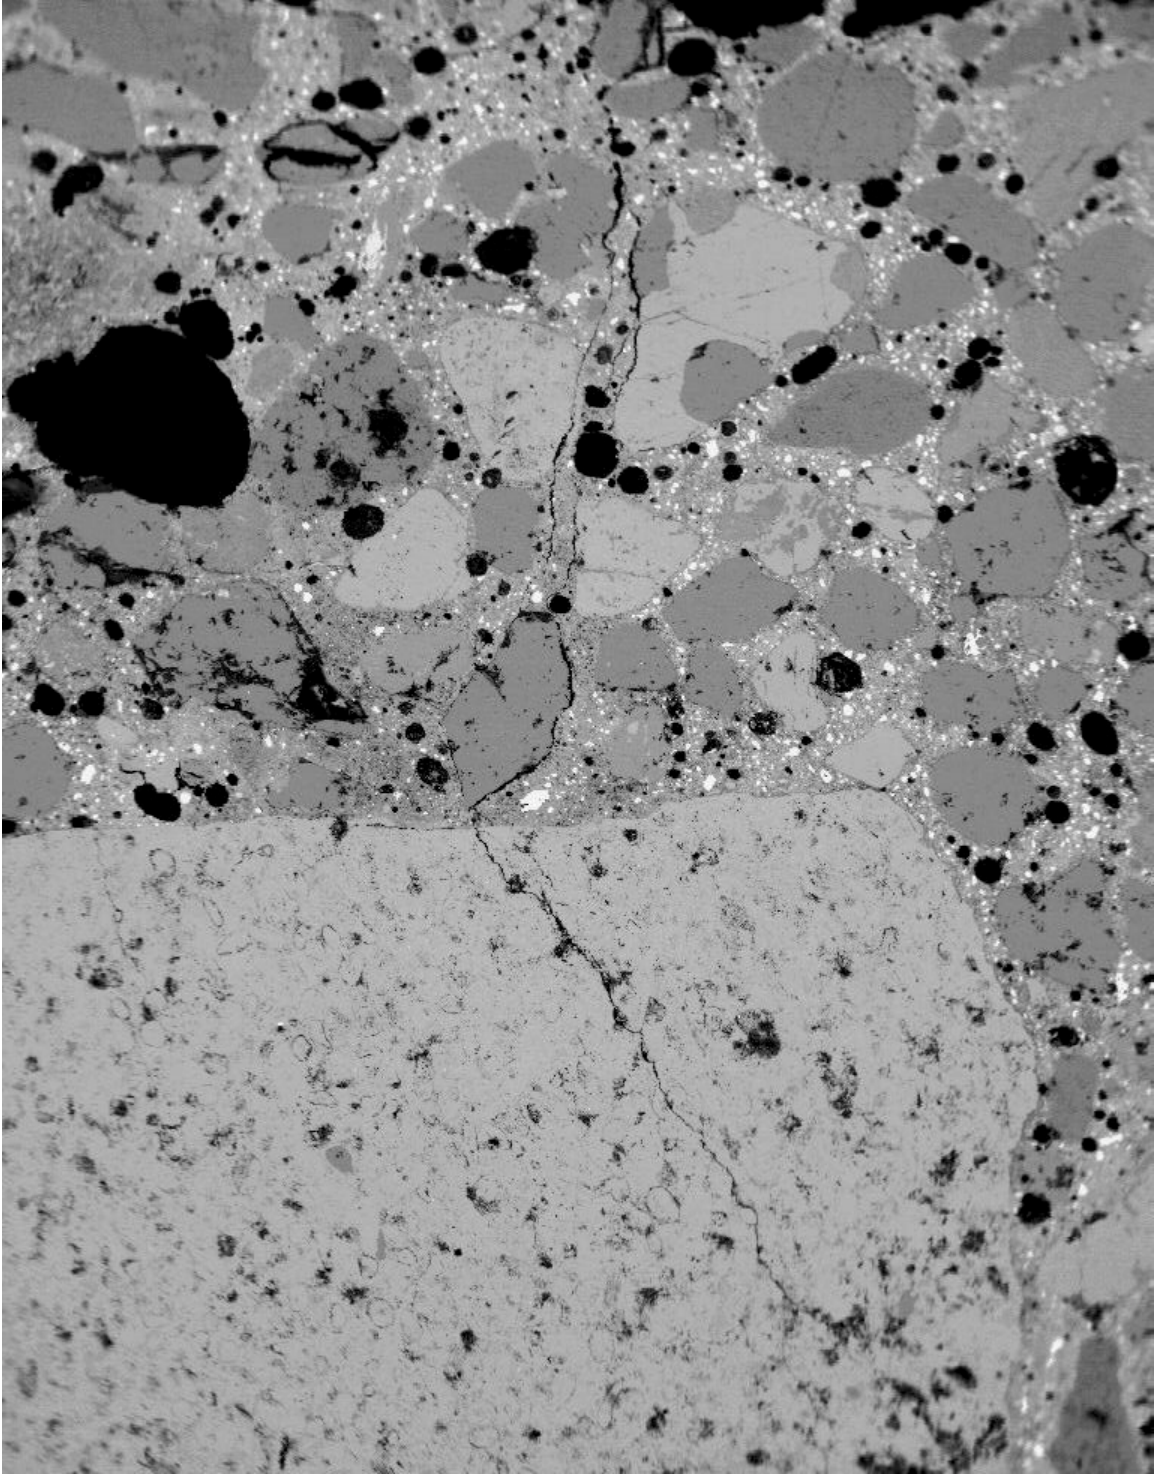
Figure 33. SEM image of a surface crack (road surface is at the top, 5 mm field width) extending through the paste portion of the mortar and terminating in a coarse aggregate.

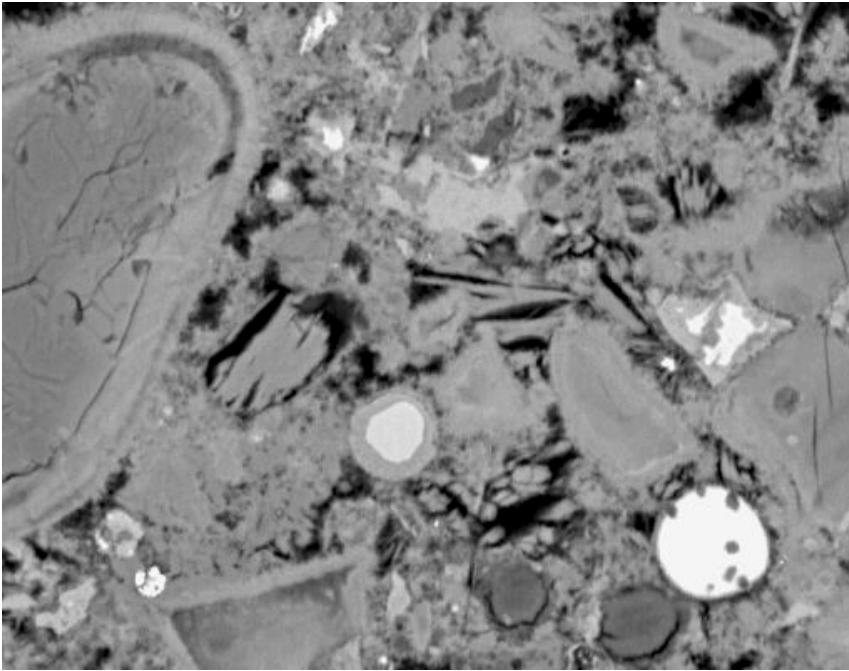
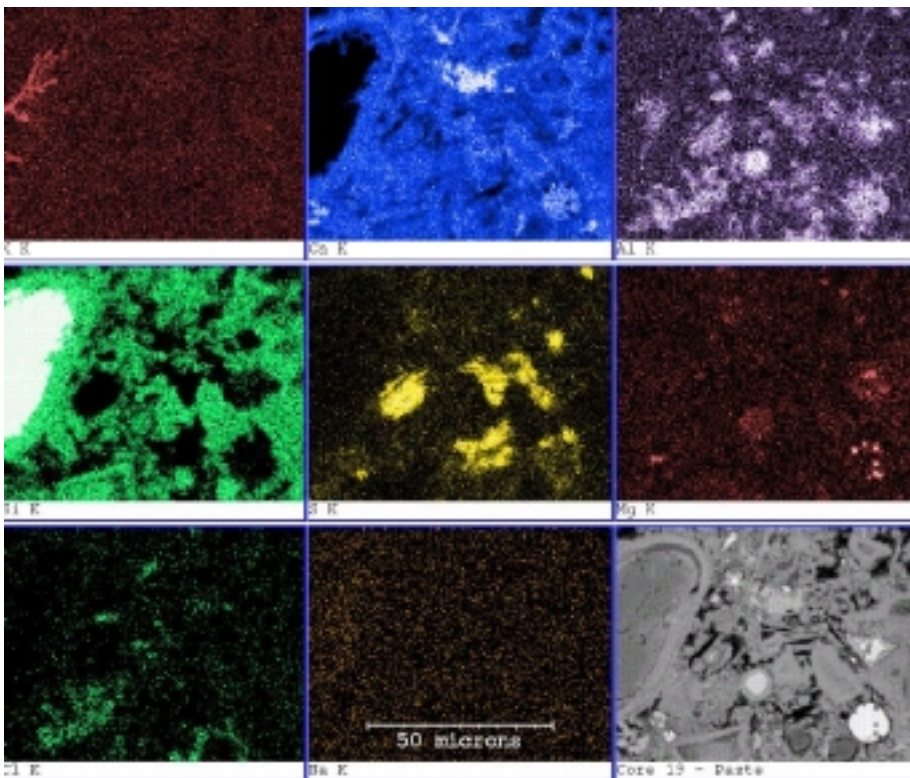
Figure 34 shows SEM images of the cement paste from Core 19. The upper, backscattered electron, image shows a region that includes a shale grain (left side), and hydration products, fly ash (circular), and pores (black). Alkali-silica reaction gel within the aggregate may be located using the potassium X-ray image (upper-left of the nine image series) yet no cracking is seen within the paste. Ettringite in the cement paste may be identified by its platy parting and by the combined X-ray images of intermediate aluminum, high sulfur, and intermediate calcium intensities. The occurrence of ettringite within the cement paste is common and may be either primary or a replacement of monosulfate. The gaps surrounding the ettringite grains are, in part, shrinkage phenomena due to the microscope vacuum but may also be a result of dissolution. The relatively large, irregular-shaped pores (black) may indicate dissolution of monosulfate and calcium hydroxide. Field examinations of this pavement did not find any evidence of overall expansion, making the occurrence of ettringite apparently innocuous. Regions of the chlorine (lower-left) and intermediate-intensity aluminum images delineate chloroaluminate, or Friedel's salt.

Figure 34. Back scattered electron image of Core 19 paste microstructure showing ASR-affected shale (left) and fly ash (circular). X-ray image regions of high sulfur (yellow) and intermediate aluminum (purple) mark locations of ettringite while regions of high chlorine (lower left image) denote locations of chloroaluminate.

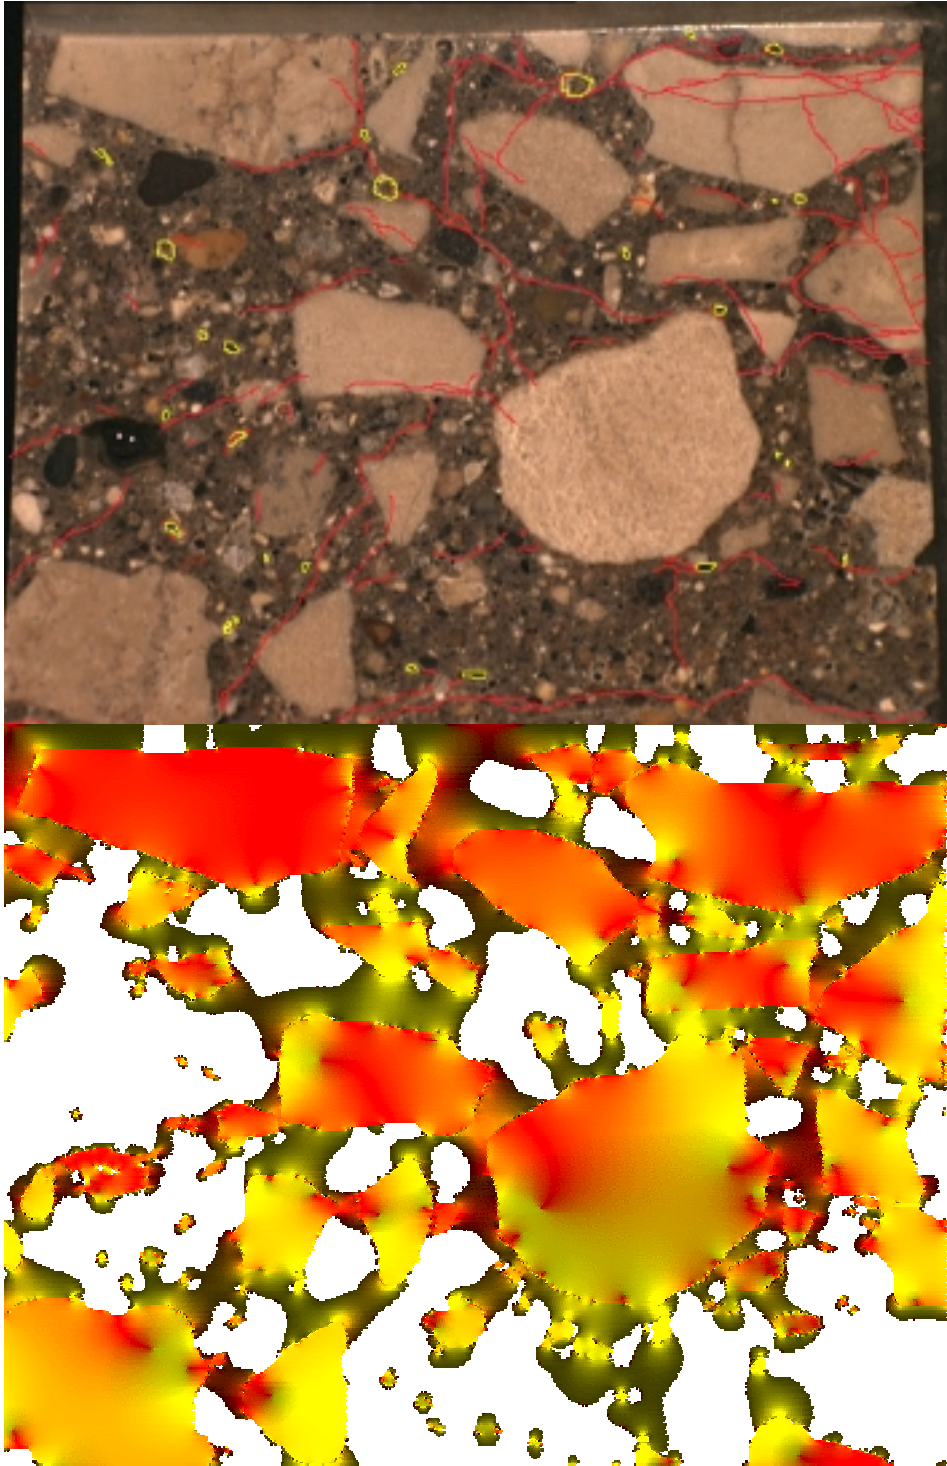
Figure 37. Top portion of core 19 with cracks (red) and ASR-affected shale grain (yellow) shows cracking through both the cement paste and coarse aggregate. A color-coded stress image resulting from a simulation of aggregate expansion showing regions of high stresses in red correlates well with some, but not all of the observed cracking.

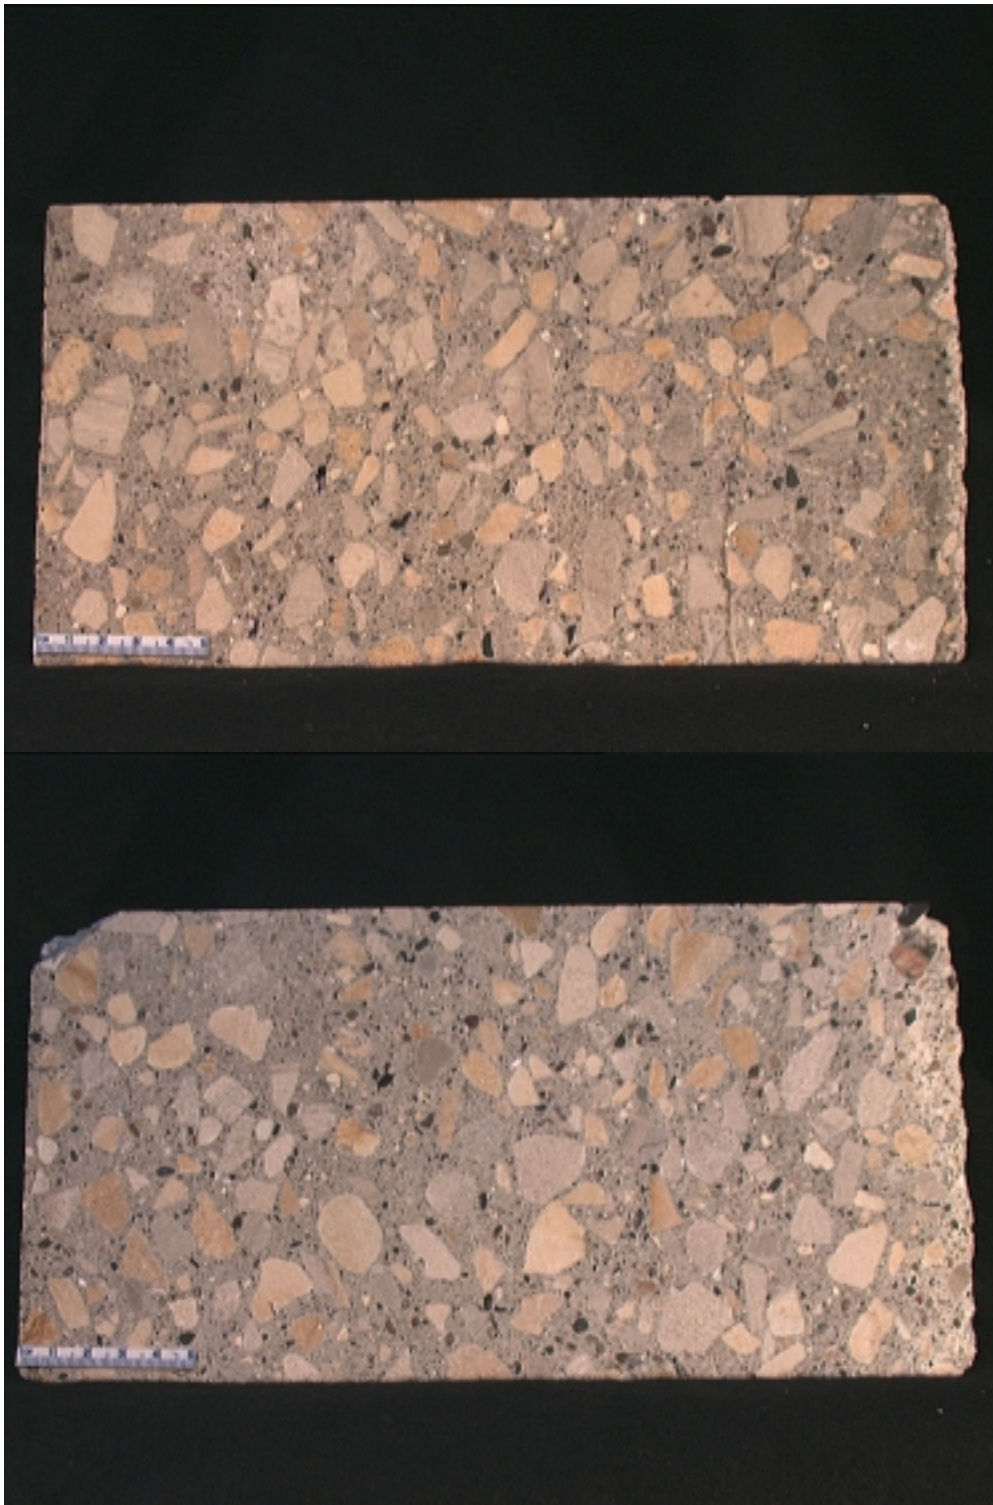
Figure 38. Cores 11, joint (top) and 12, mid-panel (bottom) cross section with horizontal crack in lower-most third. Some segregation is visible in both cores.

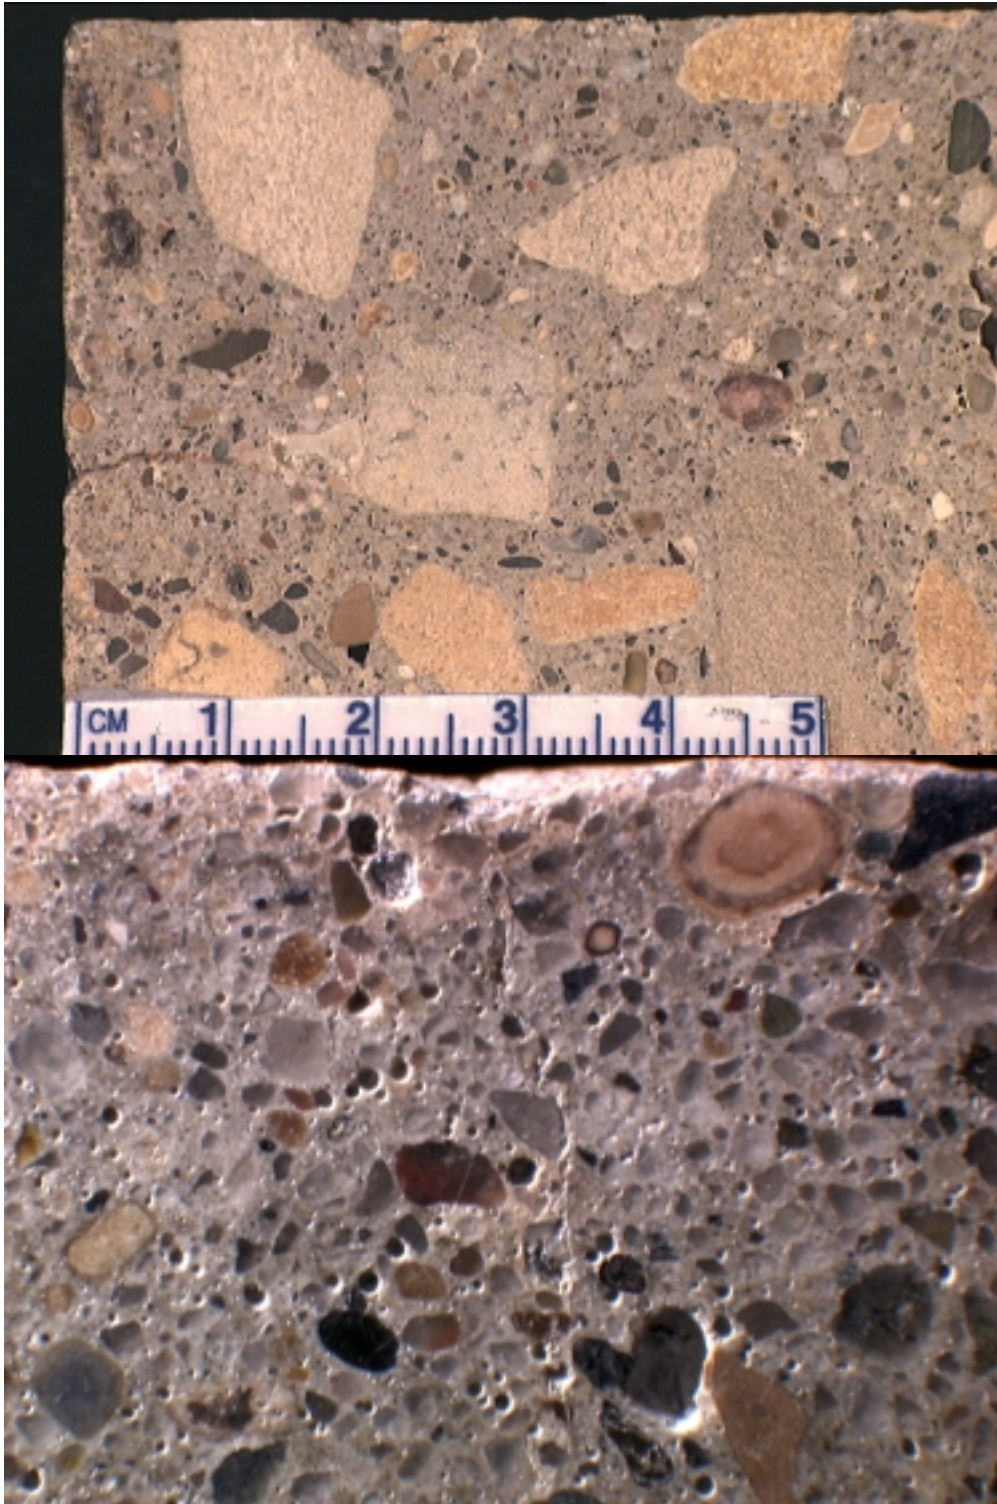
Figure 39. Surface cracking in Core 11 to about 20 mm passes through both the mortar and coarse aggregate. Lower image shows minor surface carbonation and cracking within the mortar. Field width 8 mm.

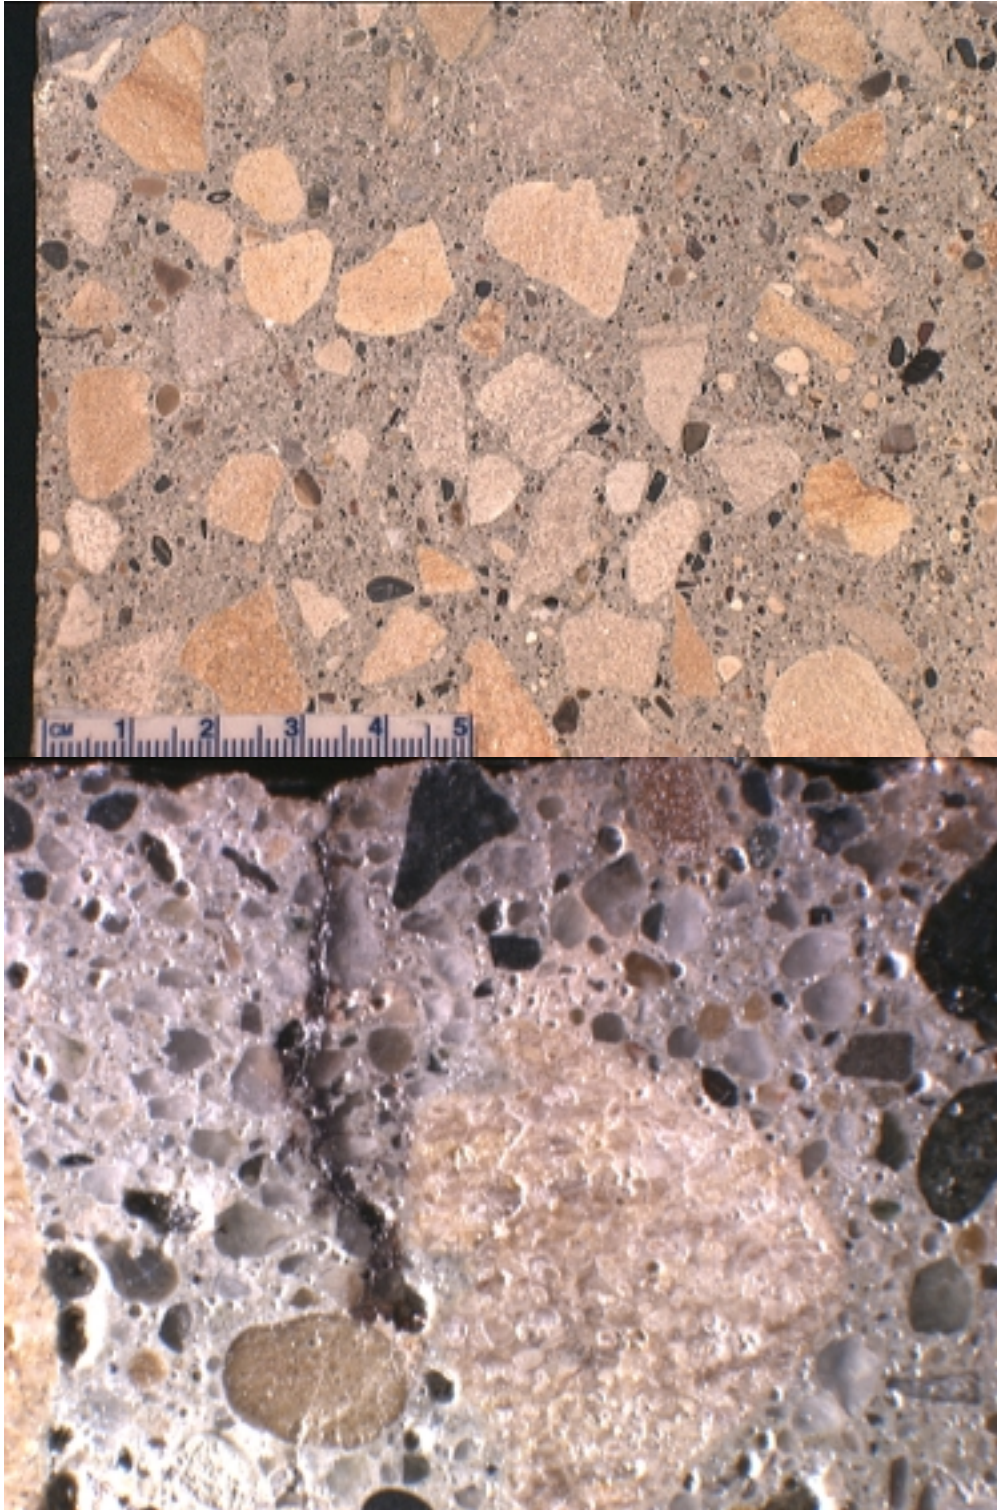
Figure 40. Surface crack in core 12 (approx. center-left) appears to be entirely within the mortar, and the lower image shows the crack plane through mortar highlighted using ink. 8 mm field width.

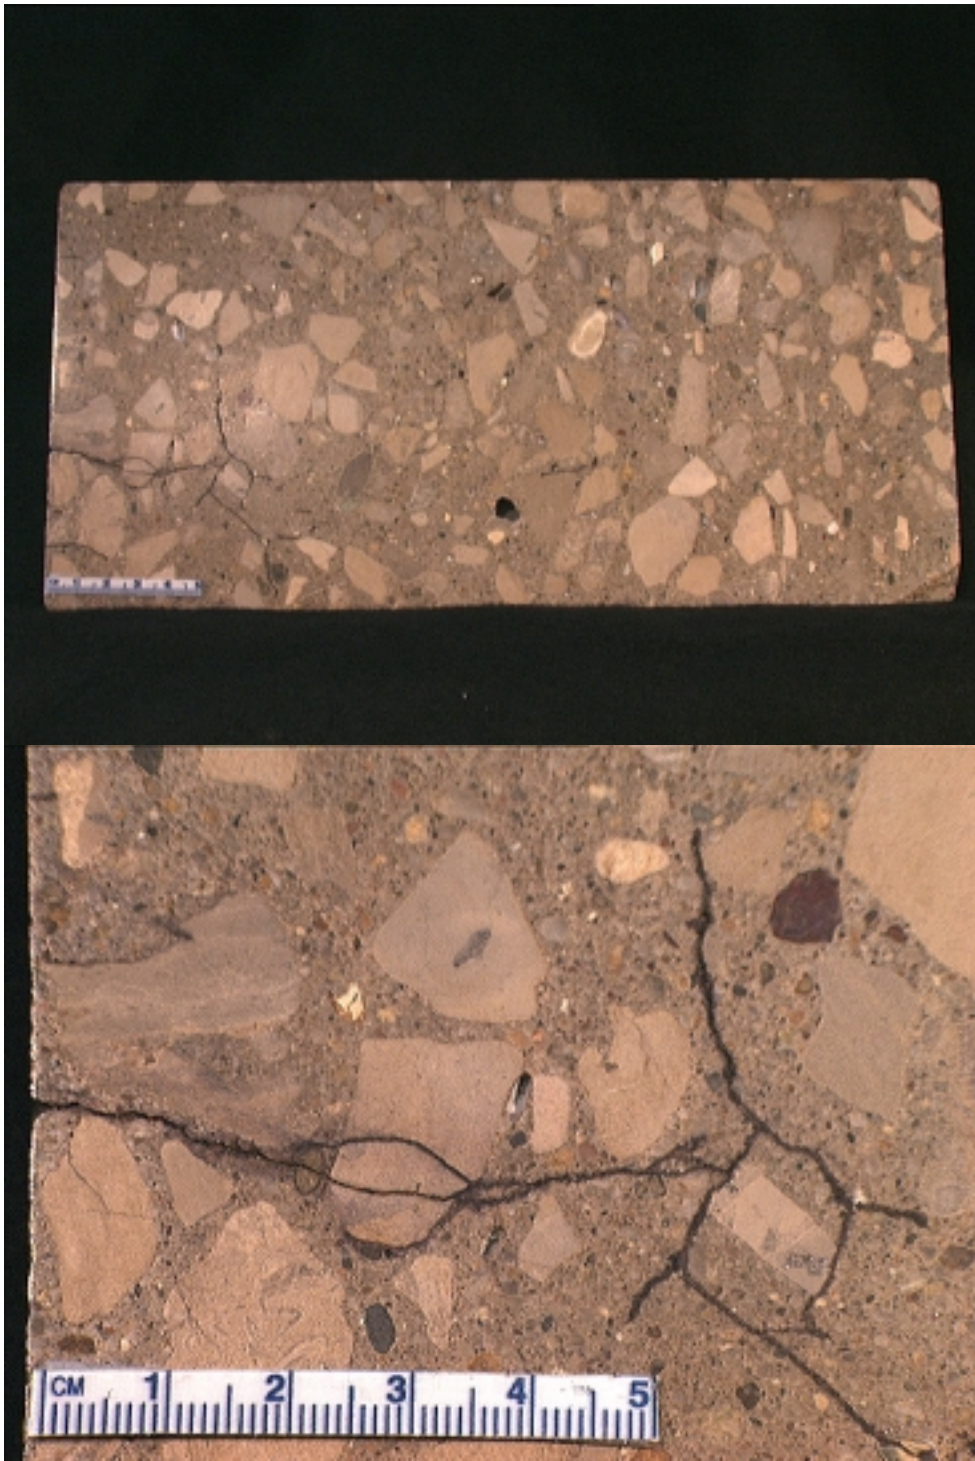
Figure 43. Core 29 cracking near surface passes through both the mortar and coarse aggregate. Cracking also follows close along paste-aggregate interface and is typical of a shrinkage crack. Cracking in aggregate and in the mortar at depth may reflect freeze-thaw damage, as the air void system in the upper half of this core is much poorer than that in the lower half.
