**NIST GCR 02-843-1**  
**(Revision)**

# **Analysis of Needs and Existing Capabilities for Full-Scale Fire Resistance Testing**

Jesse Beitel  
Nestor Iwankiw  
*Hughes Associates, Inc.*  
*3610 Commerce Drive, Suite 817*  
*Baltimore, MD 21227-1652*

Prepared for  
*U.S. Department of Commerce*  
*Building and Fire Research Laboratory*  
*National Institute of Standards and Technology*  
*Gaithersburg, MD 20899-8660*

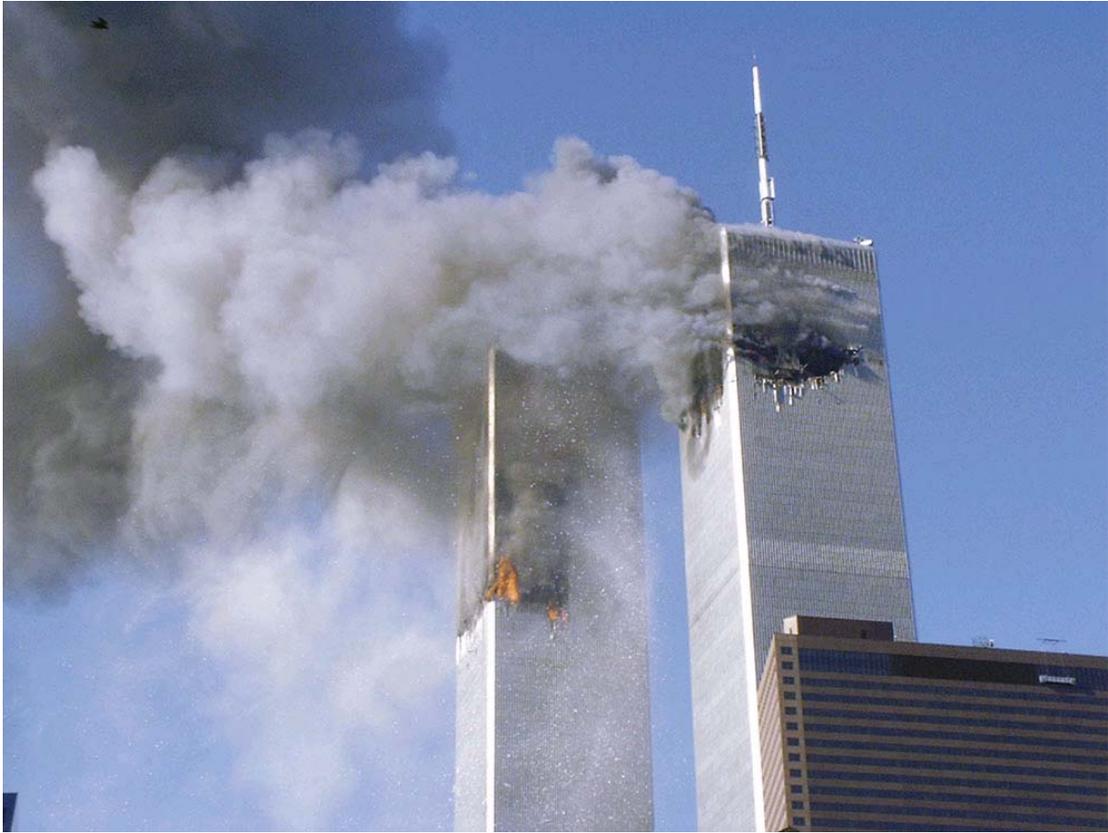
Figure 2.1a shows the fires in the damaged WTC 1 and 2 Towers before collapse, while Figure 2.1b shows the blaze in WTC 5. The representative fire damage in WTC 5 is given in Figure 2.1c, while the aforementioned column tree connection and floor failures are pictured in Figure 2.1d.

**Figure 2.1a Damaged and Burning WTC 1 (right) and WTC 2 (left) on Sept. 11, 2001**

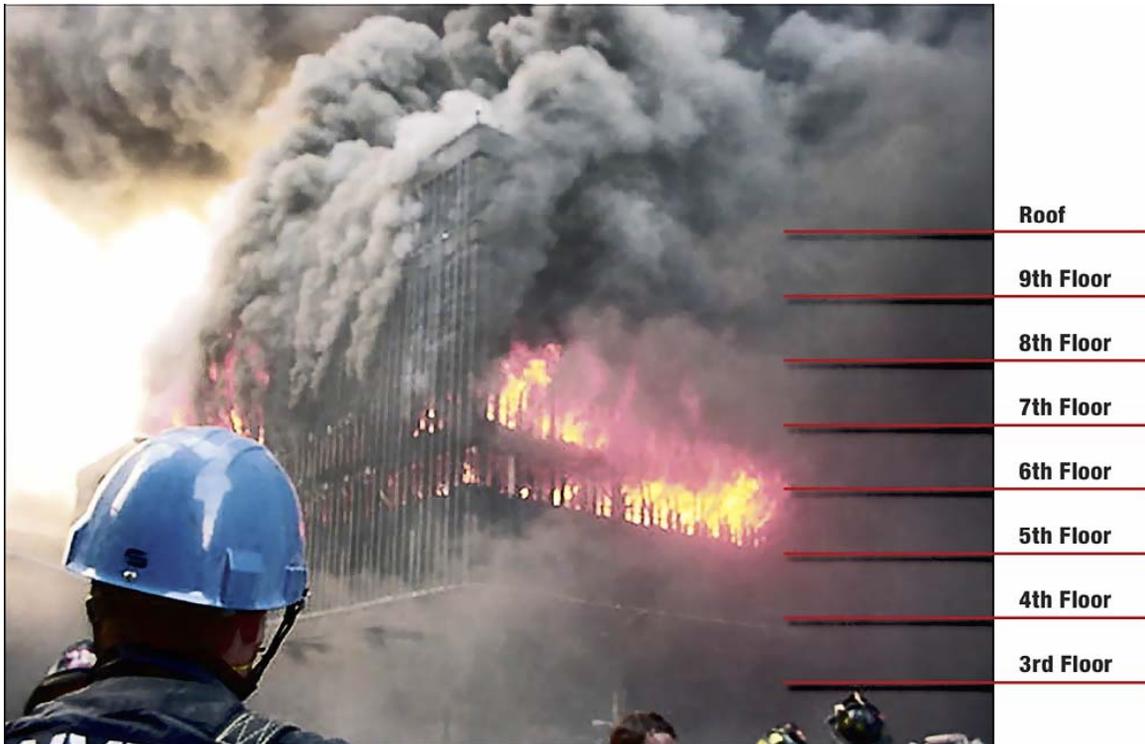
**Figure 2.1b Fires in WTC 5**

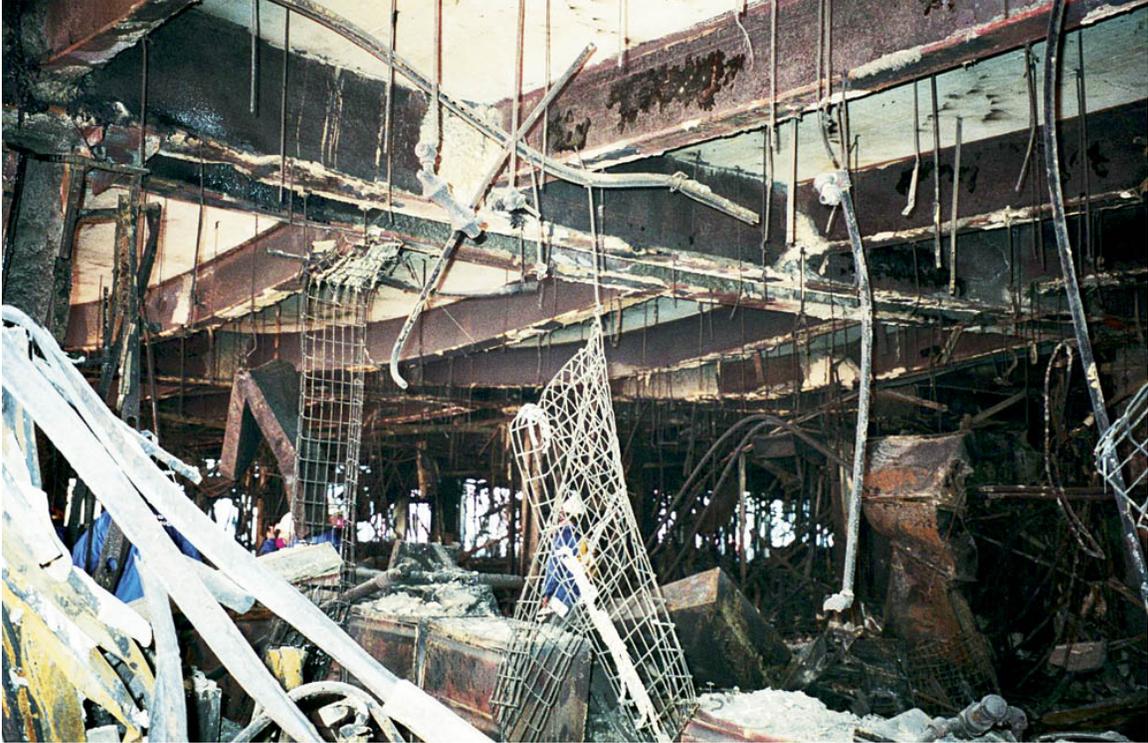
**Figure 2.1c Fire Damage in WTC 5**

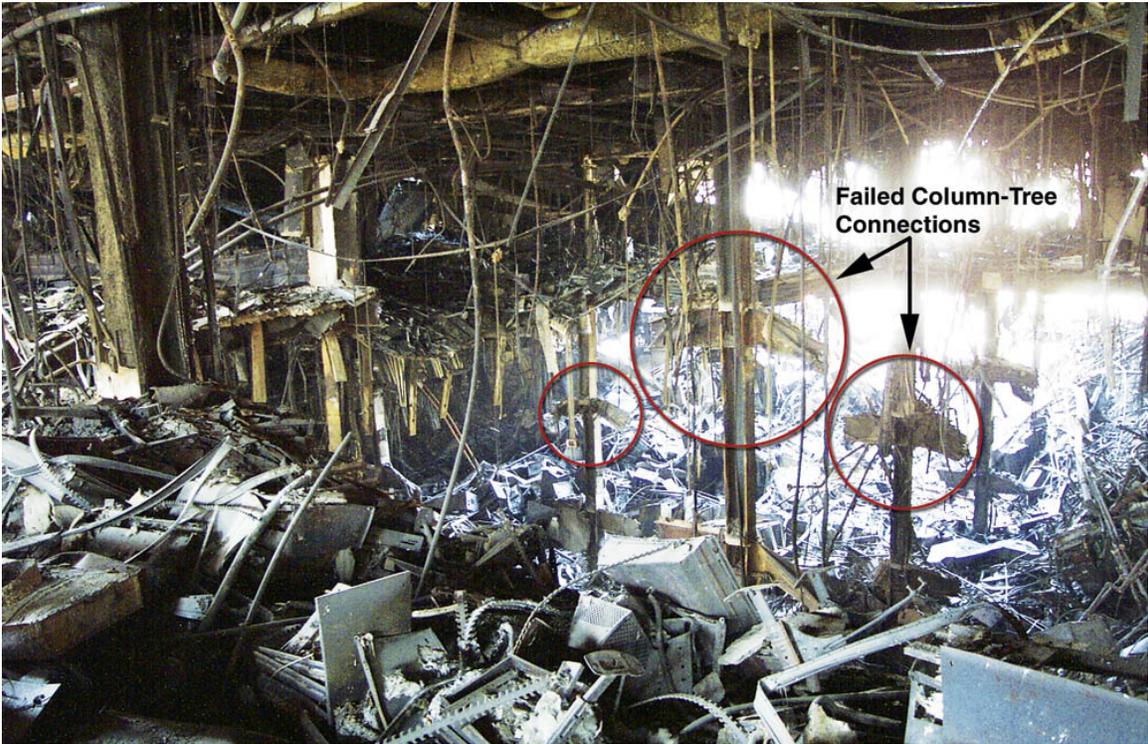
The 9-story WTC 5 building suffered extensive structural damage due to WTC 1 debris, which subsequently led to partial collapses of 4 floors due to fires. Interior floor beam splices

between supporting column-tree stubs and beams were identified as the point of fire-induced failure of these several floor bays.

**Figure 2.1d Partial Connection and Floor Failures in WTC 5**

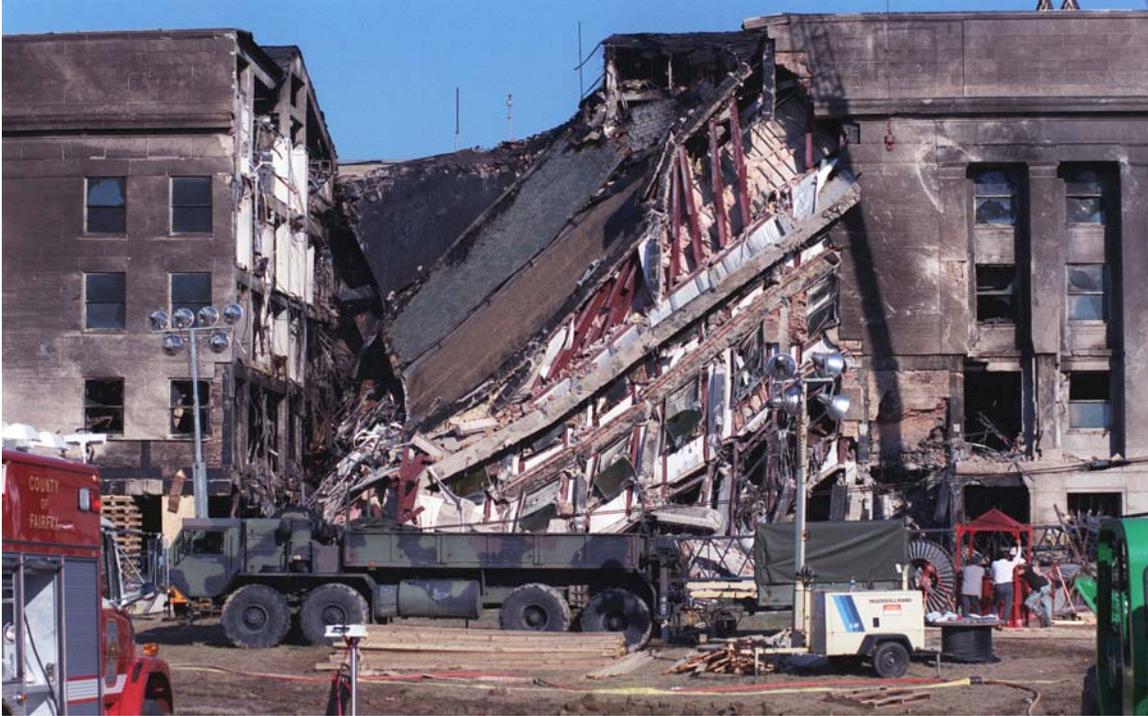
On September 11, 2001 the 5-story Pentagon building in Washington, DC, was struck by an aircraft, resulting in extensive damage and fire (see Figure 2.2). The Pentagon was constructed between 1941 and 1943 of hardened, cast-in-place reinforced concrete. News, anecdotal and visual observations indicate that there were some partial structural collapses in the Pentagon due to the ensuing fires approximately 30 minutes after the jet impact. An official investigation of the incident is being prepared but has not yet been released. There is no other publicly available information on the nature and progression of the structural damage in the Pentagon resulting from the jet crash and subsequent fire.

**Figure 2.2 Pentagon Collapse from the Sept. 11, 2001 Attack**

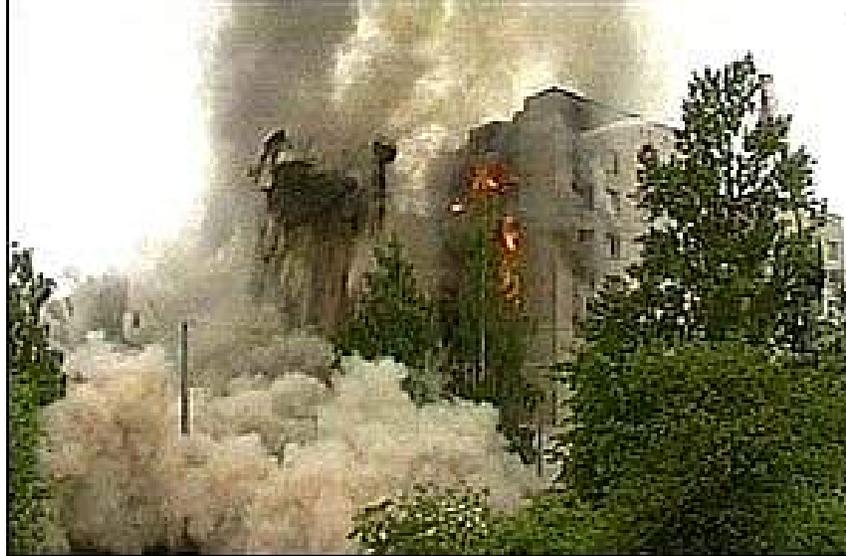
Another recent fire-induced building collapse occurred in St. Petersburg, Russia on June 3, 2002 (BBC News Online, 2002; Ottawa Citizen, 2002). This building was a 9-story concrete apartment block that totally collapsed after about a one hour fire (See Figure 2.3). The news services reported only 1 related casualty, with about 400 other residents safely evacuating the burning building prior to collapse. It was reported that ongoing reconstruction work at this site had accidentally ruptured a gas line, which ignited and fueled this fire.

**Figure 2.3 Collapse of Burning Apartment Block in St. Petersburg, Russia**

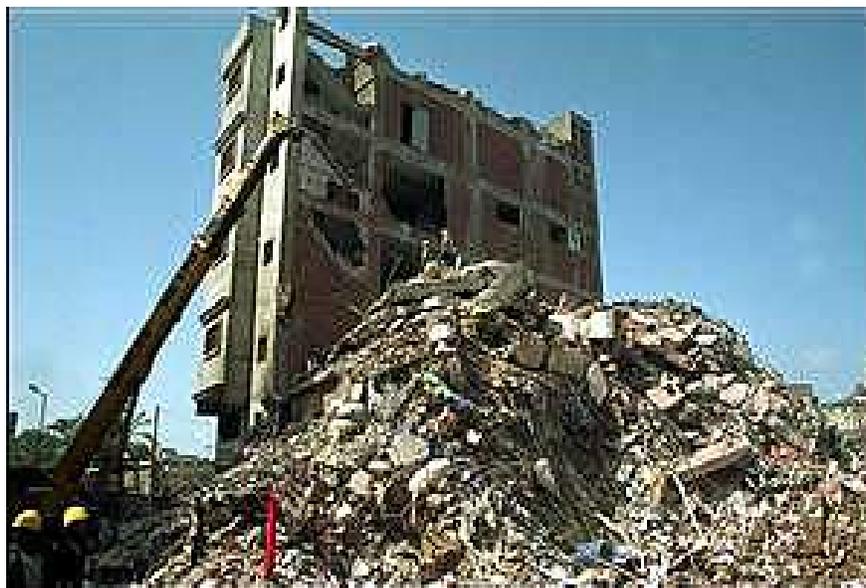
A fire-initiated collapse of a 6-story reinforced concrete textile factory occurred in Alexandria, Egypt on July 19, 2000 (Reuters News, 2000; BBC News, 2000). The fire started in the storage room at the ground floor. Fire extinguishers were non-functional, and the fire spread quickly before firefighters arrived. Approximately nine hours after the start of the fire, when the blaze seemingly was under control and subsiding, the building suddenly collapsed, killing 27 people. Figure 2.4 shows a photograph of this collapse.

**Figure 2.4 Collapsed Textile Factory in Alexandria, Egypt**

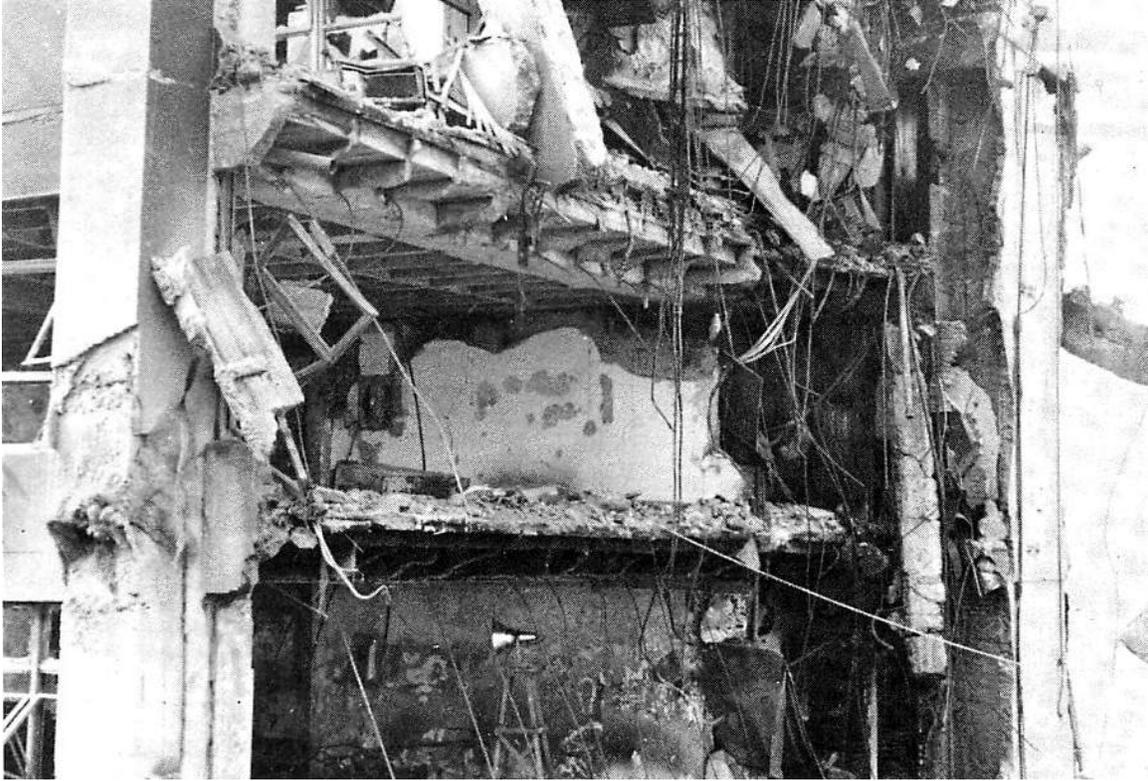
On May 21, 1987, Sao Paulo experienced one of the biggest fires in Brazil, which precipitated a substantial partial collapse of the central core of the CESP Building 2. This was a 21-story office building, headquarters of the Sao Paulo Power Company (CESP). Buildings 1 and 2 of this office complex were both constructed of reinforced concrete framing, with ribbed slab floors. According to Berto and Tomina (1988), these two buildings had several unique internal features and contents. Both buildings retained their original wood forms used for pouring the concrete floor slabs. Low-height plywood partition walls were also installed in the interiors. The ceiling in CESP 1 was made of plywood attached to the wood forms, while plaster tiles covered the ceiling in Building 2. Both buildings had automatic fire detection and manual fire alarms, but no automatic sprinkler system. Six footbridges connected these 2 buildings to permit convenient pedestrian access at various levels across a separation distance of 9.5 m.

The CESP fire started on the fifth floor of Building 1 from electrical causes, and progressed rapidly upward due to the combustible (wood) ceilings, the underlying formwork, and lack of adequate compartmentalization. Due to the severity of the Building 1 fire and other factors, it not only spread within this building, but also to the companion Building 2. The subsequent fires in CESP 2 ignited simultaneously on several floors due to the high thermal radiation from the original CESP 1 fire. In the presence of similar combustible partition walls and wood floor formwork, the CESP 2 fire also spread quickly. Firefighting efforts in both buildings were unsuccessful. Approximately two hours after the beginning of the fire in CESP 2, its structural core area throughout the full building height collapsed. This collapse was attributed to the thermal expansion of the horizontal concrete T-beams due to fire exposure. This led to the fracture of the vertical framing elements and their connections in the middle of the building, and the subsequent progressive loss of gravity load-carrying capacity (Figure 2.5). After the Building 2 collapse, the fire in Building 1, which was burning out, then re-ignited in floors 1-4 due of the flaming debris pile on the lower levels from Building 2. It was reported that this entire incident, from the original fire ignition in Building 1, spread to Building 2, the collapse of CESP 2 core, and the final re-ignition and burning of the lower floors of Building 1 lasted a total of about seven hours. The fire occurred in the evening and no casualties were reported.

**Figure 2.5 CESP 2 Core Collapse in Sao Paulo, Brazil**

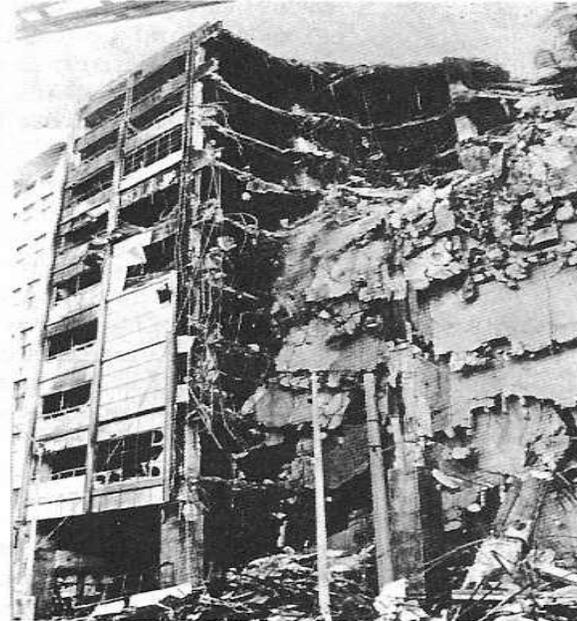
Papaioannou (1986) documented two large department store fires in Athens, Greece in 1980. These suspected arson fires occurred on December 19, 1980. The Katrantzos Sport Department Store was an 8-story reinforced concrete building. Its fire started at the 7<sup>th</sup> floor and rapidly spread throughout the building, due to lack of vertical or horizontal compartmentalization and the absence of an automatic sprinkler system. Collected evidence indicated that the fire temperatures reached 1000 °C over the 2-3 hour fire duration, and the firefighters concentrated on limiting fire spread to the adjacent buildings. Upon extinguishment of these fires, it was discovered that a major part of the 5<sup>th</sup> through 8<sup>th</sup> floors had collapsed. Various other floor and column failures throughout the Katrantzos Building were also observed, (see Figure 2.6). The cause of these failures was considered to be restraint of the differential thermal expansion of the structure that overloaded its specific elements or connections.

**Figure 2.6 Katrantzos Department Building in Athens after the 1980 Fire**

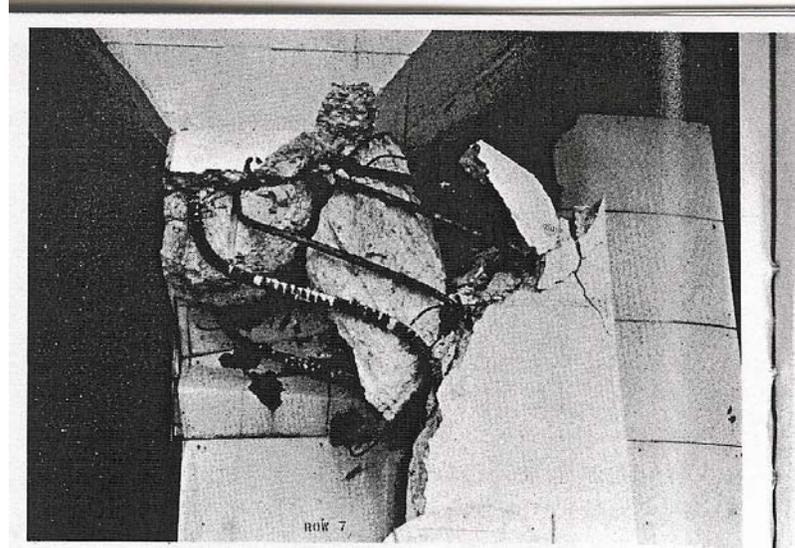
A partial roof and column collapse of the Military Personnel Record Center occurred on July 12, 1973 (Sharry, et.al., 1974). This was a large 86 m by 222 m, 6-story office building constructed of reinforced concrete. The building was located in Overland, MO and was built in the late 1950's. Sprinklers were present only on the first and second floors. The fire was reported to have started on the 6<sup>th</sup> floor. Due to the high fuel load of 21.7 million record files stored on the 6<sup>th</sup> floor, the fire burned out of control for 20 hours. The fire was finally extinguished after 4 days. The roof collapse began after approximately 12 hours of fire exposure, and involved 30% of the roof slab above the estimated point of fire origin. Subsequently, most of the remaining freestanding columns on the 6<sup>th</sup> floor collapsed. Minimal fire damage was experienced below the 6<sup>th</sup> floor. The collapse and damage were later attributed

to the large horizontal expansion of the 18 cm thick, conventional concrete roof slab that was supported by 41 cm reinforced square-tied columns. There were no expansion joints in the floors or roof. Lateral roof displacements of almost 60 cm occurred in one corner. Figure 2.7 shows the extent of the sixth floor horizontal deformation and damage to the concrete columns due to thermal expansion of the roof. The damage to the columns appeared to be analogous to the brittle column failures that have often occurred during earthquakes.

**Figure 2.7 Large Lateral Deformations and Failure of Columns at Sixth Floor of Military Personnel Records Center**

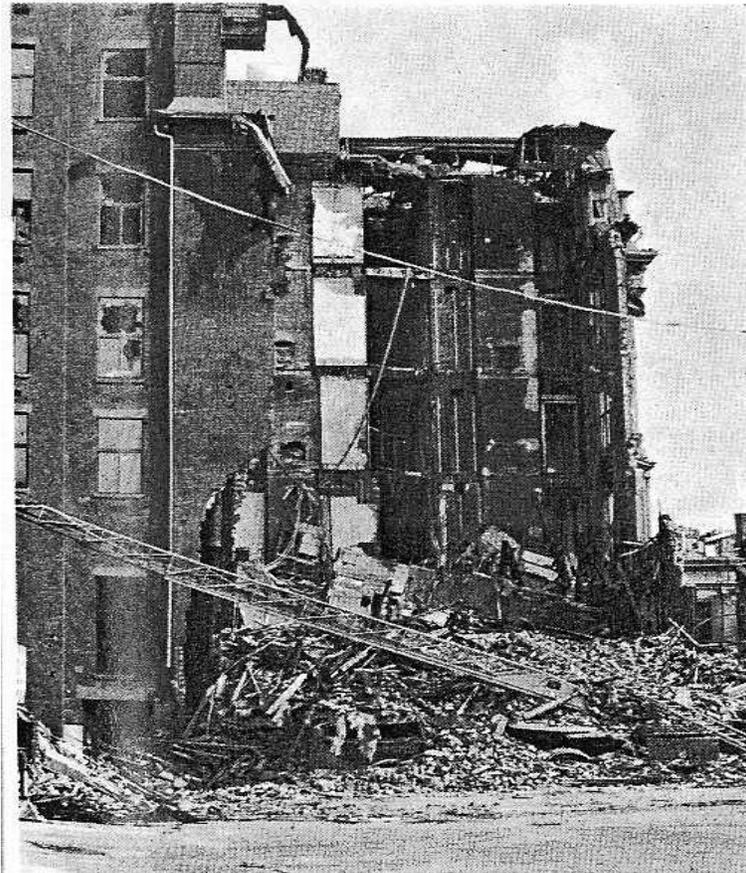
Another fire collapse occurred at the historic Hotel Vendome in Boston, MA. Built in the late 19<sup>th</sup> century of masonry and cast iron, this 5-story building was being renovated when a fire started at on June 17, 1972. After burning for almost 3 hours, all five floors in a 12 m by 13.7 m section collapsed (See Figure 2.8). This incident and the subsequent investigation were described in the *NFPA Fire Journal*, (January, 1973). Ongoing renovation work had caused excessive stresses on the bearing wall under a cast iron column, which was apparently already on the verge of overloading before the fire event.

**Figure 2.8 Boston Vendome Hotel Collapse**

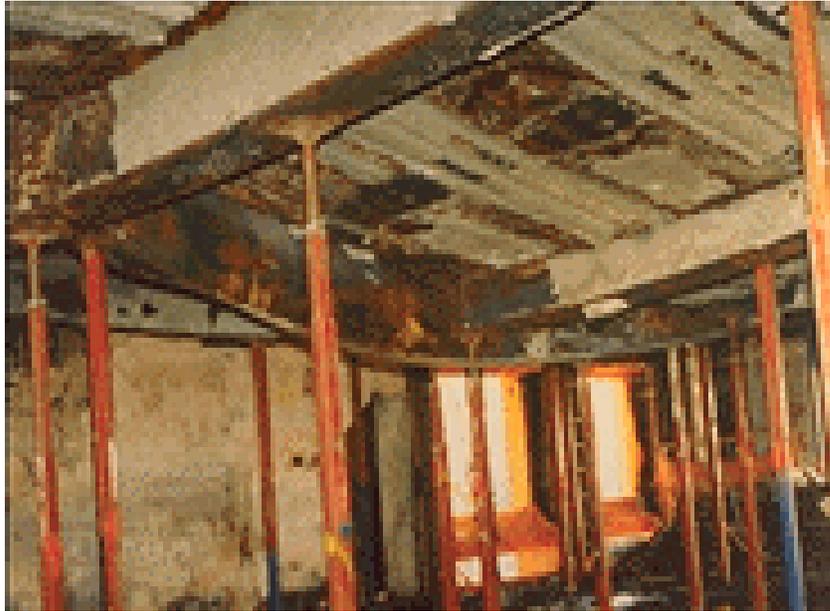
The 1980 MGM Grand Hotel fire in Las Vegas (Clark County Fire Department, 1981) killed 84 people, injured another 679 people, and caused hundreds of millions of dollars worth of property damage (Clark County Report). The First Interstate Bank (Klem, 1988) (4 floors burned out) and One Meridian Plaza (Klem, 1991) (9 floors burned out) in the US, and the Mercantile Credit Insurance Building and Broadgate fires in the UK (Newman, et al., 2000) are notable examples of excellent overall structural integrity under adverse fire conditions. Some casualties and major economic losses were still incurred in these steel-framed buildings. Complete burnouts of several floors destroyed the interior contents and caused substantial and permanent floor sagging and steel beam distortions, as would be expected after a long, severe fire exposure. In the One Meridian Plaza fire, deflection of main support beams were recorded as large as 46 cm, and one entire area of the 22<sup>nd</sup> floor had deformed by 1.2–1.5 m. (See Figure 2.9). All the buildings listed in Table 2.2, with the exception of One Meridian Plaza, were repaired and returned to service. After extensive investigations and studies, One Meridian Plaza was dismantled for economic reasons.

**Figure 2.9 One Meridian Plaza Interior Fire Damage**

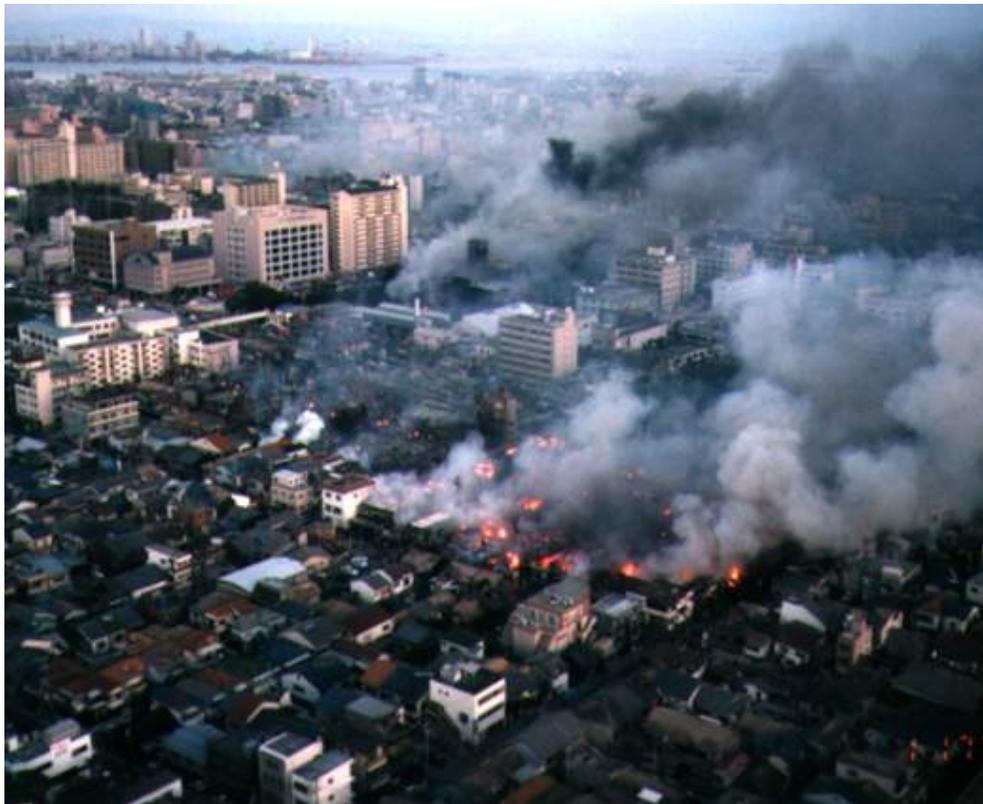
Approximately 100 fires started within minutes of the quake, primarily in the densely populated, low-rise residential areas of Kobe, Japan. It was reported that several large conflagrations had developed within 1 to 2 hours, with a total of 142 fires and numerous collapses and destruction of mostly low-rise, residential/commercial buildings of simple wood construction. Figure 2.10a and 2.10b shows pictures of the many fires in Kobe and their vast destruction after the 1995 earthquake (EQE Website).

**Figure 2.10a Post-earthquake Fires in Kobe, Japan on Jan. 17, 1995**

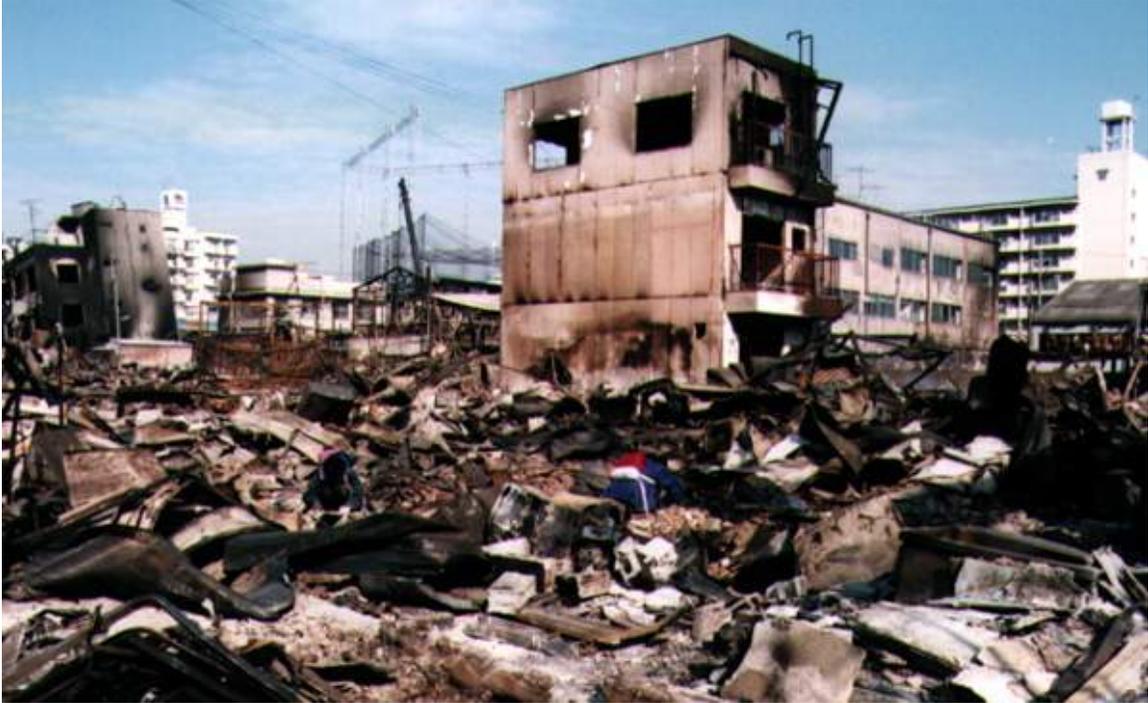
**Figure 2.10b Burned Area in the Nagata Ward of Kobe**
