**NISTIR 89-4061**

**AN ENGINEERING VIEW  
OF THE  
FIRE OF MAY 4, 1988  
IN THE  
FIRST INTERSTATE BANK  
BUILDING  
LOS ANGELES, CALIFORNIA**

**Harold E. Nelson**

**March 1989**

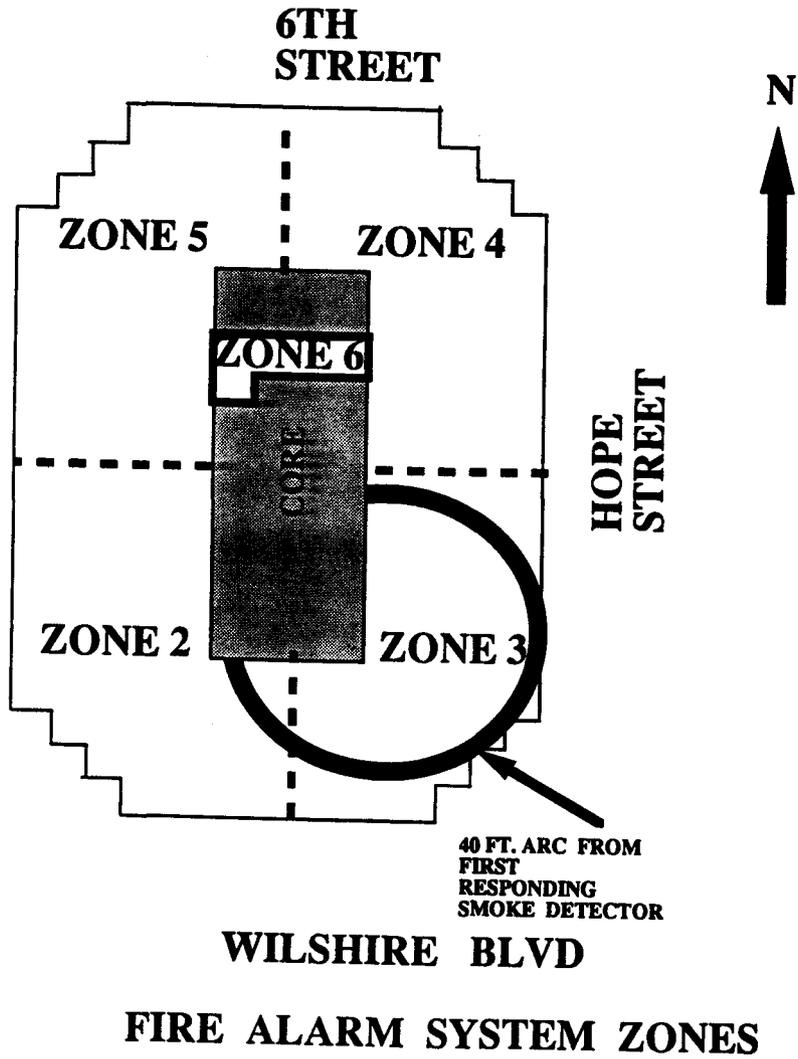
If both the burn pattern evidence and the calculations related to detector response could be considered fully reliable the point of origin would be close to the arc shown in figure 12 at a point south of the end of the central core in a position closer to zone 4 than to zone 2. However, in view of the size and rate of development of this fire both the burn pattern evidence and the

FIGURE 12 LIKELY POINTS OF FIRE INITIATION

detector response calculations must be treated with caution. More conclusive evidence would be needed to reach an irrefutable conclusion.

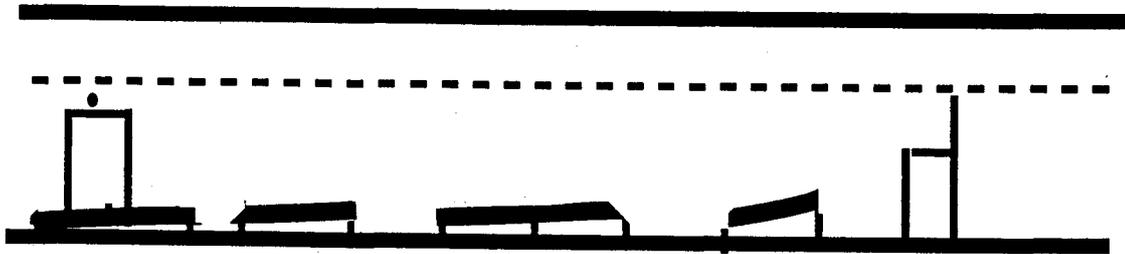
Figure 13 depicts the post fire remains of wooden workstations on the Hope Street side of the 12th floor. The portion depicted extends from the partition separating the private offices from the open trading floor space to the south end of the central core. A sloping pattern of destruction descends from the top of the workstations at the north end of the space shown to the floor at the south end of this area. Destruction extends to floor level from this point across most of the south end of the floor. In many fires the lowest point of burning is taken as indicative of the point of fire origin.

**FIGURE 13. BURN PATTERN IN WOODEN FURNITURE ON HOPE ST. SIDE**

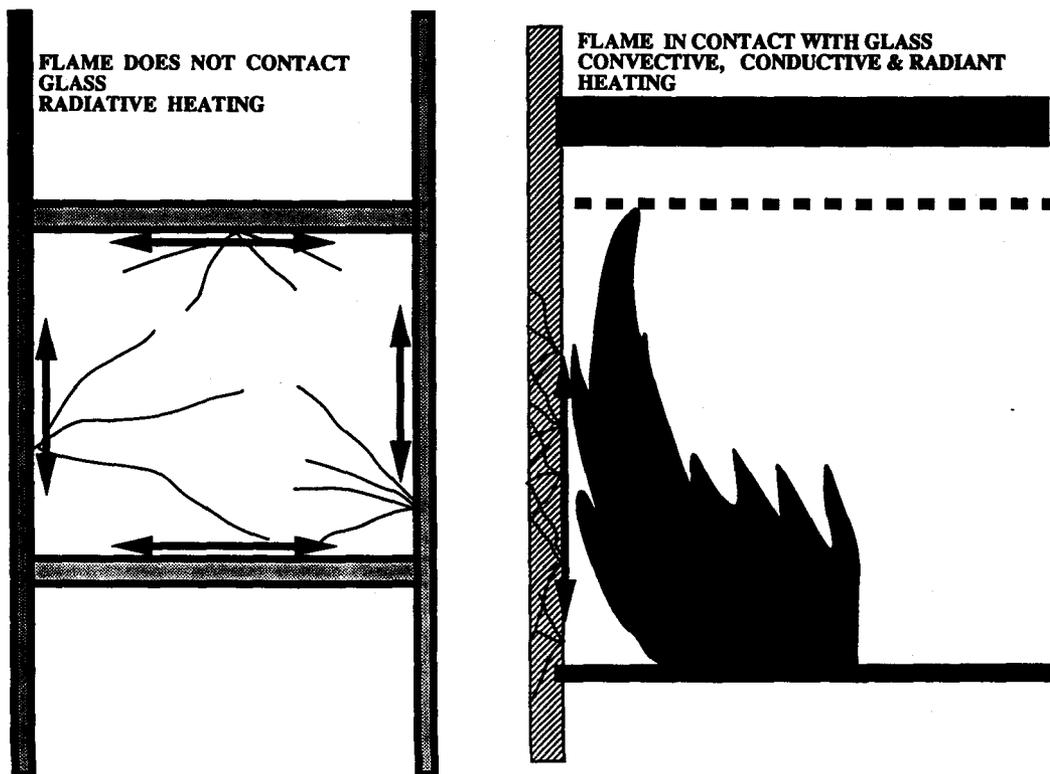
## Glass Breakage. (FIGURE 19)

One reason that it is not possible to determine whether the windows broke before or after flashover is that glass characteristically breaks in two manners.

- a. Radiant heating without flame contact. If flame does not contact the glass surface, heating of the glass is by radiant energy. In that case, the portions of the glass shielded from direct radiation do not heat-up as quickly as that portion exposed to direct radiation. As this occurs, internal stresses build up in the glass due to the greater thermal expansion of the more heated surface over the shielded surface. Theoretical calculations have indicated that when the temperature difference between the shielded and unshielded portions of the glass reaches about 100 F, radial cracks will travel from the boundaries quickly reaching a point of failure of the glass.

- b. Flame in contact with glass. Where direct contact is made between flame and glass, a thermal shock causing massive stresses between the hot side and the cool side of the plate occurs. This causes rapid cracking through the glass and failure of the glass whether or not general heating of the glass has taken place. The thicker the glass, the more likely this type of failure.

On this basis, if the fire source location is near the core, flames probably did not reach the glass prior to the development of flashover temperatures. Flashover conditions then produced radiation that heated the glass to its point of failure. Conversely, if the point of initiation was close to the windows, flame contacted the glass and the windows broke prior to flashover. In this latter case the early venting of the fire may have prevented the development of true flashover conditions.

**FIGURE 19. FIRE CAUSES OF GLASS BREAKAGE**

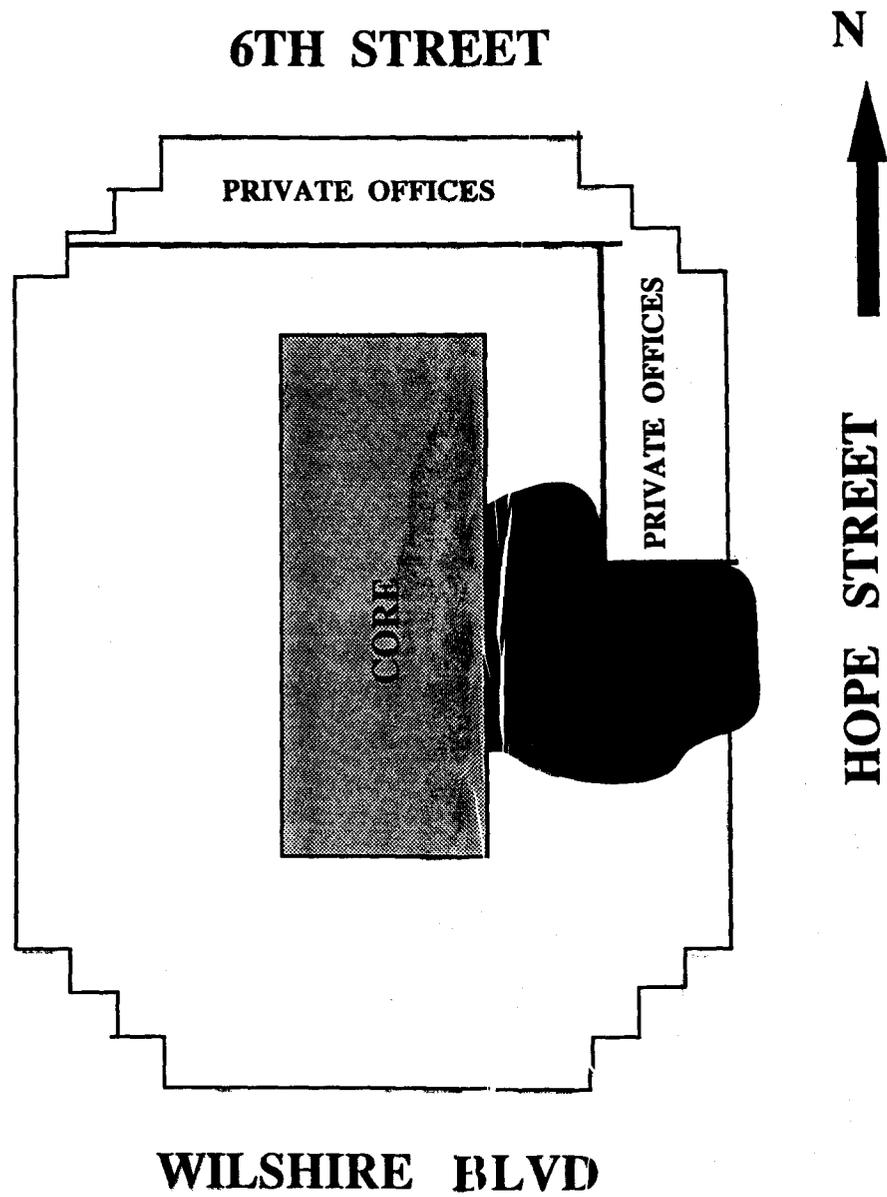
**FIGURE 20. AREA OF FIRE INVOLVEMENT AT 10:37**

The most likely occurrence is localized high (flashover range) temperatures produced by the flame and high temperature gases nearest the fire source. This caused window breakage in the immediate area. It is likely that the initial venting of the fire, depicted in figure 20, occurs before involvement of other portions of the floor. At the moment of breakage it is possible that the resulting opening is large enough to allow the fire to draw into the floor all of the air needed for the complete combustion of the material burning at that time.

**ABOUT 10:37 FIRST WINDOWS BREAK**

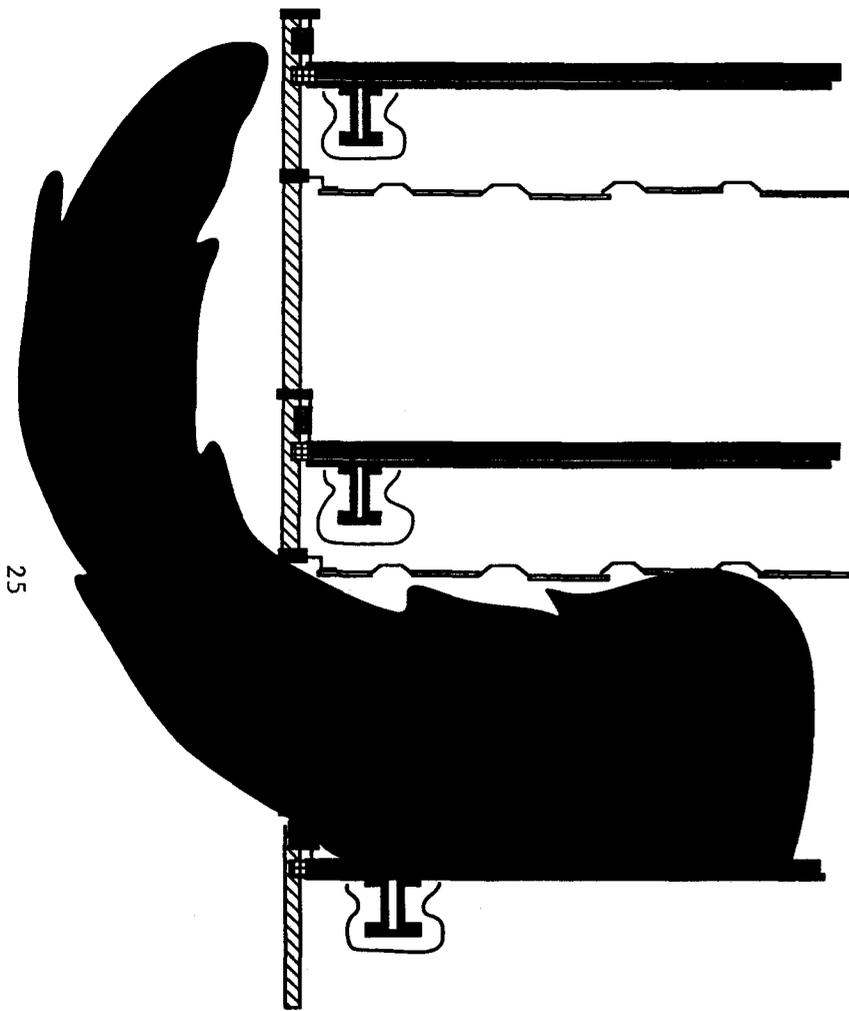
FIGURE 23. EXTENTION OF FUEL RICH FLAME

At the time of first breakage, it was likely that the fire is on the fuel rich side and expelled significant quantities of unburned gases forming a large flame, such as shown in figure 23. Such a flame could have broken glass and started some ignitions on the floor above or, failing to break the glass, radiated the material on the 13th floor preheating it. Since no ignitions are reported on the 13th floor at this time, the latter condition is more likely.

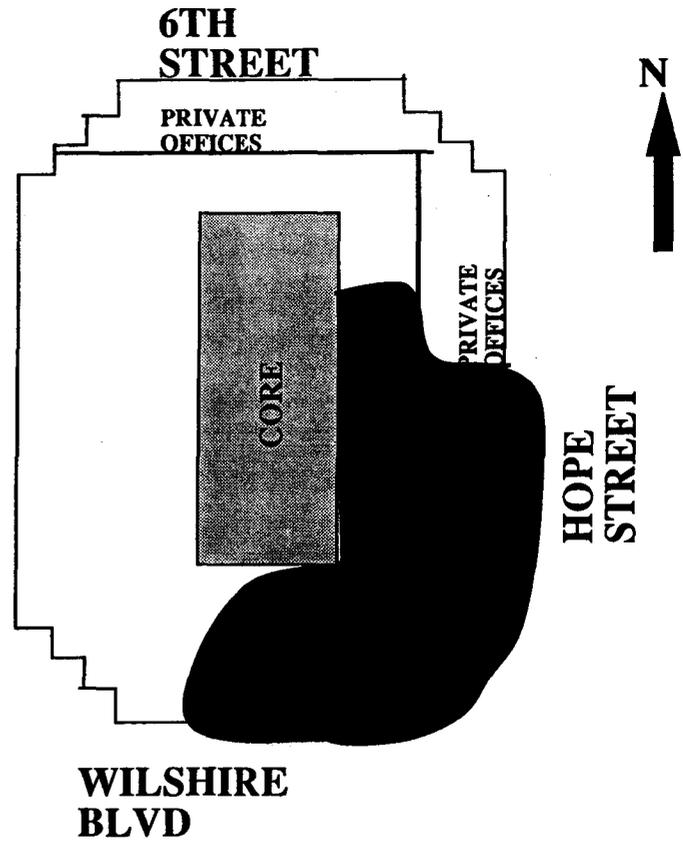
FIGURE 24. AREA OF INVOLVEMENT  
AT 10:40 P.M.

Figure 24 estimates the extent of spread through the 12th floor at 10:40 p.m. As time progresses, the fire spreads across more surface area and windows are broken out over Wilshire Boulevard. By about 10:40 p.m., there are reports of extensive fire on both the Wilshire Boulevard and the Hope Street sides of the building. The prime means of fire spread continues to be radiant ignition of groups of workstations by the flame extension from the burning fuel. Shortly after 10:40 p.m., fire starts to progress along the west side of the building.

ABOUT 10:40 SPREAD COVERS  
MORE THAN 1/4 OF PERIMETER

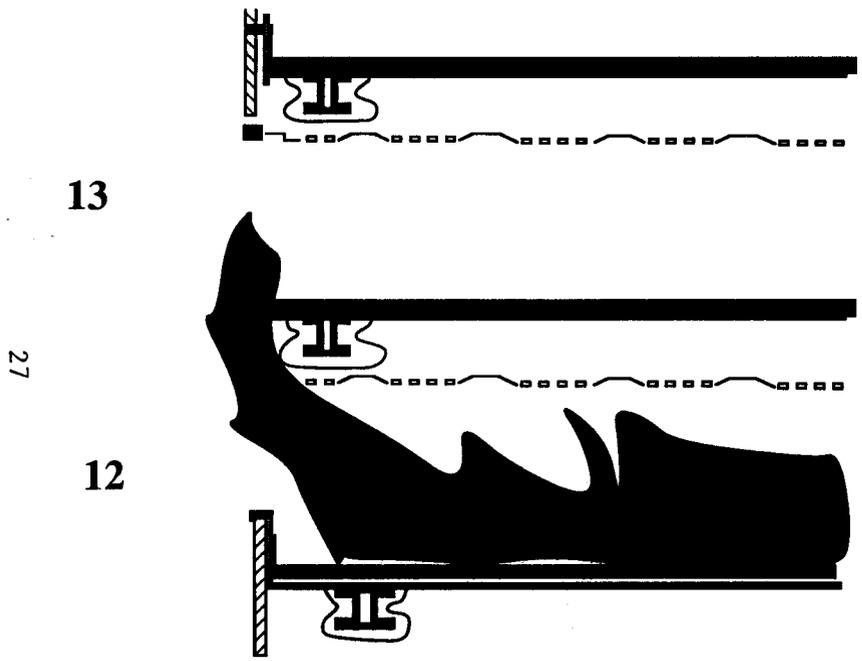
FIGURE 25. FIRE EXTENTION TO 13TH FLOOR

Fire spreads to the 13th floor at about 11:00 p.m. Flame emitting from most of the 12th floor windows. In view of the ventilation provided by the broken windows the length of flame extension is a function of air-rich burning. The extension is in the range shown in figure 25. Exceptions appear on video tapes where extensive flame emission come from windows of individual offices (presumably as the individual rooms flashover.) It is likely that at least portions of the suspended ceiling have failed by this time (11:00 p.m.) thereby exposing the spandrel panel and end of the floor slab to direct flame impingement.

Four different potential means of fire transmission between floors were noted from photographs, video tapes, fire department observations, and post fire evidence. It is impossible to determine which caused the first ignition or which was most prevalent. These four identified fire transmissions means are:

- a. Massive extension of flame covering the window area on the floor above.
- b. Failure of the suspended ceiling and glass spandrel panel, followed by lapping of the flame around the end of the floor slab.
- c. Flame transmission between the glass spandrel panel and the end of the floor slab. In this instance the actual transmission of fire may have resulted from failure of the gypsum board panel extending from the window sill on the floor above the fire to floor level, failure of the aluminum window sill or mullions, or failure of the glass spandrel panel.
- d. Passage of flame through spaces around pipes and other penetrations of the floor slab. This route was evidenced by burn traces in the core area.

ABOUT 11 PM IGNITION ESTABLISHED ON 13TH FLOOR

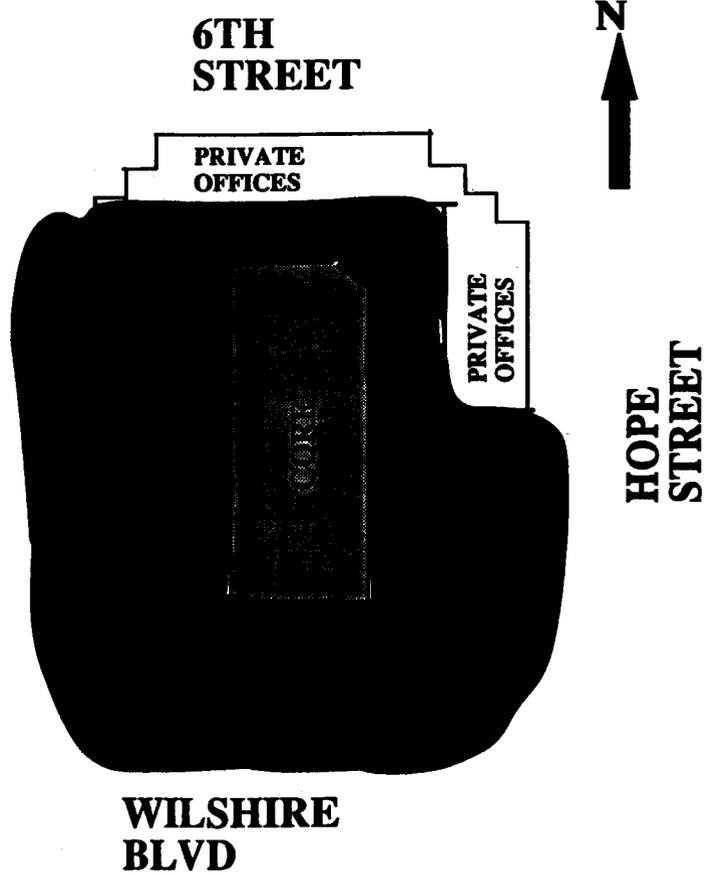
FIGURE 26. AREA OF INVOLVEMENT AT 11:30 P.M.

Photographs indicate that the fire reaches the northwest corner of the 12th floor at about 11:30 p.m. Fire involvement is estimated as shown in figure 26. Propagation around the floor slows as more of the floor becomes involved. It is possible that a portion of the flame is pulled towards the center of the building once the 13th floor is involved. This can reduce the flame extension along the ceiling, slowing down the rate of radiant ignition of new workstations and other fuel. Photographs indicate that during the next 30 minutes the fire progressively penetrates the offices along the north wall from west to east, reaching the northeast corner about midnight. It appears that the ceiling-high gypsum board partitions enclosing these offices retard their involvement.

ABOUT 11:30 PM FIRE WRAPS FLOOR EXCEPT OFFICES - FIRE EXTENDS TO OFFICES DURING NEXT HALF HOUR

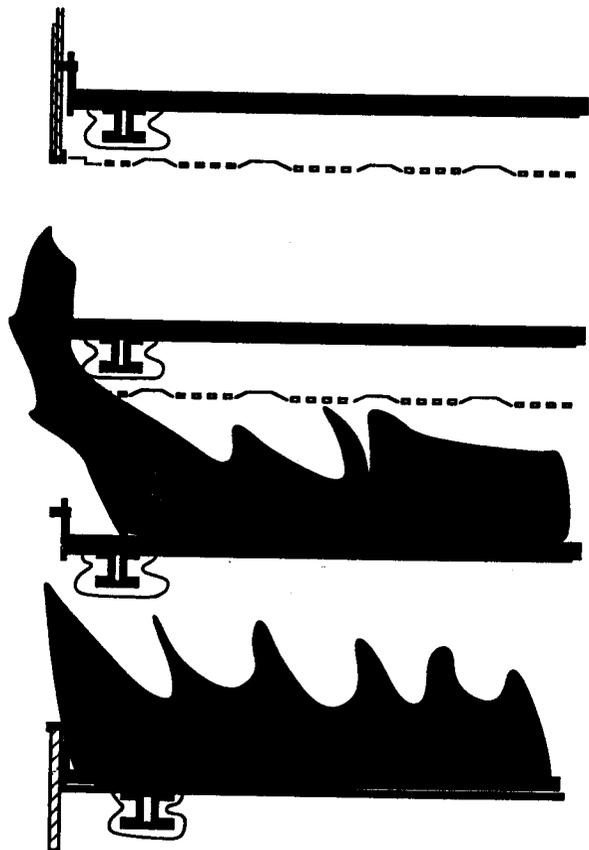
FIGURE 27. SPREAD TO 14TH FLOOR

ABOUT 11:40 PM IGNITION ESTABLISHED ON 14TH FLOOR

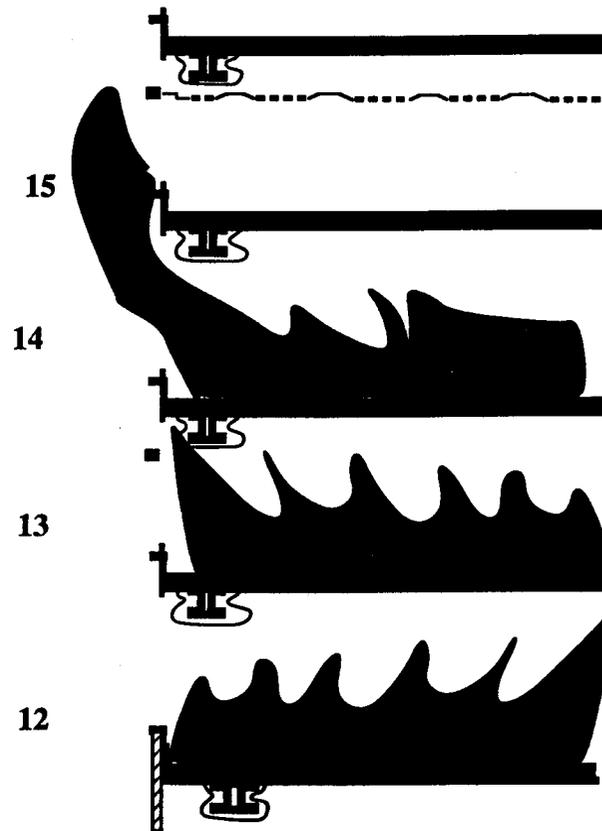
FIGURE 28. FIRE EXTENTION TO THE 15TH FLOOR

The reported time of extension to the 15th floor is about 12:20 a.m. Figure 28 depicts the envisioned relationship of flame orientations. This emphasizes the concept that flame being drawn in on the lowest floor and pushed out on the highest floor with the upward movement of the neutral plane.

ABOUT 12:20 AM IGNITION ESTABLISHED ON 15TH FLOOR

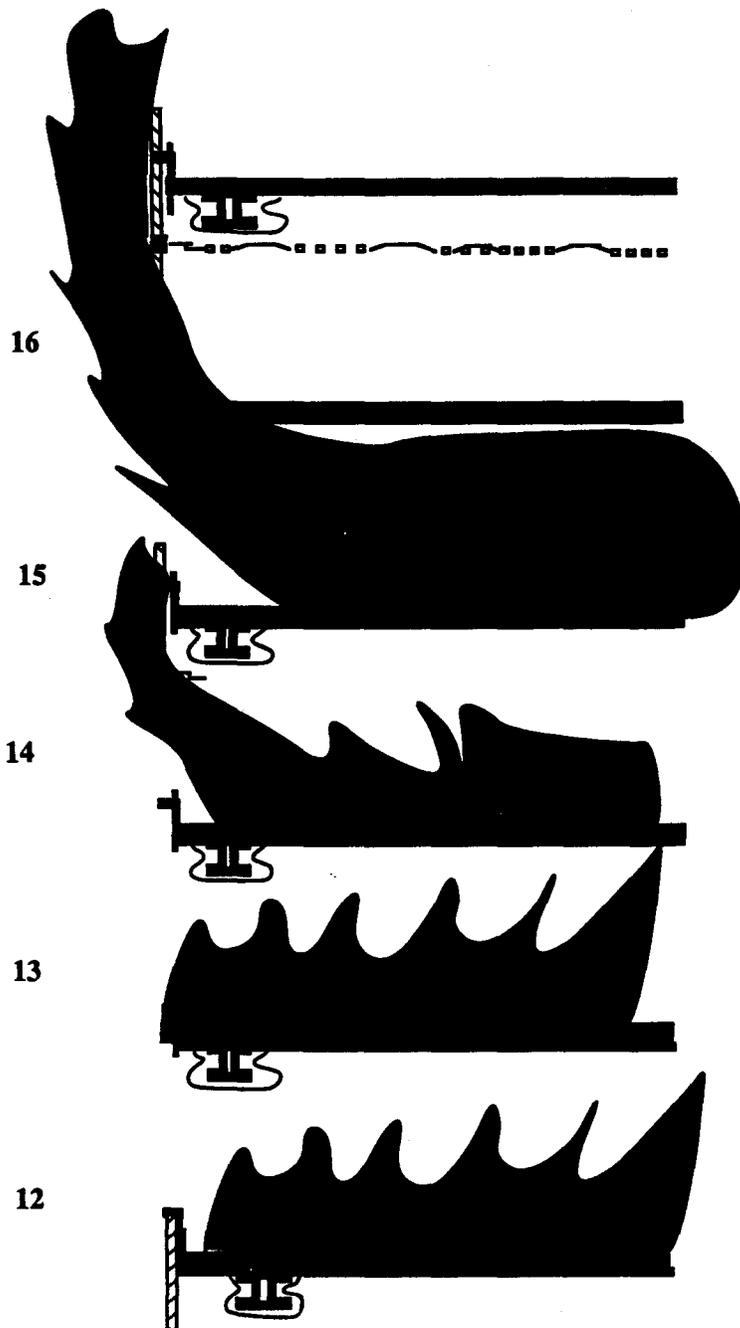
FIGURE 29. FIRE EXTENTION TO THE 16TH FLOOR

Figure 29 shows a very tall flame extension from the 15th to 16th floor. The fire department now stops the fire on the 16th floor. Direct fire damage is limited to the north end and the south west corner of the floor. The 16th floor is the only floor where a fire stop is made soon enough to preserve evidence of the means of fire propagation. The burned ceiling portion over unburned furniture in the south west section of this floor is evidence of exterior flame penetration lapping from the 15th floor onto the 16th floor ceiling. An extensive flame is necessary to produce this result.

ABOUT 12:50 AM IGNITION ESTABLISHED ON 16TH FLOOR
