**NIST NCSTAR 2**

# **Draft Report of the Technical Investigation of The Station Nightclub Fire**

March 2005

A fire occurred on the night of Feb. 20, 2003, in The Station nightclub at 211 Cowesett Avenue, West Warwick, Rhode Island. A band that was on the platform that night, during its performance, used pyrotechnics that ignited polyurethane foam insulation lining the walls and ceiling of the platform. The fire spread quickly along the ceiling area over the dance floor. Smoke was visible in the exit doorways in a little more than one minute, and flames were observed breaking through a portion of the roof in less than five minutes. Egress from the nightclub, which was not equipped with sprinklers, was hampered by crowding at the main entrance to the building. One hundred people lost their lives in the fire. On Feb. 27, 2003, under the authority of the National Construction Safety Team (NCST) Act, the National Institute of Standards and Technology (NIST) established a National Construction Safety Team to determine the likely technical cause or causes of the building failure that led to the high number of casualties in that fire. This report documents the procedures, findings, and

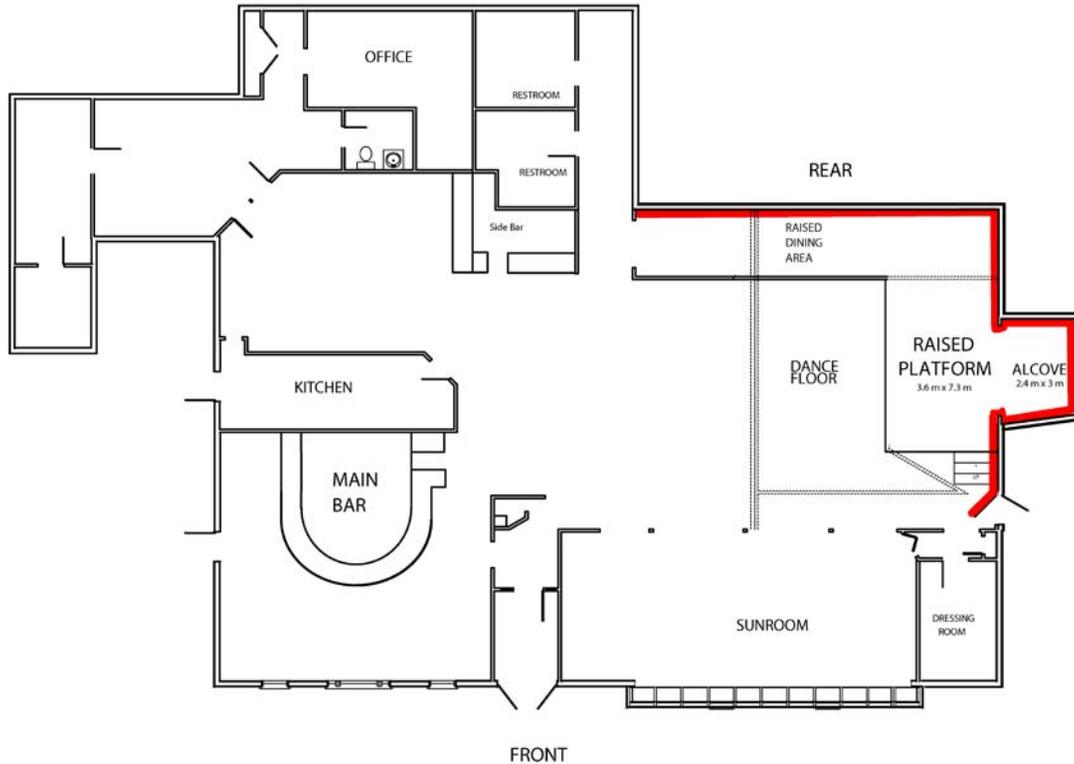
The photographs of the nightclub interior do clearly show gaps where two sheets of foam meet. Gaps between the foam and the wall can also be observed at various locations, typically at external corners of the alcove. While the gray color of the foam can be observed in some photos of various bands that had performed at The Station, later photos show a darker color, indicating that the foam may have been sprayed with a black paint. The surface of the foam also had a glittery appearance that may have been a result of the wet paint being dusted with glitter or sparkle dust. Some of the glitter would have become partially embedded in the wet paint and would have provided the more sparkling appearance that was observed in some of the video of the nightclub interior.

**Figure 4-1. Portion of Nightclub with Polyurethane Foam Mounted on Wall (shaded red section).**

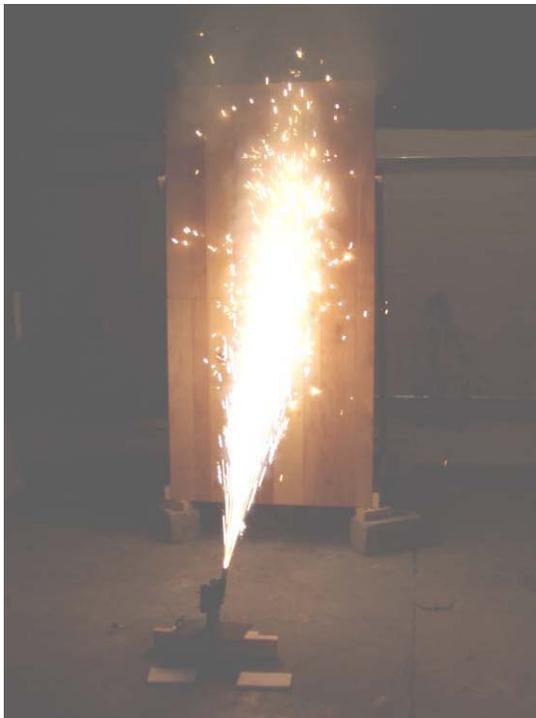
Figure 4-14a shows the sparklers from the gerb impinging on the wood panel about half way through the test. No ignition was observed. The hot sparklers did create small black marks and craters in the finish of the panel, as can be seen in Figure 4-14b.

**Figure 4-14a. Gerb impinging on wood panel**

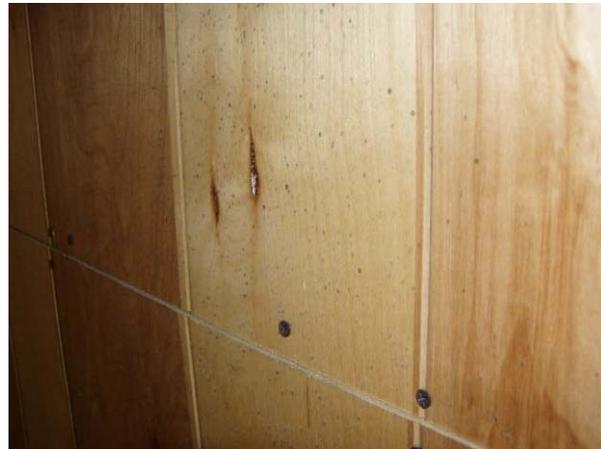
**Figure 4-14b. Damage to wood panel following impingement by sparklers from gerb. Lip on panel surface can be seen as line below mounting screws.**

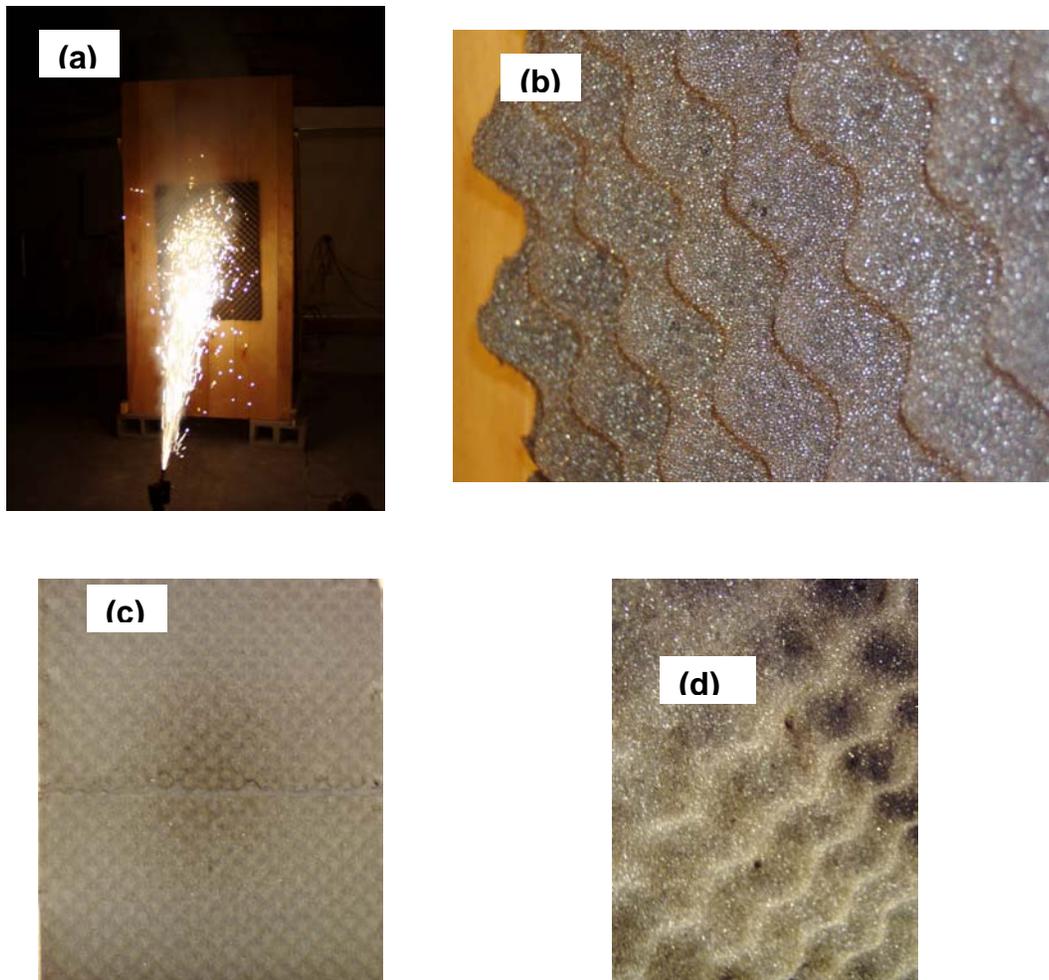
The experiment was repeated with a new piece of foam. The lower piece of foam overlapped the upper piece of foam, creating a small ledge as shown in Figure 4-15c. The positioning of the gerb was the same. The results were similar to the previous experiment; i.e., no ignition, just minor scorching and small holes in the foam from some of the sparks (see Figures 4-15c and 4-15d). The temperatures in the plume as a function of time are plotted in Appendix F, Figs. F-24 and F-25.

**Figure 4-15. Gerb impinging fire retardant polyurethane foam (a); evidence of pitting (b); horizontal ledge at mid-plane to catch sparks, and evidence of scorching in second sample (c); and close-up of scorched area (d).**

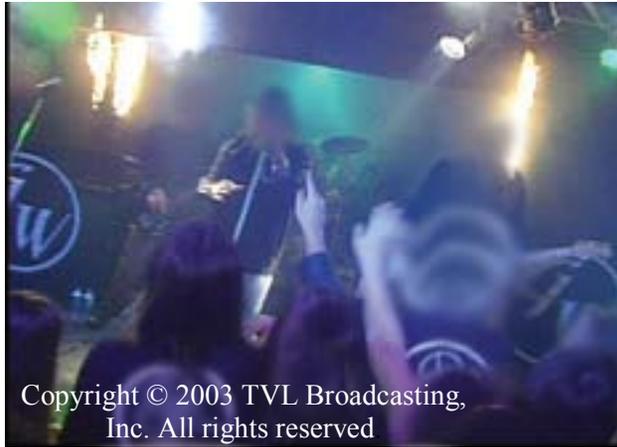
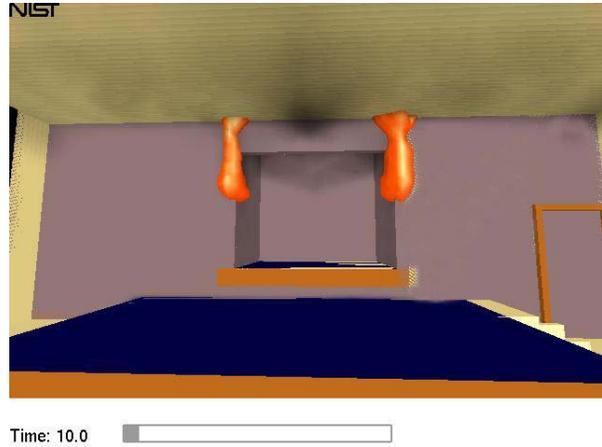
The images from the video in Figures 5-43 and 5-44 capture the initial state of the fires on each side of the platform shortly after the gerb discharge had stopped. At 10 seconds after ignition, the fire can be seen burning on two surfaces at each of the corners; this is also considered in the simulation with the

**Figure 5-43. Initial growth of fire on foam at corner of the alcove (10 seconds)**

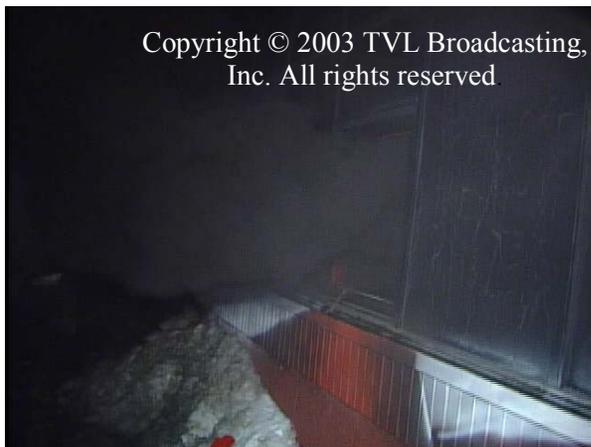
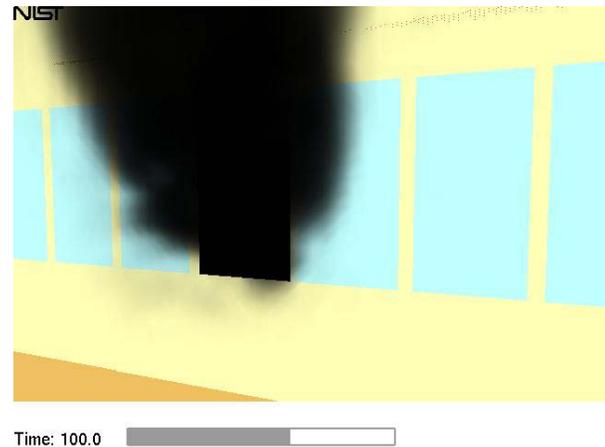
**Figure 5-47. Smoke billowing outside from broken sunroom window (100 s)**

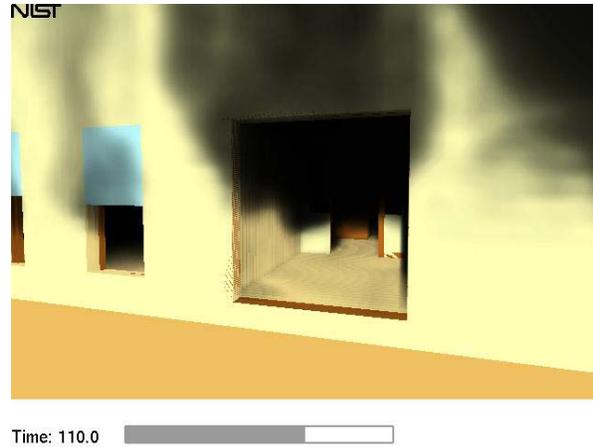
**Figure 5-48. Light smoke emanating from front door of nightclub (110 seconds)**

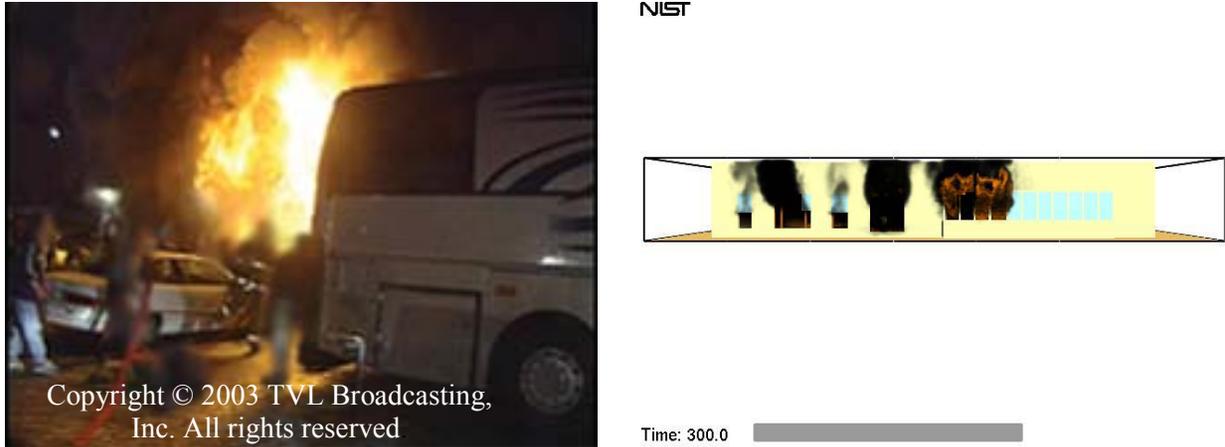
**Figure 5-52. Flames breaking through front door and sunroom windows (337 seconds, video, 300 seconds simulation)**

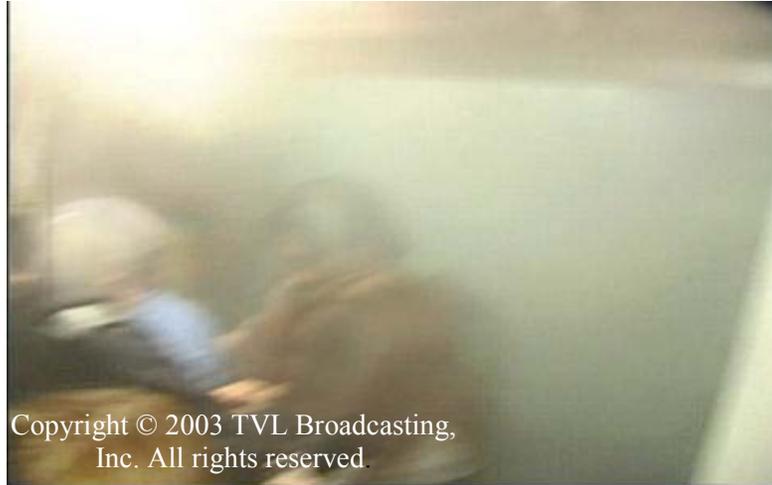
Although Figure 6-3 is of poor quality because the camera was in motion at the time, this video frame depicts a series of occupants evacuating through the main exit (note that the white surface at the lower right corner of the frame is one of the open exterior doors). The video time of this still frame is 0:07:33 (0:01:11 fire time). A male and a female are visible near the center of the frame; however, occupants cannot be seen immediately behind them. It would be expected that the occupant density ahead of these

**Figure 6-3. Evacuating Occupants [2]**

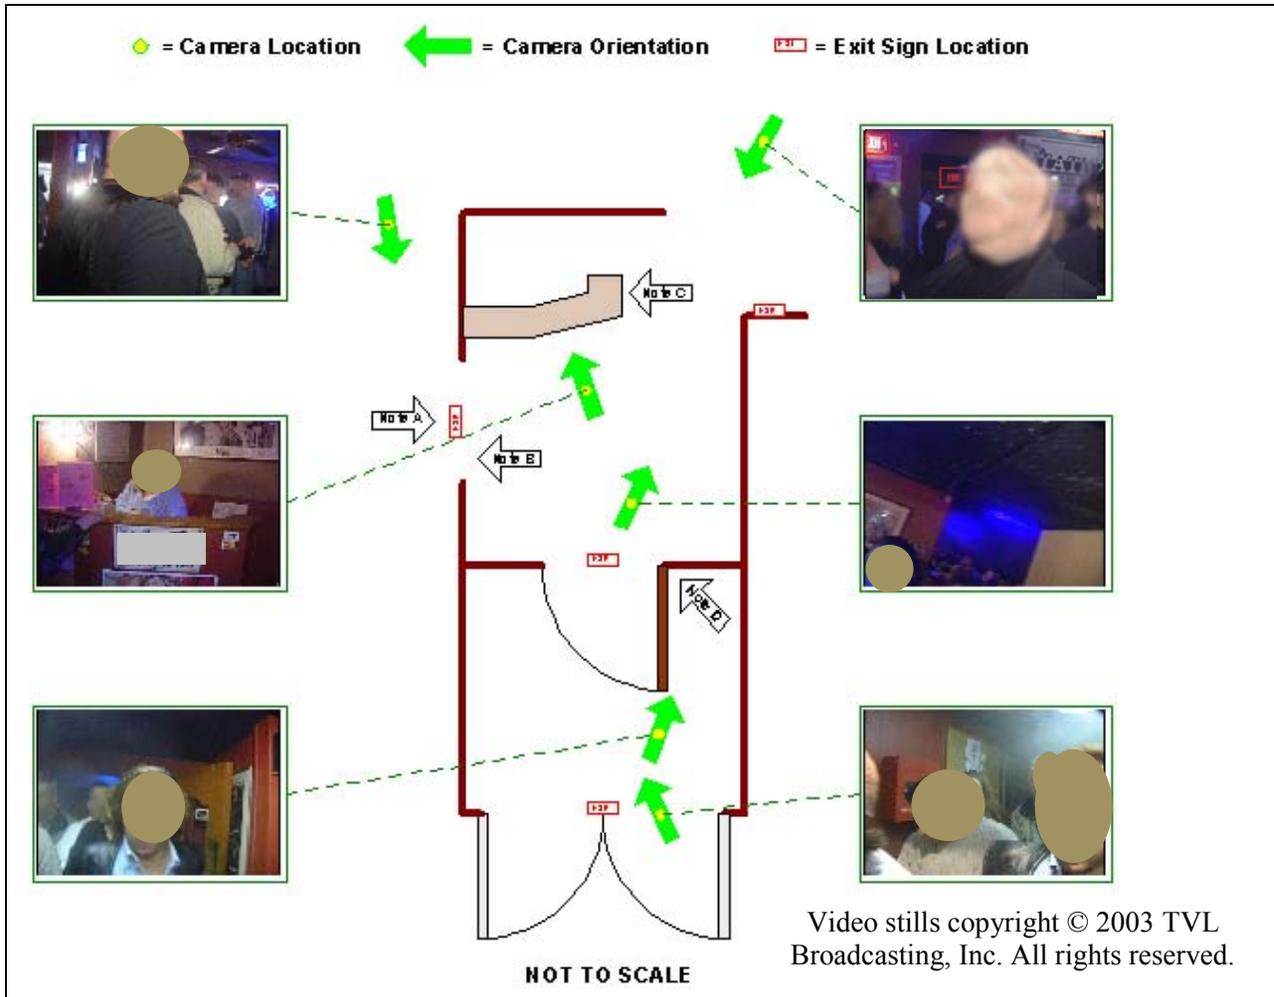
**Figure 6-12. Detail of Main Exit Vestibule Area (Video frames copyright © 2003 TVL Broadcasting, Inc. All rights reserved)**

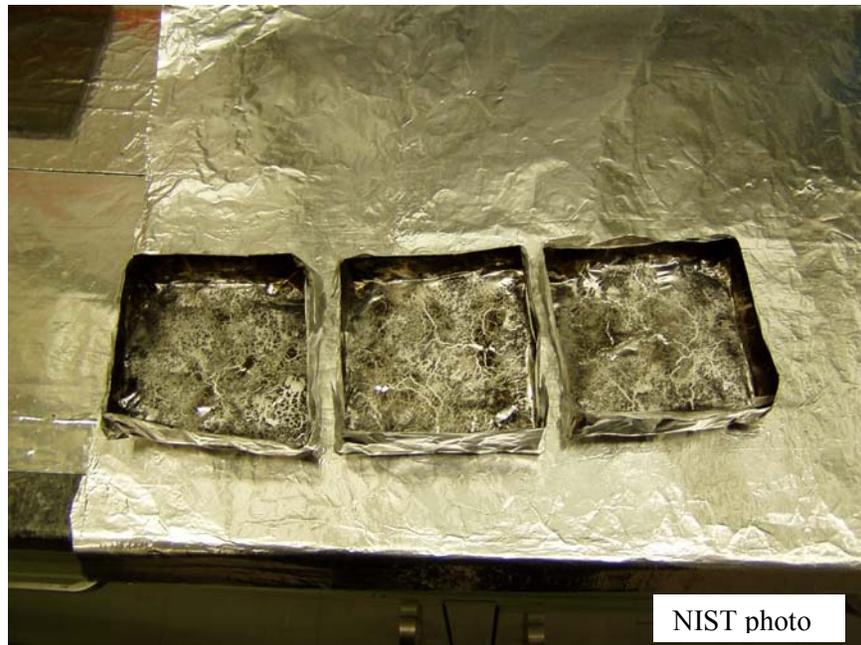
**Figure D-4. Burn Residue of Polyurethane Foam after Cone Calorimeter Test.**
