**NIST NCSTAR 1-5D (Draft)**

**Federal Building and Fire Safety Investigation of the  
World Trade Center Disaster**

# **Reaction of Ceiling Tile Systems to Shocks (Draft)**

September 2005

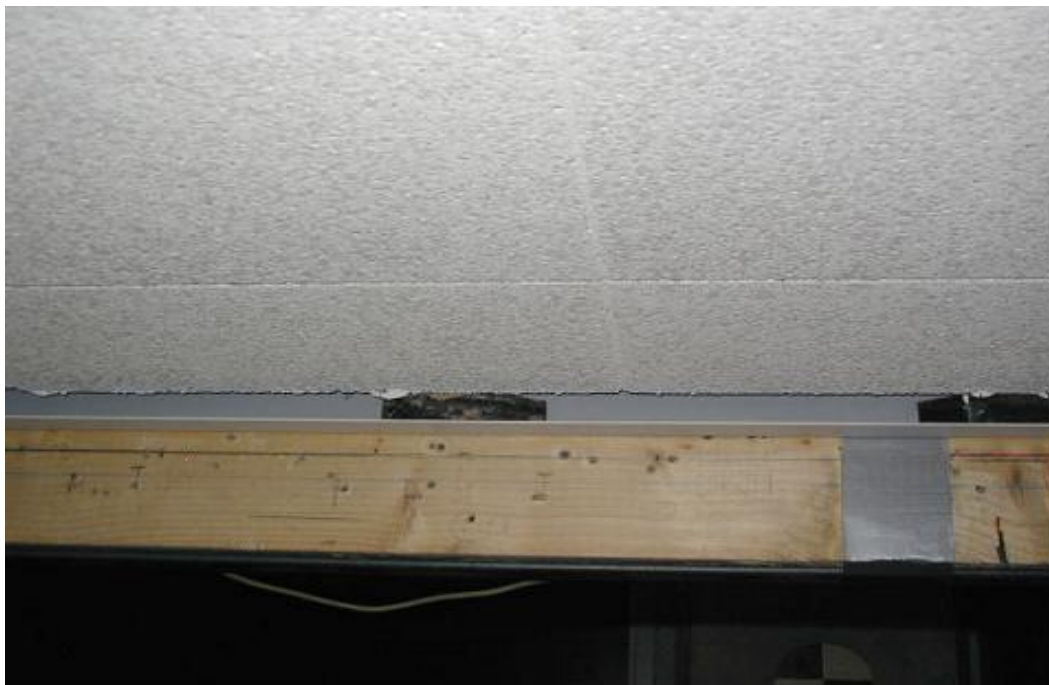
**Figure 3–1. Displacement of perimeter tiles over perimeter spring clips following Test 20 for ceiling system CS1.**

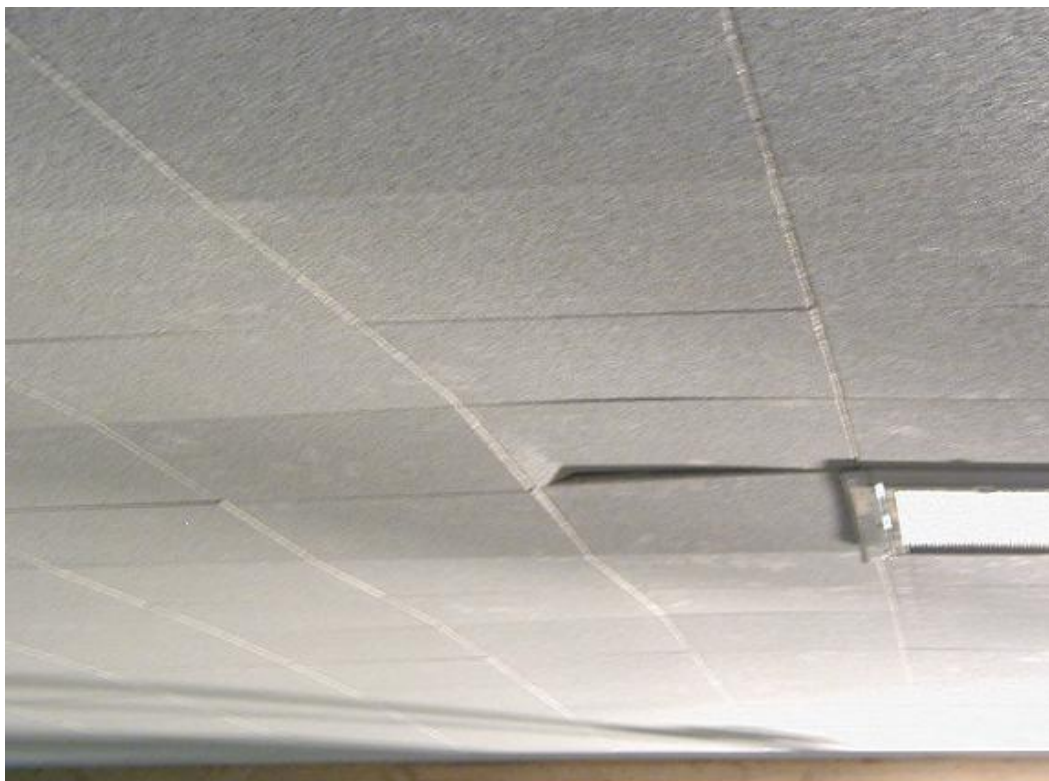
**Figure 3–2. Bottom view of damage to ceiling system CS1 following Test 20.**

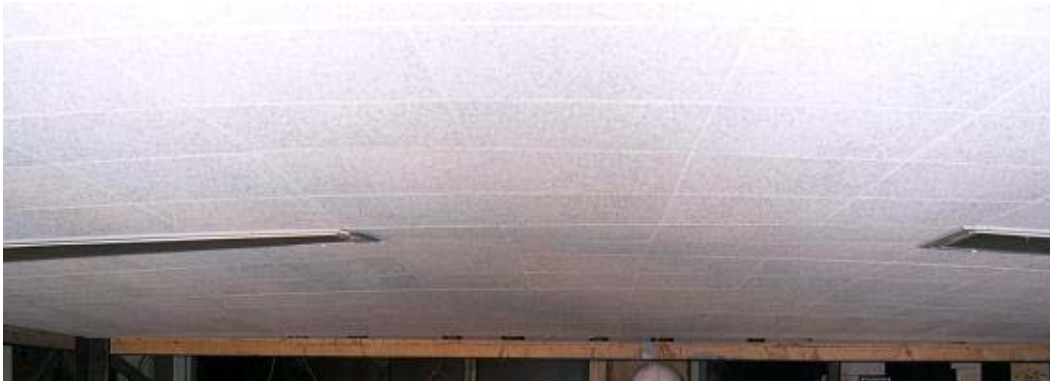
Figure 3–3. Bottom view of damage to ceiling system CS1 following Test 20.

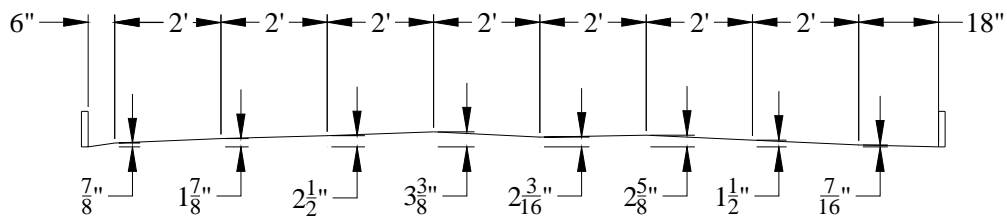
Figure 3–4. Permanent vertical displacements of Z-bars in the east-west direction following Test 20 for ceiling system CS1.

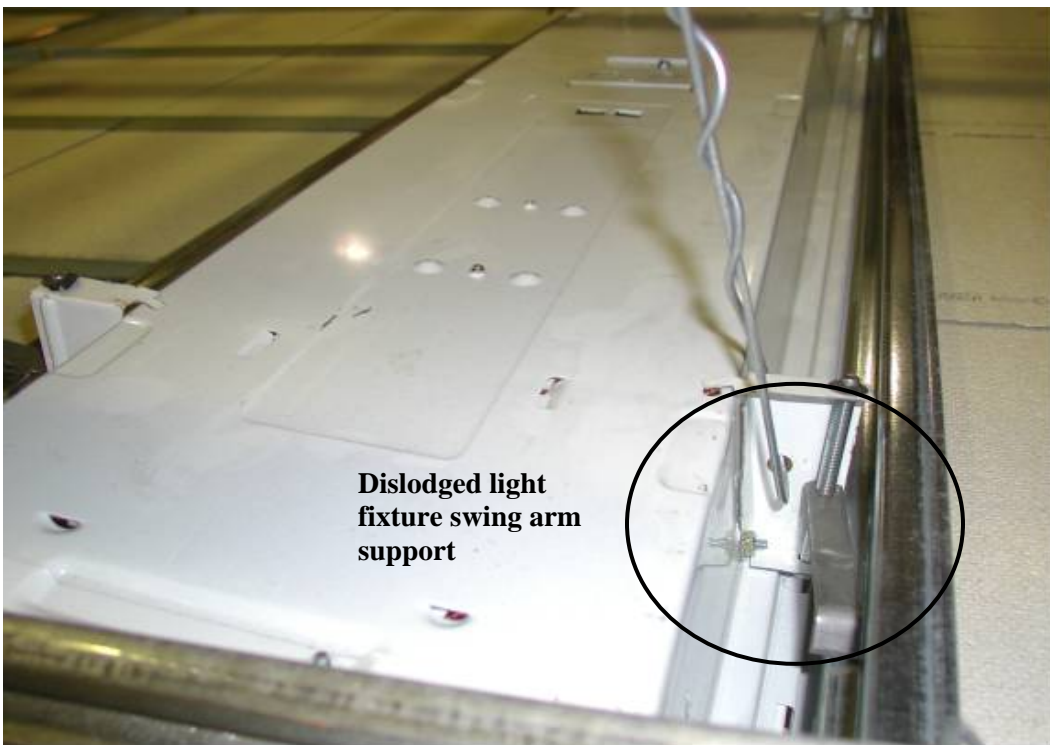
Figure 3–5. Light fixture swing arm support dislodged following Test 21 for ceiling system CS1.

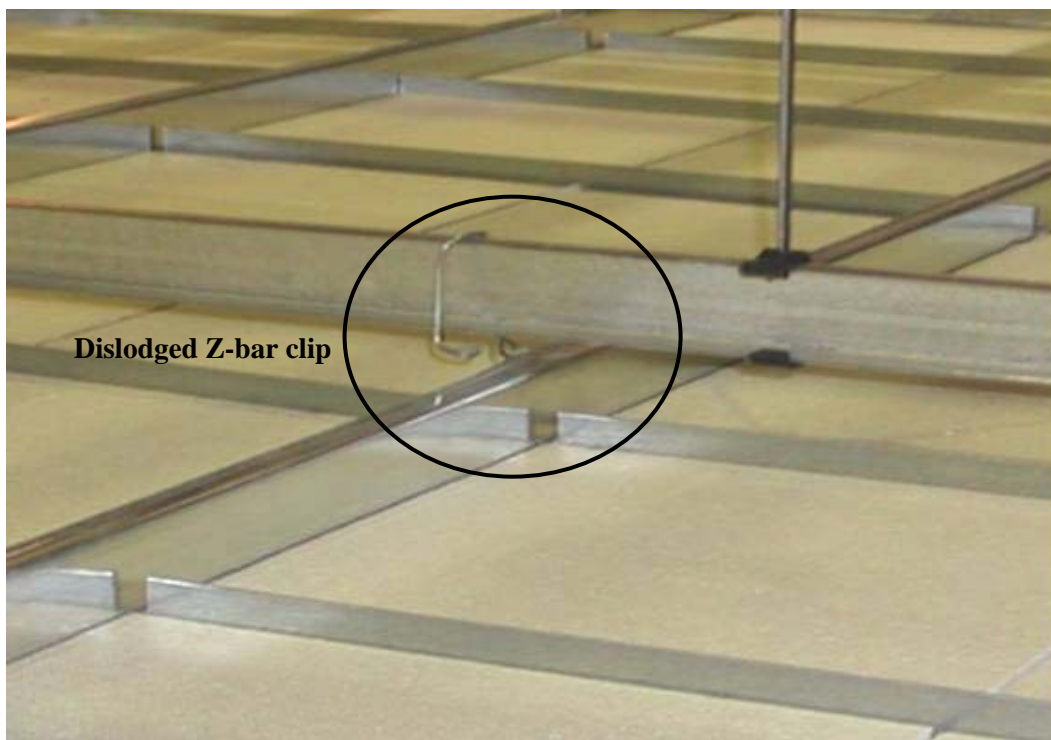
**Figure 3–6. Dislodged Z-bar clip in ceiling system CS1 following Test 21.**

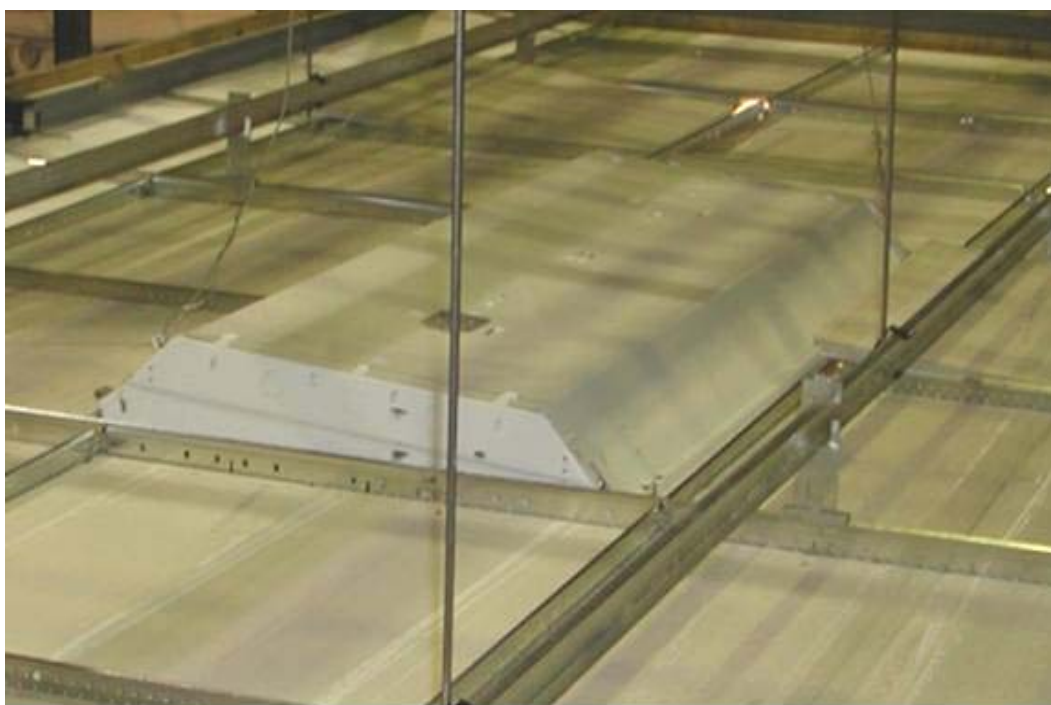
**Figure 3–7. Dislodged southern light fixture corner in ceiling system CS2 following Test 14.**

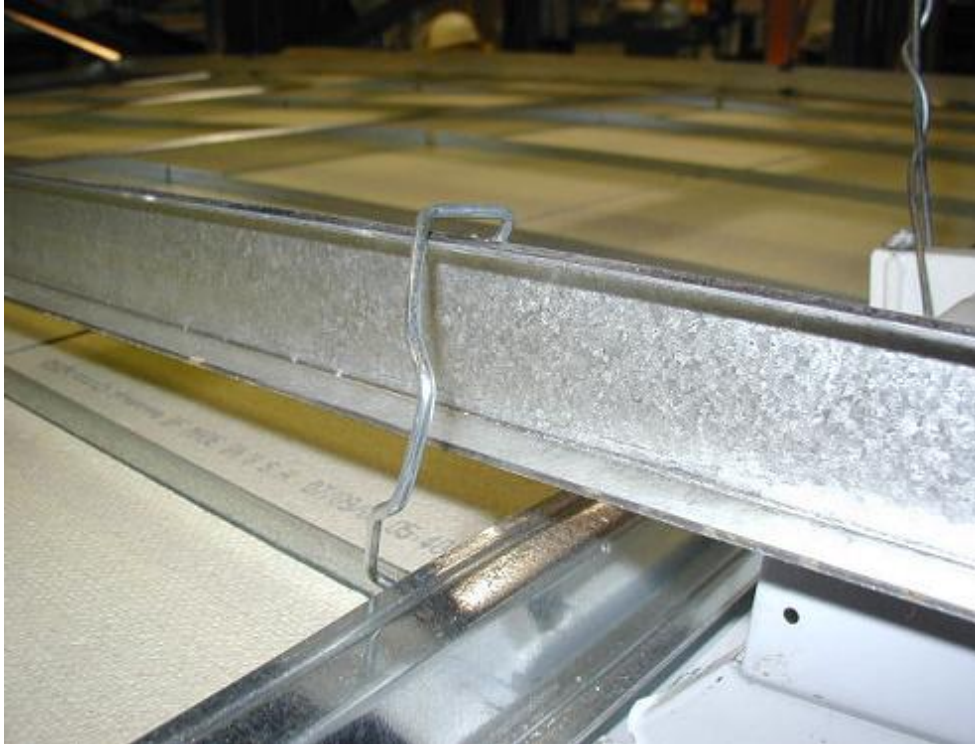
**Figure 3–8. Stretching of Z-bar clips located at northern light fixture corner in ceiling system CS3 following Test 20.**

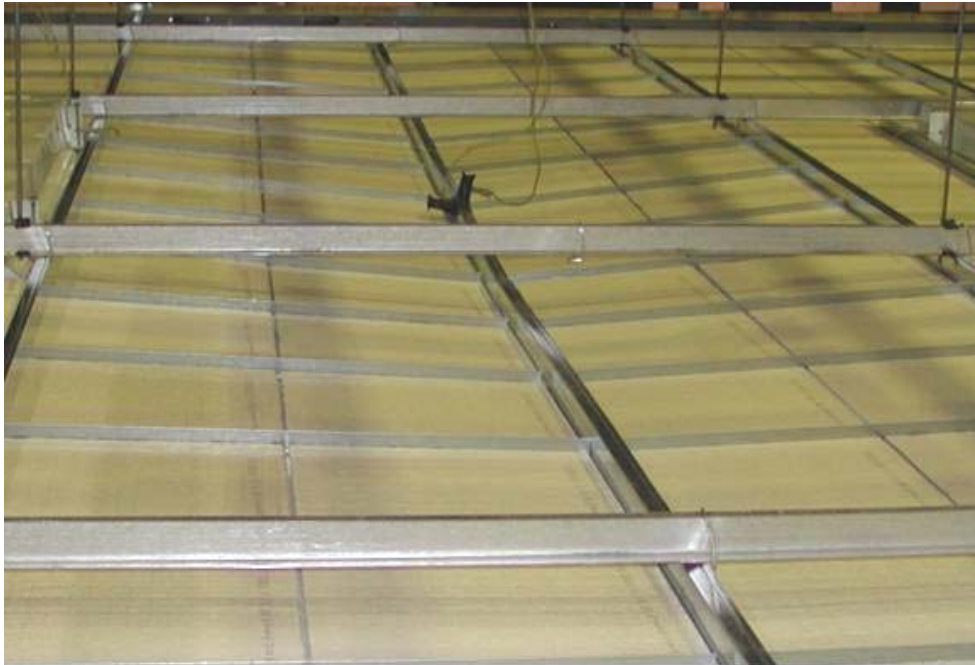
**Figure 3–9. Damage to the center of ceiling system CS3 following Test 20.**

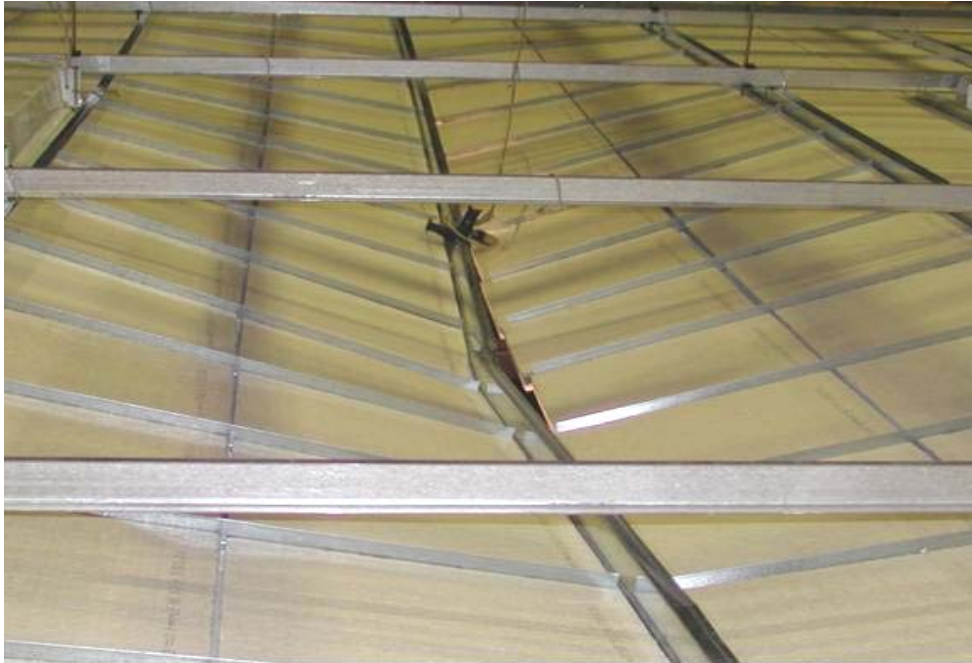
**Figure 3–10. Damage to the center of ceiling system CS3 following Test 23.**

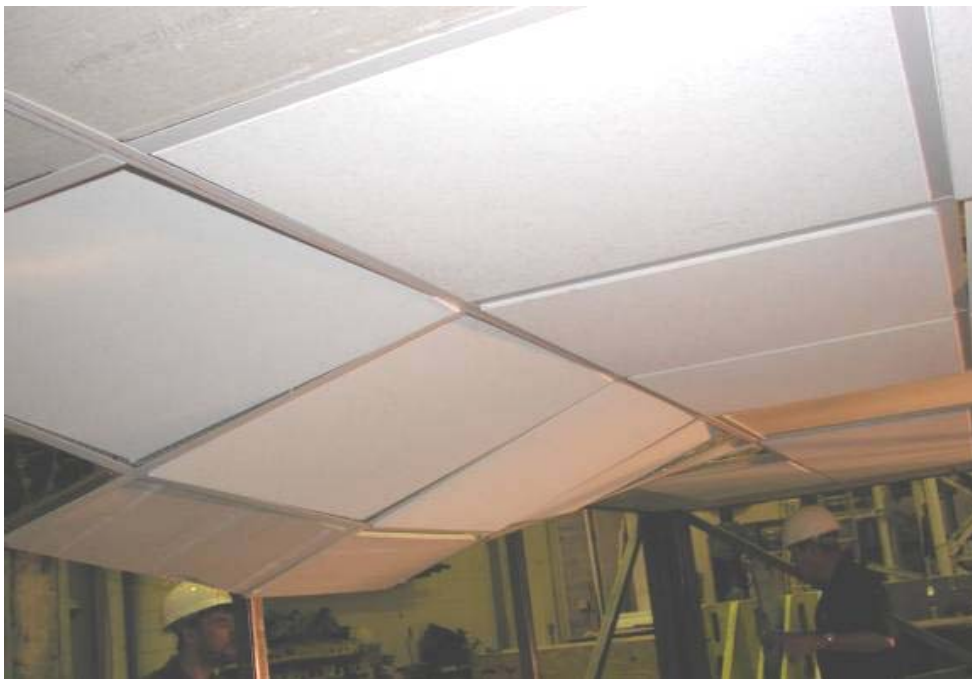
**Figure 3–11. Damage to the northern perimeter of ceiling system CS4 following Test 23.**

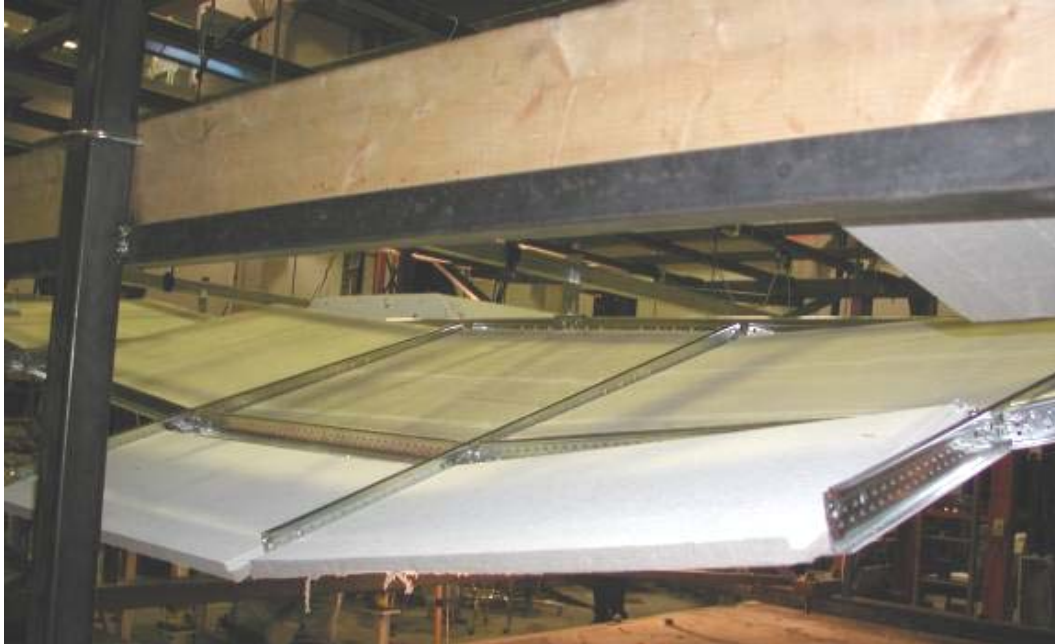
**Figure 3–12. Damage to the northern perimeter of ceiling system CS4 following Test 23.**

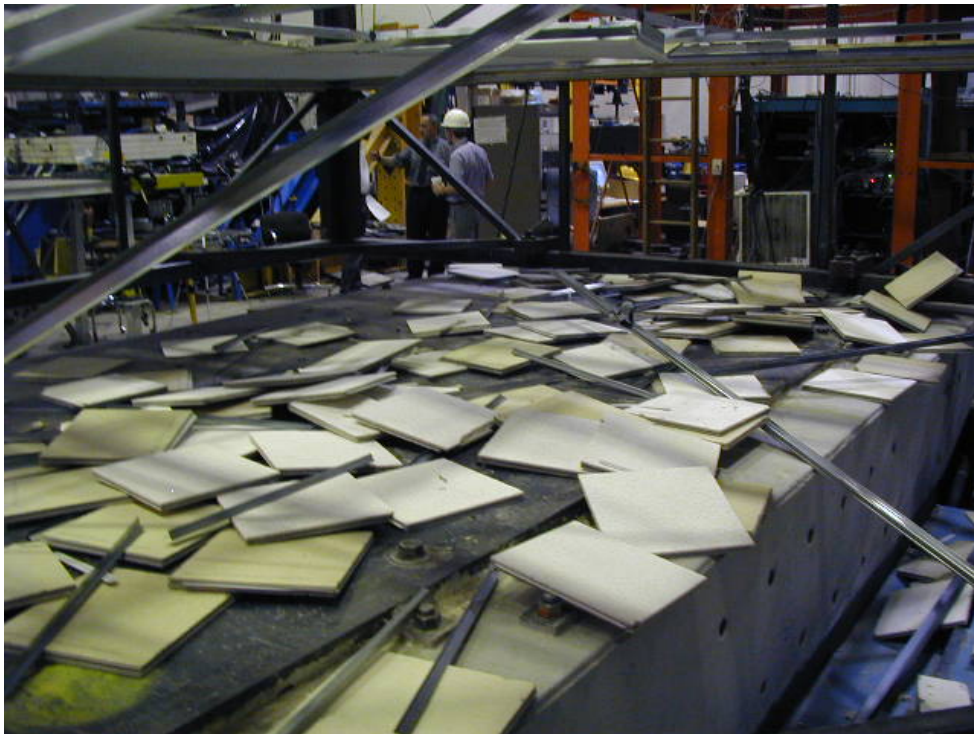
**Figure 3–13. Collapse of ceiling system CS3 after 2.5g earthquake excitation.**

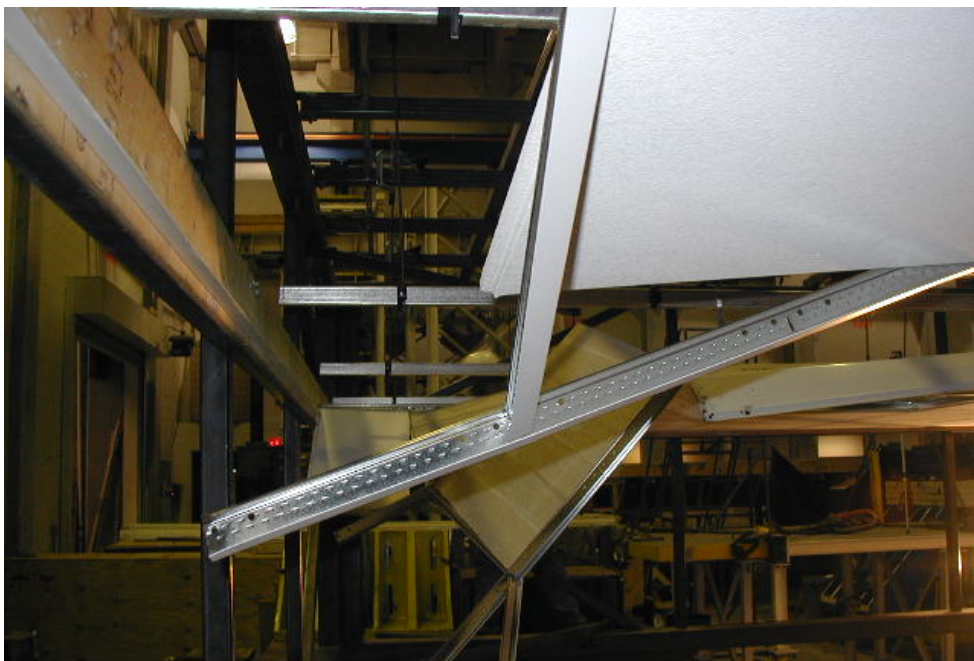
**Figure 3–14. Damage to north perimeter of ceiling system CS4 after 1.75g earthquake excitation.**
