Performance of externally bonded fiber-reinforced polymer retrofits in the 2018 Cook Inlet Earthquake in Anchorage, Alaska

Earthquake Spectra

DOI: 10.1177/87552930211028609

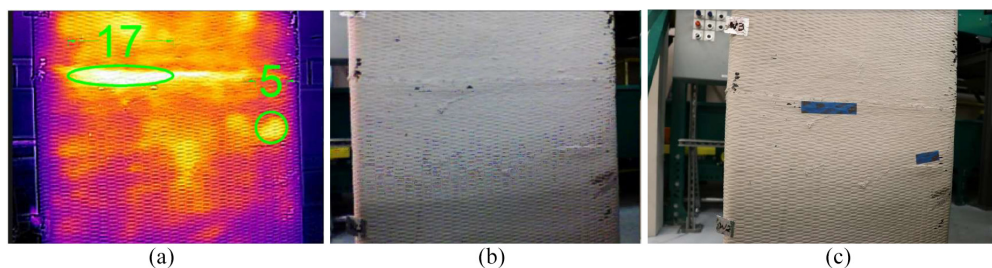
Figure 2. Example infrared thermography and acoustic sounding results on a section of the column: (a) IR image overlapped with photography from FLIR camera (dimensions in cm), (b) photograph of the same area with FLIR camera, and (c) debonded areas marked with blue painter's tape after acoustic sounding. This figure shows a good visual match between the IR thermography and acoustic sounding results.

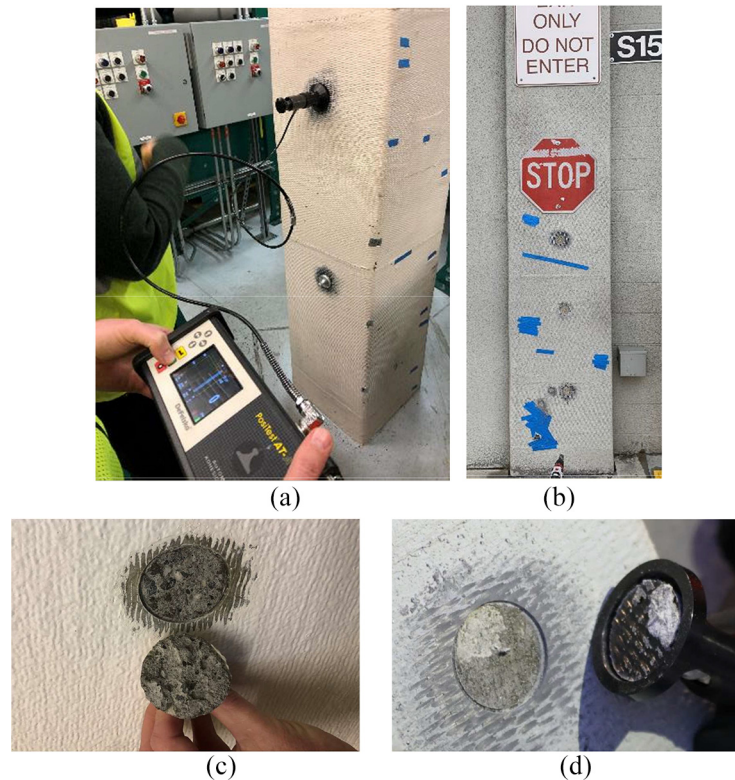
Figure 4. (a) An example of the bond pull-off test setup, (b) a column after bond-pull-off tests and typical bond pull-off test failure modes such as (c) Mode G, cohesive failure mode in concrete and (d) Mode E, interfacial adhesive failure mode.

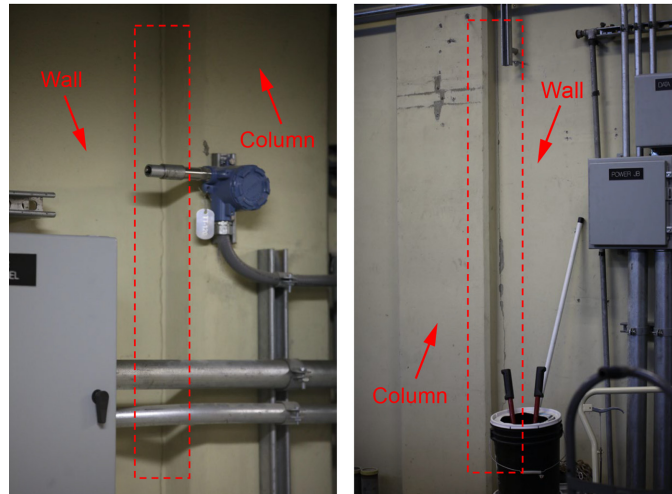
Two facilities in the Anchorage water and wastewater treatment plant that were retrofitted with EBFPR were investigated in the reconnaissance effort: (1) the heat exchange facility and (2) the water treatment building. In the heat exchange facility, an EBFPR retrofit was applied to a load-bearing wall that was modified to include an opening for egress into a new extension of the original structure. As shown in Figure 5, the CFRP was applied around the perimeter of the portal to act as additional shear reinforcement. On the exterior of the building, CFRP retrofits were used to tie precast concrete panels to the frame and foundation ensuring composite behavior of the structure in a seismic event. Design plans show only the location of the EBFPR and details related to EBFPR (number of plies, dimensions and so on), but do not show details of the precast joint. Typically, precast panels are connected to the frame using steel rods and plates. However, the reconnaissance team was not able to confirm this through visual inspection of the joint. Minor cracks were noted along the column–panel joints on the interior of the building (Figure 6), but it is not clear if these cracks developed during the earthquake or were present before the earthquake. Since CFRP retrofits were covered by nonstructural elements on the building exterior, potential damage to the EBFPR that was on the opposite side of the wall shown in Figure 6 could not be assessed.

Figure 6. Cracking along column–wall joints induced by earthquake shaking. Cracks are denoted by blue dotted lines.

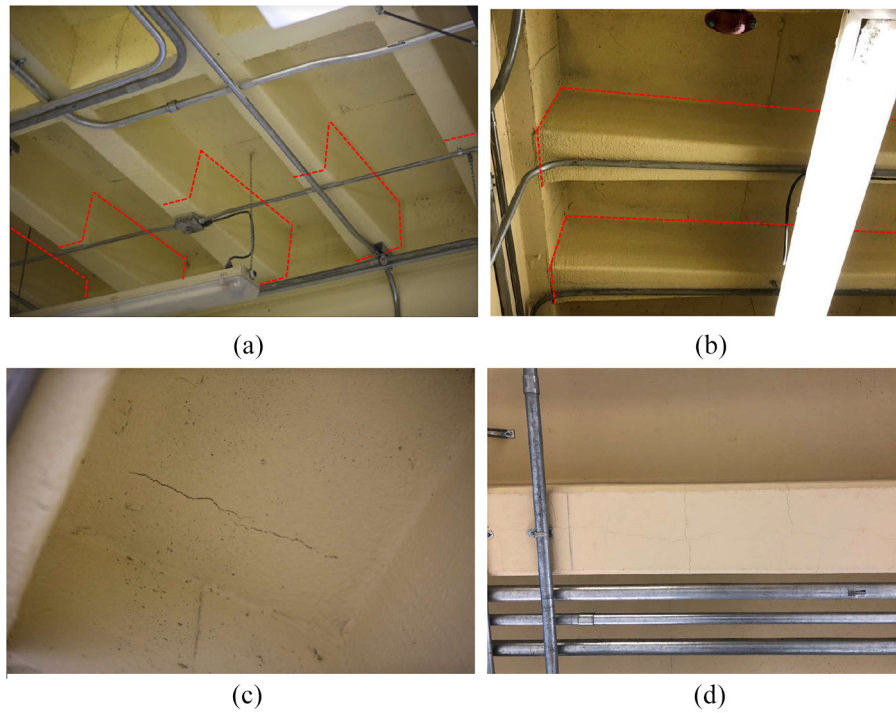
In the water treatment facility, CFRP was applied to increase the shear strength of joists in several rooms. Some hairline cracks were observed in the roof slab supported by the joists (Figure 7c), but it is not known whether those cracks existed before the earthquake. According to the building owner, some cracks observed in the joists (Figure 7d) existed prior to the earthquake. These cracks were likely caused by restrained shrinkage and/or temperature gradients. In addition, no damage to the CFRP or cracks traversing from uncovered concrete to areas with CFRP were observed. In addition, acoustic sounding of multiple joists revealed no defects.

Figure 7. (a and b) Beams retrofitted with CFRP as denoted by dotted red lines, (c) cracking in the supported roof slab, and (d) minor cracking in a beam that was not FRP retrofitted.

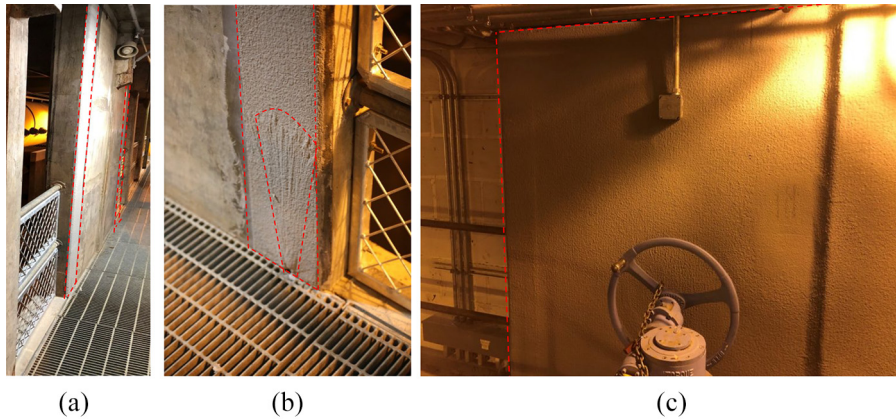
Figure 8. (a) Boundary element with CFRP denoted with a red dotted line, (b) boundary element with CFRP anchored with a splayed fiber anchor where CFRP and anchor perimeter are marked by red dashed line, and (c) a horizontally wrapped GFRP shear wall denoted with a red dotted line wrapped 30 cm behind this wall for confinement.

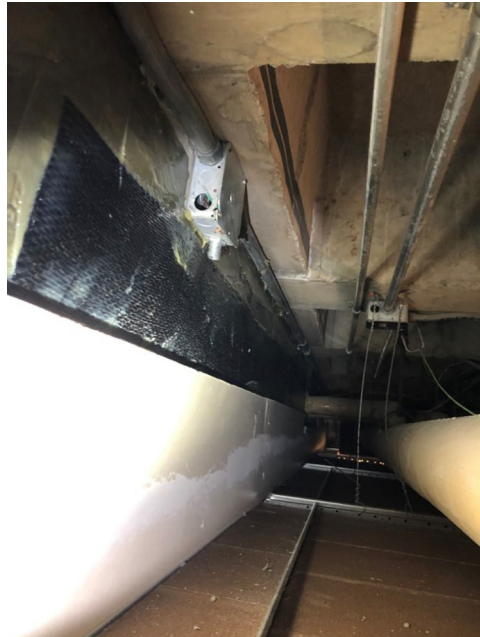
the walls. Most of the CFRP-retrofitted shear walls in the courthouse were covered with paint, grout, drywall, or paneling. The one CFRP retrofit that the team was able to look at was accessed through the ceiling grid (Figure 9). No earthquake damage was observed on the side of the walls retrofitted with EBFRRP. In multiple one-sided retrofitted walls, hairline cracks were observed on the non-retrofitted side, but it is not known whether or not those cracks existed before the earthquake. This observation illuminated the need for inspection tools that can assess the condition of the concrete underneath the CFRP.

Figure 9. CFRP retrofit above ceiling grid covered by drywall panels at Boney Courthouse.

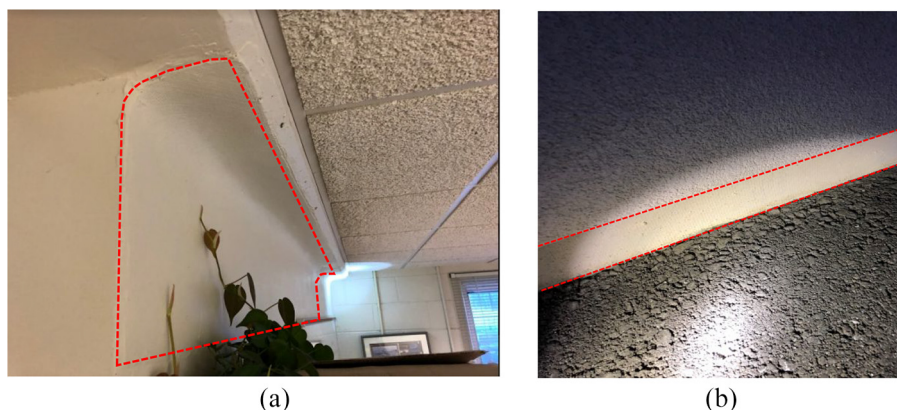
At Joint Base Elmendorf–Richardson (JBER), the Engineering Squadron building was inspected. Based on the visual inspection and information provided by building owners, location of the EBFRRP-strengthened members was determined. A single interior beam was CFRP-retrofitted on one side to improve the shear transfer capacity between the beam and the masonry wall (Figure 10a). This CFRP retrofit was added when nearby interior shear walls were removed. Steel bracing was used throughout the rest of the building for seismic bracing. No damage was observed in the retrofits inside of the buildings. On the outside of the building, roughly half of the masonry walls were retrofitted with CFRP but were covered with stucco. These CFRP retrofits extended into the foundation for improving the shear transfer between walls and the foundation (Figure 10b). Some painted CFRP retrofit was exposed near the foundation and no apparent damage to it was observed. The backside of the CFRP-retrofitted walls on the interior of the building were in good condition with no apparent damage.

Figure 10. CFRP application (a) to transfer shear between the reinforced concrete beam and the wall, and (b) to transfer shear between the outer wall and the foundation. CFRP retrofits are denoted by a red dotted line.

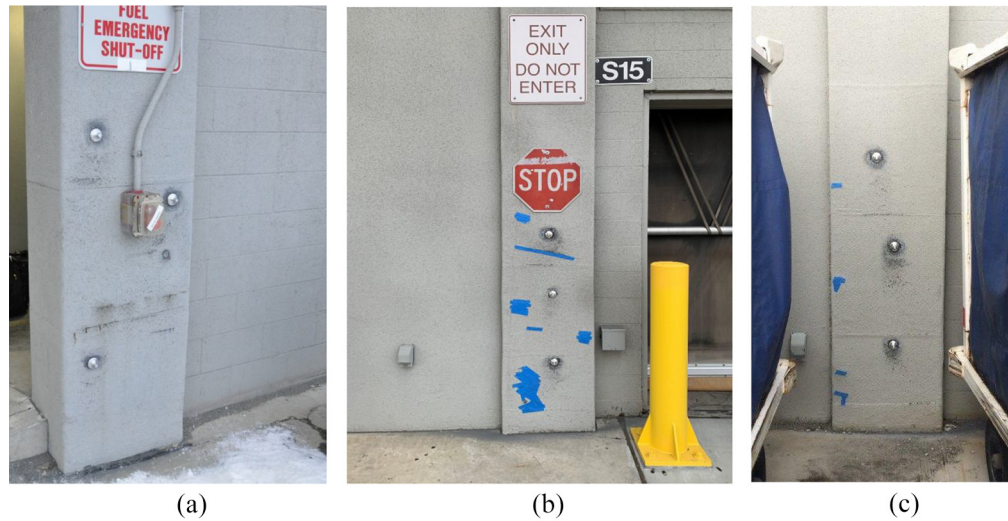
Figure 11. Exterior columns (a) #1, (b) #2, and (c) #3 at TSIA.

exposed (Figure 11a). Overlap splices between CFRP wraps were approximately 2.5 cm. The column had a cement-like protective coating and demonstrated signs of impact damage from vehicles or luggage, owing to its location near a baggage handling area. No obvious signs of earthquake damage were observed. Exterior columns #2 and #3 were positioned between two walls, with only one face of their CFRP retrofits exposed. Debonded areas were identified by acoustic sounding on columns #2 and #3 and were marked with a blue painter's tape (Figure 11). Column #1 was also evaluated by IR thermography (see section "CFRP debonding"). Three bond pull-off tests were conducted on each column and discussed in the section "Bond pull-off test results."

CFRP debonding. IR thermography combined with acoustic sounding was used on the interior column and exterior column #1. Exterior columns #2 and #3 were evaluated for debonding by acoustic sounding only. The quantitative results for these four columns are summarized in Table 2. Data indicate that debonding was more severe for the exterior columns #1 and #2 than the interior column and exterior column #3 (Table 2). The debonded areas on the interior column were within the size range (between 1300 and 16,000 mm²) that should be repaired by resin injection, per ACI 440.2R. Five out of eleven debonded areas on the exterior columns #1 and #2 exceeded the area of 16,000 mm² which, per ACI 440.2R, should be repaired by cutting out the affected sheet and applying an overlapping CFRP patch at the top of it. Exterior column #3, by contrast, had a few debonded areas that were of relatively small size, similar to those observed on the interior column.

In the pull-off test experiments conducted on exterior columns #1 and #2, the failure surface was not flat, pointing to possible bond degradation or inconsistencies in initial surface preparation. The occurrence of Mode E and low bond pull-off strength values were in good correlation with the debonding observed with acoustic sounding and IR thermography on exterior columns, which implies that CFRP retrofits on exterior columns #1 and #2 were likely affected by environmental degradation or inconsistent surface preparation. It should also be noted that immediately following the pull-off experiments on exterior column #2, a damp concrete surface was noted underneath the retrofit, which indicated that moisture was accumulating in the underlying concrete substrate (this was not observed on exterior column #1 in January during low temperature conditions). The observed dampness further suggests that environmental effects from freeze–thaw may have contributed to the low pull-off strength, if not being completely responsible for poor adhesion between CFRP and concrete on this column. Interestingly, exterior column #3 was an anomaly as all three bond pull-off strength values on exterior column #3 exceeded the load capacity of the adhesion tester and passed the minimum ACI bond strength requirements. Although columns #2 and #3 similarly had one face on the interior and the other one on the exterior of the building, the different pull-off test strengths could be due to possible differences in

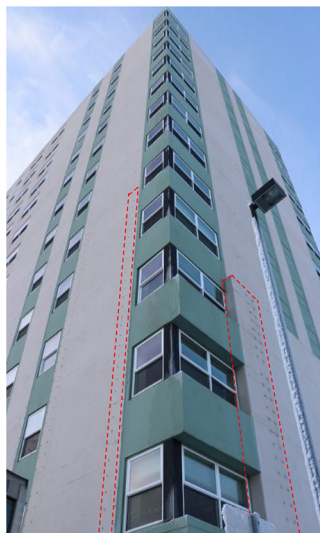
Visual inspection. No apparent earthquake damage to the EBFRR retrofits was observed in the post-earthquake inspections (Figure 12). However, like other inspected structures, most of the retrofitted structural components were not directly accessible as they were covered with nonstructural elements or architectural features. A few interior columns were identified as having exposed GFRP. Exterior GFRP and poorly epoxy-saturated carbon fibers on the North and South side of MKT, which manifested itself with readily apparent exposed dry fibers; fully saturating EBFRR with epoxy during wet layup in the field is known to be a common challenge and can possibly contribute to debonding (Figure 13a and b). Premature debonding is one of the main drawbacks of EBFRR-retrofitted systems and significant research effort has been made to develop effective anchoring using EBFRR spike anchors. Similar to EBFRR sheets installations, installation of EBFRR anchors depends on the skill of the installer and is critical for adequate performance (del Rey Castillo and Kanitkar, 2020; Grelle and Sneed, 2013). The authors also reported that inadequate fiber saturation can significantly affect the effectiveness of EBFRR-strengthened system. Exposed retrofits at MKT were evaluated for debonding by acoustic sounding. Quality of bond between EBFRR and concrete was assessed by bond pull-off tests.

Figure 12. Boundary elements confined with EBFRR and bolts on MKT, marked by red dashed lines.

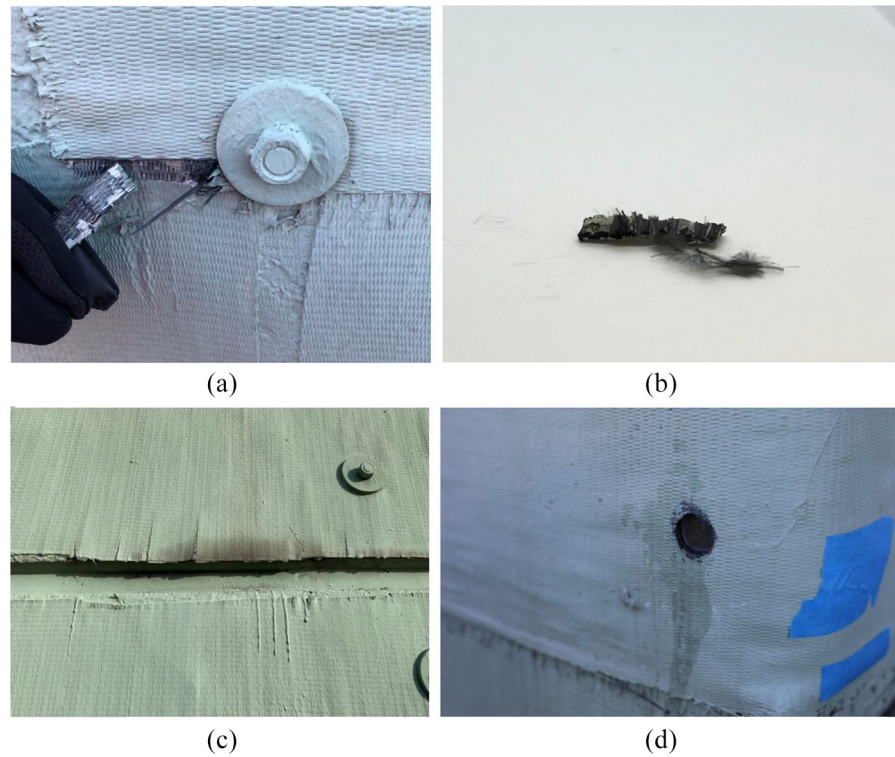
EBFRR debonding. Exposed GFRP and CFRP were evaluated for debonding by acoustic sounding. Besides minor localized defects, no debonding was observed in the GFRP retrofits, both on the interior and exterior of the structure. Exterior CFRP retrofits, however, exhibited areas of debonding as shown in Figure 14. Similar to some CFRP retrofits at TSIA, moisture was observed below the exterior CFRP retrofits at MKT in some cases and might have contributed to the debonding observed (Figure 13c and d).

Figure 13. Exterior CFRP debonding (marked by blue painter's tape) on a boundary element at MKT: (a) front view and (b) side view from the window well.
