EXPERIMENTAL STUDY ON FIRE RESISTANCE OF A FULL-SCALE COMPOSITE FLOOR ASSEMBLY IN A TWO-STORY STEEL FRAMED BUILDING

ABSTRACT

Keywords: Composite floors; steel buildings; fire resistance; compartment fire experiments

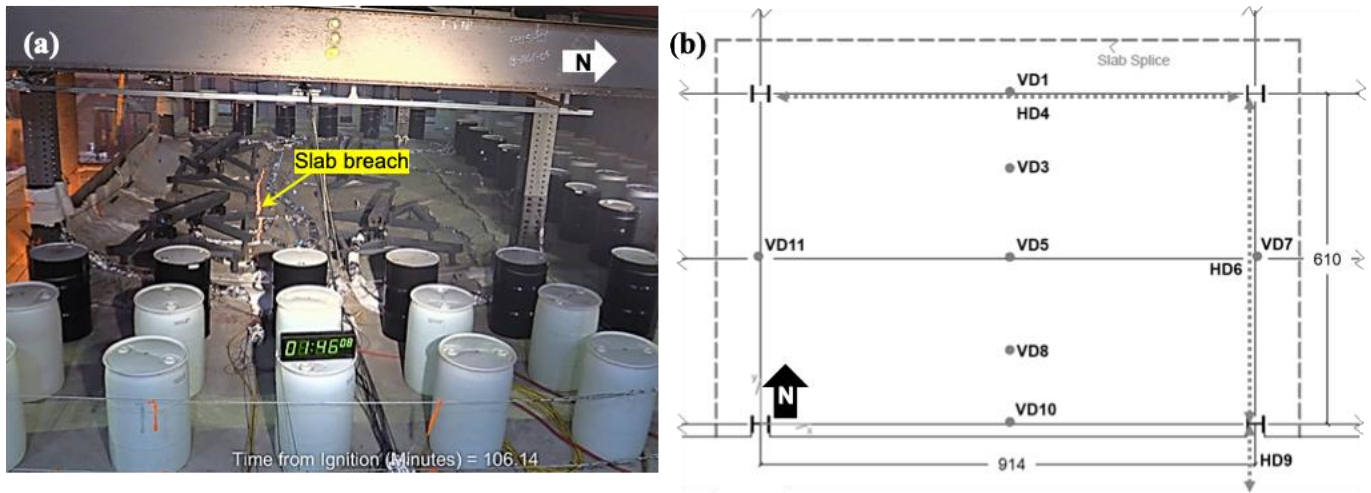
The loaded test floor assembly continuously sagged during heating, while sequentially developing concrete fractures at various locations. No explosive spalling of the concrete was visible during or after the experiment, however, small ‘popping’ sounds continued during heating indicating that (micro) spalling was occurring between the bottom of the slab and the steel deck. Concrete surface cracks first appeared along the east and west girders as well as the north edge beam of the test bay about 20 min to 30 min after ignition. Around 40 min into heating, the southeast corner of the heated floor slab fractured making a loud noise. After 70 min, tensile fracture of the concrete was visible near the longitudinal (east-west) centreline of the test floor. Reaching 100 min in fire, small flames were intermittently visible above the top of the heated slab towards the east and west ends of this longitudinal crack, indicating failures of some screw joints of steel deck units in those locations. From this point forward, the mechanical loads on the south side of the test slab appeared to be supported by the steel deck and the south edge beam with concrete hanging cantilever, Figure 7(a). The fire and mechanical loading were removed at 107 min due to safety concerns.

Figure 7. (a) Breach of the test floor slab; (b) Locations of displacement measurements with dimensions in cm.

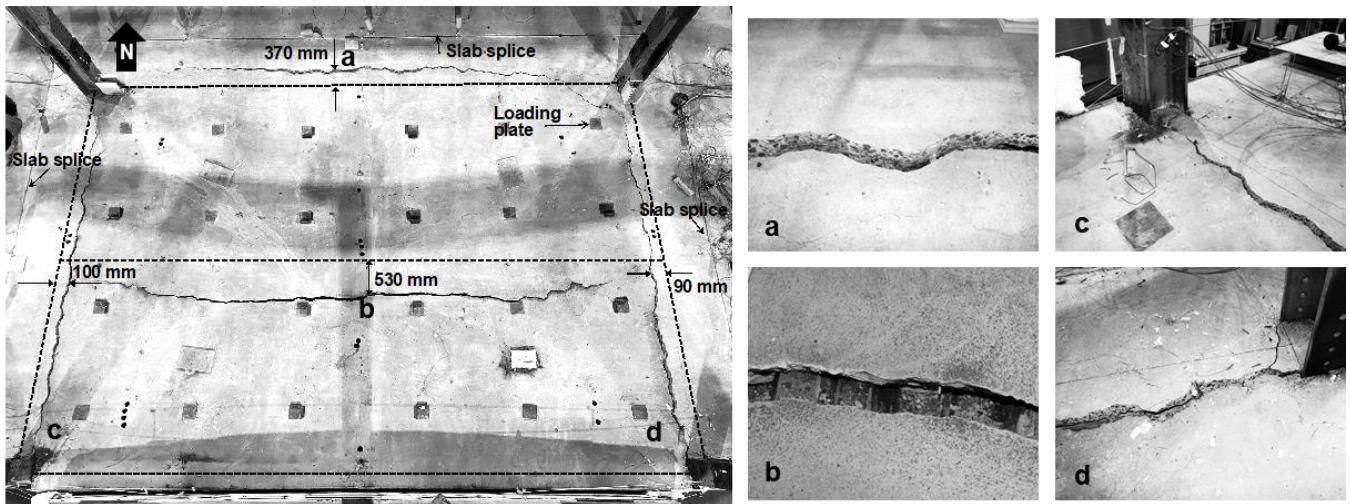
Figure 10 shows the final fracture pattern of the test floor slab after cooling. As mentioned earlier, concrete cracks developed along the north, east, and west edges of the test bay, followed by the longitudinal cracks 530 mm or less south of the secondary beam. Most of WWR (59 mm²/m) across the thicker lines of fractures visible in Figure 10 completely ruptured. Neither concrete failures along the south (free) edge (i.e., separation from the south edge beam) nor slab splice failures were witnessed. Based on crack openings of the concrete, the east and west edge cracks were initiated near the flanges of the southeast and southwest columns, whereas the north edge crack was propagated from the midspan or its vicinity. No through-depth fractures were observed around the northeast and northwest columns.

The middle breach of the test floor slab appeared to be occurred due to catenary action in the north-south direction where the steel decking was continuous into the north adjacent bay. It is believed that the tensile membrane action of the test floor slab was not achieved or developed in a limited fashion because of the early formation of concrete fractures and ruptures of welded wire reinforcement along the east and west

edges. These through-depth cracks located 100 mm or less inside of the test-bay column grid, which formed shortly after fire ignition and continued to widen unchecked during heating. Thus, the headed stud anchors on the east and west girders were ineffective to induce tension in the concrete in the east-west direction as the heated floor slab continued to deflect downward. In contrast, the north edge crack formed 370 mm or less north of the north primary beam (i.e., outside of the test-bay column grid) and thereby the headed stud anchors on all three 9.1 m long beams appeared to provide anchorage of the concrete and steel decking against tension developing in the north-south direction. As the vertical displacement of the test floor increased in fire, the excessive tension would develop more effectively in the north-south direction than in the east-west direction until WWR finally ruptured at critical locations. This WWR rupture would happen in the concrete where the vertical displacements were greater, i.e., south of the secondary beam as shown in Figure 8(b).

Figure 10. Top of the test floor slab after cooling. Dashed lines define the test-bay column grid. The four photographs on the right (a through d) show close-ups of concrete fractures.

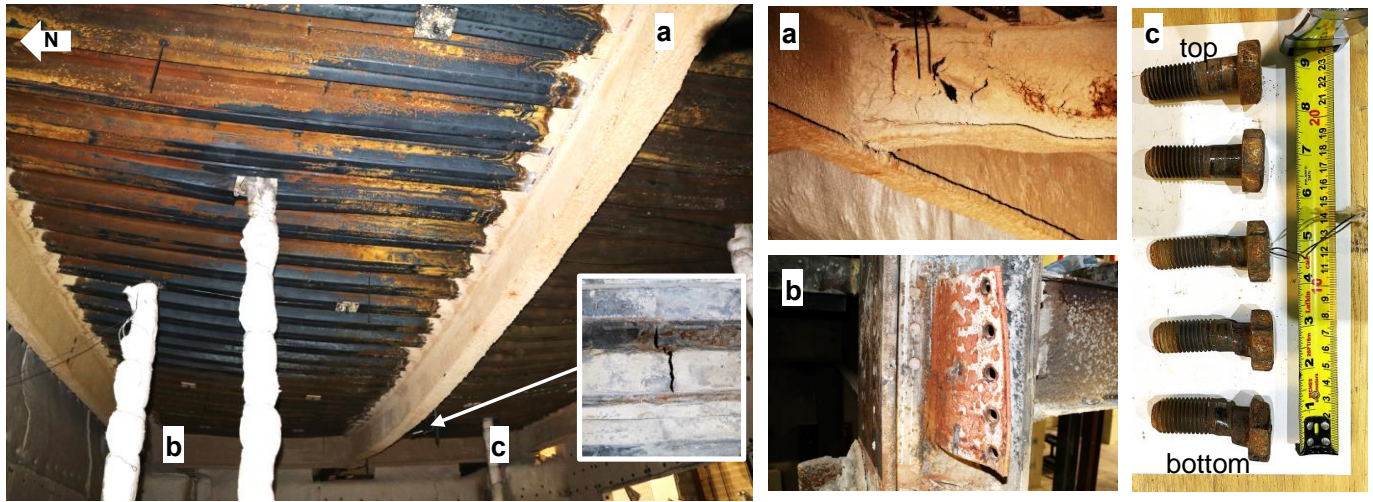
Figure 11 shows the underside of the test floor assembly after cooling. The steel deck below concrete fractures (Figure 10) mostly maintained its integrity with good ductility. Only a local rupture was found in the deck unit below the east end of the mid-panel longitudinal crack, i.e., near the west edge of the top flange of the east girder. All three 9.1 m long W16×31 beams exhibited permanent strong axis bending deformation and local buckling near the beam ends. Furthermore, the north and south primary beams also exhibited twisting and lateral deformations. The end connections of these beams, however, maintained their structural integrity. The east and west W18×35 girders showed little residual vertical deflection and exhibited minor out-of-plane deformations in the webs near the end connections. The extended shear tabs

welded to the northeast and the northwest columns exhibited noticeable out-of-plane deflection but no bolt failures. The extended shear tabs welded to the southeast and the southwest columns deflected little, whereas there were partial shear ruptures in the lower bolts of the southeast connection. The sprayed fireproofing on the beams and girders mostly remained intact, although fissures were evident on the beam web near the end connections and at the lower beam web of the secondary beam at midspan.

Figure 11. Fire-exposed steelwork of the test floor assembly after cooling. Close-ups of some deflected steel parts are shown in a through c.

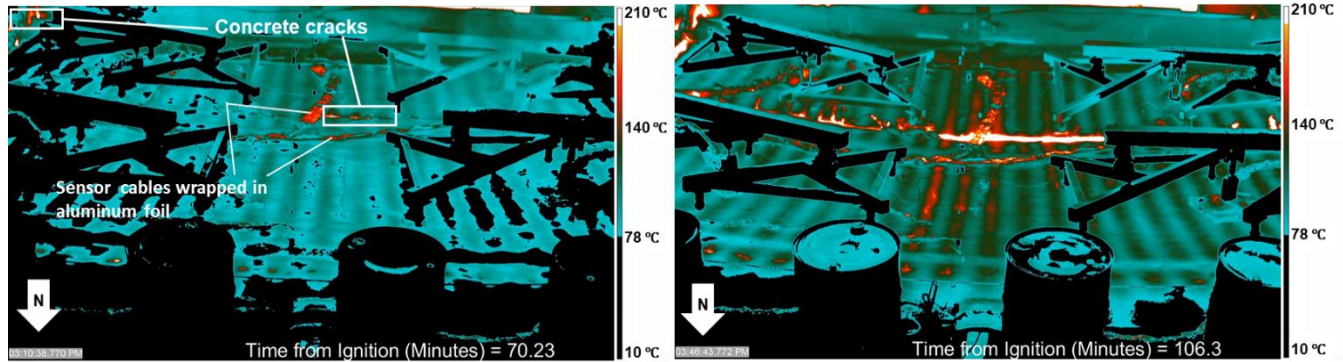
Furthermore, this test has revealed some potential issues related to the integrity of a composite floor assembly as part of compartmentation under fire loading. As shown in Figure 13, the centre breach in the test floor slab, initiated prior to the specified rating period of 120 min, was accompanied by ruptures of the wire reinforcement in tension at the mid-panel displacement of 350 mm ($L/26$) or greater. A minimum

code-required amount of shrinkage reinforcement ($59 \text{ mm}^2/\text{m}$) used in the test assembly was insufficient to resist thermally induced tension during the investigated fire. Although the steel deck continuously running in the transverse (north-south) direction of the test assembly appeared to be ductile at large vertical displacements, failure of side deck joints (screws failure at the decking overlap), local deck ruptures, exposure of the heated decking units within concrete cracks allowed the penetration of flames and hot gases beyond the test compartment. This condition could have potentially ignited cotton waste placed on the unexposed surface, failing to meet the standard fire testing criterion (i) as mentioned above.

Figure 13. Thermal images of the top of the test floor slab at 70 min and 106 min after fire ignition.
