# Firebrands Generated in Shurijo Castle Fire on October 30th, 2019

Sayaka Suzuki <sup>(b)</sup>\*, National Research Institute of Fire and Disaster (NRIFD), 4-35-3 Jindaiji-Higashimachi, Chofu, Tokyo 182-0012, Japan
Samuel L. Manzello <sup>(b)</sup>, National Institute of Standards and Technology (NIST), 100 Bureau Drive, Gaithersburg, MD 20899, USA

*Abstract.* A fire started in Shurijo Seiden, or the main hall of Shurijo Castle, Nahacity, Okinawa, Japan on the morning of October 30th, 2019. The fire resulted in loss of 8 structures and many important Okinawan cultural assets. The original Shurijo Castle was destroyed many years ago and a replica was constructed and rebuilt to be as close as possible to the original building. The replica was fabricated mainly from wood (*Chamaecyparis taiwanensis*). Firebrands were reported during the fire. In this study, firebrands from Shurijo Castle was collected and analyzed. The data was compared with those from other investigation as well as experimental data.

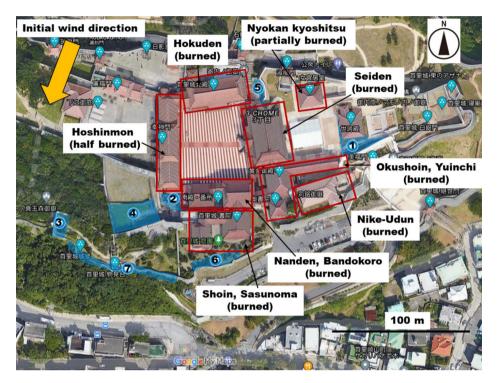
On the morning of October 30th,2019, a fire started in Shurijo Seiden, Shurijo Castle, located in Naha-city, Okinawa, Japan. Figure 1 shows Shurijo Castle, before the fire. The exact time of the start of the fire is unknown. The heat was detected by a sensor at 2:34 AM on the 1<sup>st</sup> floor of Shurijo Seiden. Security guards saw smoke already filled around 2:35–2:37 AM. The fire was notified to Naha-city Fire Department at 2:41 AM and firefighters arrived at 2:48 AM. When they arrived, the fire was already observed ejecting the flame from Shirijo Seiden [17]. The fire spread quickly and overwhelmed firefighters, which resulted in the loss of 8 buildings (6 of them were totally destroyed, 1 was half destroyed, and 1 was partially destroyed) (see Fig. 2) [16]. In total, around 4,800 m<sup>2</sup> was burned.

Figure 2. Map of Shurijo Castle. Burned buildings and firebrand collection sites are indicated.

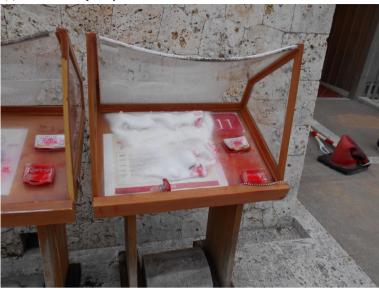
#### (a) Melted stamp rally board

After the fire, investigation was undertaken and firebrands were collected in Shurijo Castle Park on November 4<sup>th</sup>, 2019 and November 5<sup>th</sup>, 2019. Figure 5 shows the situation after the fire disaster. Plastic from some of exhibit (approxi-

mately 30 m upwind from Seiden, or main hall) was melted. Trees were half burned, clearly only the side of the fire (near the location 6 in Fig. 2).

Figure 5. Images shown for impacts of fires. a Melted stamp rally board b Half burned trees.

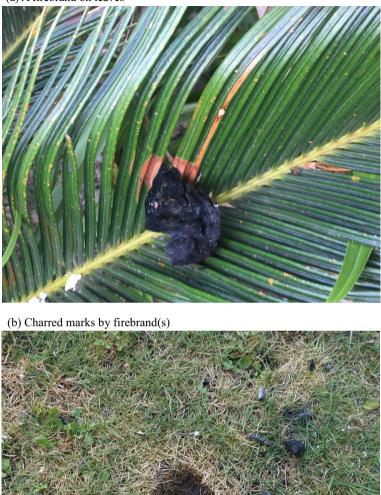
(a) A firebrand on leaves

Figure 6. Pictures of collected firebrands. a A firebrand on leaves b Charred marks by firebrand(s).

may penetration) and main structural components are usually concrete. While these features do not prevent the possibility of spot fire ignitions, it appears to reduce the possibly, as no resident intervention measures were documented, and no spot fire ignition of structures were reported. In addition, the relative humidity (RH) was high, around 64% to 71%. While firebrands ignited grass and leaves, the fire never spread, as shown in Fig. 6.

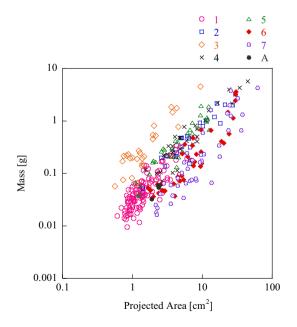
Figure 7 shows the mass and the projected area of firebrands collected. The number in Fig. 7 corresponds to the number in Fig. 2. Figure 7 is shown in log–log scale to show the size difference. The location 1, at the upwind location of the fire,

Figure 7. Size and Mass of firebrands collected from Shurijo Castle fire. Numbers and A indicate the collection site.

had the largest number of smaller firebrands compared to other locations. Firebrands collected at location 3 showed heavier trends than those from other locations. Location 3 is within the forest, and firebrands were collected on the ground. It is possible only heavier firebrands landed on the ground as firebrands would land on tree first then drop (land) on the ground.

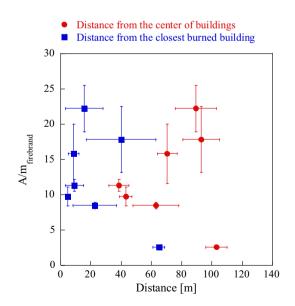
Here A is the projected area of a firebrand,  $m_{firebrand}$  is the mass of a firebrand, and D is the flying distance. Given the liner relationship between the mass and the projected area of firebrands,  $\frac{A}{m_{firebrand}}$  was calculated and plotted in Fig. 8 along with distance from a) center of the buildings, and b) the closest burned building. The distance and  $\frac{A}{m_{firebrand}}$  shows the positive relationship except for location 3 in Fig. 2.

Figure 8. The relationship between the ratio of projected area and mass of firebrands vs distance from the source.

As discussed before, firebrands collected location 3 are heavier than those from other locations and have an impact on Fig. 8. Figure 9 shows the results of internet survey taken from [22]. This internet survey was done through the company (macromill). Three hundred twenty-one people in Naha-city joined this survey at the begging of February 2020. Questions were related to the location at the time of the fire, whether or not they saw the fire or firebrands, and what size of firebrands they observed. The location was identified based on the local area name

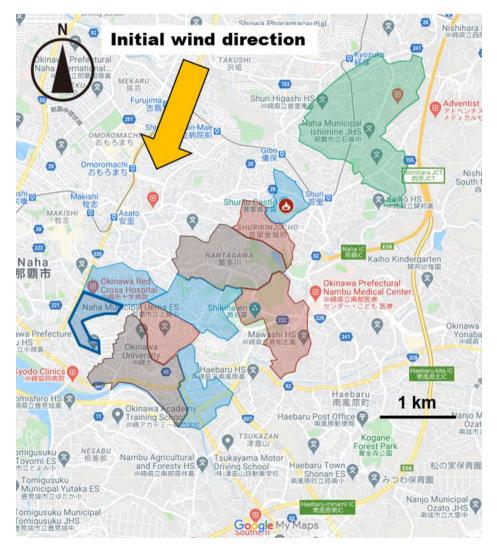
Figure 9. Firebrands transport distance based on online survey. Gray: firebrand size is small like powder, Green: firebrand size less than 1 cm, Blue: firebrand size between 1 and 5 cm, Red: firebrand bigger than 5 cm.

and witness information was cooperated with the location. Based on the survey, firebrands from Shurijo Castle fires were observed upwind and at least 6 km downwind from the fire. It is useful to understand a big picture of firebrand travel distance from the fire without going to the site and talking with witness while more detailed data and more attempt will be needed in the future. While this enabled to see the firebrand distribution from the source in larger area, it shows firebrand distribution may not be as simple as it can be assumed based on Ta number.

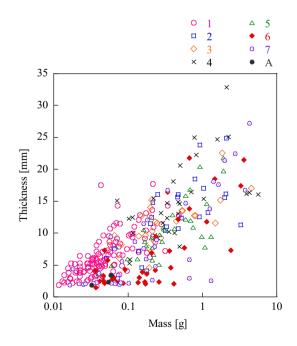
Figure 10 shows the thickness and the mass of firebrands collected. This relationship is more diverse than previous experimental data [13–15]. A variety of thicknesses were seen in firebrands collected, especially from location 1, 6 and 7 for given mass.

Figure 10. Thickness and Mass of firebrands collected from Shurijo Castle fire.

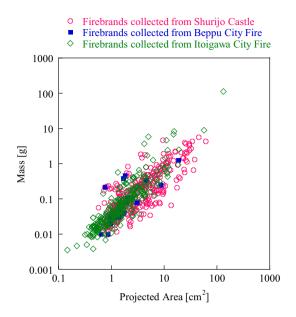
Figure 11 shows the comparison with firebrands collected in different investigations in Japan, namely, the 2010 Beppu-city fire [9], and the 2016 Itoigawa-city fire [10]. Wind speeds during the fires are different from those from the Shurijo Castle fire. Yet, since actual firebrand data from actual fires is limited, it is important to compare results, nonetheless. The wind speeds of Beppu-city fire and the Itoigawa fire were around 10 m/s with an average 9 m/s, respectively. Figure 9 shows all firebrands follow a single relationship, despite vast difference in the fires and the fuel sources of the firebrands.

The Itoigawa-city fire contained larger number of smaller firebrands than the other fires compared here. One firebrand with a mass of more than 100 g is inclu-

# Figure 11. Comparison from previous investigation in Japan, Beppu city fire and Itoigawa city fire.

ded in Fig. 11, which makes it appear the Itoigawa-city fire produced a larger number of large firebrands, which in fact is not the case. Compared to the firebrand collection sites in the Itoigawa-city fire, which were mainly on roads or on roof tops, in the case of Shurijo Castle fire, firebrands were collected on the grass. For these reasons, it was difficult to find or collect smaller firebrands, as these could have landed under the grass itself, making it hard to see.
