Microstructure changes during failure of PVDF-based photovoltaic backsheets

Stephanie L. Moffitt¹

¹Engineering Laboratory, National Institute of Standards and Technology, Gaithersburg, MD, USA

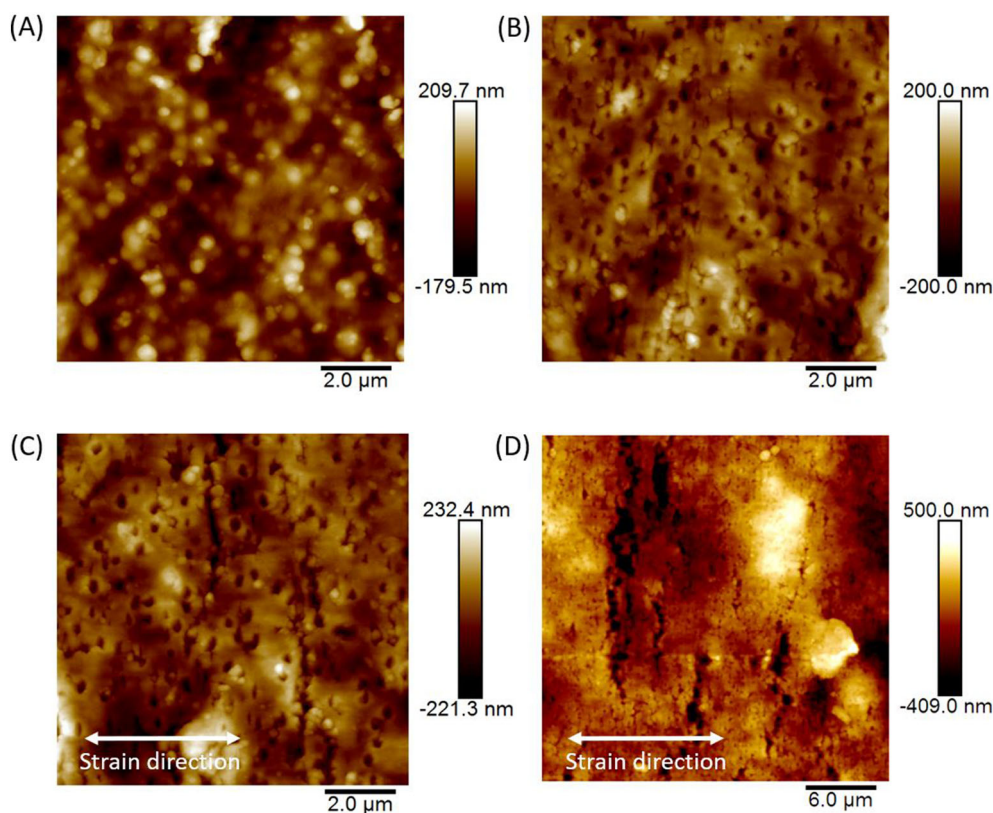
AFM topography of the fresh, unaged FS sample reveals submicron roughness (Figure 3A). The surface texturing appears to be

dominated by spherical-like protruding structures several hundred nanometers in diameter. These structures are probably due to titania pigments distributed in the polymeric matrix (Figure 2B). After exposure to A3 aging conditions, the spherical structures become less prevalent and are replaced by pits of a comparable size (Figure 3B). The submicron pit structures are more clearly imaged by SEM (Figure 4A).

The spherical-like structures observed on the surface through AFM (Figure 3A) and SEM (Figure 4) are of comparable size to typical titania pigment particles.^{33,34} The particles also appear much brighter in the SEM images, as is expected for heavier elements.³⁵ As mentioned above, Raman spectroscopy has confirmed that titania is present on the surface of the FS samples (Figure 2B). Thus, we propose that the surface pitting of the aged FS samples is due to a loss of titania pigment particles. It is reasonable to suggest that if the titania particles were released, a pit of similar size would be left behind.

The surface pitting may be further facilitated by a loss of PMMA content due to the photocatalytic effect of the titania particles. In the FS sample, an increase in accelerated aging exposure time results in a decrease in the carbonyl peak at 1730 cm^{-1} (Figure 5). Quantification of the decline in peak intensity is shown in Figure 5B. The decline in the carbonyl peak is persistent. In contrast, the C-F peak at 1180 cm^{-1} remains largely unchanged throughout the full exposure. As stated above, the carbonyl peak likely comes from PMMA content blended into the PVDF polymer.²⁷ Thus, the FTIR results suggest that the PMMA content of the outer layer undergoes significant chemical degradation while the PVDF content remains stable.^{27,36} Given that in

FIGURE 3 AFM topography of FS sample: (A) unaged, (B) after 4000 h of aging, (C) after 4000 h of aging and application of 5% tensile strain in the transverse direction (TD, direction shown with white arrow), and (D) after 4000 h of aging and application of 25% TD tensile strain (direction shown with white arrow) [Colour figure can be viewed at wileyonlinelibrary.com]

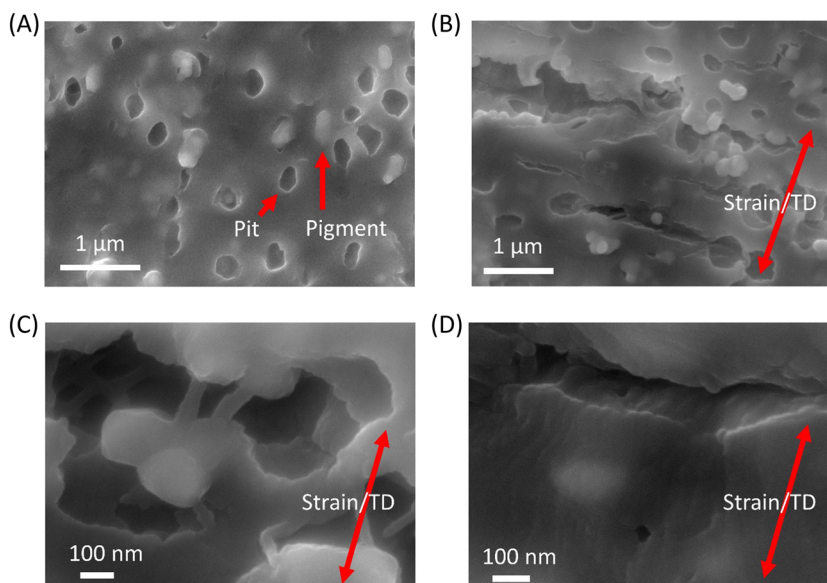
FIGURE 4 SEM images of FS samples exposed to (A) 4000 h A3 aging and (B–D) 4000 h of aging and application of 5% tensile strain applied in the TD direction [Colour figure can be viewed at wileyonlinelibrary.com]

Despite the presence of surface pits that could serve as a nucleation site for fracture, no significant structural degradation (i.e., cracking) is observed after A3 aging of the FS samples before strain is applied. We note that the free-standing nature of the samples during aging removes strain effects from thermal mismatch between the backsheet and other modules components (e.g., glass and busbars). Thus, strain was applied post-aging employing the fragmentation test described above. Once tensile strain is applied, surface cracks form in the aged samples (Figures 3C,D and 4B–D). Microcracks observed with AFM are on the order of microns and confocal images of these strained samples (SI, Figure S4) do not show microcracks. The microcracks appear to form as a coalescence of surface pits (Figure 4B). The cracks form perpendicular to the strain direction. Fibrous structures bridge the cracks (Figure 4C).

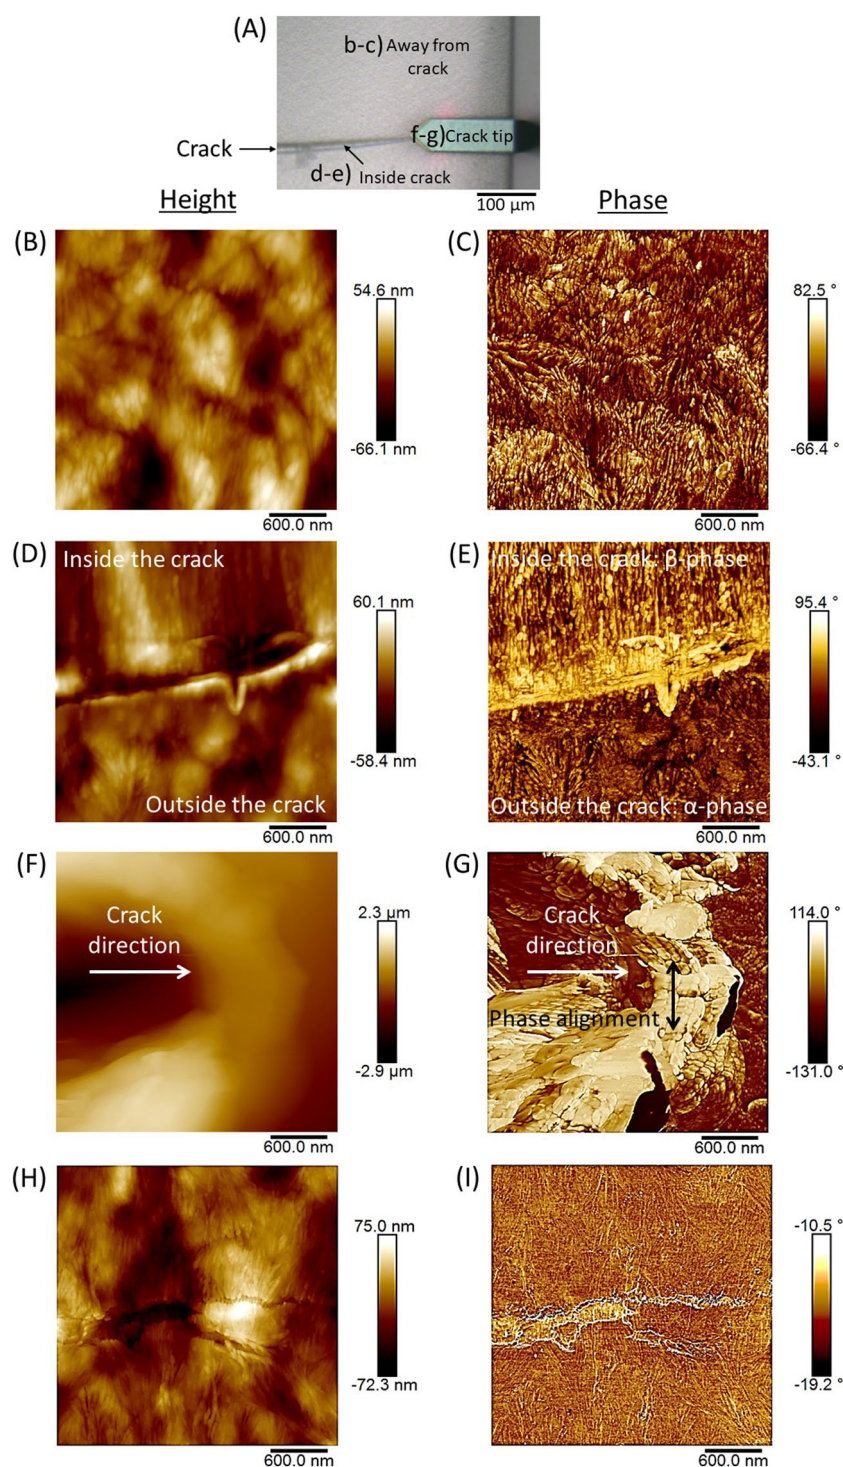
AFM images demonstrate changes in the surface morphology near the cracked regions. Away from the crack (Figure 6B,C) the surface microstructure of the LC samples is made of spherulite

FIGURE 6 (A) Optical image of representative crack in LC sample with representative AFM collection points indicated. AFM height (left) and phase (right) images taken of the LC samples surface collected (B, C) away from the crack, (D, E) on the edge and inside the crack, (F, G) at the crack tip, and (H, I) at a micro-crack. In F and G, a white arrow shows the crack direction and black arrows in highlights the direction of the observed morphology alignment. [Colour figure can be viewed at wileyonlinelibrary.com]

structures, the hallmark of α phase PVDF.^{35,37} Inside the crack, AFM reveals a significant change in the microstructure. Instead of spherulite bundles, the structure becomes more ordered and directional. Furthermore, using the intermittent contact mode on the AFM and monitoring the phase signal, a significant phase contrast between the region inside versus outside the crack was observed (Figure 6E), indicating differences in mechanical properties (e.g., stiffness, adhesion, dissipation, etc.) between these regions. These results suggest that the PVDF polymer within the crack has undergone a phase transition from α to β phase due to significant deformation during cracking. The β phase of PVDF is the elongated, all-trans polar conformation of PVDF, while the α phase is the gauche, nonpolar conformation which creates a helix-type structure.³⁸ The polymer morphology at the crack tip (Figure 6G) is ordered and directional, as is consistent with β phase PVDF.³⁷ Previous work has shown that α to β phase transitions can occur in cracked and strained pure PVDF polymers.³⁹ Further, α to β phase transformation has been observed to be part of the crack propagation mechanisms in pure PVDF.⁴⁰ Figure 6H shows that cracks can also occur in the rigid lamella of the spherulites, breaking the lamella instead of causing phase transformation of crystallites. Additional work is planned to conduct an in-depth X-ray scattering study to investigate α to β phase transitions during crack growth in aged PVDF backsheets. However, the study is outside the scope of the current manuscript.

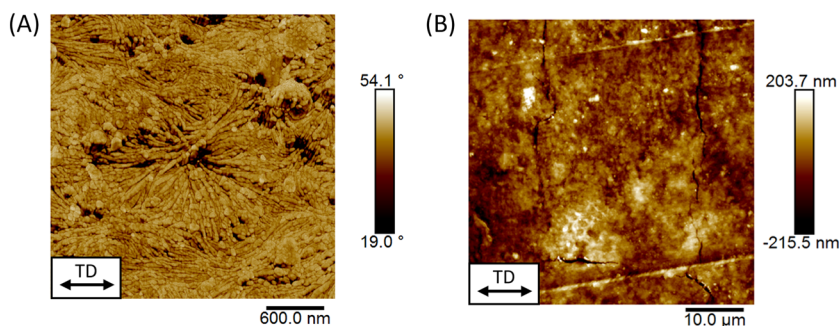
AFM images of the aged LC surface (Figure 6). Similarly, the AZ sample, which also has a pure-PVDF surface layer, also does not show signs of surface pitting (Figure 7).

FIGURE 7 (A) High magnification AFM phase image of AZ sample before the application of 5% strain and (B) AFM topographic image of AZ sample after the application of 5% strain in the TD as indicated [Colour figure can be viewed at wileyonlinelibrary.com]

fragmentation test described above. Unlike the LC sample, a prominent change in the surface was not observed near cracks induced by the fragmentation test. Rather, the morphology changes were not limited to the cracks and instead occurred more globally throughout the sample (SI, Figure S5c). This difference is likely because during the fragmentation test, strain is applied globally across the whole film, rather than locally by inhomogeneities induced by a busbar (as in the LC sample or in the regions of the AZ module backsheet that were not retrieved). The observation of a more subtle and more global change in surface morphology is also seen in the FS samples (SI, Figure S5b). Thus, while the small strains ($\leq 5\%$) applied by the fragmentation test successfully reproduce field cracking on a macro-level, the microstructure changes of the FS and AZ samples are smaller and more global than those seen in the LC sample. This difference is attributed to the different nature of the strain application.

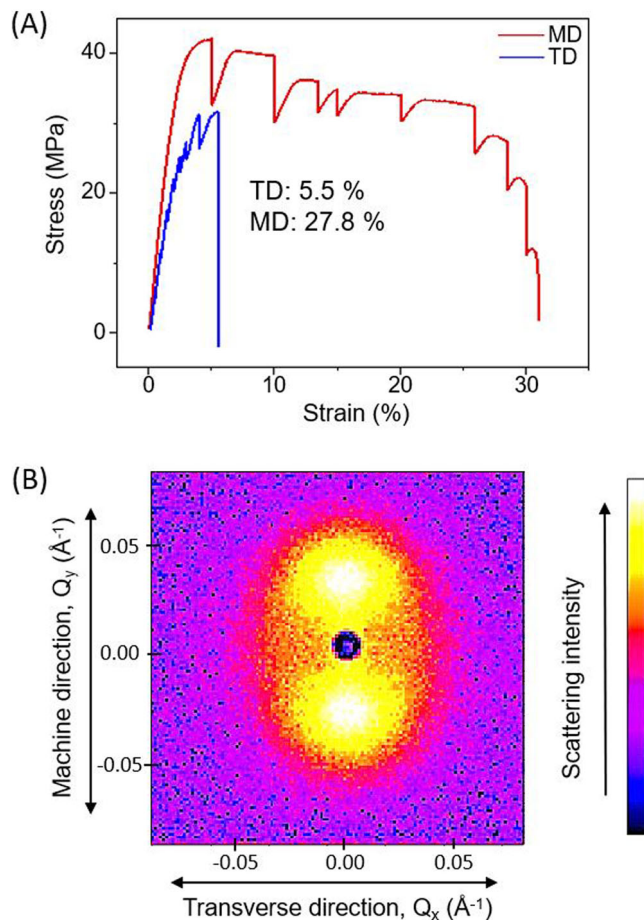
FIGURE 8 (A) Typical stress-strain curve for the AZ sample when tensile strain was applied in either the machine or transverse direction (MD or TD). The elongation at break is recorded in the inset for both the TD and MD. (B) 4-m SANS pattern of the AZ sample [Colour figure can be viewed at wileyonlinelibrary.com]

During fragmentation testing specific strain is added gradually in steps to observe the fracture behavior. This step-based approach produces stepped stress-strain curves (Figure 8A). The elongation at break was significantly weaker in the TD (5.5%) compared to the MD (27.8 %) (Figure 8A). This result is in-line with the field observation that crack formation was often oriented along the machine direction. An AFM topographic image of the AZ sample after stretching 5% in the TD is shown in Figure 7B. Cracks appeared perpendicular to the TD (aligned with the MD). Though the AZ sample was not cracked initially, the fragmentation test revealed that the material was predisposed to crack once a small strain was applied. This may explain why the fielded module was cracking near the module busbars; regions along busbars are anticipated to be exposed to strain effects due variations in module topology.

To investigate whether the significant anisotropy in the tensile strength was related to anisotropy in the polymer structure, small-angle neutron scattering was performed on the AZ and FS samples to characterize the sample-averaged microstructure. Pronounced anisotropic scattering is seen near 0.04 \AA^{-1} , with higher intensity in the machine direction of the polymer. Scattering in this range is

anticipated to originate from the long-period spacing (i.e., the spacing between crystalline domains) of the PVDF polymer.⁴¹ It is likely that the processing of the polymer induced preferred orientation of the crystalline domains. The anisotropy in the microstructure may explain the anisotropy in the tensile strength. Earlier studies have seen similar anisotropy in the tensile modulus of PVDF/PMMA/TiO₂. In the work by Hosoda and Yamada, the TD had a lower tensile modulus than the MD.³⁵ The authors attributed this behavior to the anisotropy in the crystalline structure of the polymer where the crystals are oriented in the MD. When strained in the MD, the amorphous regions between the lamella enable the spherulites to deform, whereas in the TD more strain is placed on the rigid lamella which break instead of deforming. This results in less than 20% elongation at break for the TD versus over 200% for the MD.³⁵
