NIST Technical Note 2203

**Fire Resilience of a Steel-Concrete
Composite Floor System: Full-Scale
Experimental Evaluation for Influence
of Slab Reinforcement (Test #2)**

Test #2 investigates the influence of the slab reinforcement on the structural integrity of the 9.1 m × 6.1 m steel-concrete composite floor subjected to combined mechanical loads and compartment fire exposure. The fire test bay was situated on the ground floor in the middle edge bay of the two-story test building. The floor slab in the test bay was reinforced with 9.5 mm diameter deformed bars placed 30 cm on center (230 mm²/m). The test floor was hydraulically loaded to 2.7 kPa to mimic the code-prescribed gravity loads for fire conditions. Natural gas burners created a peak gas temperature exceeding 1100 °C below the test floor. The test fire lasted about 131 min, but the hydraulic loading was not removed until the test floor cooled down over 2 hours after the fire was extinguished. This experiment confirmed that the steel reinforcement played a vital role in maintaining the integrity of the composite floor under prolonged compartment fire exposure. The mid-panel vertical displacement increased at a rate less

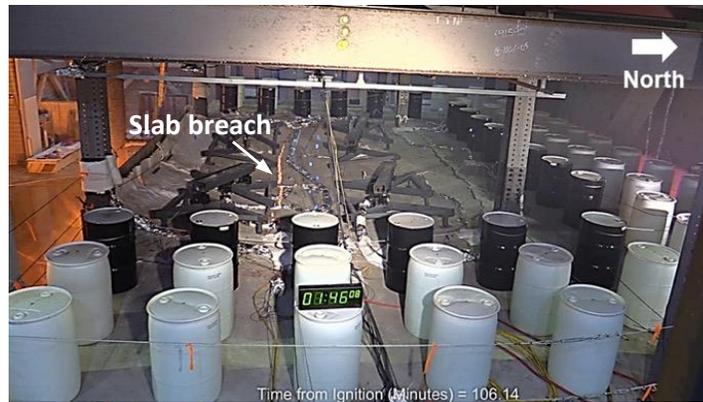
Whereas temperatures of the protected steel beams were acceptable compared to the ASTM E119 [13] limiting temperatures, significant integrity failure (concrete cracks) occurred in the heated composite floor before attaining the specified fire rating period. Large concrete cracks appeared around the hogging moment region (next to the test-bay column gridline) less than 30 min into heating, and the mid-panel concrete cracks began to occur at 70 min, exposing the hot glowing steel deck beneath along the longitudinal centerline (Fig. 2).

The limited ductility of the heated composite slab was the primary cause of the integrity failure which might initiate fire spread above the compartment of fire origin and eventually lead to local collapse mechanisms during longer (uncontrolled) fires. The steel wire reinforcement (60 mm²/m) embedded in the test floor slab ruptured in tension at critical locations as the thermally degraded composite floor sagged but before reaching the ASTM E119 displacement limit. The minimum steel reinforcement (60 mm²/m) prescribed for concrete crack control in normal conditions and permitted in standard furnace testing may not be sufficient to maintain the integrity of a full-scale composite floor undergoing the 2-hour standard fire exposure.

Fig. 2. Still image showing top of the Test #1 composite floor developing slab breach at 106 min after burner ignition.

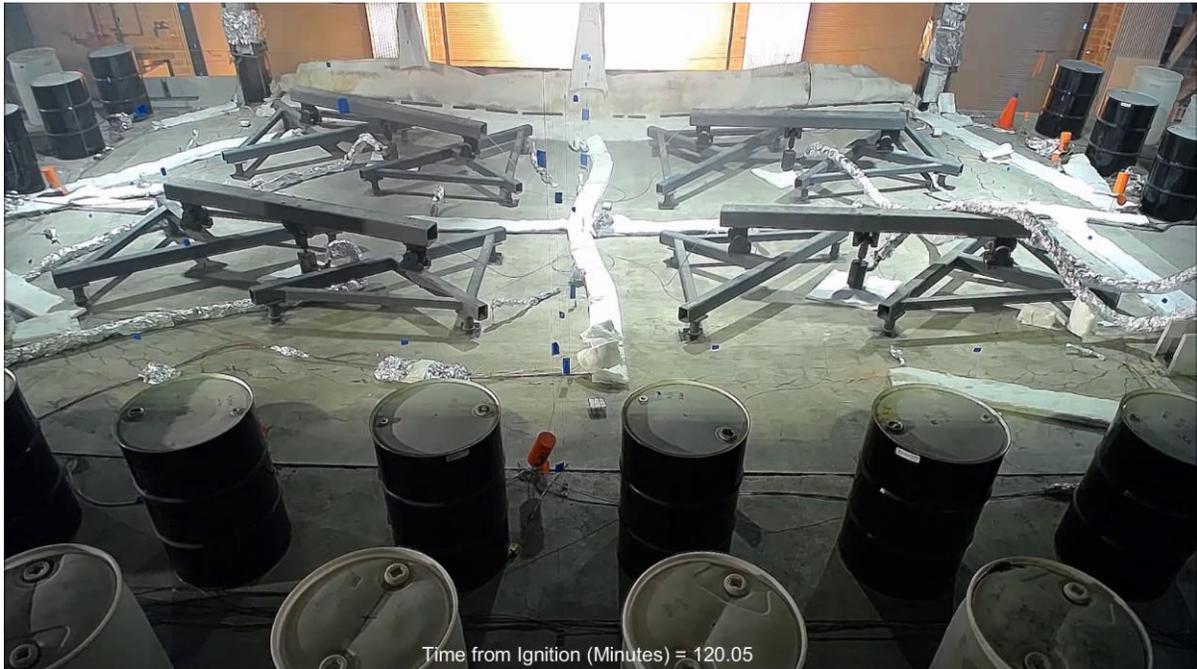
Fig. 29. Video image showing top of the test floor at 120 min after fire ignition.

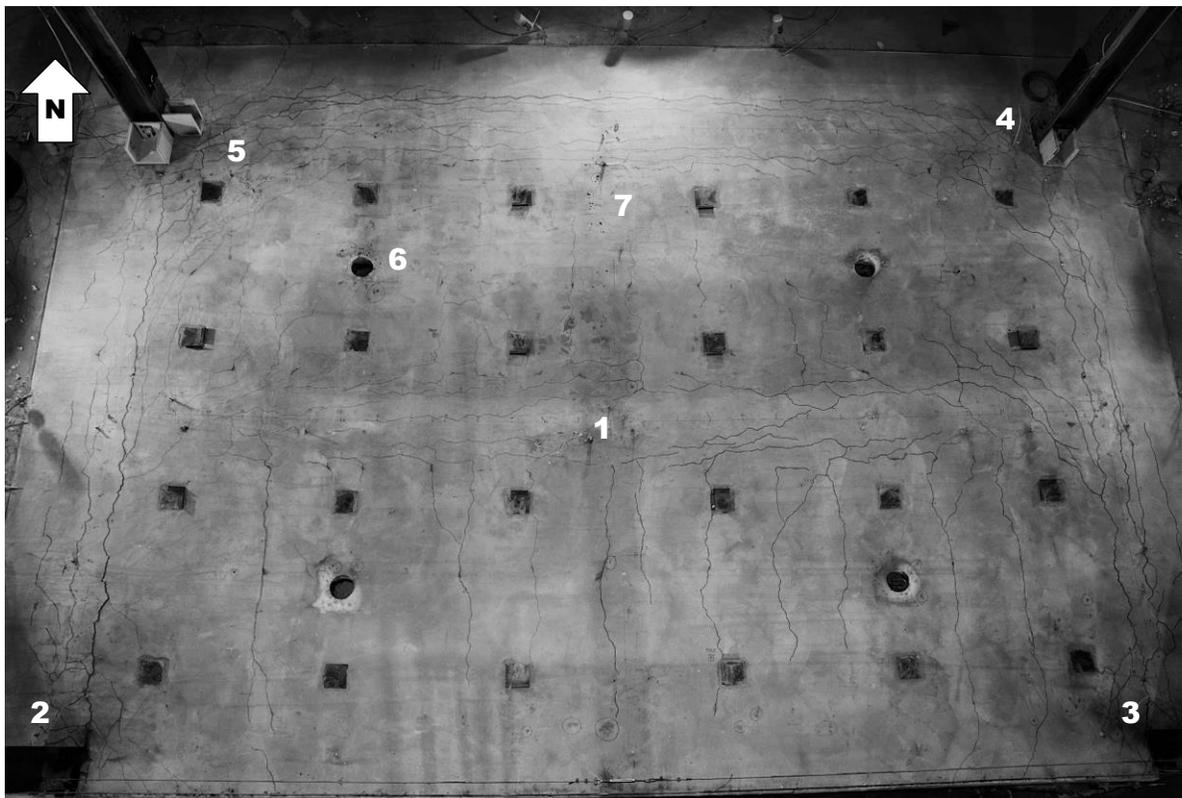
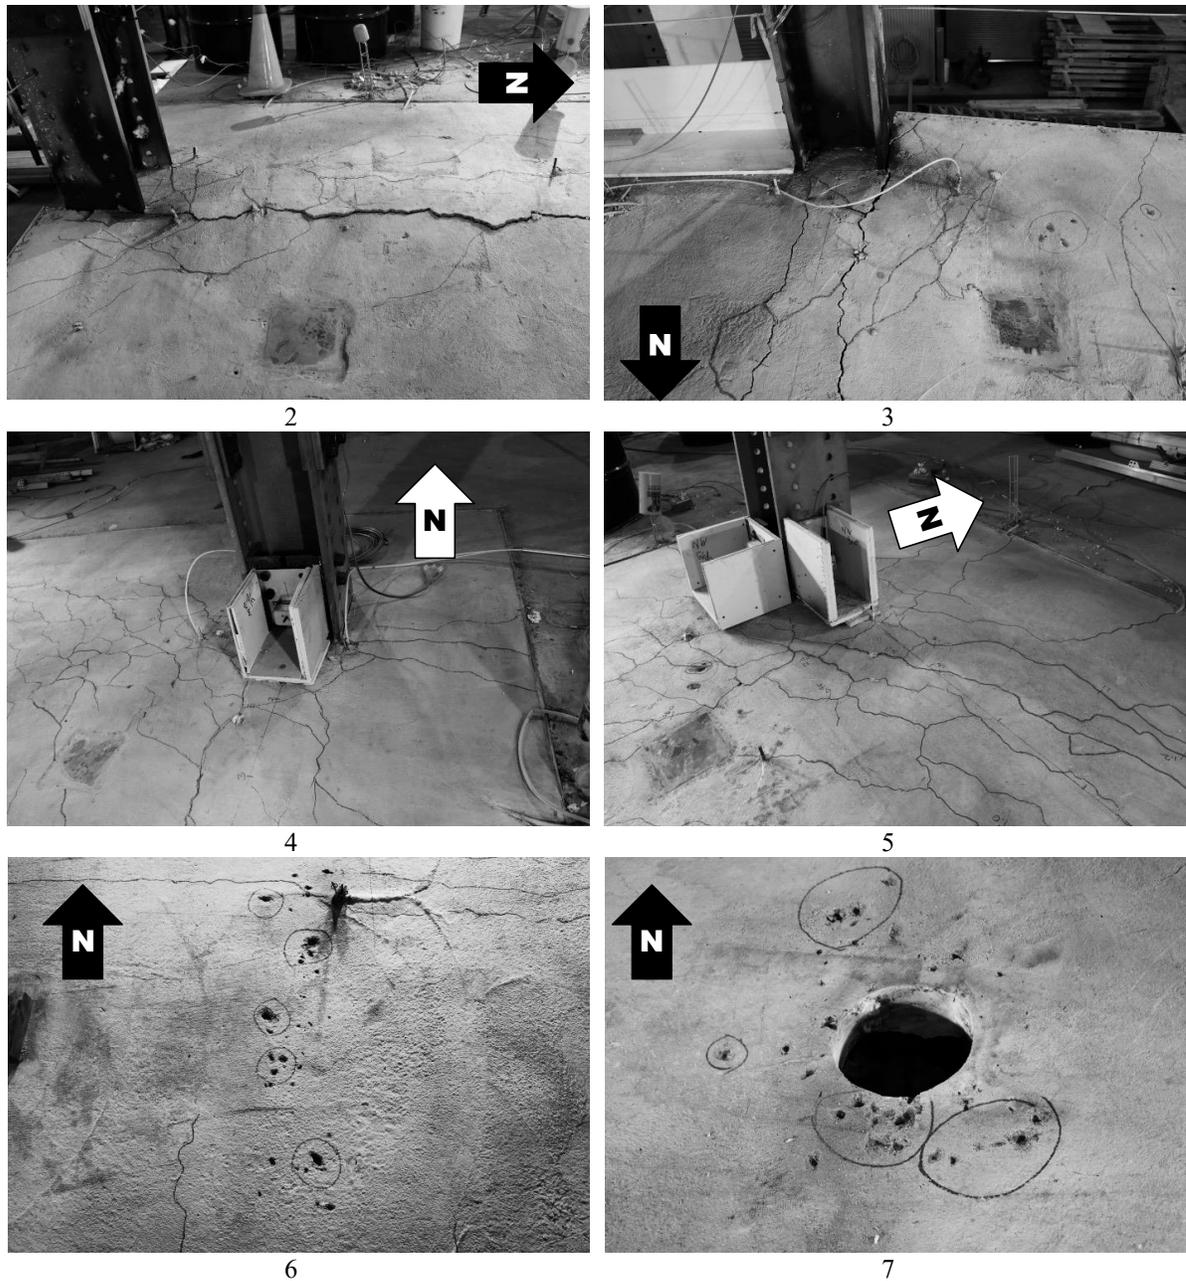
Fig. 35. Post-test photographs of the test floor slab, including closeups of concrete damage at locations 2 through 7.

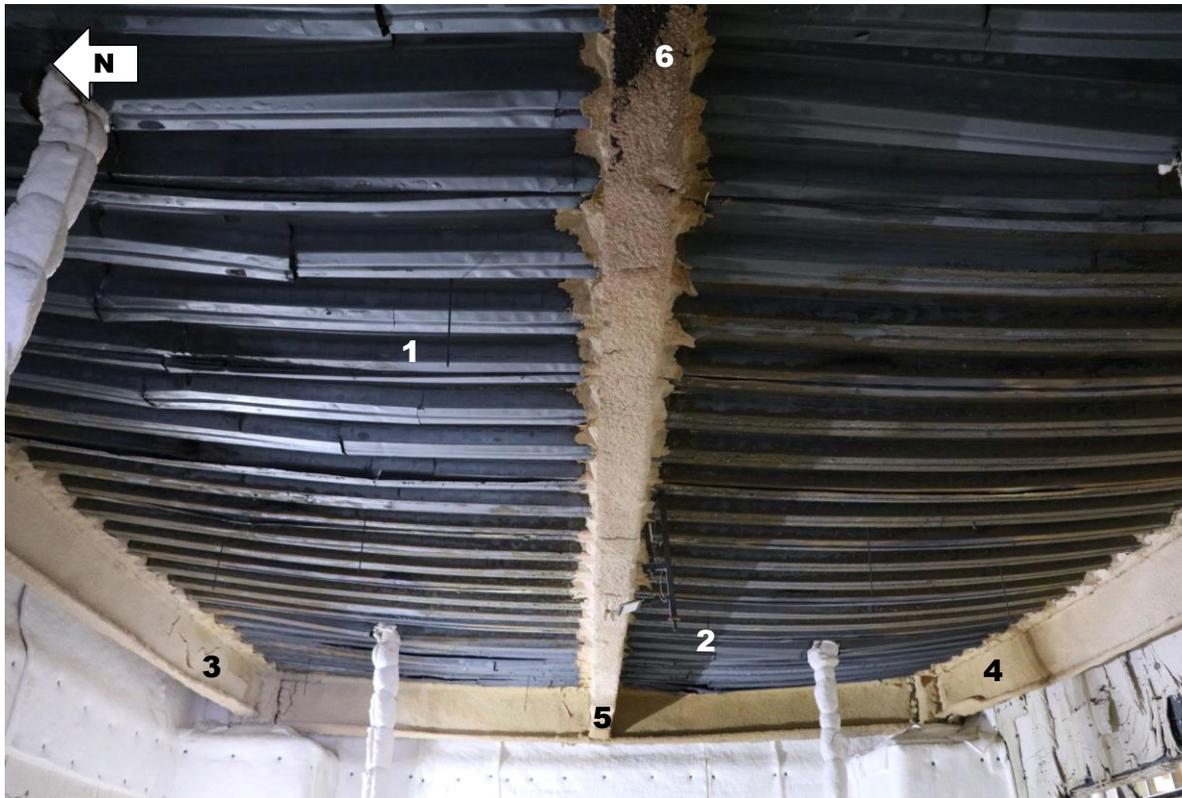
Fig. 36. Post-test photograph of the floor specimen soffit.

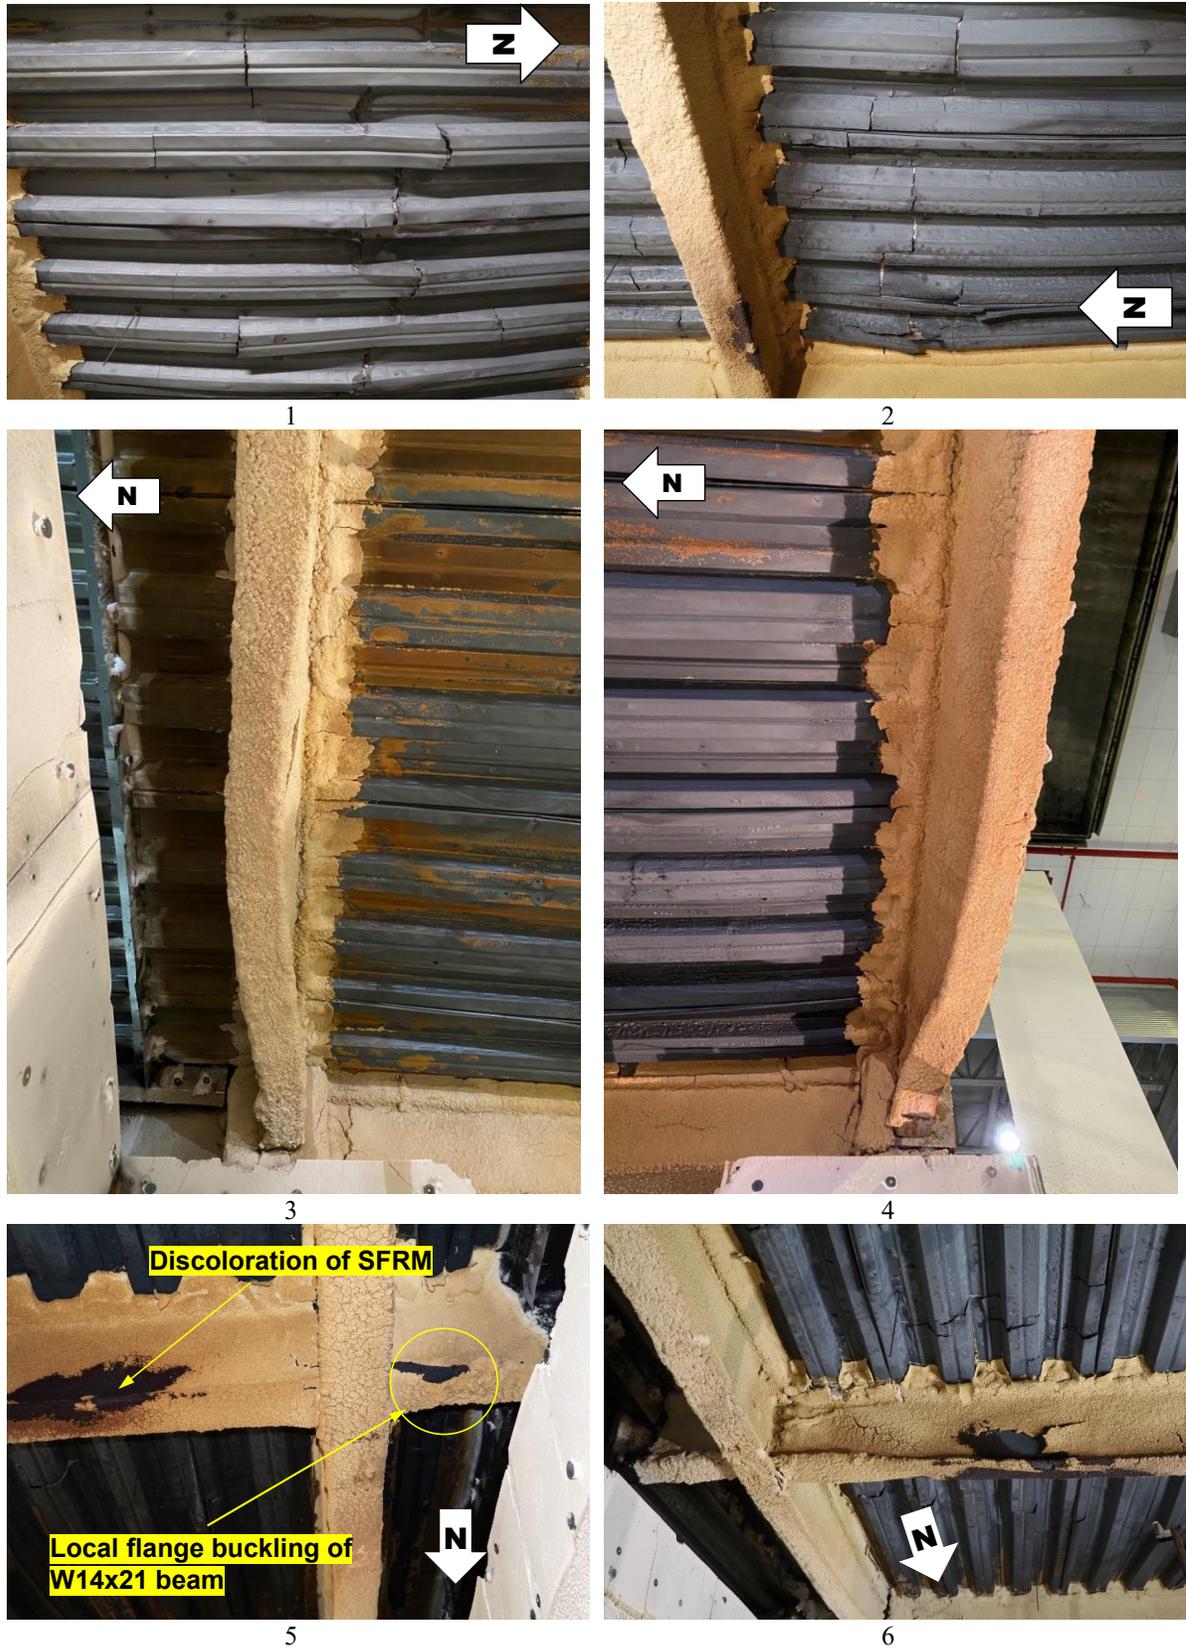
Fig. 37. Closeup photographs of steel damage at locations 1 through 6 shown in Fig. 36.

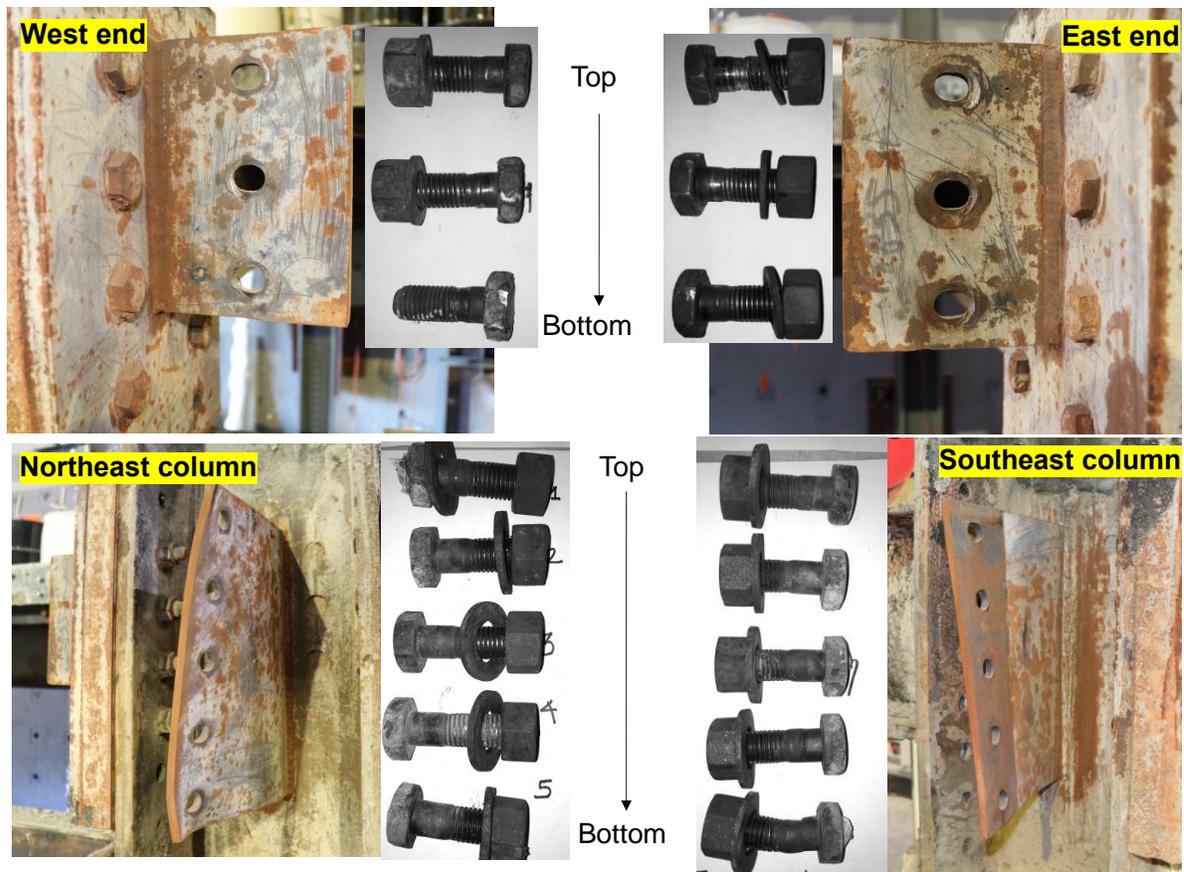
Fig. 38. Post-test photographs of the standard shear tab connections of the north edge beam (top) and the extended shear tab connections of the east girder (bottom).

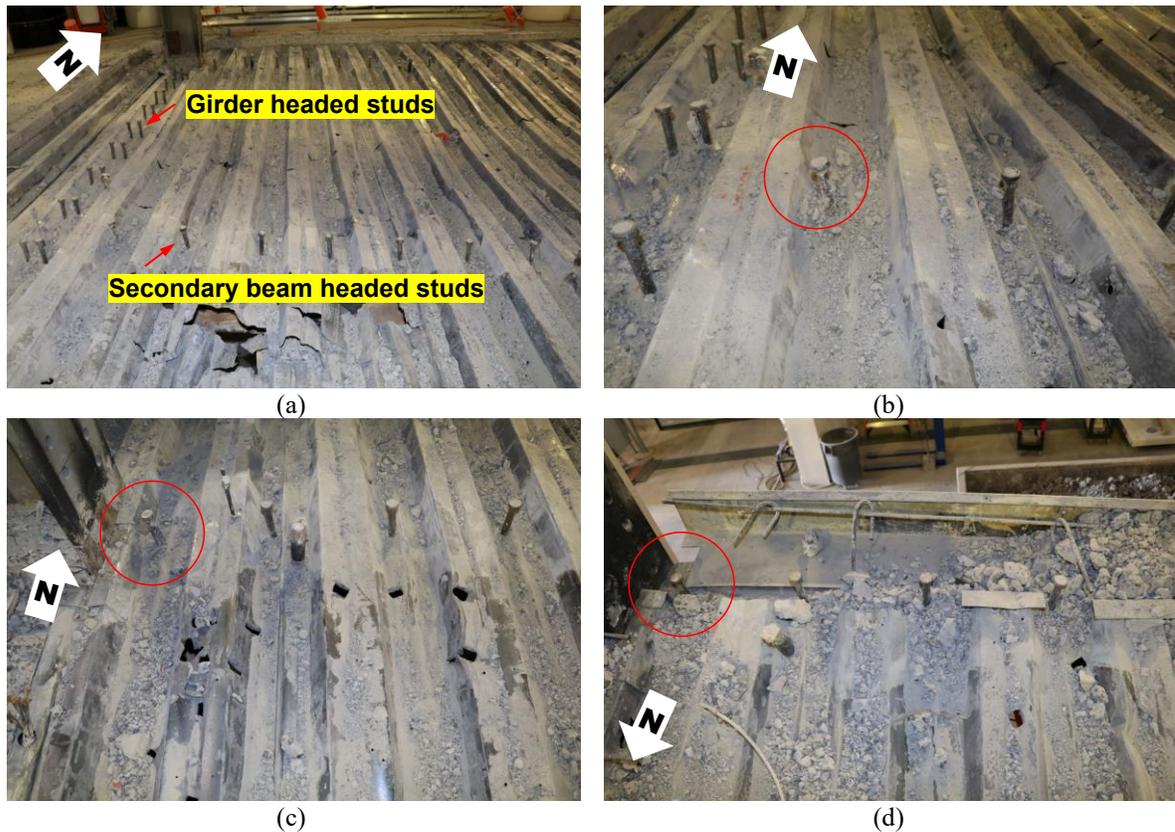
Fig. 70. Post-test photographs of headed studs after concrete removal: (a) Northwest steel decking; (b) Secondary beam; (c) North edge beam; (d) South edge beam. The beam-end stud is in a red color ring.

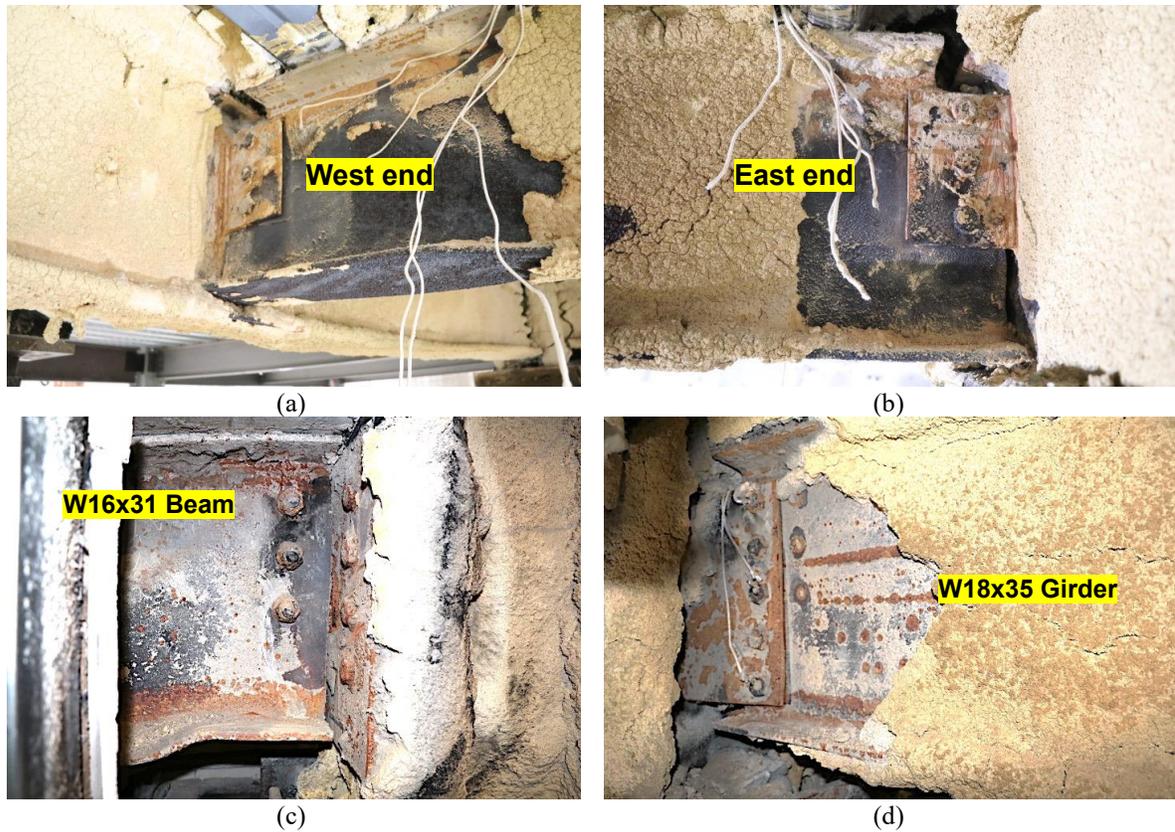
Fig. 71. Post-test photographs of shear tab connections: (a-b) secondary beam, (c) north beam, and (d) east girder. Fireproofing was removed manually.

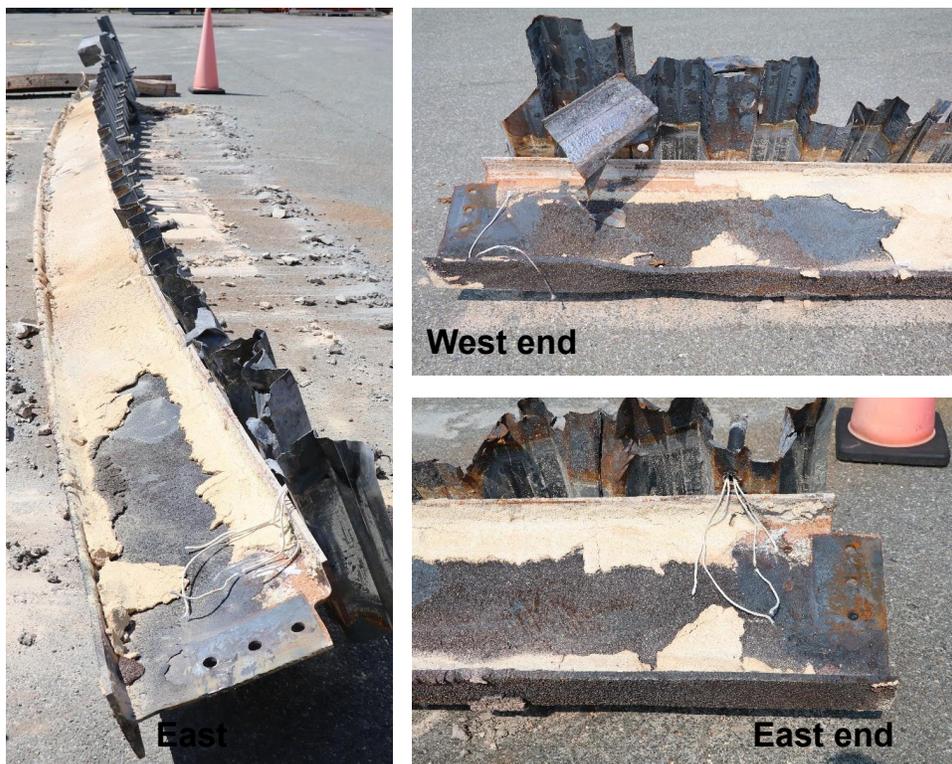
Fig. 72. Post-test photographs: Secondary beam.

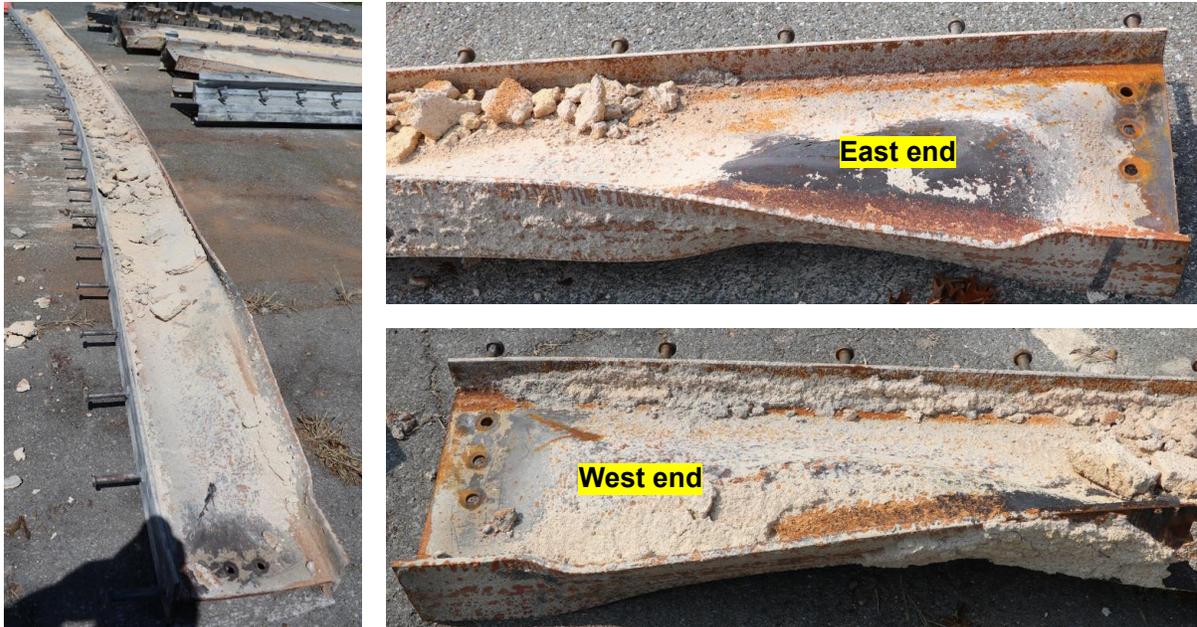
Fig. 73. Post-test photographs: South edge beam.

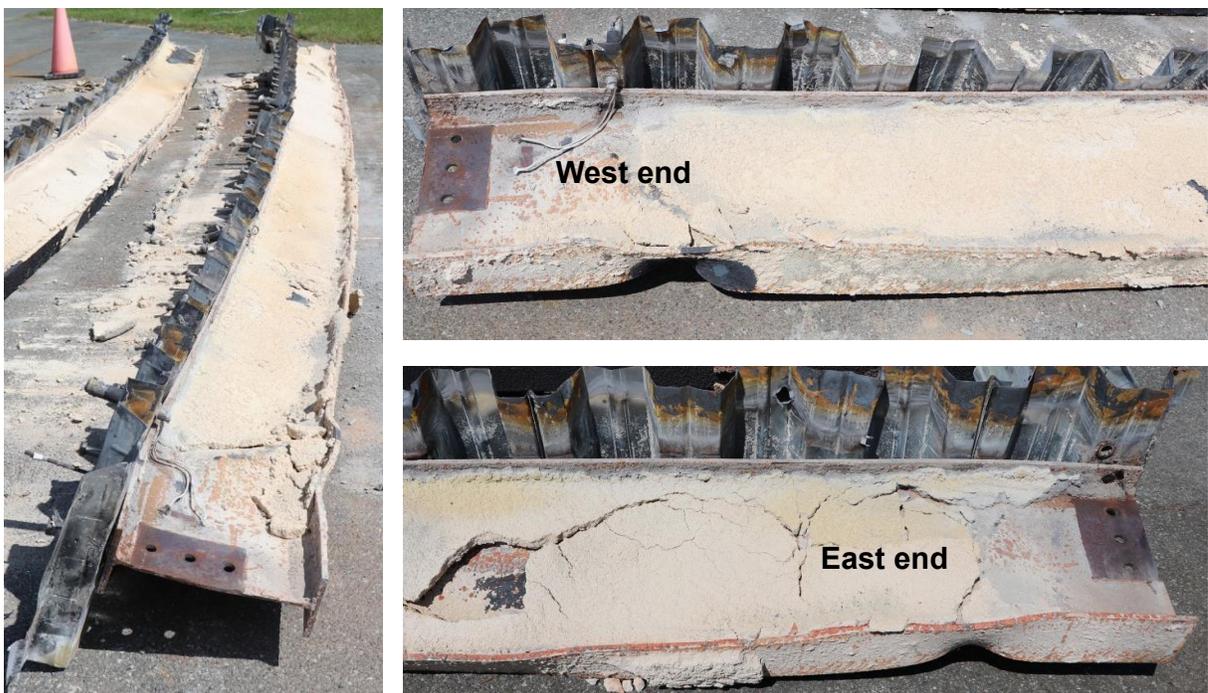
Fig. 74. Post-test photographs: North edge beam.

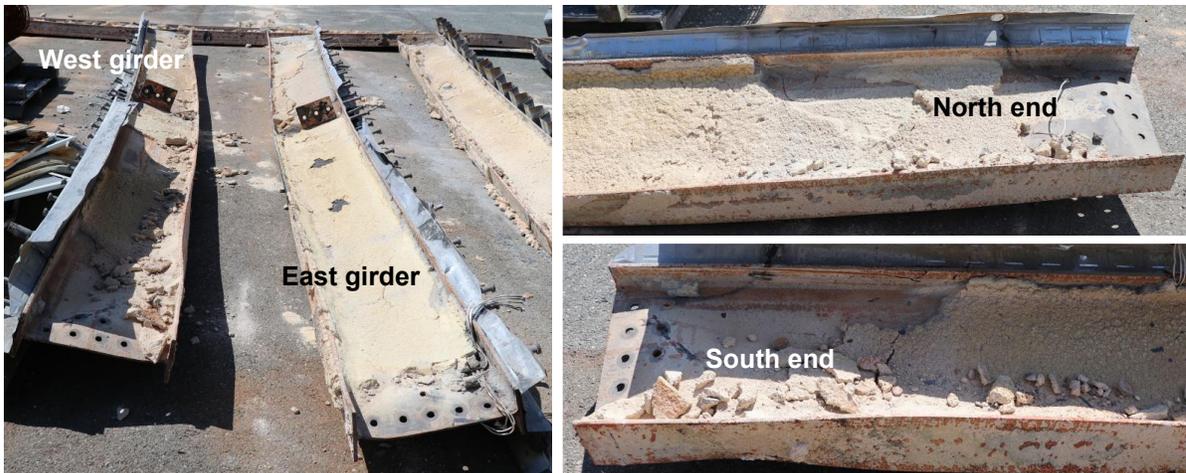
Fig. 75. Post-test photographs: Test-bay girders (left) and north and south ends of the west girder (right).

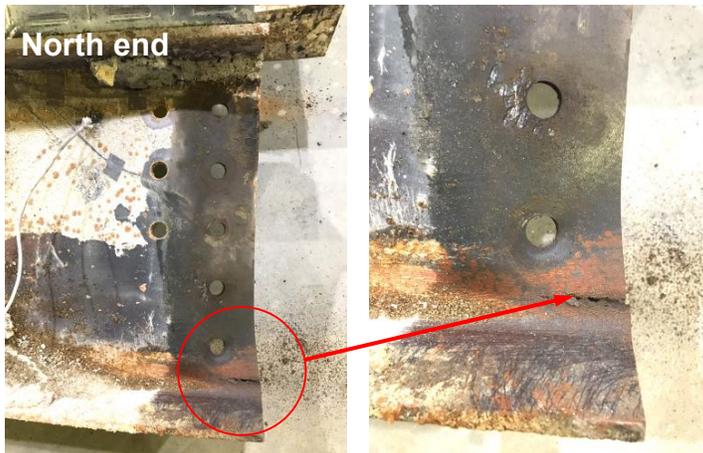
Fig. 76. Post-test photographs: West girder with rupture of the bottom web toe.

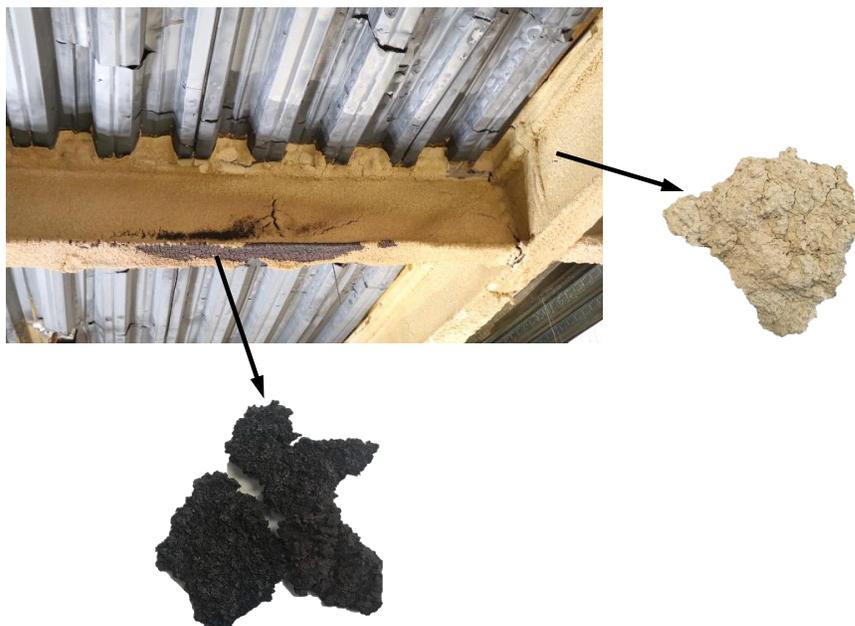
Fig. 77. Samples of fire exposed SFRM applied on the support steel beam framing.
