Fractographic failure analysis of a Procera[®] AllCeram crown using stereo and scanning electron microscopy

Objectives. Presentation of a methodological approach using stereo and scanning electron microscope examination for the failure analysis of an alumina all-ceramic premolar crown (Procera[®] AllCeram).

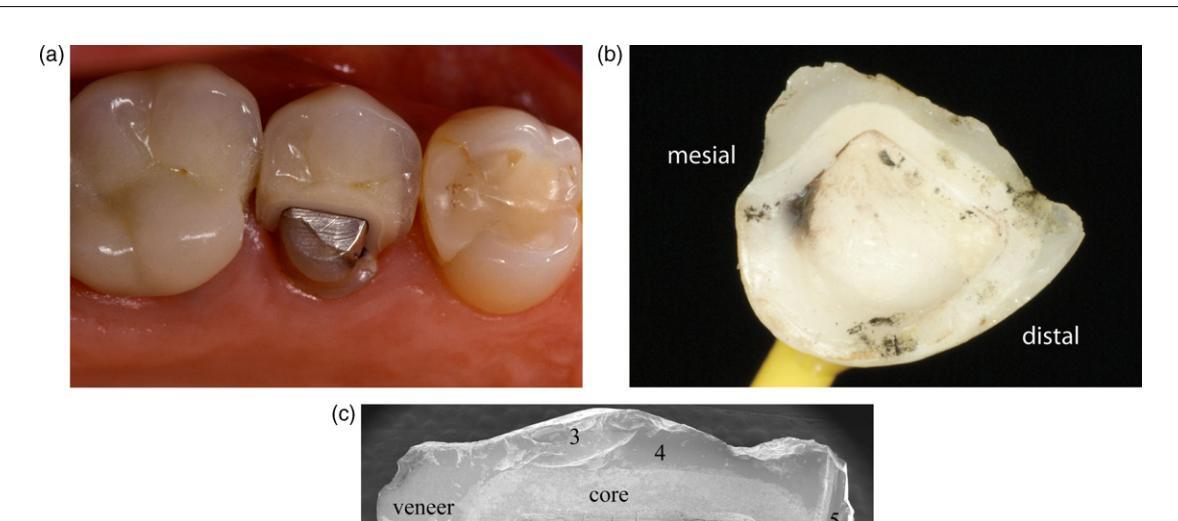
Fig. 1 – (a) Procera[®] AllCeram upper right second premolar crown fracture exposing part of tooth structure and amalgam restoration (photo: courtesy of Dr. U. Brodbeck, Zurich, Switzerland). (b) Recovered part by the patient of the broken Procera[®] AllCeram premolar crown. (c) Recovered fractured Procera[®] AllCeram crown part viewed at 16× under the SEM. Zones of interest for detailed fractographic analysis are numbered 1–5 starting at the mesial (left) margin to the other side of the crown.

A Procera[®] AllCeram (Nobel Biocare, Sweden) upper premolar crown fractured through its full-thickness after 4 years of intra-oral function (Fig. 1a). The patient remembered biting on something hard and recovered the broken half of the crown (Fig. 1b) which was used for documentation and analysis. The Procera[®] AllCeram uses a computer aided system for the core design and manufacturing which is made of 99.9 vol% of alumina and veneered with an alumina-based porcelain. The first examination of the broken Procera[®] AllCeram crown piece was performed using a stereomicroscope (Wild M3Z, Heerbrugg, Switzerland). The analysis started at one margin of the crown piece, moving upwards towards the occlusal section and finishing at the other end of the crown, photographing all recognizable features within the traveling path. Magnifications of the stereomicroscope ranged from 10–200 \times depending on the size of the characteristic marks detected while constantly changing the illumination angle for better viewing of crack features. A preliminary mapping of the observed features was then sketched out indicating areas of interest for further examination under the SEM. After securing the "as received" initial microscopic state of the fractured crown part with digital photographs, the broken crown piece was cleaned in an ultrasonic alcohol bath for 10 min. The specimen was then gold coated for the SEM and the same sequence of analysis was performed as for the stereomicroscope but using magnifications up to 4000× for higher definition of specific key crack features in the selected areas of interest marked from 1 to 5 in Fig. 1(c). Based on the microscope findings a final map was then created on an overall view of the failed component indicating the general crack propagation direction, the area where the crack originated and the sequence of crack events allowing for further discussion about the possible reasons for failure.

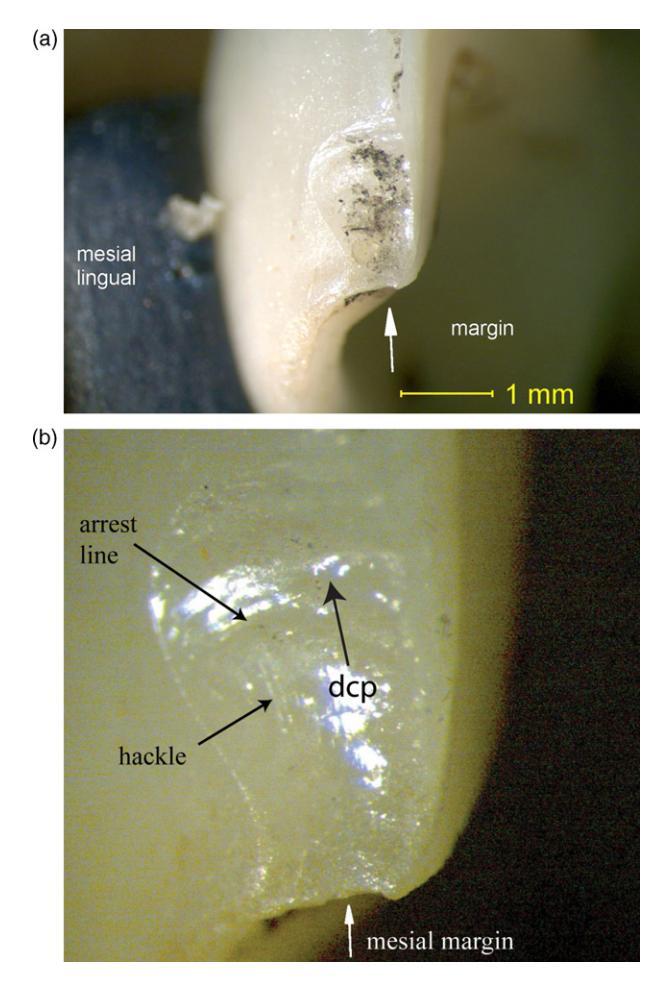
Fig. 2 – (a) Stereomicroscope image of a mesial marginal edge chip within the veneering ceramic in zone 1 before cleaning the specimen. Note the localized staining covering the chipped ceramic surface. (b) Stereomicroscope image of the same chipped zone 1 after cleaning the crown part 10 min in an ultrasonic ethanol bath removing the stain. The arrow labeled "dcp" shows the direction of crack propagation.

The initial stereo analysis starting at the mesial margin (zone of interest 1 in Fig. 1c) showed a porcelain veneer chip (1.5 mm \times 2 mm) before (Fig. 2a) and after cleaning with ethanol (Fig. 2b). The fact that the chipped surface had considerable staining before it was cleaned with ethanol indicated that the fracture of the chip must have occurred early in the clinical age of the crown. Adjusting the light at different angles, several arrest lines and hackle became clearly visible on the chip. Greater magnifications under the SEM confirmed the presence of these features including wake hackle (Fig. 3a-c) which are good indicators of the direction of crack propagation (dcp). Thus, this chip started at the mesial margin and propagated 2mm upwards within the veneering ceramic before fracture. The recovered part of the fractured Procera® crown was then examined on its rather flat fractured surface in the vicinity of the marginal mesial axial wall (zone 2). The stereo image of zone 2 (Fig. 4a) showed hackle and wake hackle easily seen on the veneering ceramic, as well as by using the SEM at greater magnifications (Fig. 4b and c). The direction of crack propagation (dcp) is again confirmed by the presence of wake hackle indicating that the crack moved from the mesial margin along the axial wall upwards towards the occlusal wall. On the occlusal side of the recovered crown part (zone 3) the veneering ceramic showed chip damage (Fig. 5a) as viewed under the stereomicroscope. Using the SEM, the concave orientation of the arrest lines (Fig. 5b) of the chipped veneering ceramic as well as the presence of many fine twist hackle (Fig. 5c) emanating from the arrest lines indicated that the chip damage started on the occlusal biting surface of the crown. The crack features of this occlusal chip however remained confined within the veneering ceramic thickness without penetrating into the alumina core. The inspection of zone 4 with the stereomicroscope nicely revealed arrays of hackle moving around the mesial axial corner (corner hackle) emanating from the alumina core towards the veneering ceramic (Fig. 6a). Higher magnifications with the stereomicroscope and fine tuning of the illumination angle revealed wake hackle within the veneering ceramic (Fig. 6b) indicating the crack front moved from mesial to distal and towards the occlusal surface. The last area of interest (zone 5) showed at low magnification the presence of a compression curl (Figs. 1b and 7a) in form of a curved lip of approximately 2 mm in vertical length. Greater magnification under the SEM within the compression curl (Fig. 7b) revealed the presence of twist and wake hackle confirming the crack path moved outwards exiting at the axial distal wall. The key findings obtained after stereo analysis are sketched out as shown in Fig. 8(a) and confirmed by a summary SEM image (Fig. 8b) on which arrows have been drawn indicating the general direction of crack propagation based on the presence of identified crack features.

the photographed surface, in the same direction as the white arrows labeled "margin" in Fig. 2(a) and (b). A force in this direction, applied on the veneer seated surface, is unlikely to arise from hard food, unless such a food particle has become wedged beneath the margin. Also, the force location and direction is unlikely to arise from a dental instrument once the crown is cemented in place. The force direction has been confirmed by fractographic markings such as hackle and wake hackle. The presence of staining and the growth of the gingiva into the space as seen in Fig. 1(a) indicate that this mesial margin veneer chip must have occurred early in the lifespan of the crown. This chip may have occurred during the cementation procedure when finger pressure was exercised vertically to seat the crown on the tooth shoulder preparation generating a predominant local contact stress on a slightly overhanging veneering ceramic causing it to chip off. The veneer ceramic is a rather weak material (bending strength \approx 100 MPa, Young's modulus \approx 70 GPa, K_{IC} \approx 1 MPa \sqrt{m}). Hence, any overhanging build-up of this ceramic over the high-strength, high-density alumina core margin will be at risk for early failure during cementation or initial chewing cycles and should be avoided during fabrication of the crown. Another possibility may be that the marginal chip occurred during fabrication in the dental laboratory without being noticed and the crown

cemented as received with a predamaged zone (i.e. the chip) in an area of stress concentration (i.e. the crown margin).

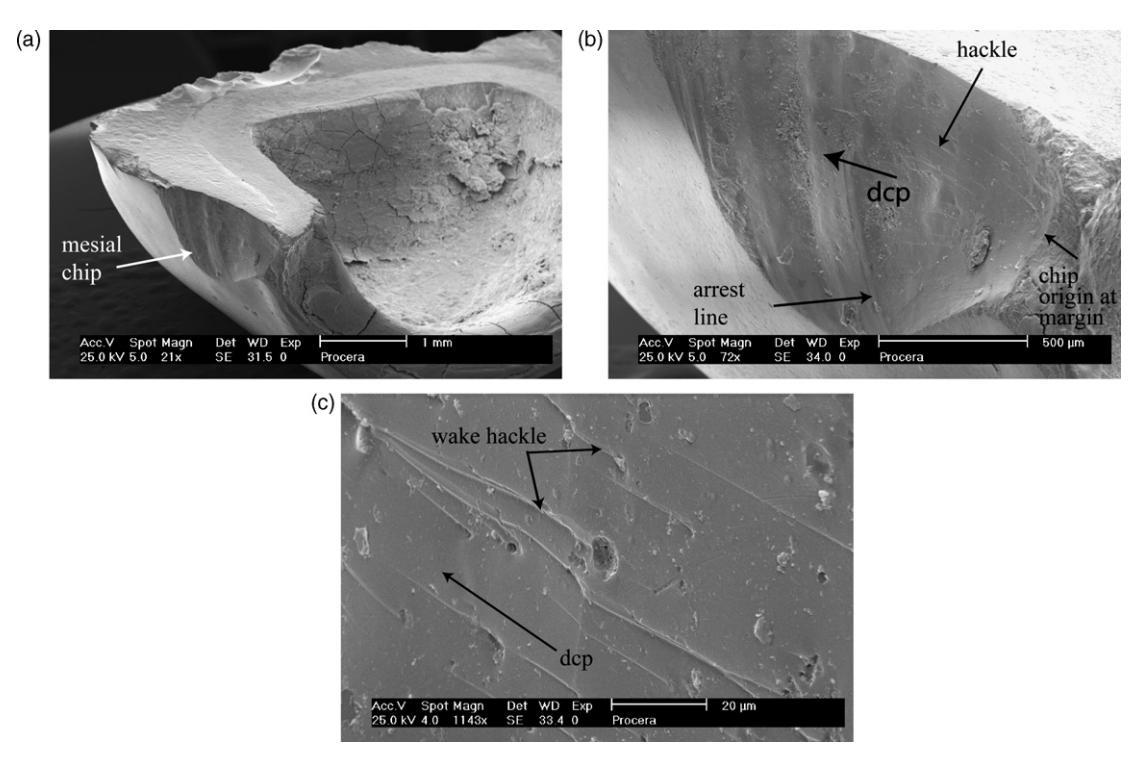
Fig. 3 – (a–c) SEM images of the chip in zone 1 at different magnifications. Arrest lines, hackle and wake hackle are recognizable and provide the direction of crack propagation (dcp) as marked by a black arrow from the margin upwards.

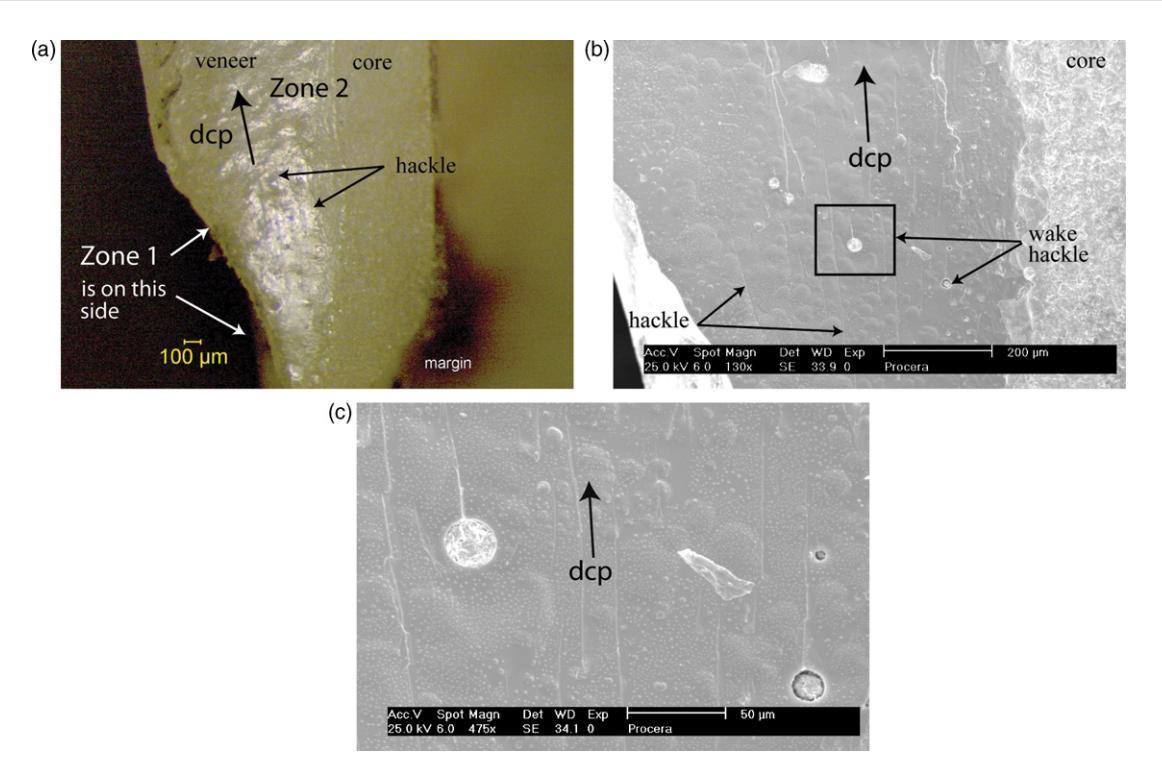
Fig. 4 – (a) Stereomicroscope image of zone 2 of interest. Parallel running hackle lines are concentrated in the veneering ceramic. These indicate the direction of crack propagation is from the bottom to top in this view. (b and c) Same area as in (a) viewed under the SEM at higher magnification. Hackle and wake hackle (emanating from pores and inclusions) are easily distinguished and used to indicating the crack was running upwards towards the occlusal side.

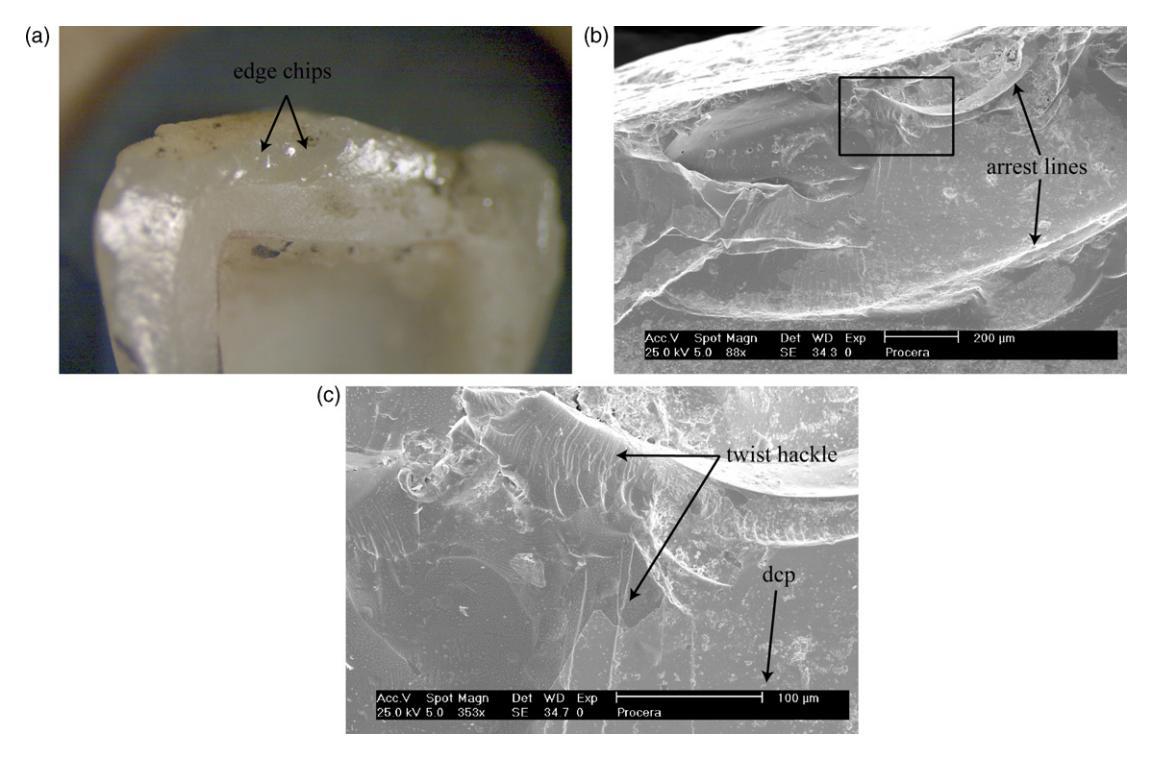
Fig. 5 – (a) Stereomicroscope image focusing on zone 3 showing occlusal surface chip damage. (b and c) SEM images at higher magnifications of zone 3. The veneering ceramic surface has occlusal edge chip damage delimited by arrest lines from which emanate fine twist hackle. The concavity of the arrest lines as well as the river pattern of the twist hackle indicate that the direction of crack propagation (dcp) within the edge chip is running from top to bottom (black arrow).

The other chip damaged area located at the occlusal side of the crown definitely occurred as a secondary event since the twist hackle emanating from several arrest lines remained confined within the ceramic veneer, not reaching the alumina core material. In addition to this observation, the general direction of crack propagation as evidenced by wake hackle seen within the zones of interest clearly moved from mesial to distal. The exact origin could not be located but must have been in the vicinity of the mesial edge chip which acted as a predamaged site on which hoop stresses (generated during mastication) concentrated and from which a critical crack started and propagated along the axial and occlusal walls until fracturing the whole crown into two parts, one remaining on the tooth (Fig. 1a), the other recovered by the patient (Fig. 1b) and used for the fractographic analysis.

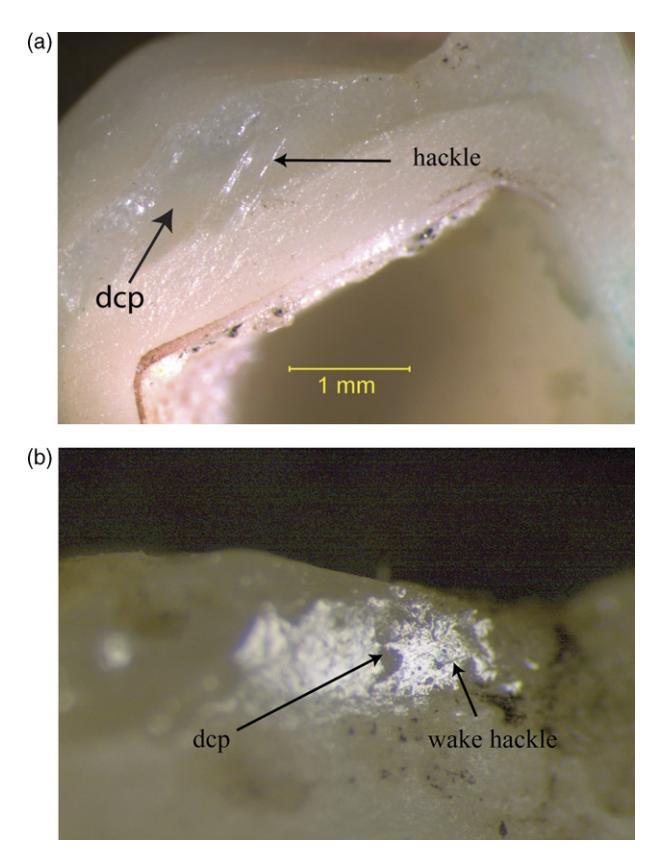
Fig. 6 – (a and b) Stereomicroscope images of zone 4 showing an array of corner hackle radiating from the core towards the veneer confirmed by wake hackle in the veneer. This radiating fan-like pattern is generated when a crack goes around a corner of a structure. The direction of crack propagation (dcp) is marked by a black arrow.

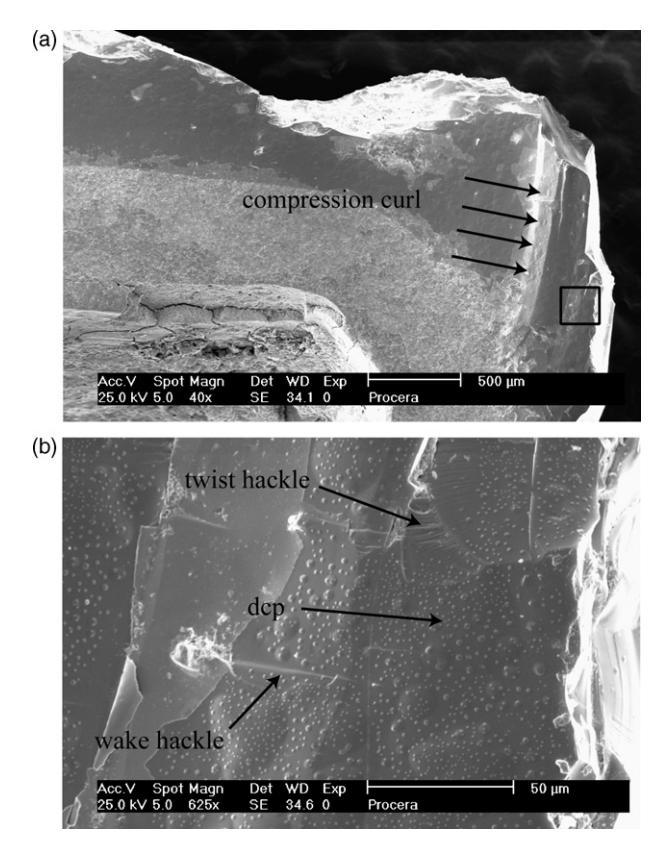
Fig. 7 – (a and b) SEM images of zone 5 (distal portion of the crown part) showing a 2 mm in length compression curl in which wake hackle and twist hackle confirm the final breakthrough of the fracture crack.

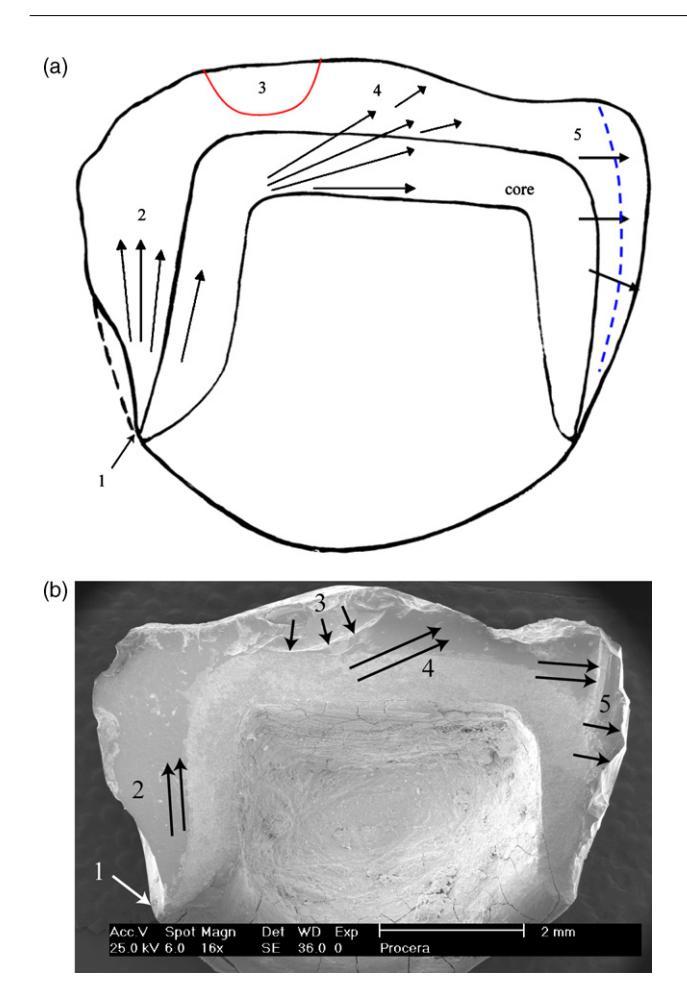
Fig. 8 – (a and b) Sketched illustration of the stereo findings as well as a summary image of SEM mapping the general direction of crack propagation of the recovered broken Procera[®] AllCeram crown part.
