Fractographic Analysis of All Ceramic Restorations

George D. Quinn,* Janet B. Quinn,** and S. Scherrer***

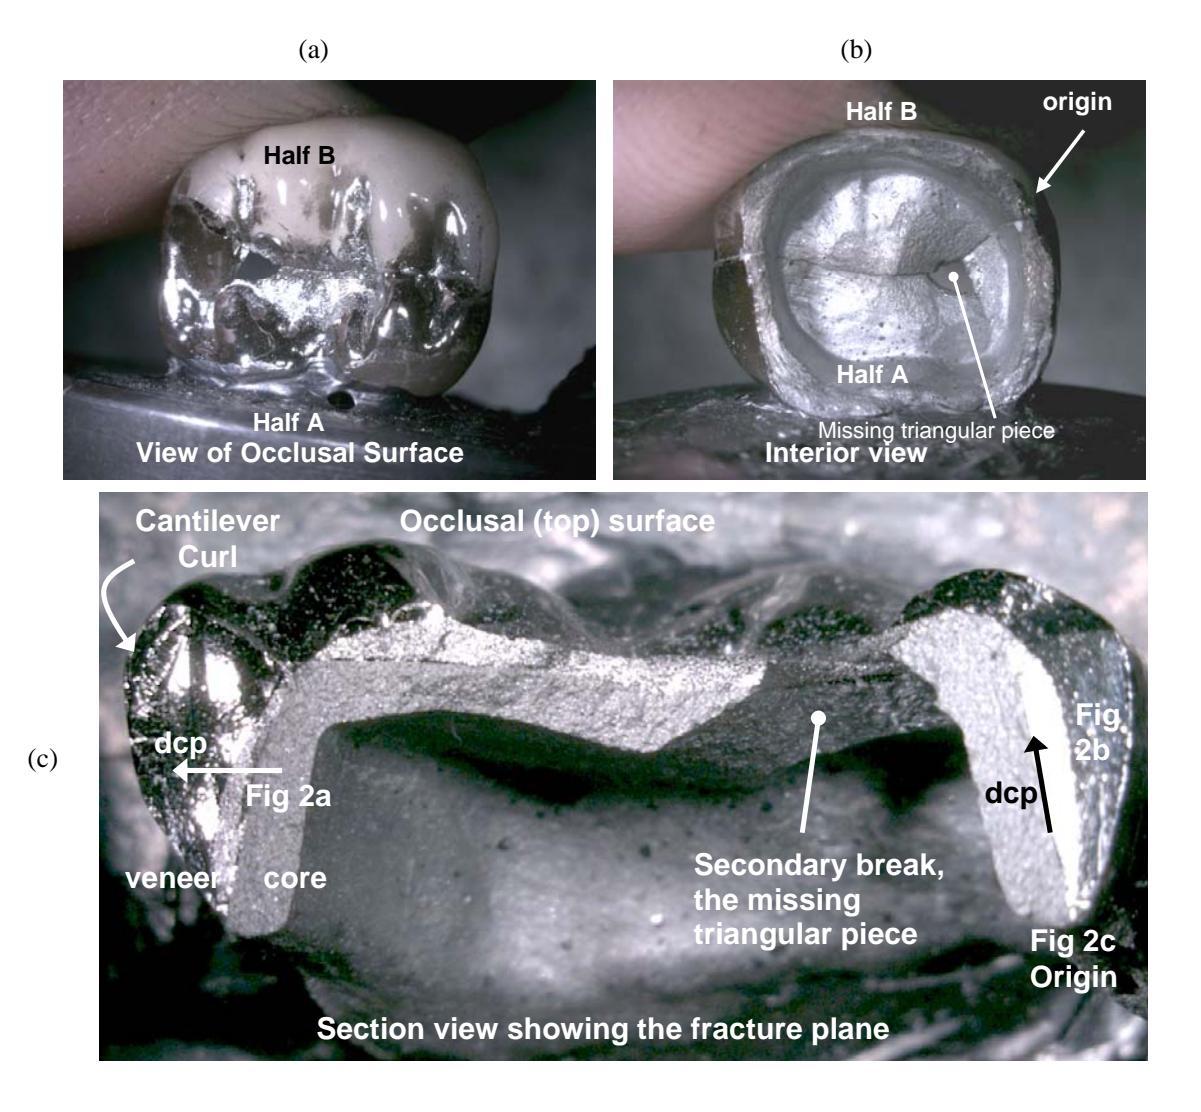
Figures 1 and 2 show a Cerestore^{a,b} alumina-magnesia spinel fractured molar crown that was documented by J. Quinn et al. in Ref. 5. This was an upper molar crown that failed after 17 years. It is likely a left mandibular first molar. The uncoated crown was initially examined with an optical microscope. A gold coating was then applied to the fracture surfaces to prepare the specimen for the scanning electron microscope, but also to enhance a second optical examination. The coating cuts down on internal reflections and light scatter making the fracture surface easier to discern. In the optical photographs the gold coating has made the veneer look dark and the core material lighter. The fractographic markings for this and the following cases are explained in the captions to the figures.

These markings allowed us to determine that the origin was located at the margin of the crown and the vertical split nature of the fracture suggests that hoop stresses around the bottom of the crown caused the breakage. A specific material flaw or source crack could not be identified at the origin. At the present time we are unable to discern or recognize such a flaw in this particular material, but with more experience we expect to be able to acquire this skill. By the time the crack propagated over to the opposite side, the two halves hinged apart in bending thereby creating the telltale cantilever curl.

Figure 1 Case A. Fractured Cerestore alumina-spinel molar crown with an origin on the margin. (a) is a top occlusal surface view showing the two cleaved halves held together. Such handling is permissible with brittle materials, provided that it is done carefully.² Half A is fully-gold coated and half B is partially-gold coated. (b) shows a view of the interior looking up into the crown. The missing triangular piece was caused by secondary breakage. The origin was on the margin, at the bottom of the crown. (c) shows an optical photo of the fracture surface of half B with arrows showing the direction of local crack propagation (dcp). The dark outer regions are the gold-coated glassy veneer. The lighter gray inner portions are the gold-coated core ceramic material. Close-ups of three identified regions are shown in the next Figure.

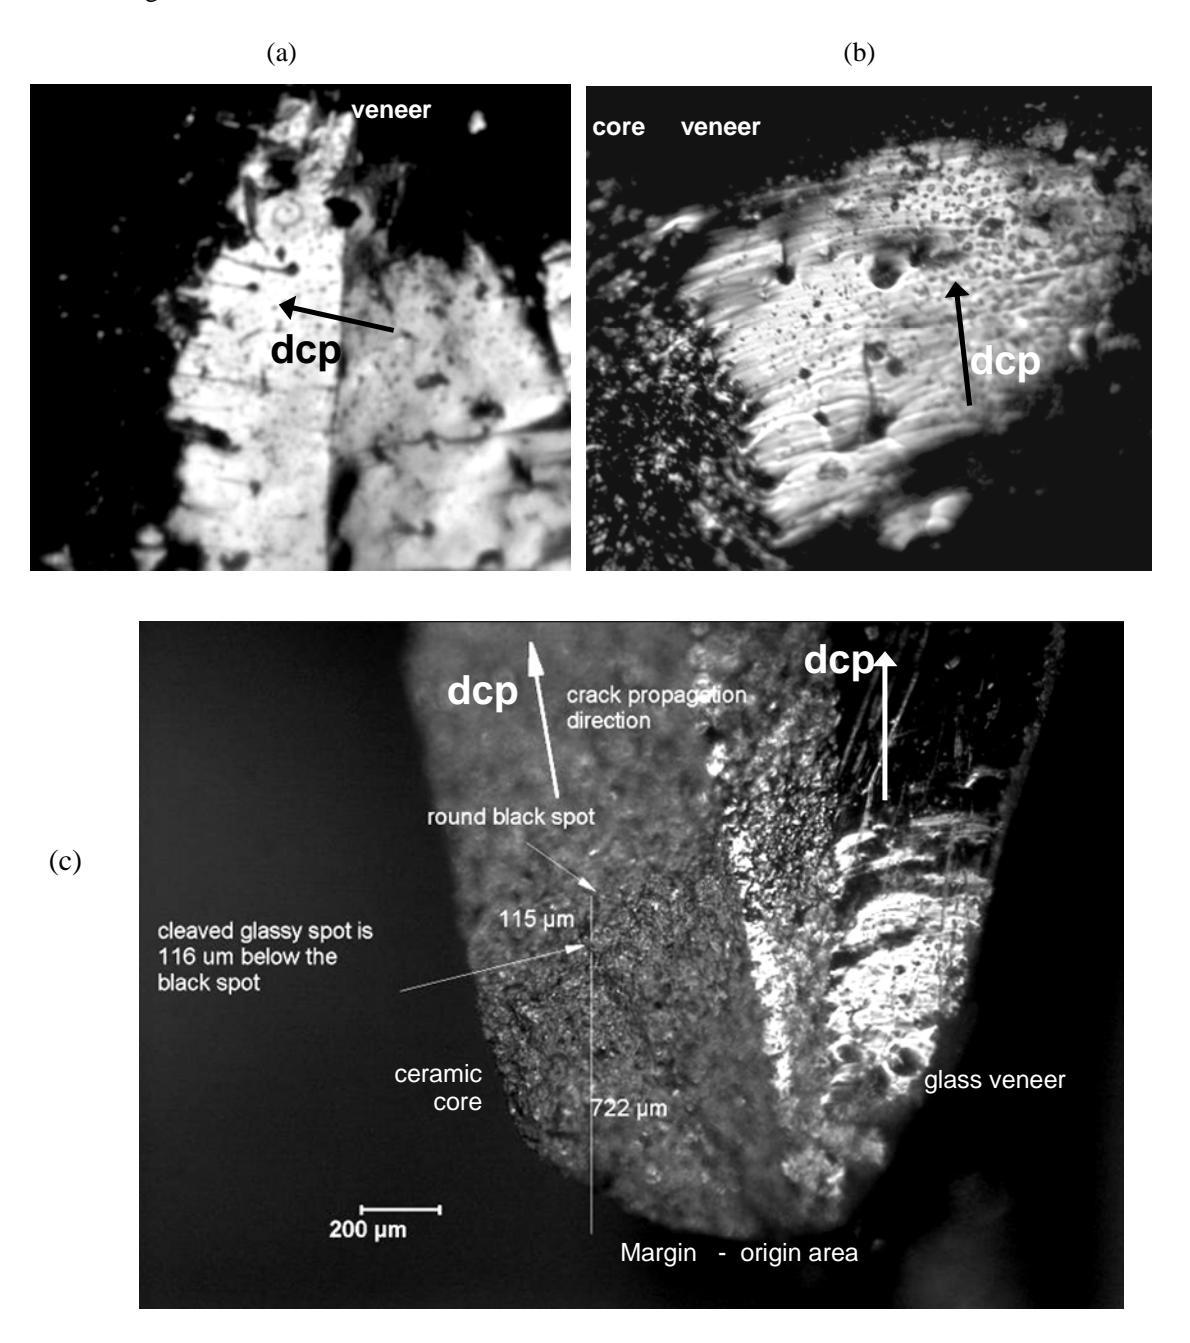
Figure 2 Case A continued. Fractured Cerestore alumina-spinel molar crown. (a) shows "wake hackle" from tiny bubbles in the veneer glass. Wake hackle is a step in the fracture surface created by a crack passing by an obstacle. The step points in the direction of local crack propagation. This location is on the left of view Figure 1c and indicates the direction of crack propagation (dcp) was as shown by the arrow. (b) shows wake hackle and faint "gull wings" from bubbles in the veneer on the right side of the crown. At this location the crack was running in the direction of the arrow from the margin (bottom) of the crown to the top. Careful scrutiny of the adjacent core ceramic material showed that it also had wake hackle generated by pores in the ceramic, and pointed in the same direction. (c) is an optical image at the margin with working notes of the origin area. A distinct flaw is not recognizable in either the veneer or the core.

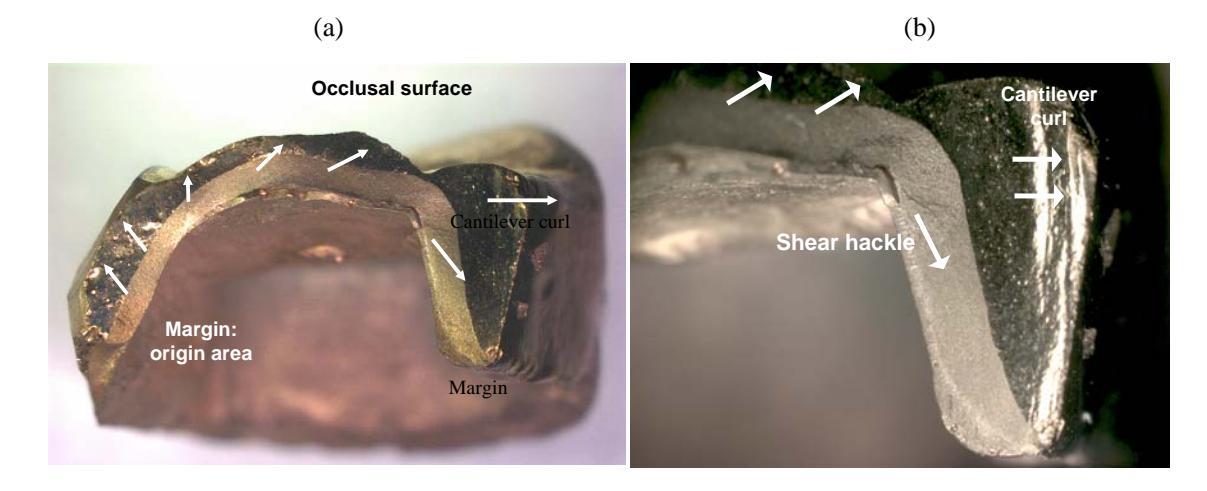
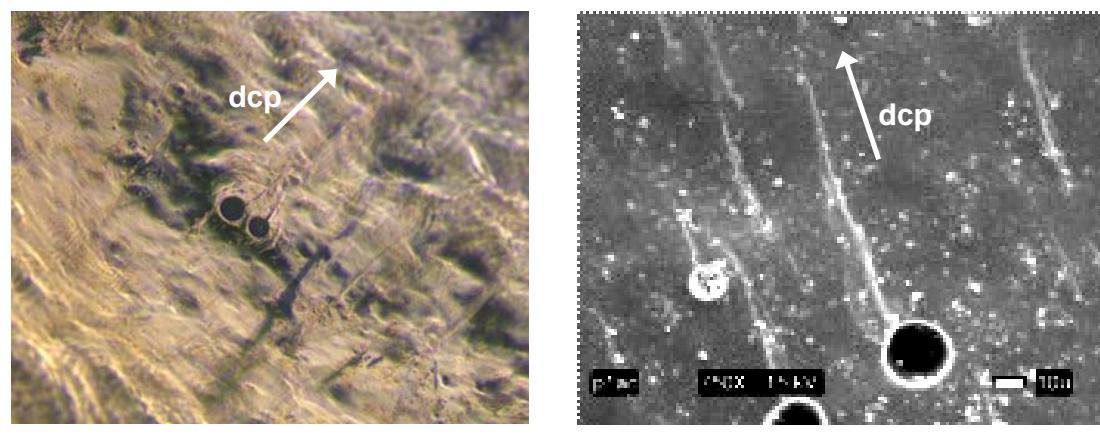
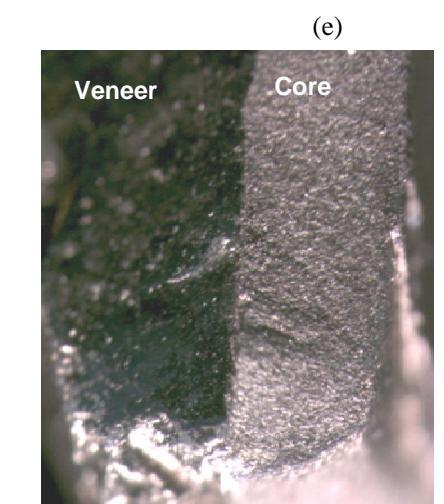
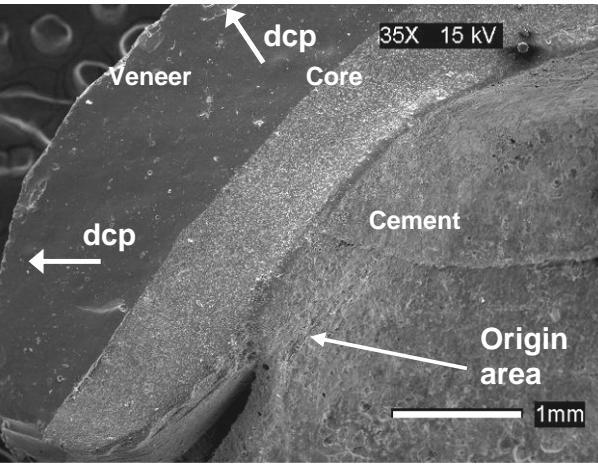
Figure 3 shows a similar case, also from Ref. 5, but for a Procera®AllCeram 99.9% purity alumina.^c This crown broke after one to two years of use. It also split vertically, probably in response to hoop stress. The fractographic markings again lead to a margin origin site. A specific single origin is also not evident in this case. Nevertheless we observed that the origin site is on the inside of the crown coincident with the end of the cement bond to the core material. This site undoubtedly is susceptible to stress concentrations.

Figure 3 Case B. Procera alumina molar crown. The crown split vertically into two halves. (a) and (b) show the fracture surface after gold coating. The veneer glass is dark and the core ceramic is a lighter shade. The arrows show the local direction of crack propagation as indicated by shear hackle around the inside corner, the cantilever curl, and from wake hackle markings in the veneer. (c) and (d) are examples of wake hackle from pores in the veneer. (e) and (f) show optical and SEM images of the margin, respectively. The origin is in the core ceramic at the stress concentration site at the end of the cement bond. (dcp = direction of crack propagation)

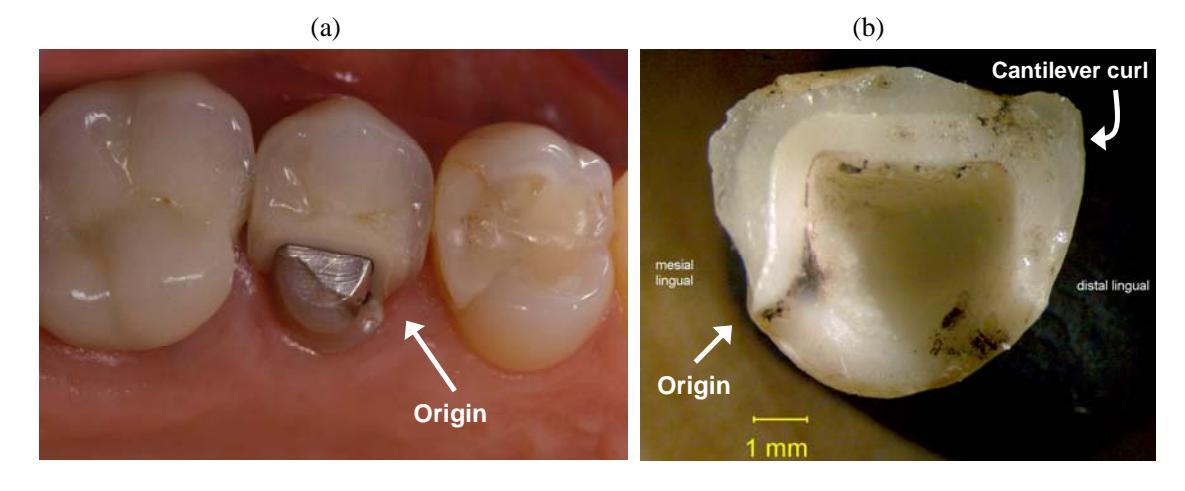
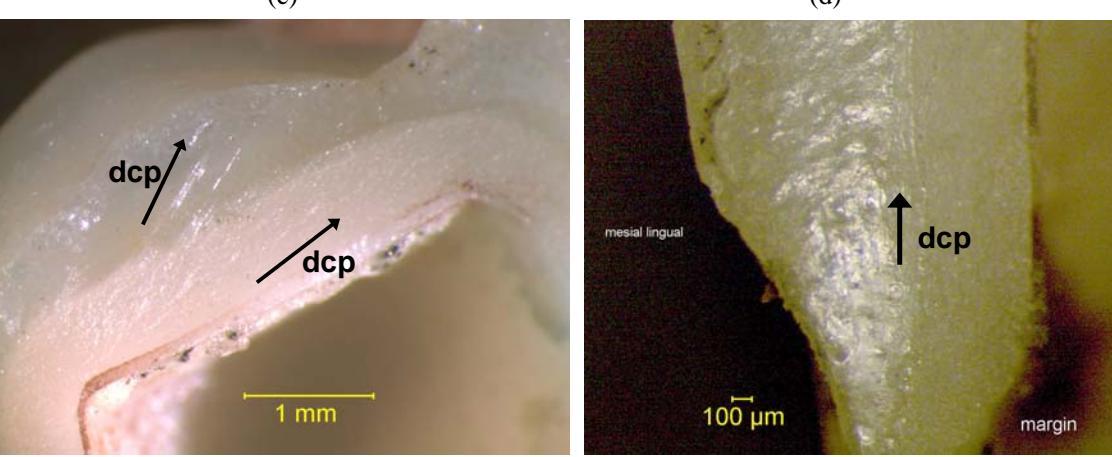
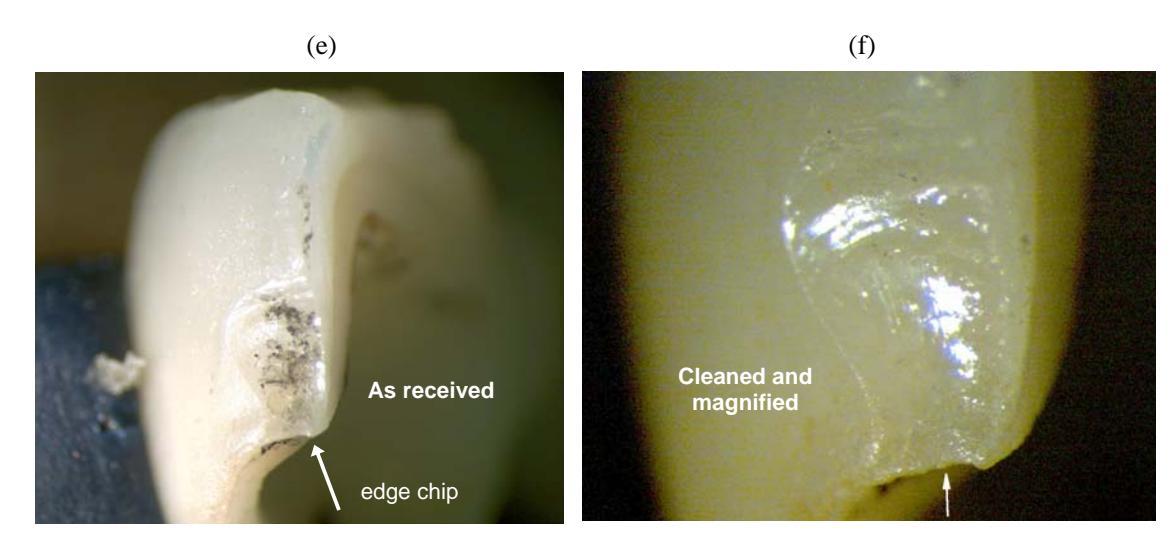
The third crown, also a Procera®AllCeram alumina, is shown in Figures 4 and 5. This is an upper premolar crown that fractured after four years of intra-oral function. The patient remembered biting on something hard. One half of the broken crown was available for examination. In hindsight, it may have been advantageous to have taken a replica of the matching half that was destroyed during extraction, but we were fortunate that the retrieved piece had all the relevant information for a analysis. Unlike the two previous cases, we were able to make a full analysis in this instance and find the exact origin flaw. This crown failure was analyzed in about one hour solely on the basis of an examination with a stereo optical microscope. Figures 4 a-f are optical images of the crown from that examination. As such, some of the details were "washed out" and do not reproduce well, but they are shown to demonstrate what an optical microscope examination can reveal. Keep in mind that the fractographer has a much better and clearer view when looking through the microscope. Subsequent scanning electron microscope examination produced sharper images shown in Figure 5.

Fracture in this crown occurred in multiple steps. One event created an initial chip flaw on the margin. Subsequent exposure and use caused a second crack from this chip, but on a different plane which ran up and split the crown. Hoop stresses generated by normal oral function caused the crack propagation.

Shear hackle around the inside corners of the core, a cantilever curl, and wake hackle again led back to the margin-initiated fracture origin. The origin was a well-defined edge chip on the

Figure 4 Case C. Procera alumina molar crown that broke from a margin chip. These are optical images without any coatings. (a) is a clinical view with the origin marked. (b) is one half of the fractured crown. (c) shows a fanlike array of shear hackle (between the two arrows which show the propagation direction) in both the veneer and core emanating from the top inside corner. (d) is from near the margin on the left side and shows tiny wake hackle from veneer pores. The crack ran from bottom to top. (e) and (f) show the origin was an edge chip from a force applied on the bottom of the margin aimed upwards. (dcp = direction of crack propagation)

veneer. The edge chip was discolored suggesting that it had been present for quite some time. Gum tissue had grown into the space vacated by the chip, further indicating that the chip fragment had been gone for some time. The direction of the edge chip was interesting since it appeared to have been from a force directed upwards on the margin on the underside of the crown. The chip was probably created during fabrication or installation. The chip fragment separated from the crown and could have been docile if the patient was lucky. Unfortunately for the patient, localized cracking damage near the initiation site of the chip grew into a second large crack on a different plane that eventually propagated up into the crown body and finally split it. Ionomer cement and discoloration were observed on the fracture surface in a region near the occlusal surface suggesting that this portion had been fractured for some time prior to the ultimate separation of the piece. Some small fractures in the form of edge chips reached down from the occlusal surface, but these were all incidental, secondary, and occurred after the crown split. The edge chips showed no indication of having affected the path of the primary crack. (Such secondary cracking often can be dismissed by simply observing whether they match features on the opposing fractured half. If they do not match, then it is safe to assume the cracking was secondary.) So the patient's "final bite on something hard" did not cause the most of the damage. It simply led to the final separation step.

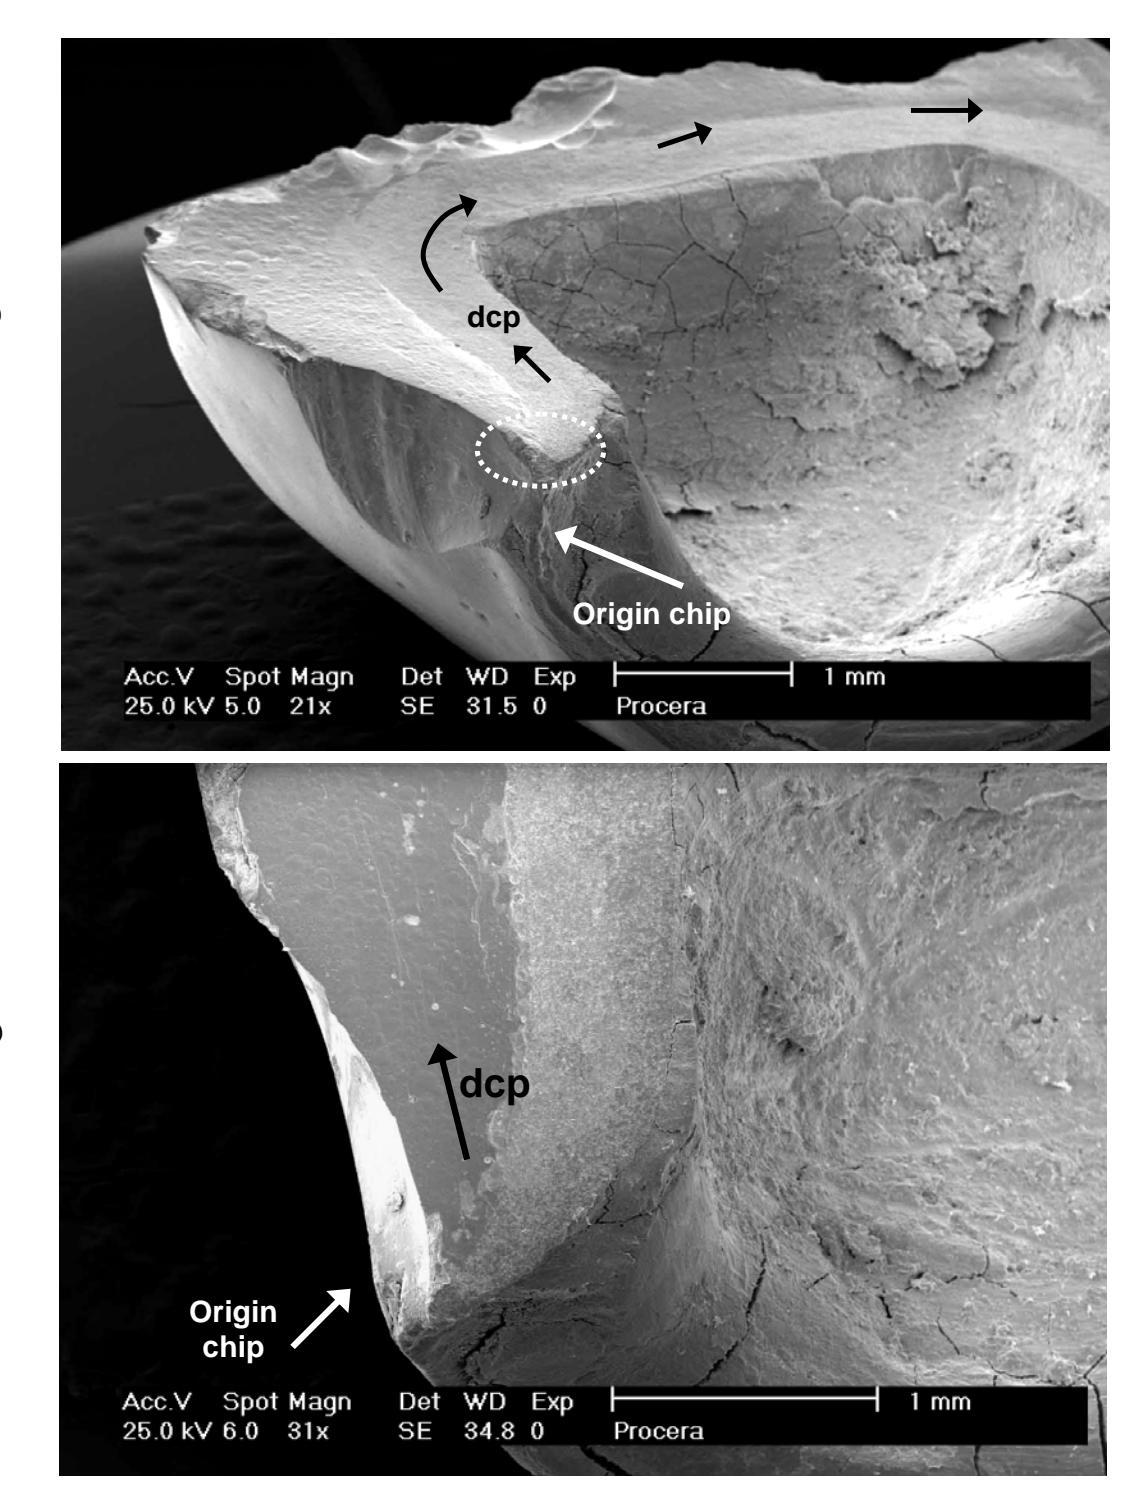
Figure 5 Case C continued. SEM views of the fractured crown. There are two fractures. The first was the margin chip (white arrows). The second fracture that split the crown started at the bottom at the margin in the circled area in (a) from part of the prior margin chip. The second crack ran as shown by the black arrows.

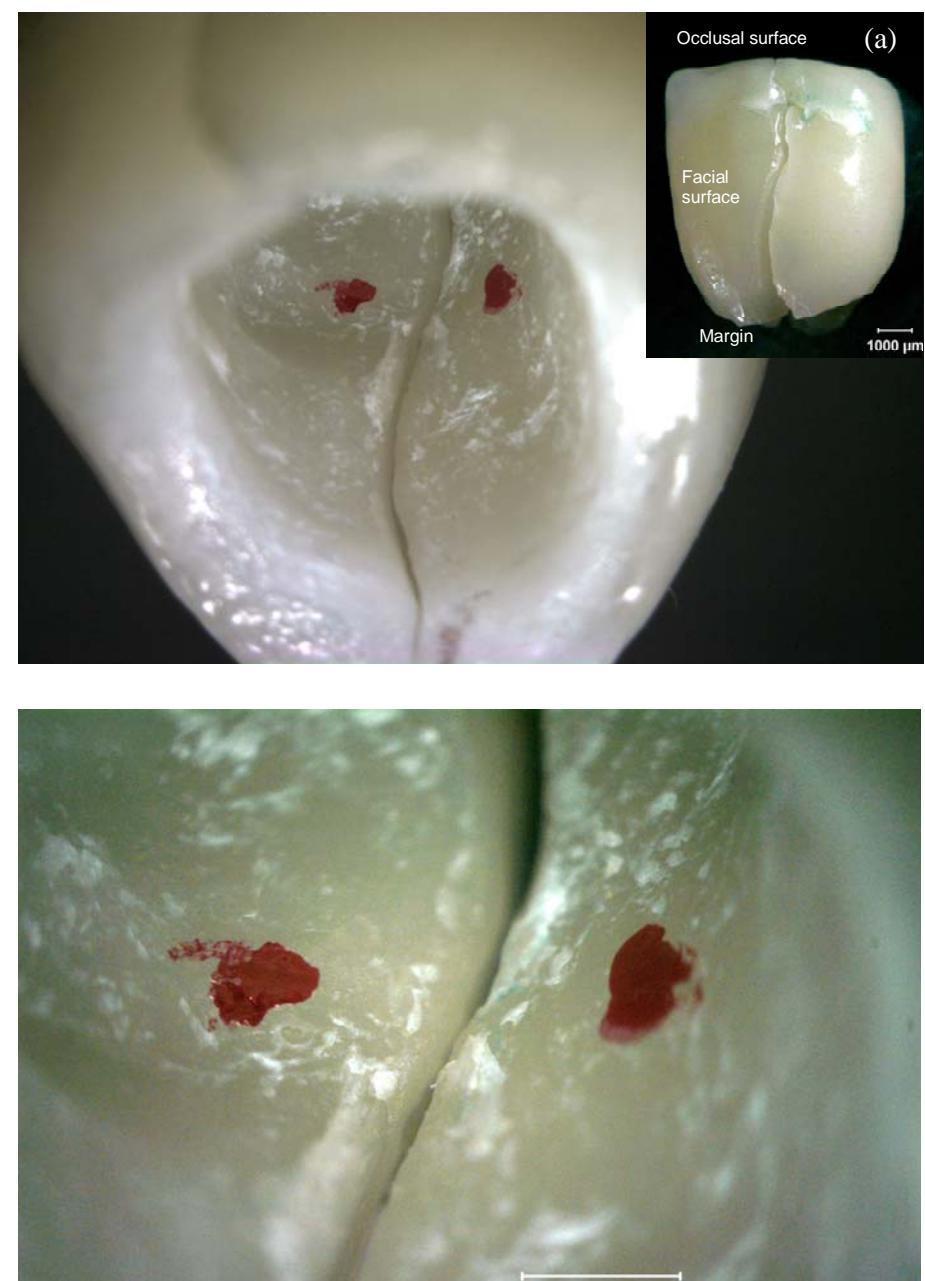
The fourth case shown in Figures 6 - 10 is an Empress 2 lithium silicate glass ceramic crown.^d This crown was presented in Reference 5, but new analysis has refined our interpretation. This anterior (#7) incisor crown had been in service only 4 months when it split into two pieces. The fracture plane was again vertical and perpendicular to the dental arch. No information was furnished on how the fracture event occurred or how the crown was fabricated or installed. Tool grinding marks on the lingual surface veneer suggested that there were some fitting problems. The two halves fitted closely together. A few small chips were missing, probably from secondary fracture, and were inconsequential to the analysis.

Figure 6 Case D. Fractured Empress II glass ceramic incisor cemented crown. The insert (a) shows a facial view of the cleaved crown. (b) and (c) show views looking up into the interior with the two halves together. The origin is located between the two marked dots on the inside surface. Residual cement has been cleared away.

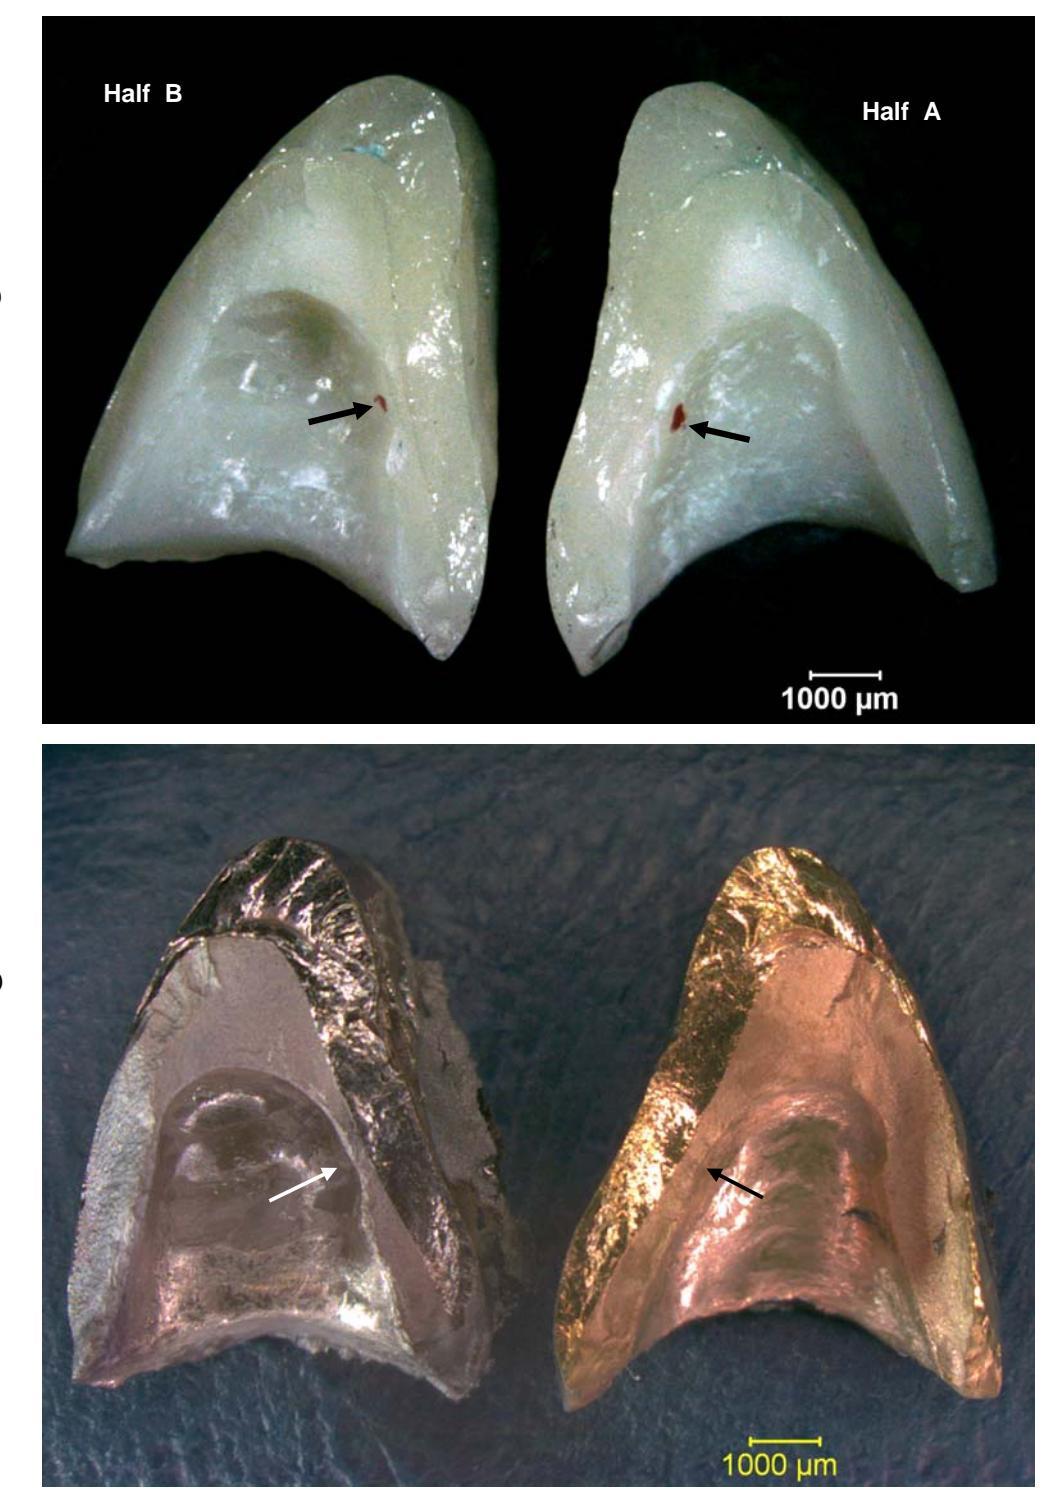
The lingual surface had some usage surface damage and also an unusually thick veneer. There were several shallow depressions ($\approx 1 \text{ mm}^2$ square area) as well as numerous conchoidal chip

fractures, small pits and gouges at mid crown height. The shallow depressions had tool marks indicating they were from adjustments to the lingual surface, presumably by the dentist once the crown had been cemented in place and opposing tooth contact checked. This adjustment was only partially successful in relieving contact from the opposing tooth as evidenced by the numerous small pits, chips, and gouges. This location was near the fracture origin region.

Figure 7 Case D continued. (a) and (b) show the fracture surfaces of the two halves. (a) shows an optical photo of the uncoated halves B and A, and (b) shows gold-coated surfaces. The glass veneer coating reflects more. It is evident the veneer thickness is very uneven and out of normal guidelines. It is very thick on the lingual side and very thin on the facial side. The arrows mark the origin site located on the *inside* of the crown at the thinnest part of the core ceramic material.

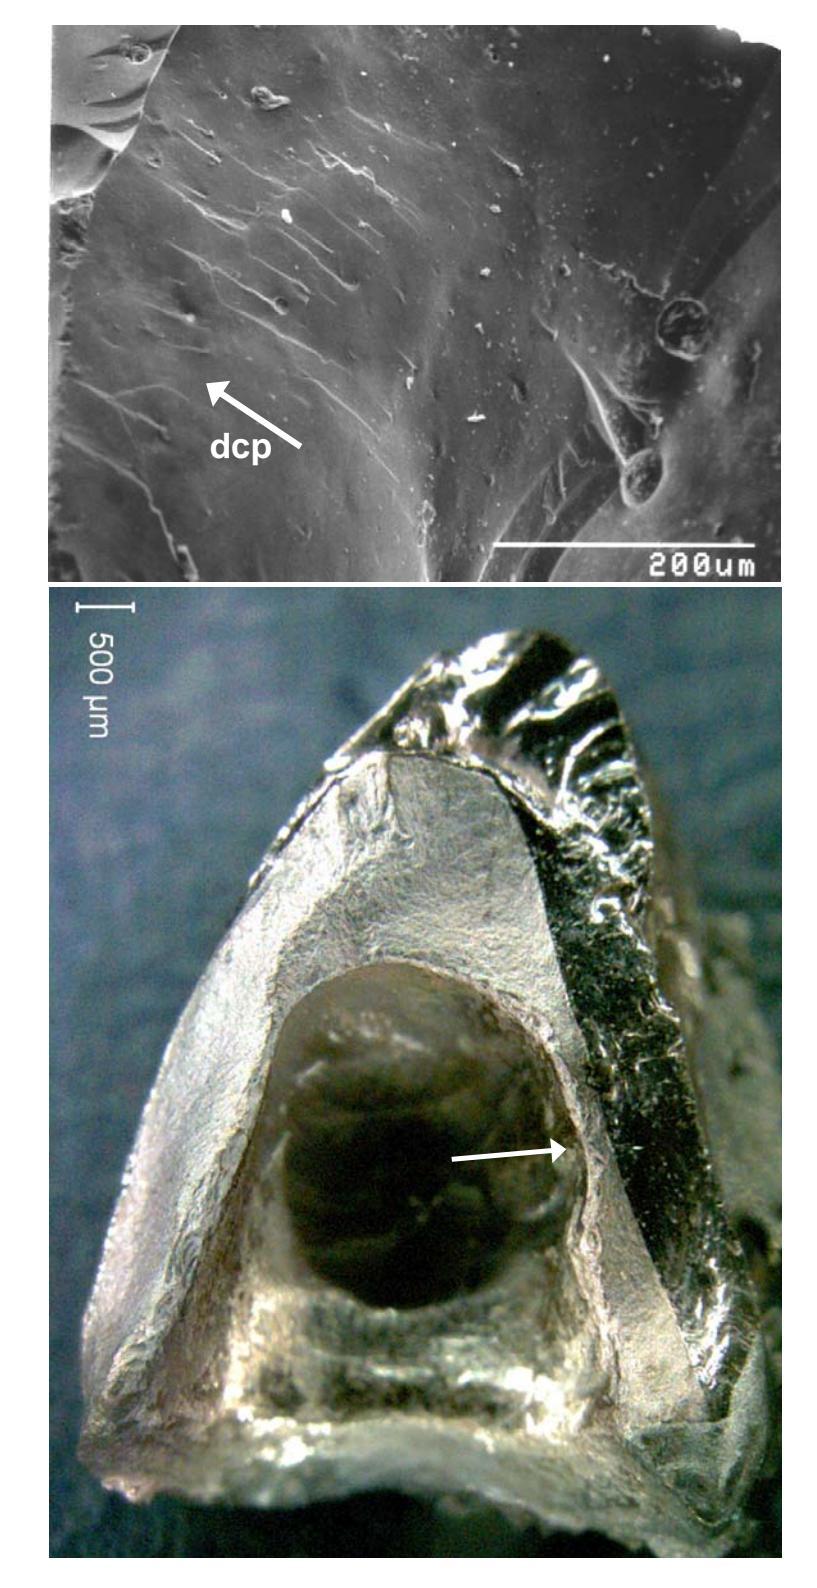
Figure 8 Case D continued. (a) shows an SEM image wake hackle in the glassy veneer from a region near the occlusal surface of the A half. The wake hackle shows that the crack was running in the direction of the arrow in this region. All the wake hackle in the entire crown showed fracture was from the inside to the outside. (b) shows the origin site is a cone crack on the inside surface (arrow). The following photos show this site in more detail.

The application of green tinting dye for an optical examination and a subsequent SEM examination brought out a number of telltale brittle material fracture features. Fractographic markings in the glass ceramic core material were difficult to detect, but subtle hackle markings were similar to features observed on bend strength test specimens of the same material. Extensive wake hackle was detected from bubbles in portions of the glassy veneer as shown in Figure 8a. Seven or eight crack arrest lines were also detected.

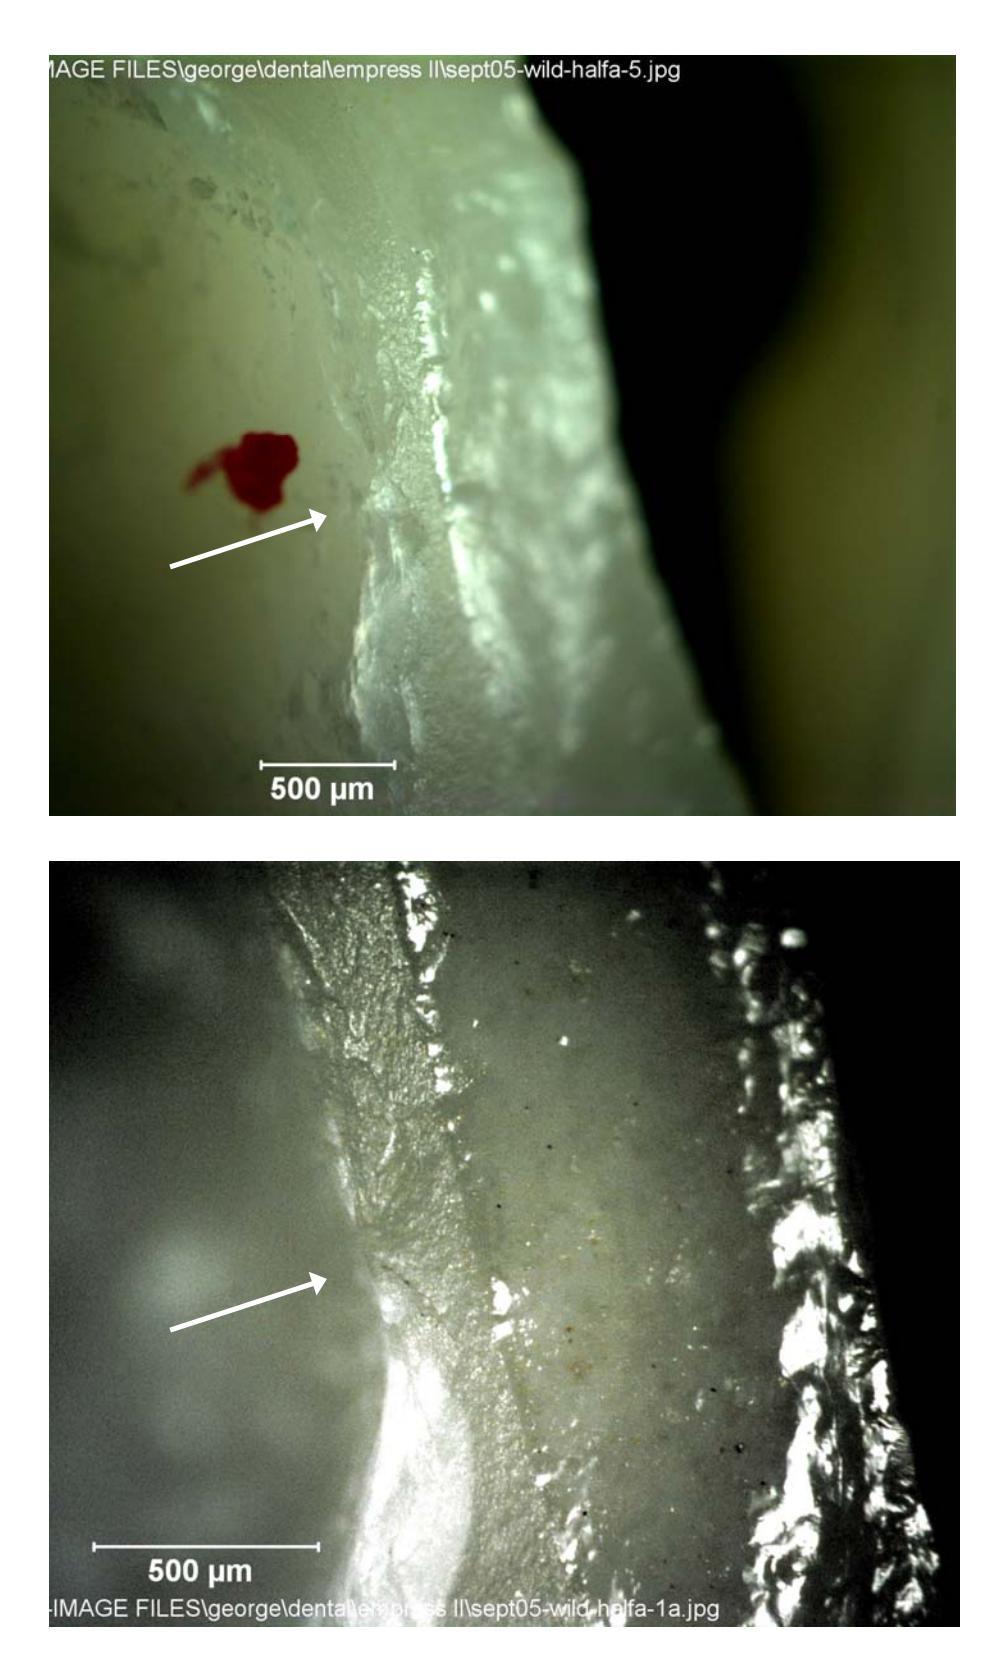
Figure 9 Case D continued. (a) and (b) are optical images of the origin which originated from a contact on the inside of the crown at the thinnest point of the core.

This internal contact damage origin initially had been dismissed as secondary chipping damage, created during extraction or handling. Only after repeated examination was it realized that <u>both halves</u> showed matching damage features characteristic of blunt contact damage at the exact same location on the cementatious surface of the crown. This surface was uneven and had raised hills, ridges and depressions.

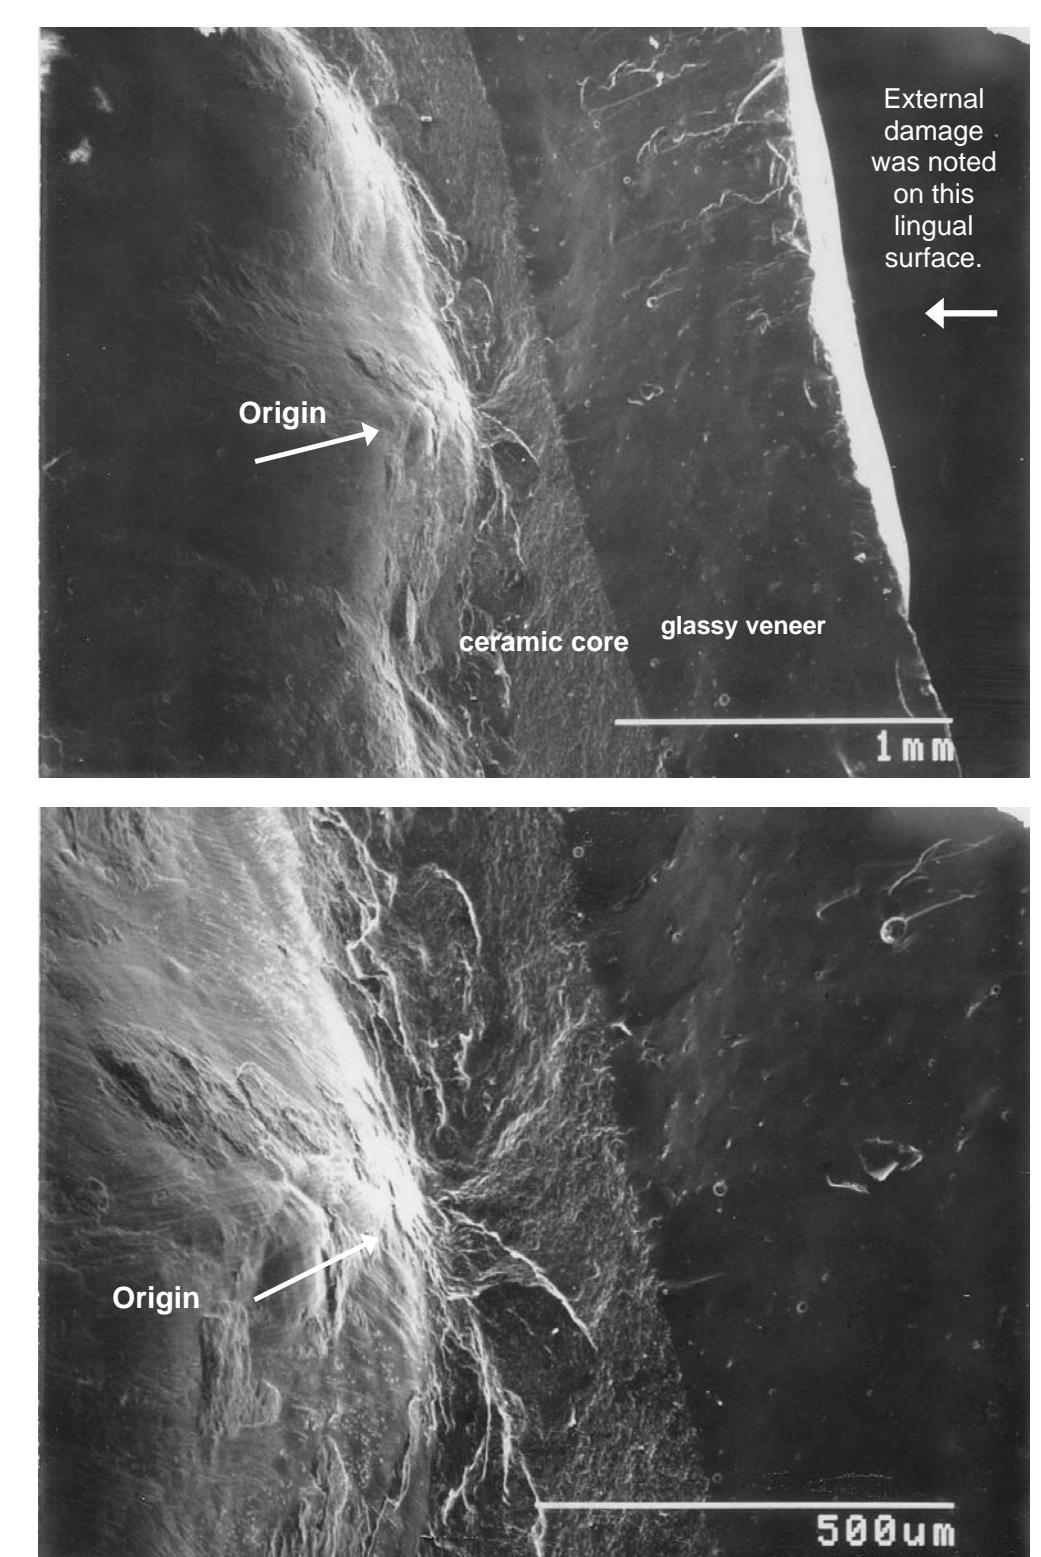
Figure 10 Case D continued. (a) and (b) are SEM images of the origin (arrows). Notice all the wake hackle in the veneer aiming away from the interior. The crack ran from the inside to the outside. The inside surface is uneven and there are mold or tool marks in the vicinity. This region is directly opposite a region of extensive localized contact damage on the <u>exterior</u> lingual veneer surface on the right (not visible in this view).

The crown was carefully examined for evidence of residual stresses at the interface of the core and veneer. Such evidence might be crack redirection where the crack approached or encountered the interface. Over most of the crown, there was no such evidence as shown in Figure 10. One incidental region was noted where the crack did change direction at the boundary.

In summary, the Empress II crown had uneven veneer and core wall thicknesses. Fracture initiated from contact damage on the *inside* of the crown, possibly due to a fabrication handling error, or possibly due to an uneven fit. Opposing tooth contact in the same vicinity on the crown exterior surface (as evidenced by shallow pit and chip damage) may have created the initial stresses in the origin area. Surface grinding adjustments and veneer damage in the same area suggested a fitting problem. The final splitting crack was driven by normal usage stresses.

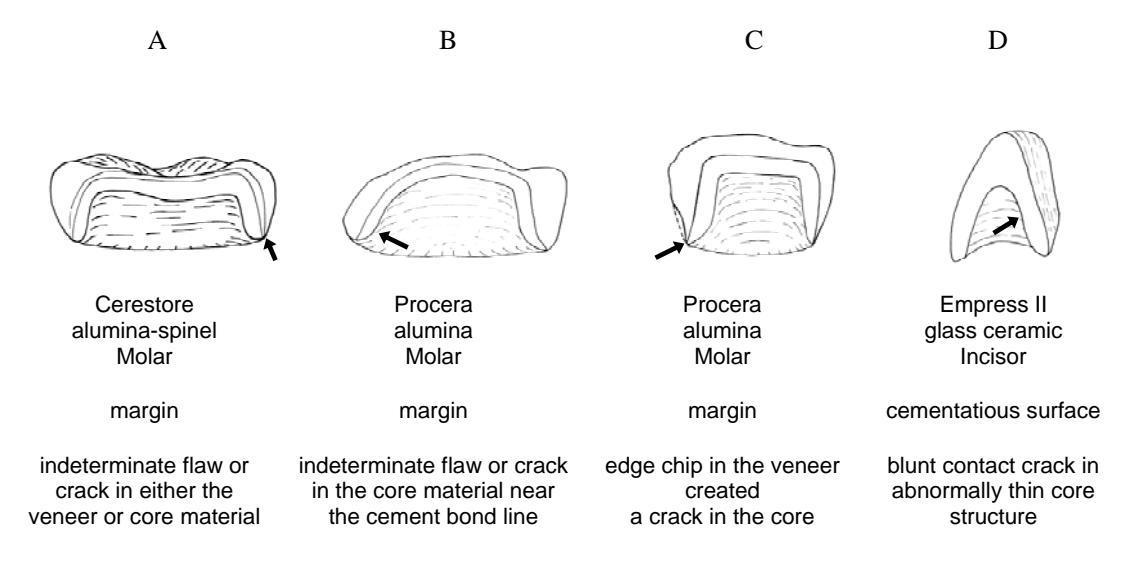
These four crowns cases are part of a growing body of fractographic analyses of crown failures. All four split vertically, perpendicular to the dental arch, from hoop stresses. Several crowns showed evidence of multiple events leading to failure. One event created a crack or flaw. Subsequent exposure and stresses led to crack propagation and fracture often on a different plane. Figure 11 shows the summary findings. Specific gross material flaw origins were not be detected in any

Figure 11 Summary findings for the four cases.
