Experimental Study on Fire Resistance of a Full-Scale Composite Floor Assembly in a Two-Story Steel Framed Building

National Institute of Standards and Technology, Gaithersburg, Maryland, USA

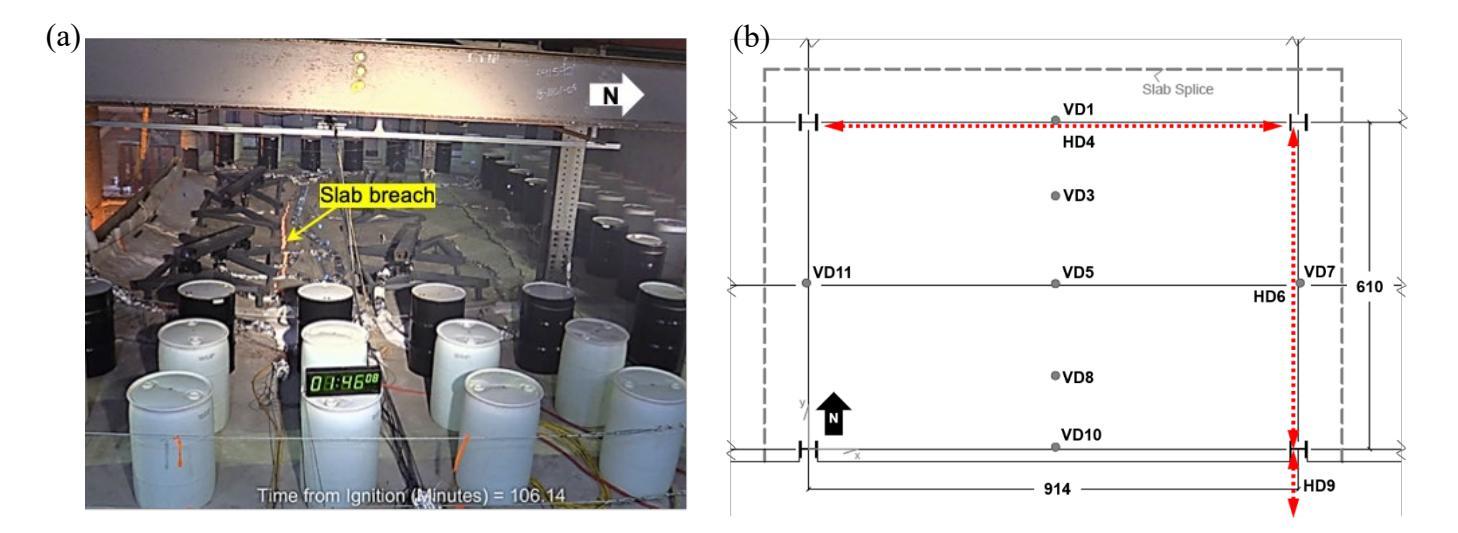
The mechanically loaded test floor assembly continuously sagged during heating, while sequentially developing concrete fractures at various locations. No explosive spalling of the concrete was visible during or after the experiment, however, small 'popping' sounds continued during heating. This might indicate that (micro) spalling was occurring between the bottom of the slab and the steel deck. Concrete surface cracks first appeared along the east and west girders as well as the north edge beam of the test bay about 20 min to 30 min after ignition. Around 40 min into heating, the southeast corner of the heated floor slab fractured with a loud noise. After 70 min, tensile fracture of the concrete was visible near the longitudinal (east-west) centerline of the test floor. Reaching 100 min in fire, small flames were intermittently visible above the top of the heated slab towards the east and west ends of this longitudinal crack, indicating failures of some screw joints of steel deck units in those locations. From this point forward, the mechanical loads on the south side of the test slab appeared to be supported by the steel deck and the south edge beam with concrete hanging cantilever, Figure 9(a). The fire and mechanical loading were removed at 107 min due to safety concerns.

The middle breach of the test floor slab appeared to be occurred due to catenary action in the north-south direction where the steel decking was continuous into the north adjacent bay. It is believed that tensile membrane action was not achieved or developed in a limited fashion because of the early formation of concrete fractures and ruptures of welded wire reinforcement along the east and west edges. These through-depth cracks located 100 mm or less inside of the test-bay column grid, which formed shortly after fire ignition and continued to widen during

Figure 9 – (a) Breach of the test floor slab; (b) Locations of displacement measurements with dimensions in cm

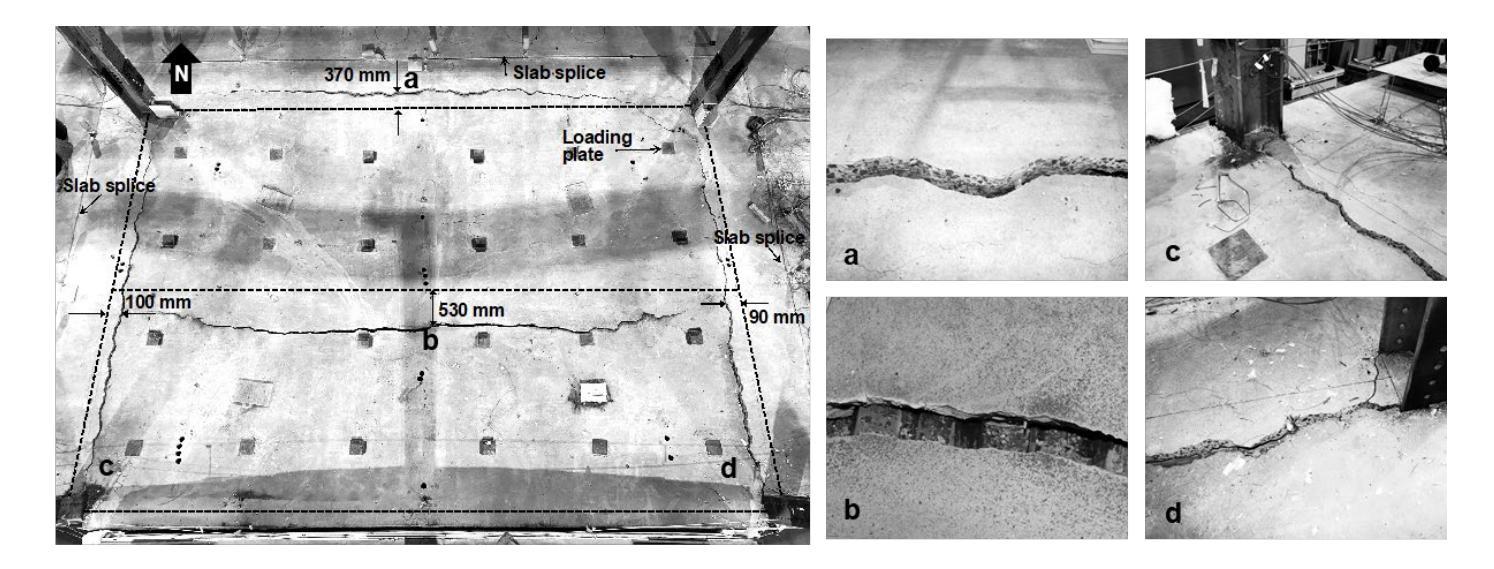
Figure 12 shows the final fracture pattern of the test floor slab after cooling. As mentioned earlier, concrete cracks developed along the north, east, and west edges of the test bay, followed by the longitudinal cracks 530 mm or less south of the secondary beam. Most of welded wire reinforcement (60 mm²/m) across the thicker lines of fractures visible in Figure 12 completely ruptured. Neither concrete failures along the south (free) edge (i.e., separation from the south edge beam) nor slab splice failures were witnessed. Based on crack openings of the concrete, the east and west edge cracks were initiated near the flanges of the southeast and southwest columns, whereas the north edge crack was propagated from the midspan or its vicinity. No through-depth fractures were observed around the northeast and northwest columns.

heating. Hence, the headed stud anchors welded atop the east and west girders were ineffective to induce tension in the concrete in the east-west direction as the heated floor slab continued to deflect downward. In contrast, the north edge crack formed 370 mm or less north of the north primary beam (i.e., outside of the test-bay column grid) and thereby the headed stud anchors on all three 9.1 m long beams appeared to provide anchorage of the concrete and steel decking against tension developing in the north-south direction. As the vertical displacement of the test floor increased in fire, the excessive tension would develop more effectively in the north-south direction than in the east-west direction until welded wire reinforcement finally ruptured at critical locations. This welded wire reinforcement rupture would happen in the concrete where the vertical displacements were greater, i.e., south of the secondary beam (VD8) as shown in Figure 10(b).

This study revealed some potential issues related to the integrity of a composite floor assembly as part of compartmentation under fire loading. As shown in Figure 15, the center breach in the test floor slab, initiated prior to the specified rating period of 120 min, was accompanied by ruptures of the wire reinforcement in tension at the mid-panel displacement of 350 mm (L/26) or greater. A minimum code-specified amount of the shrinkage reinforcement (60 mm²/m) used

in the test assembly was insufficient to resist thermally induced tension during the investigated fire. Although the exposed steel deck appeared to attain superior ductility at large vertical displacements, failure of side deck joints (screws failure at the decking overlap) and local deck ruptures occurred. Those local failures in the heated decking units allowed the flames and hot gases passing through concrete cracks and above the test compartment. This condition could have potentially ignited cotton waste placed on the unexposed surface, failing to meet the standard fire testing criterion (i) as mentioned above.

Figure 12 – Top of the test floor slab after cooling. Dashed lines define the test-bay column grid. The four photographs on the right (a through d) show close-ups of concrete fractures

Further study is recommended to evaluate the potential fire hazard associated with relatively 'thin' slab details permitted in the current construction practice.

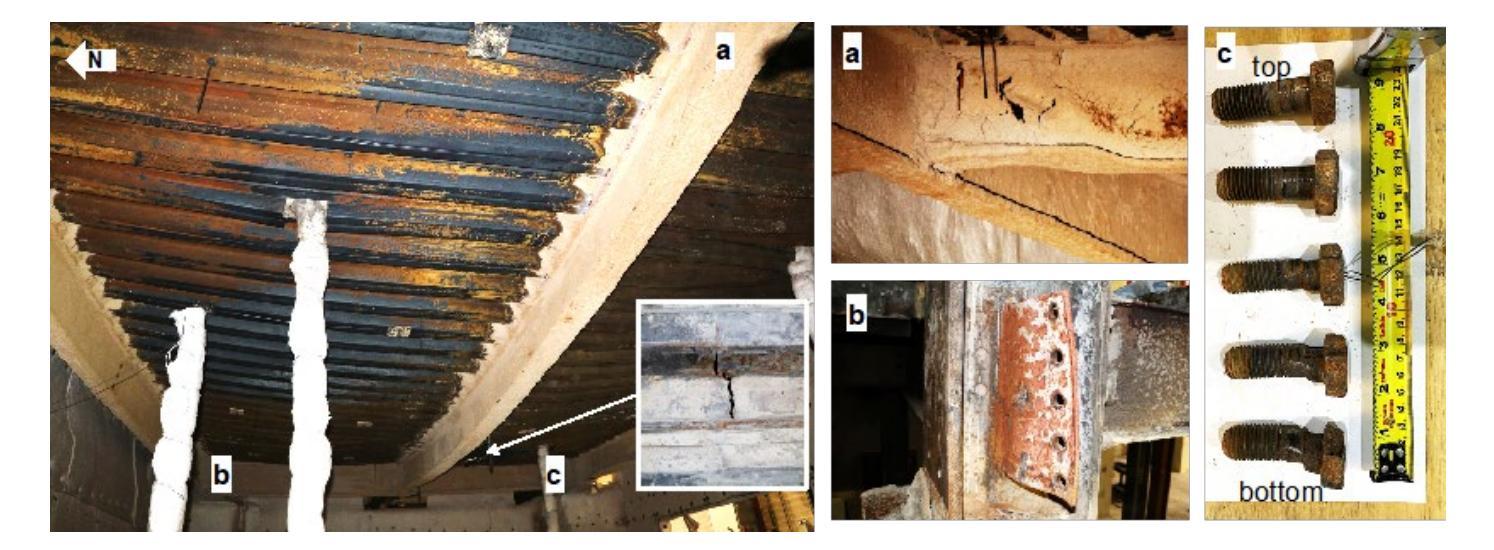
Figure 13 shows the underside of the test floor assembly after cooling. The steel deck below concrete fractures (Figure 12) mostly maintained its integrity with good ductility. Only a local rupture was found in some deck units below the east end of the mid-panel longitudinal crack, i.e., near the west edge of the top flange of the east girder. All three 9.1 m long W16×31 beams exhibited permanent strong axis bending deformation and local buckling toward the beam ends. Furthermore, the north and south primary beams also exhibited twisting and lateral deformation. Although the north beam developed local buckling toward its ends, the shear tabs of the north and south beams maintained structural integrity. The east and west W18×35 girders showed little residual vertical deflection and exhibited minor out-of-plane deformations in the webs near the end connections. The extended shear tabs welded to the northeast and the northwest column webs exhibited noticeable out-of-plane deflection but no bolt failures. The extended shear tabs welded to the southeast and the southwest column webs deflected little, but the lower bolts of the southeast connection were partially ruptured in shear. The fireproofing sprayed on the beams and girders mostly remained intact, although fissures were evident on the beam web near the end connections and at the lower beam web of the secondary beam at midspan.

Figure 13 – Fire-exposed steelwork of the test floor assembly after cooling. Close-ups of some deflected steel parts are shown in images a through c

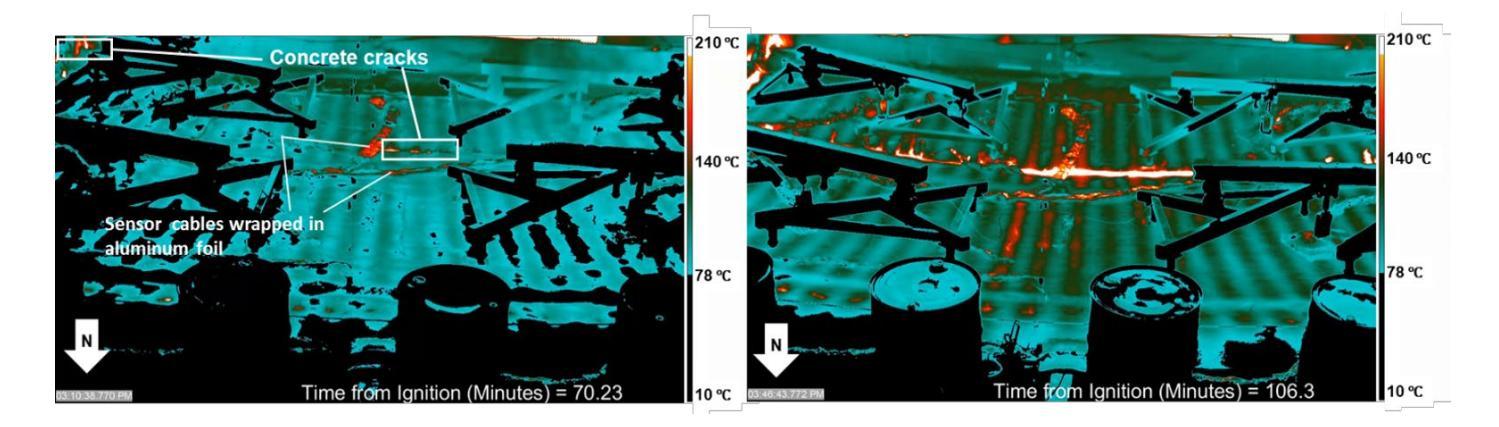
Figure 15 - Thermal images of the top of the test floor slab at 70 min and 106 min after fire ignition
