Acceptance of new batches of 9310 steel for the Charpy Machine Verification Program

May L. Martin Enrico Lucon Applied Chemicals and Materials Division Material Measurement Laboratory

September 2022

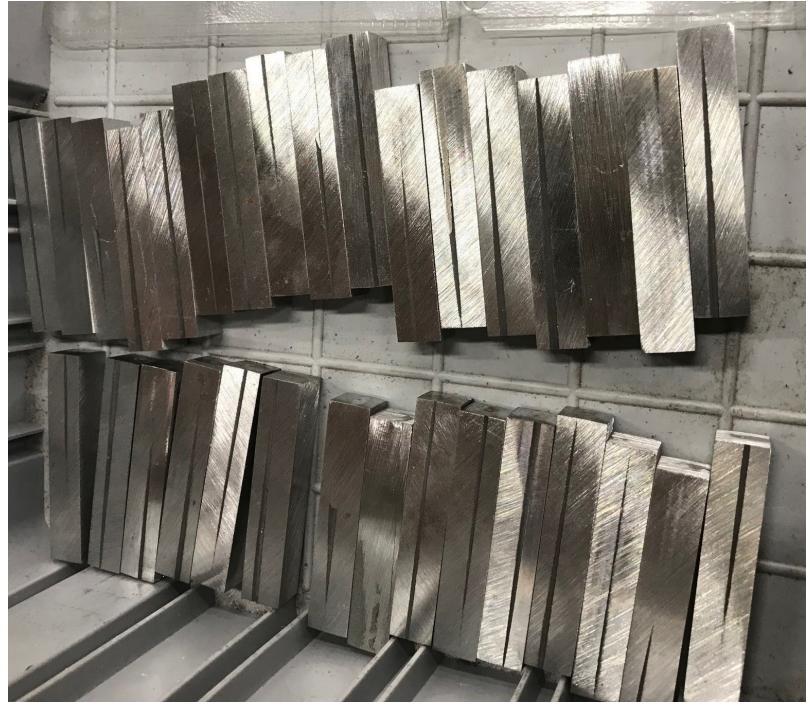
Figure 1 - Blanks obtained from Lot 11 of Heat #J0861 of 9310 steel.

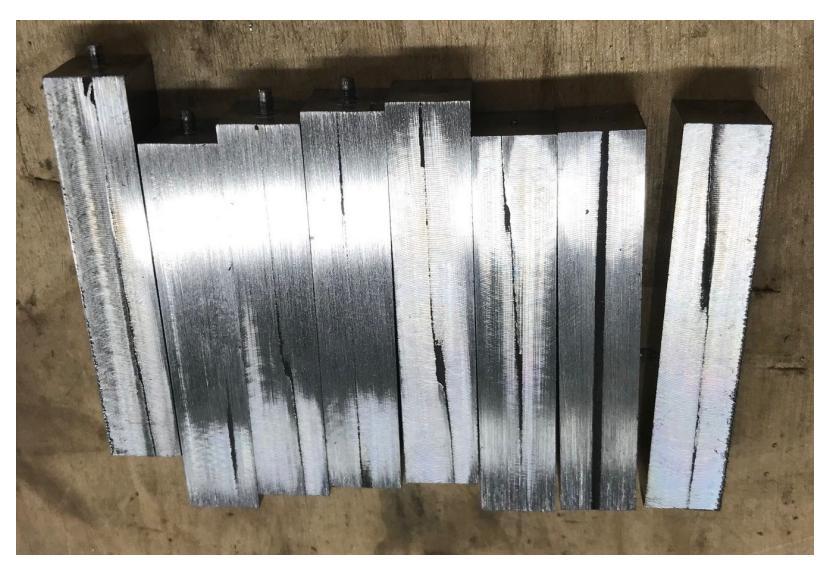
Figure 2 - Blanks obtained from Lot 35 of Heat #J0861 of 9310 steel.

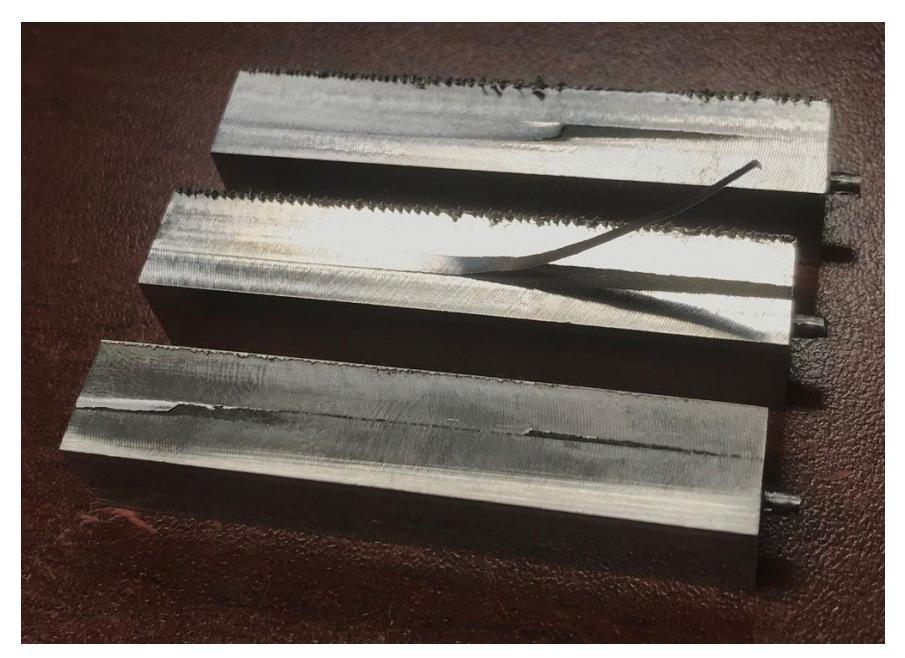
Figure 3 – Three 9310 steel blanks obtained from Lot 35 of Heat #J0861 of 9310 steel.

The rough-machined blanks received from the Contactor showed regions of long black defects that appeared like gouges on the surface. Some of these gouges were associated with strips of steel that could be pulled away from the surface, leaving a black groove behind (Figure 3).

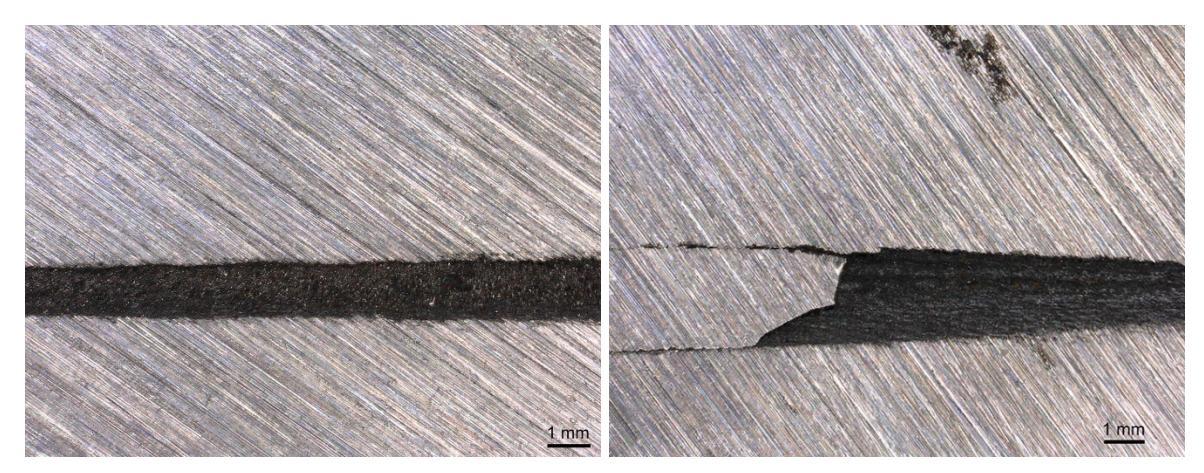
Optical micrographs of these defects are presented in Figure 4.

Figure 4 - Optical Micrographs showing the investigated defects. Both blanks were from lot 11, but the appearance is representative of the defects. The left picture shows section of defect extending along entire blank. The right picture shows a defect with a steel sliver remaining over a portion of it.

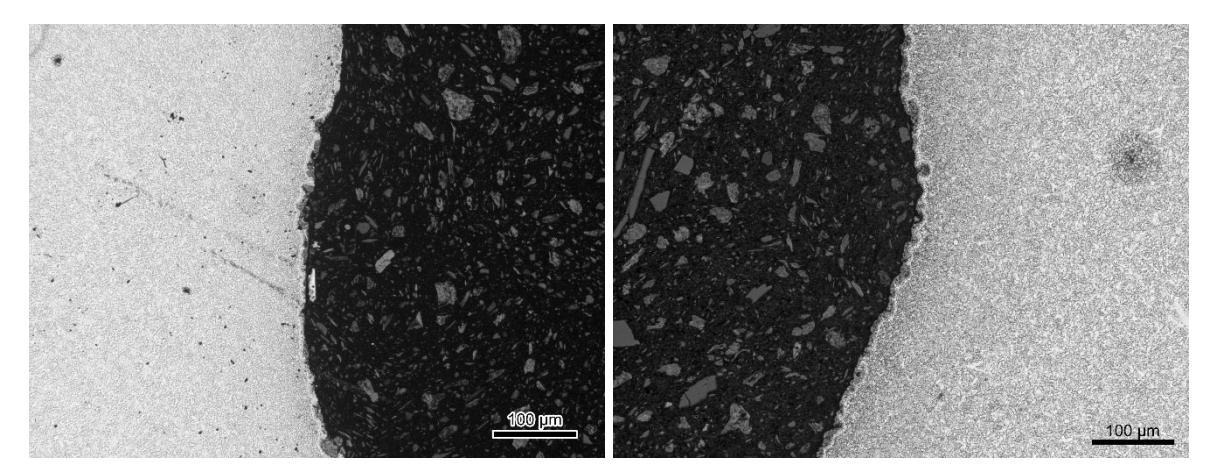
One sample from each lot that had been found to exhibit these defects (lots 11 and 35) was sectioned such that the defect was viewed in cross-section. This section was then mounted in bakelite (standard for metallography), polished to a mirror finish, and etched with a 2 % nitric acid in methanol solution (nital). Optical microscopy was conducted on these samples (Figure 5). They show a definite divot in the surface due to these gouges, which measures approximately 150 μ m. This depth is comparable to that measured by the differences in focal plane for the top and bottom of the feature, 200 μ m to 300 μ m. The black layer of the defect is visible in cross-section, Figure 6, but appears to be quite thin (10 μ m to 20 μ m). This layer is not uniform in thickness nor is it flat, but it infiltrates into the steel surface, much like the behavior of corrosion product in corrosion pits. The section also shows no large defects running through the bulk of the material, just the surface defects. (Note that no large bulk defects were observed prior to or after etching, suggesting the defects are primarily located at or near the surface.)

Figure 5 - Optical micrographs of mounted, sectioned, and etched samples showing the cross-section of the divots. The left picture shows a sample from Lot 35, while the right picture shows a sample from Lot 11. The black material is the bakelite mount.

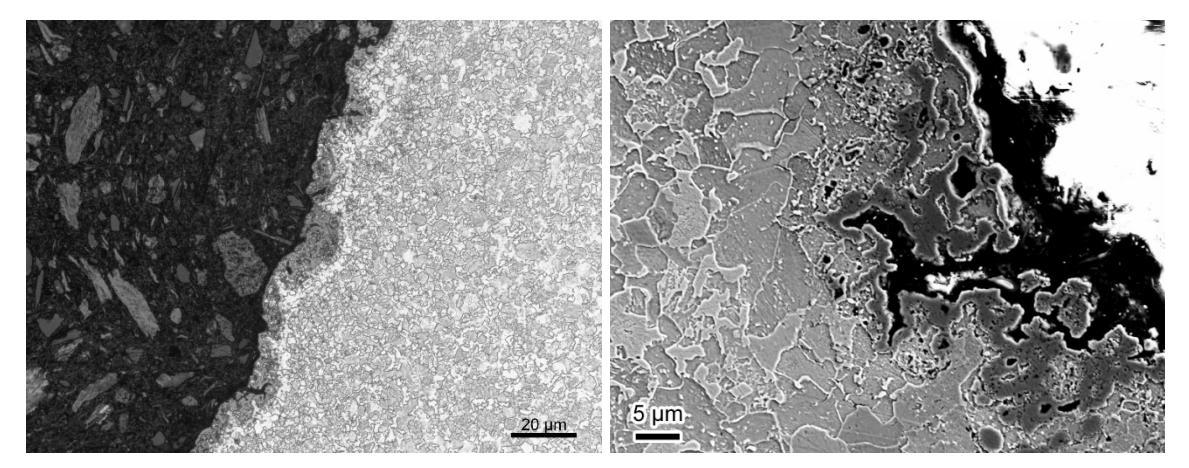
Figure 6 – Left picture: high magnification optical micrograph of base of sectioned divot, sample from Lot 11 (Figure 5 right). Note the thick (10 μ m to 20 μ m) dark grey layer at the surface of the steel. Right picture: SEM micrograph of the cross-section showing infiltration of the (darker) surface layer into the steel microstructure.

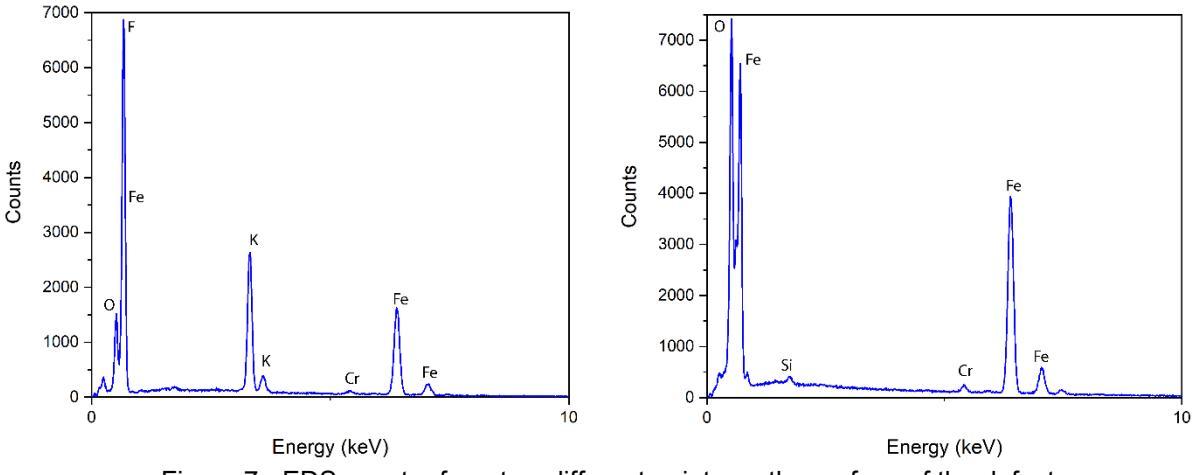
Chemical analysis by electron dispersive spectroscopy (EDS) was conducted on a scanning electron microscope (SEM) operated at either 10 kV or 30 kV. EDS uses characteristic x-rays generated by the sample interacting with the electron beam to determine the elemental composition of the material. Spectra taken from the surface of these areas reveal the presence of potassium, silicon, and oxygen (Figure 7), with the exact components and the relative contributions to the spectra varying as a function of position. The spot scans still reveal iron, chromium, and nickel signal, but the possibility remains that these could be due to background contributions (underneath the thin surface layer) rather than due to the metallic contributions within the black layer.

Figure 7 - EDS spectra from two different points on the surface of the defect.

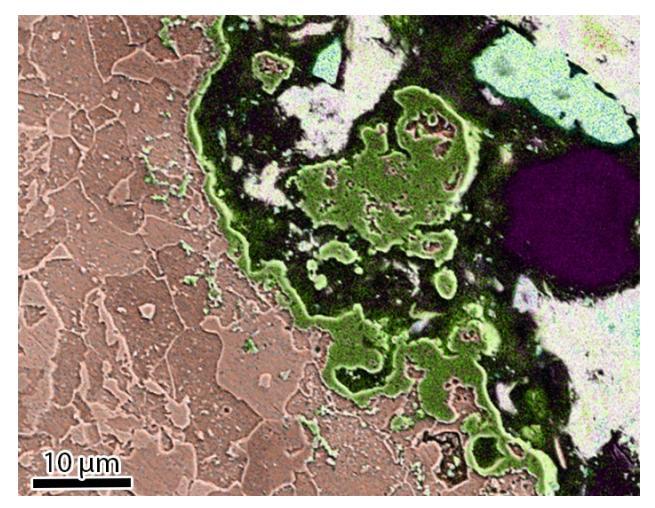
The EDS chemical analysis of the general surface of the cross-section shows an oxygen-rich layer approximately 500 nm thick, consistent with a native oxide surface layer. Within the pit itself, the surface layer becomes larger (Figure 8). The chemical composition again varied by position, but suggested that the layer was generally rich in oxygen, with some areas rich in silicon. It is possible that the phases that were rich in lighter elements like potassium were dissolved on the surface layer by the acid etchant, and that is why they were not detected in the sectioned samples.

Figure 8 - Element color maps overlaid on SEM micrograph. Green is oxygen-rich area, orange is iron-rich area.

The composition and appearance of the material inside these defects suggest that they are segregation zones formed during steel-making, which were not properly removed during the final steps of processing. While the phases were not identified though diffraction analysis, the results presented here are consistent with oxides and other slag components. The flaking off of the covering steel surface layer, and the composition, suggest that this material is brittle. As it appear to be confined to the surface (< 1 mm), it is possible that this layer will (or can) be mostly removed during sample machining. The bluntness of the shape of these defects means that they are unlikely to be strong stress concentrators during mechanical loading and, therefore, are unlikely to affect Charpy testing performance. However, they are an undesirable and visually noticeable feature that should be avoided in the future.
