**NIST NCSTAR 1-6A**

**Federal Building and Fire Safety Investigation of the  
World Trade Center Disaster**

**Passive Fire Protection**

September 2005

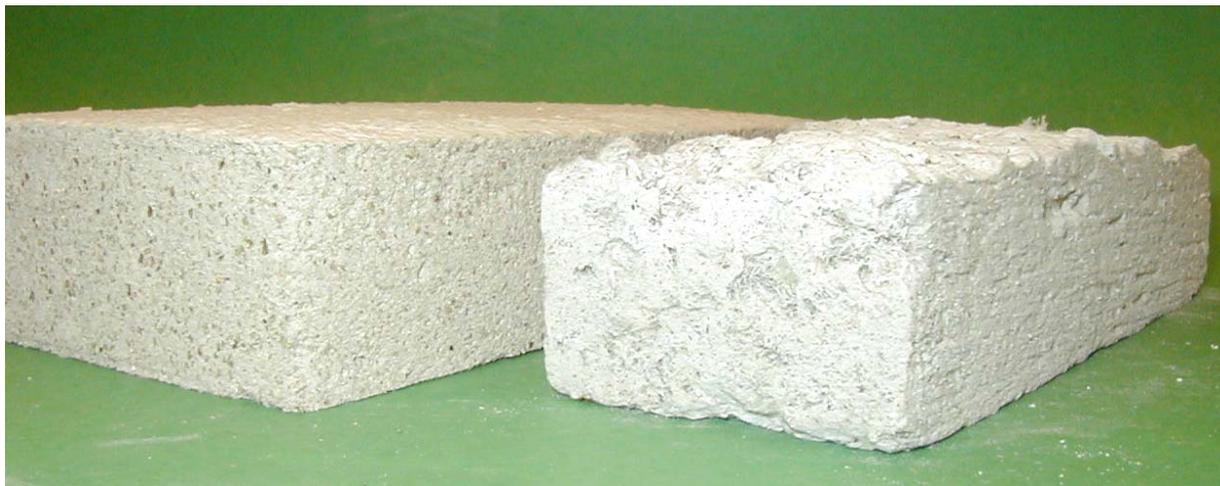
**Figure 1–1. Examples of sprayed fire-resistive materials: (left) material based on gypsum and vermiculite aggregate; (right) material based on mineral fibers and cementitious binder.**

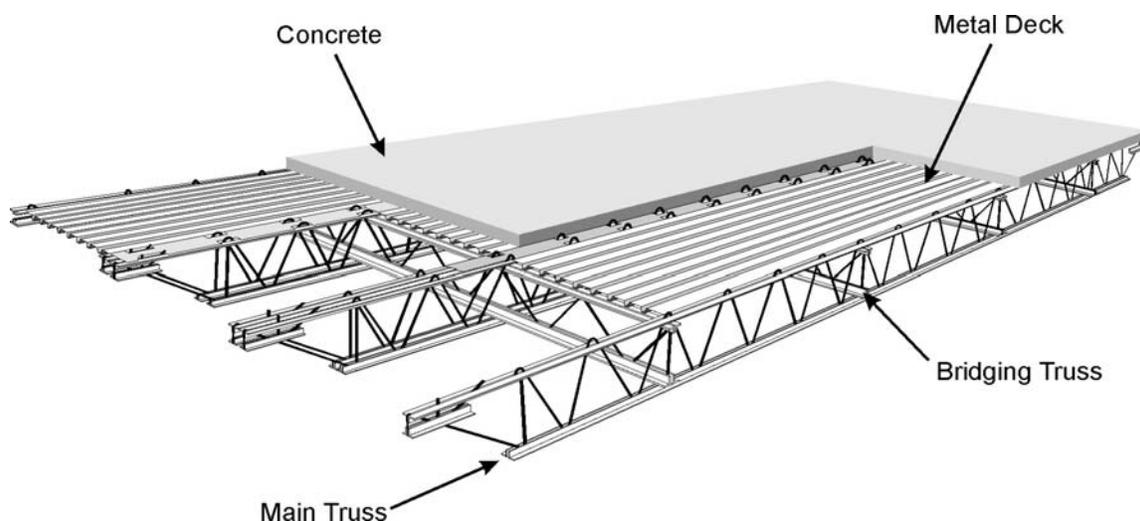
**Figure 3–2. Schematic of composite floor truss system.**

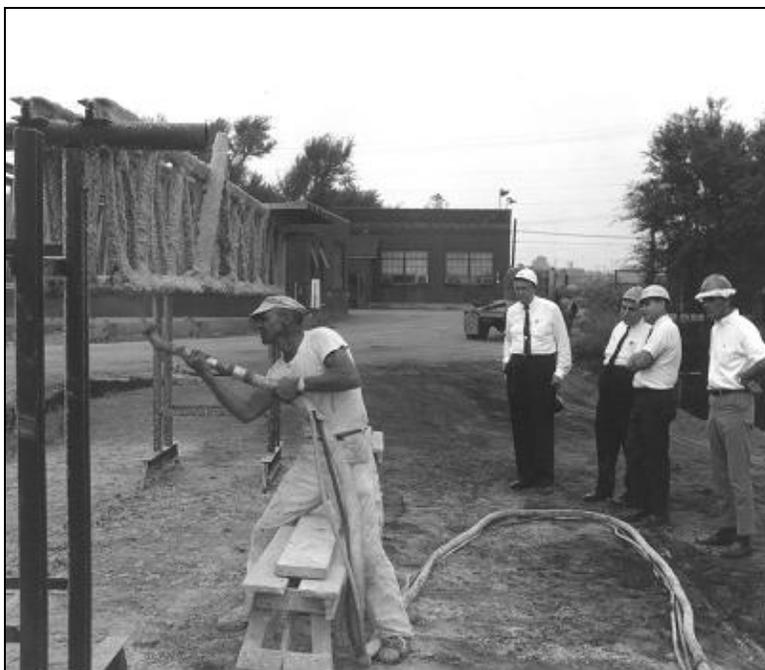
**Figure 3–3. Demonstration of application of Monokote sprayed fire-resistive material to floor trusses.**

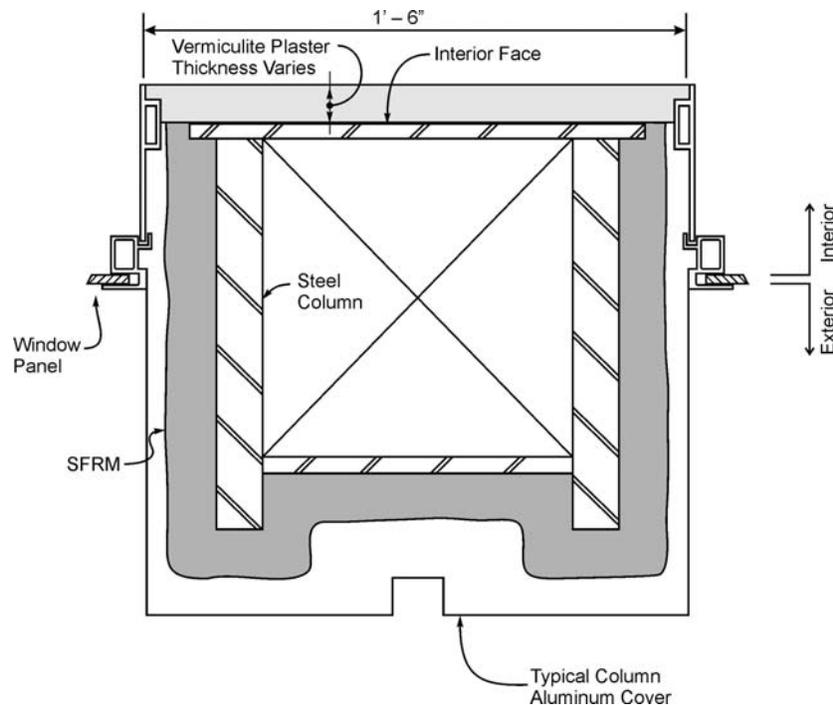
**Figure 3-4. Thermal insulation for perimeter columns.**

For the inside face of the columns, Alcoa proposed to apply a high “k” value (thermal conductivity) material. This application would provide thermal protection while permitting heat migration from the room air to the column steel under service conditions. Figure 3-4 illustrates the thermal protection design for the perimeter columns.

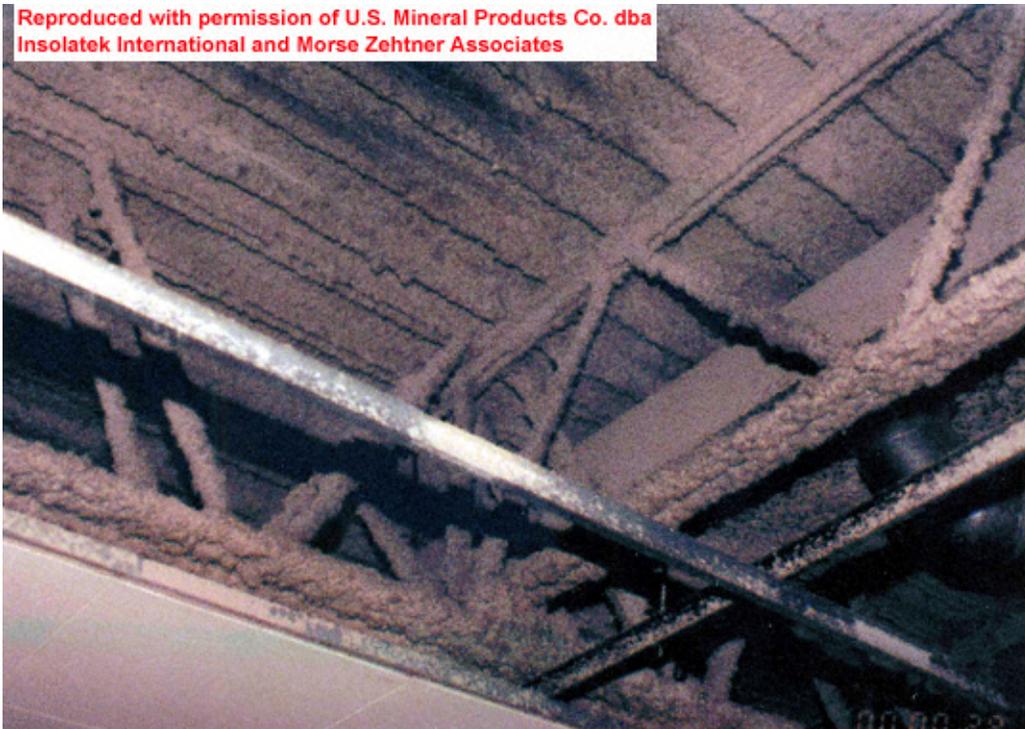
Figure 3–5. Intersection of main truss and bridging truss showing general good coverage of SFRM on truss members but thickness varies on web bars.

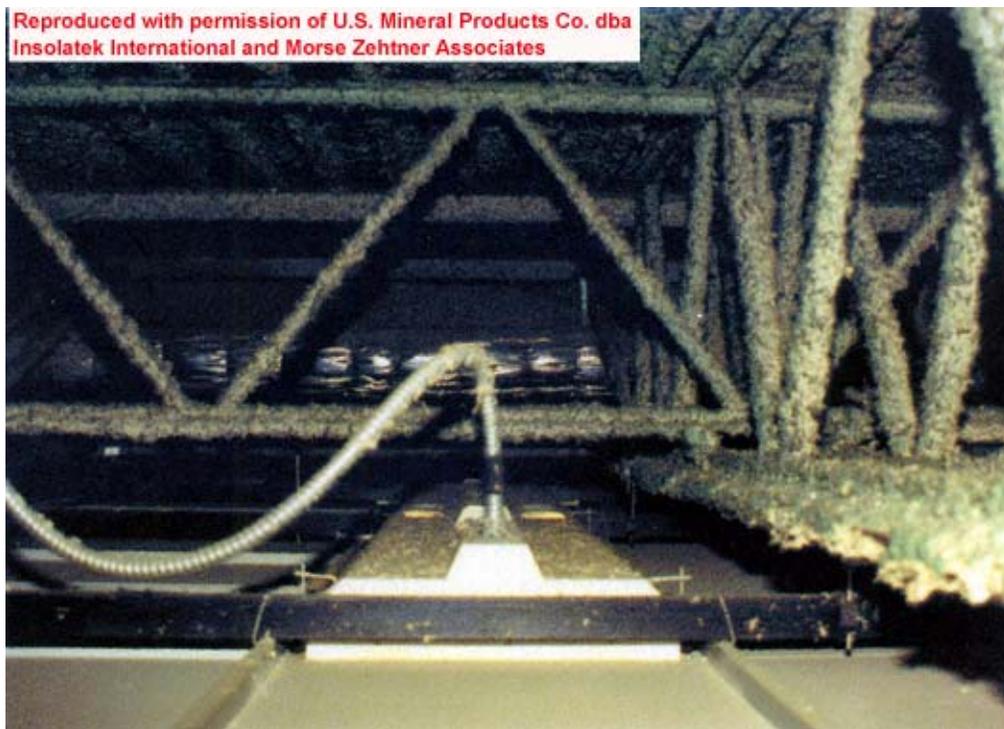
Figure 3–6. Intersection of main truss and bridging truss showing thinner SFRM on members of bridging truss.

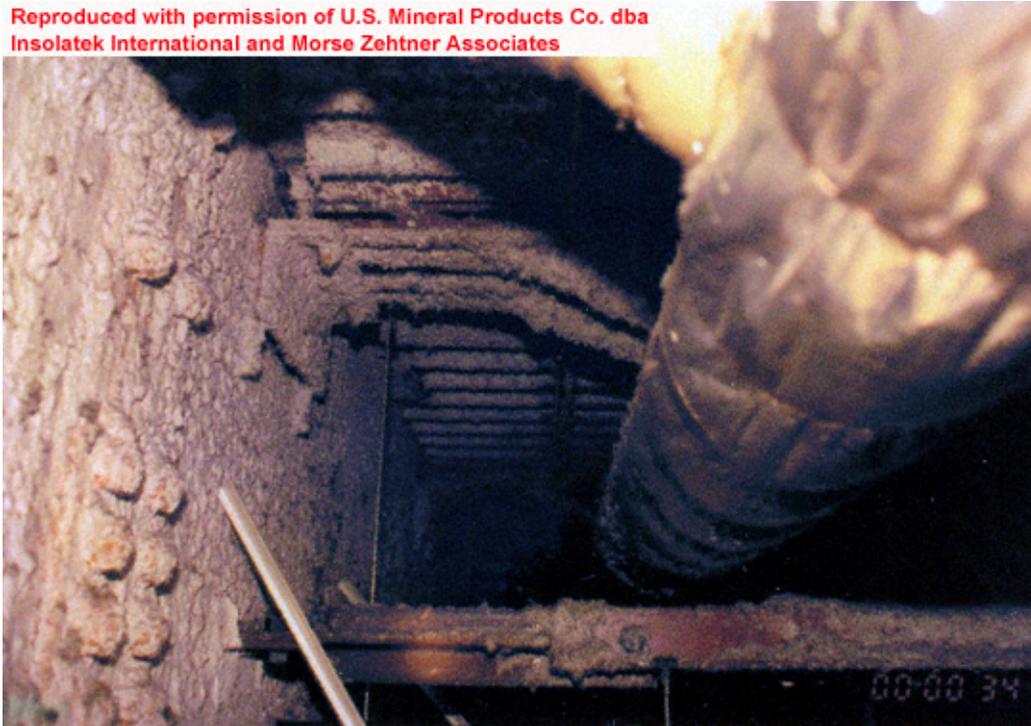
**Figure 3–7. Connection of main truss to spandrel beam showing relatively thin SFRM on truss seat and no SFRM on damper.**

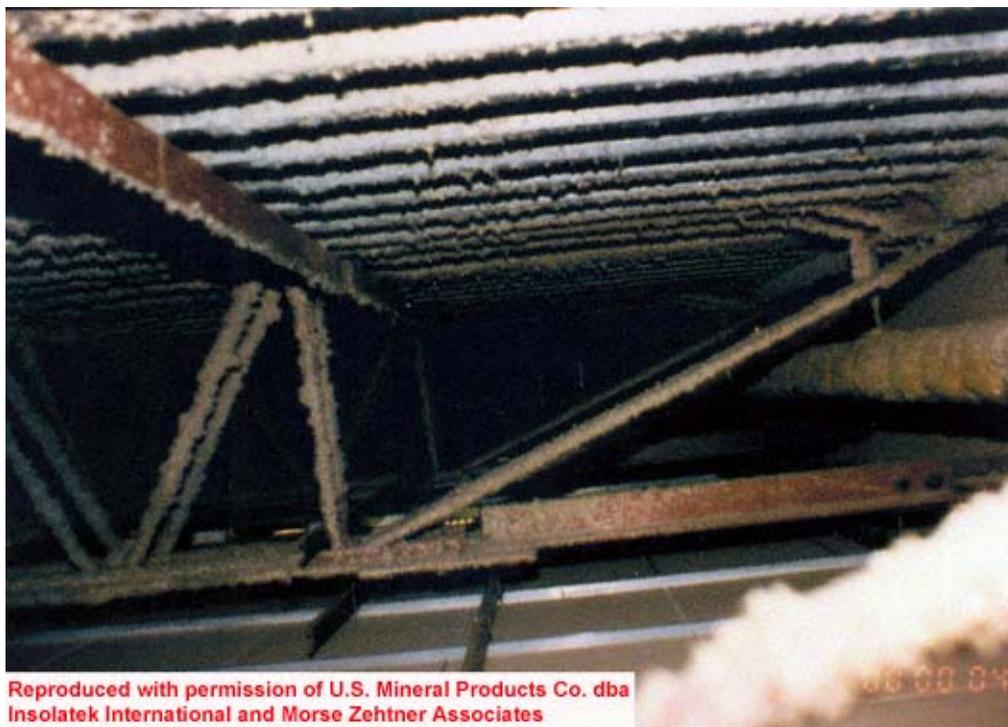
**Figure 3–8. End of main truss showing low thickness of SFRM on truss members and no SFRM on damper saddle.**

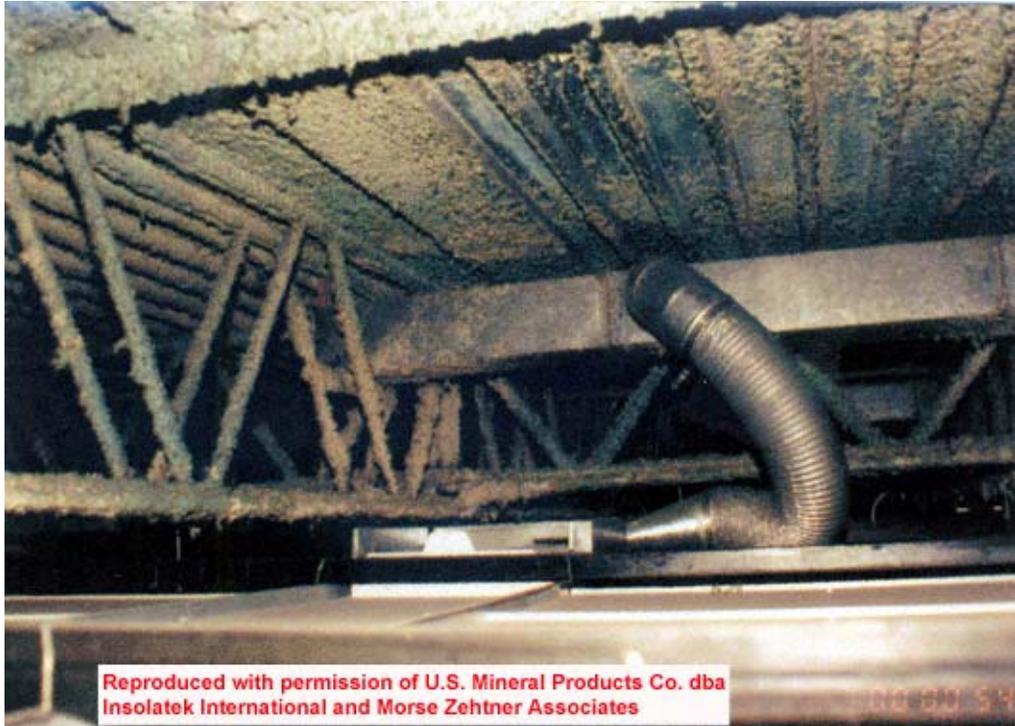
Figure 3–9. Intersection of main truss and bridging truss showing thin SFRM on the ends of some web bars; SFRM was not applied to the metal decking.

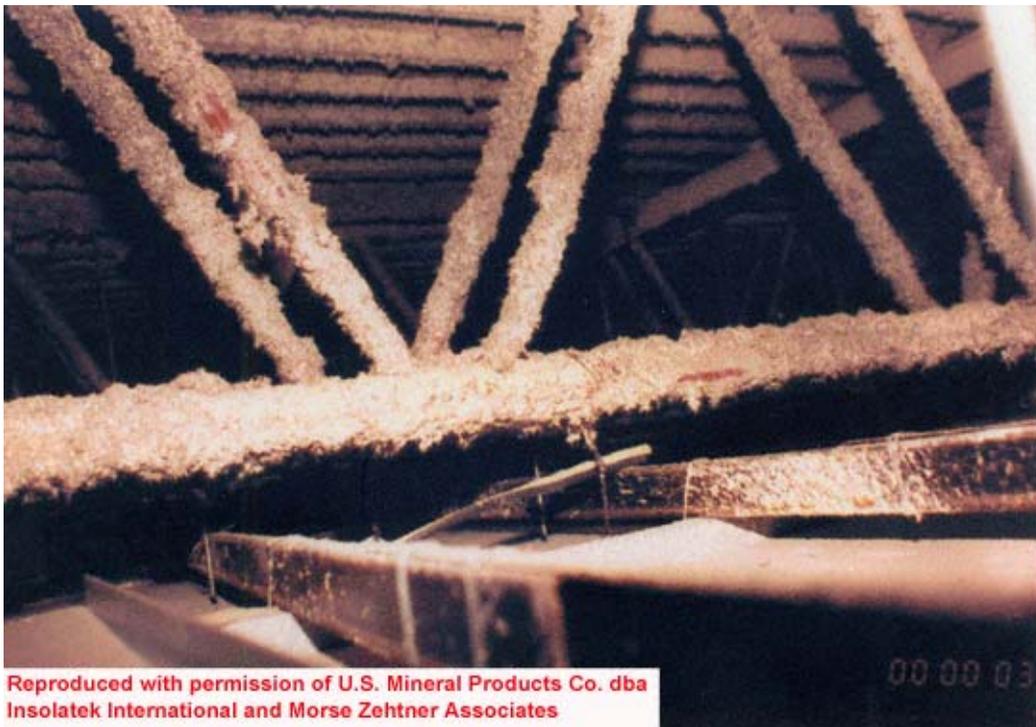
Figure 3–10. Example of damage to SFRM during installation of utilities.

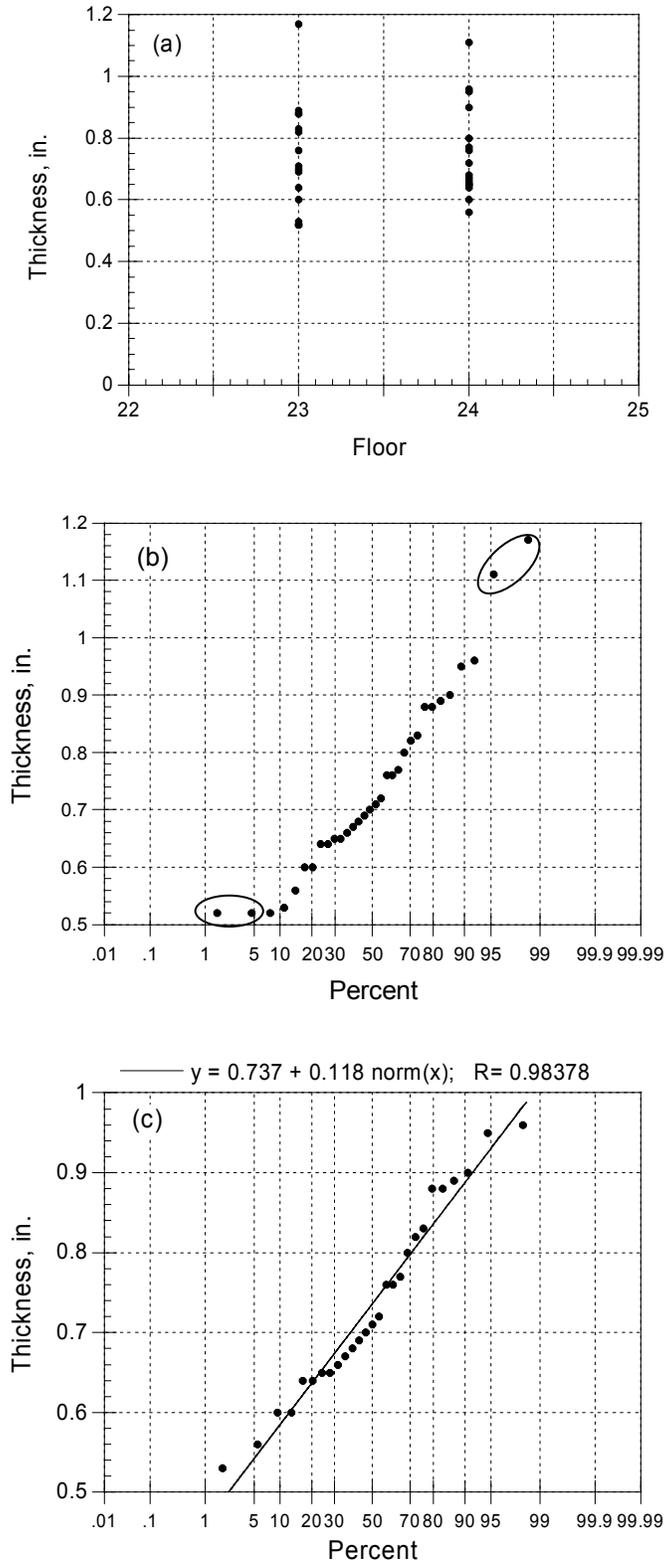
**Figure 4–1. (a) Dotplot of average thickness from floor trusses for floors 23 and 24, (b) normal probability plot of all average thickness values, and (c) normal probability plot of average thickness with four values (six points) excluded.**

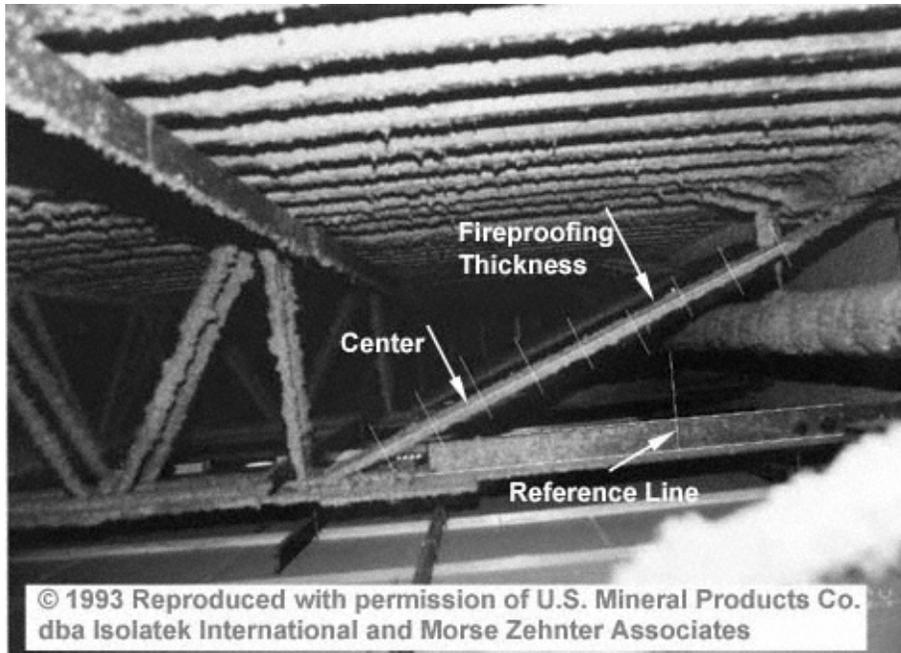
**Figure 4–2. Example of measurement procedure used to estimate SFRM thickness from photographs.**

- Each measurement in pixels was multiplied by the scaling factor (in./pixel) to estimate the bar radius plus SFRM thickness. This provides two measurements at each cross section.
- The radius of the bar was subtracted to provide the estimate of the SFRM thickness.

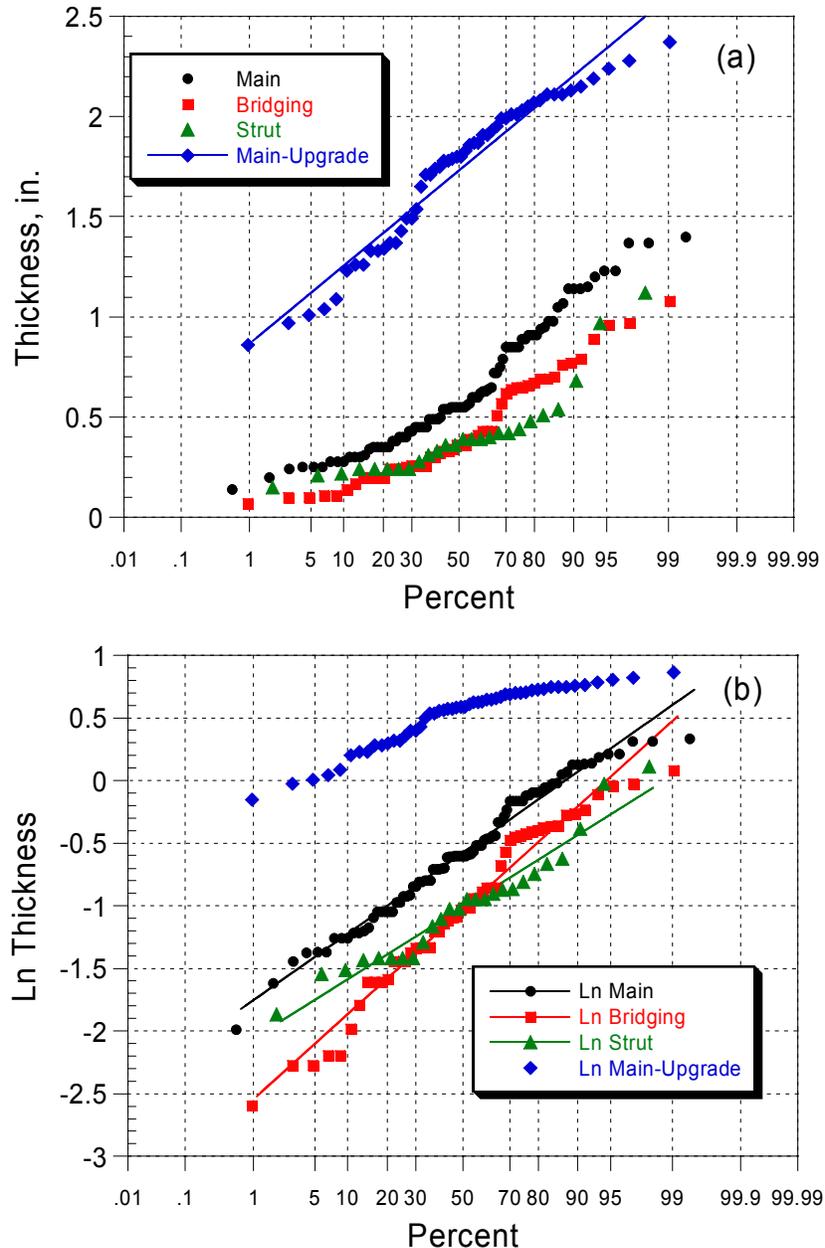
**Figure 4–3. (a) Normal probability plot of estimated SFRM thickness based on photographs, and (b) normal probability plot of natural logarithms of thickness (Data provided by PANYNJ).**

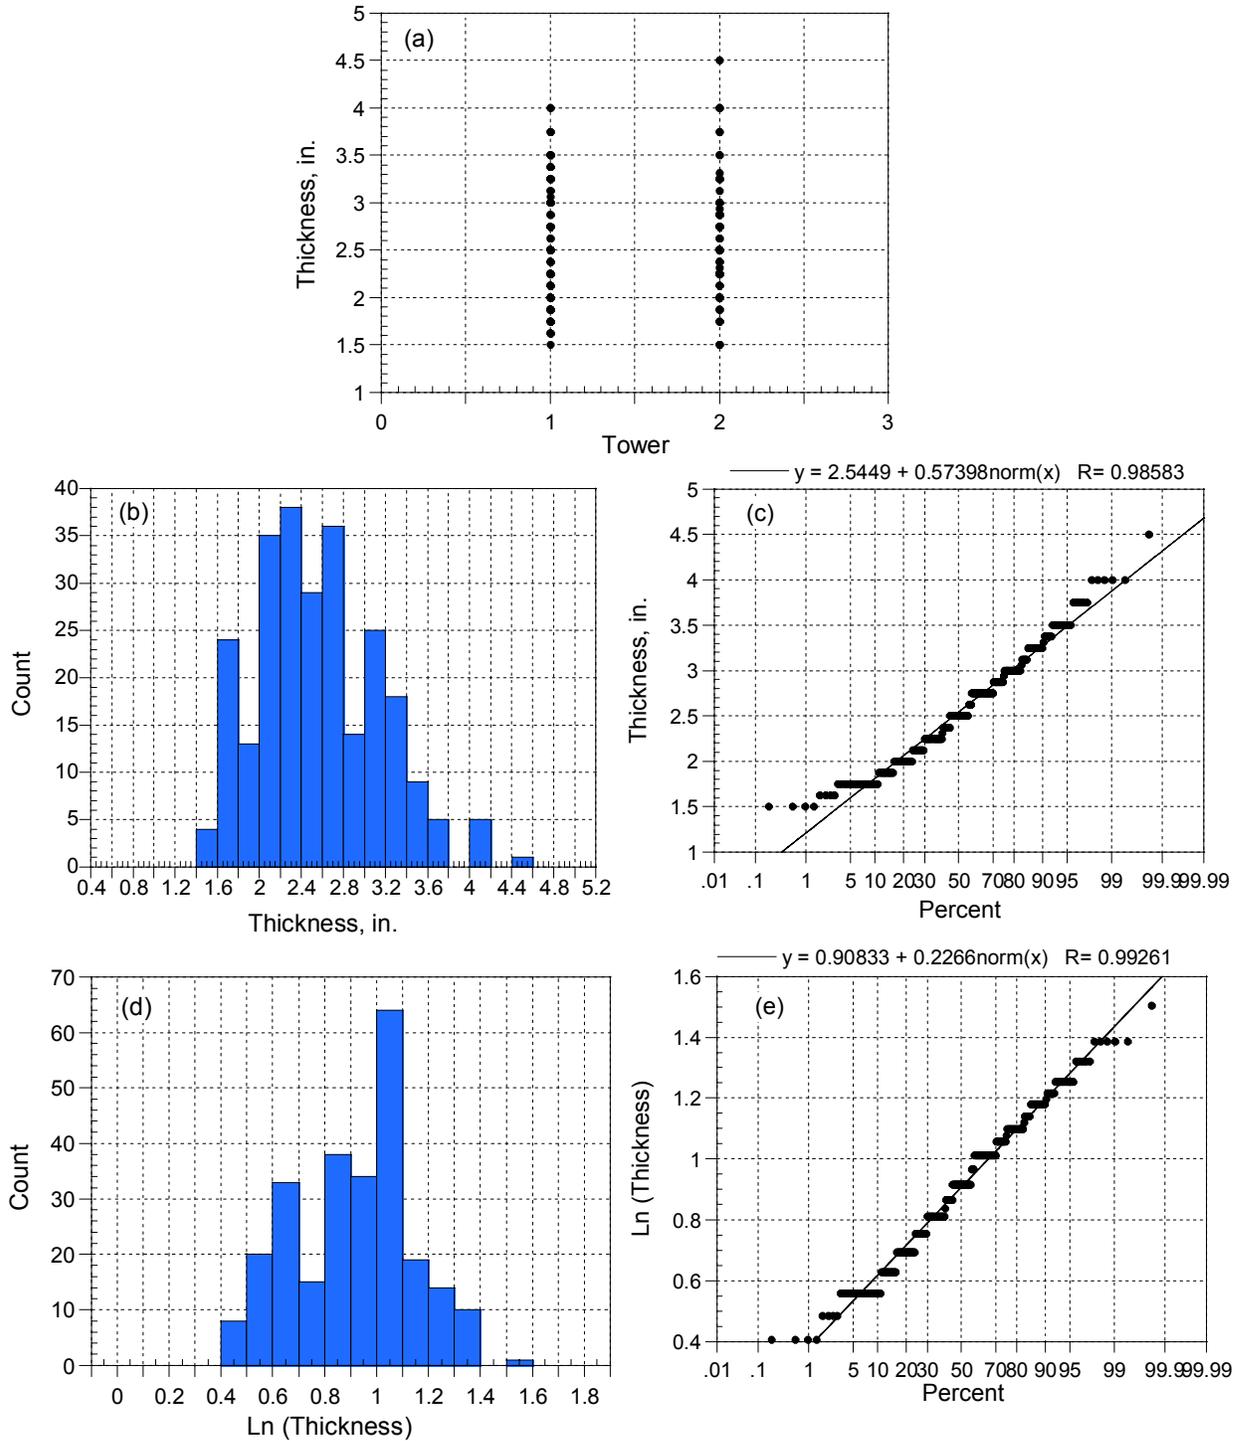
**Figure 4–4. (a) Dotplot of individual thickness measurements on floor trusses from Port Authority Construction Audit Reports, (b) histogram of thickness measurements, (c) normal probability plot of thickness measurements, (d) histogram of natural logarithms of thickness measurements, and (e) normal probability plot of natural logarithm of thickness measurements.**

The overall standard deviation of 0.6 in. includes two contributions: (1) the variation of thickness at the cross section (within-truss variability), and (2) the variation of average thickness between trusses (between-truss variability). Figure 4-5 shows these two components of the thickness variability for the two towers. Figures 4-5 (a) and (c) show the within-truss variability, and Figs. 4-5 (b) and (d) show the variation of average thickness of each truss. From analysis of variance, it was found that the within-truss standard deviation is 0.4 in., and the between-truss standard deviation is also 0.4 in. The within-truss standard deviation of 0.4 in. is similar to the standard deviation of the estimated individual thicknesses obtained from analysis of the photographs of upgraded main trusses.

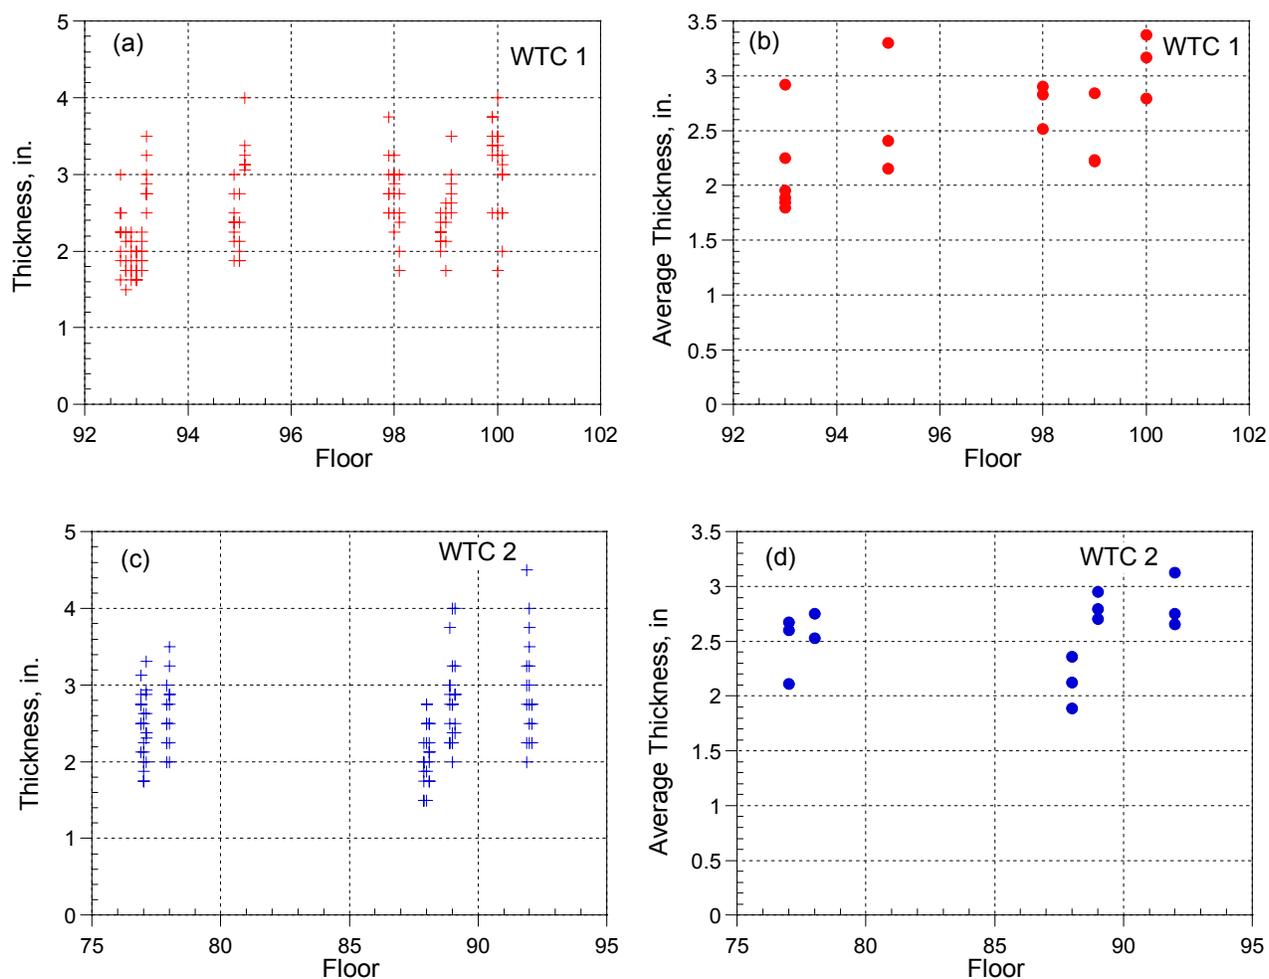
**Figure 4–5. SFRM thickness on floor trusses in upgraded portions of WTC towers: (a) individual measurements in WTC 1, (b) average thickness in WTC 1, (c) individual measurements in WTC 2, and (d) average thickness in WTC 2 (data provided by PANYNJ).**

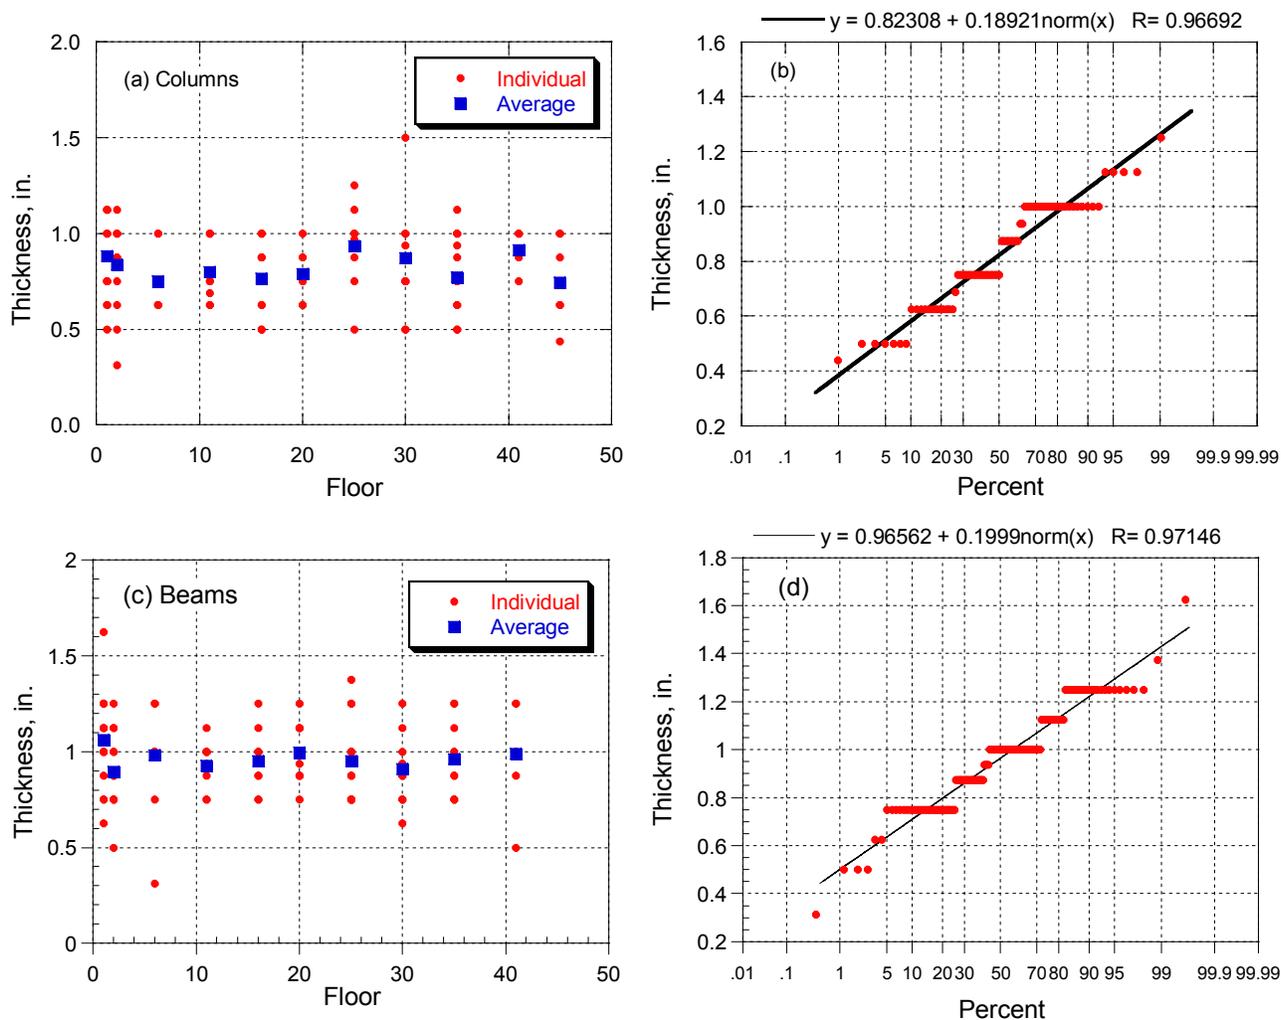
**Figure 4–6. Thickness of re-applied SFRM in elevator shaft 10/11 of WTC 1: (a) Individual and average thickness for core columns, (b) normal probability plot of individual measurements on columns, (c) individual and average thickness for core beams, and (d) normal probability plot of individual measurements on beams (data provided by PANYNJ).**

Fig. 4-6 is lower than the variation observed in the floor trusses. This is not unexpected because the planar surfaces of the beams and columns result in more uniform application of the sprayed fire-resistive material than for the slender truss members. This results in reduced differences in the average thickness of SFRM on different members and less variability within a member.

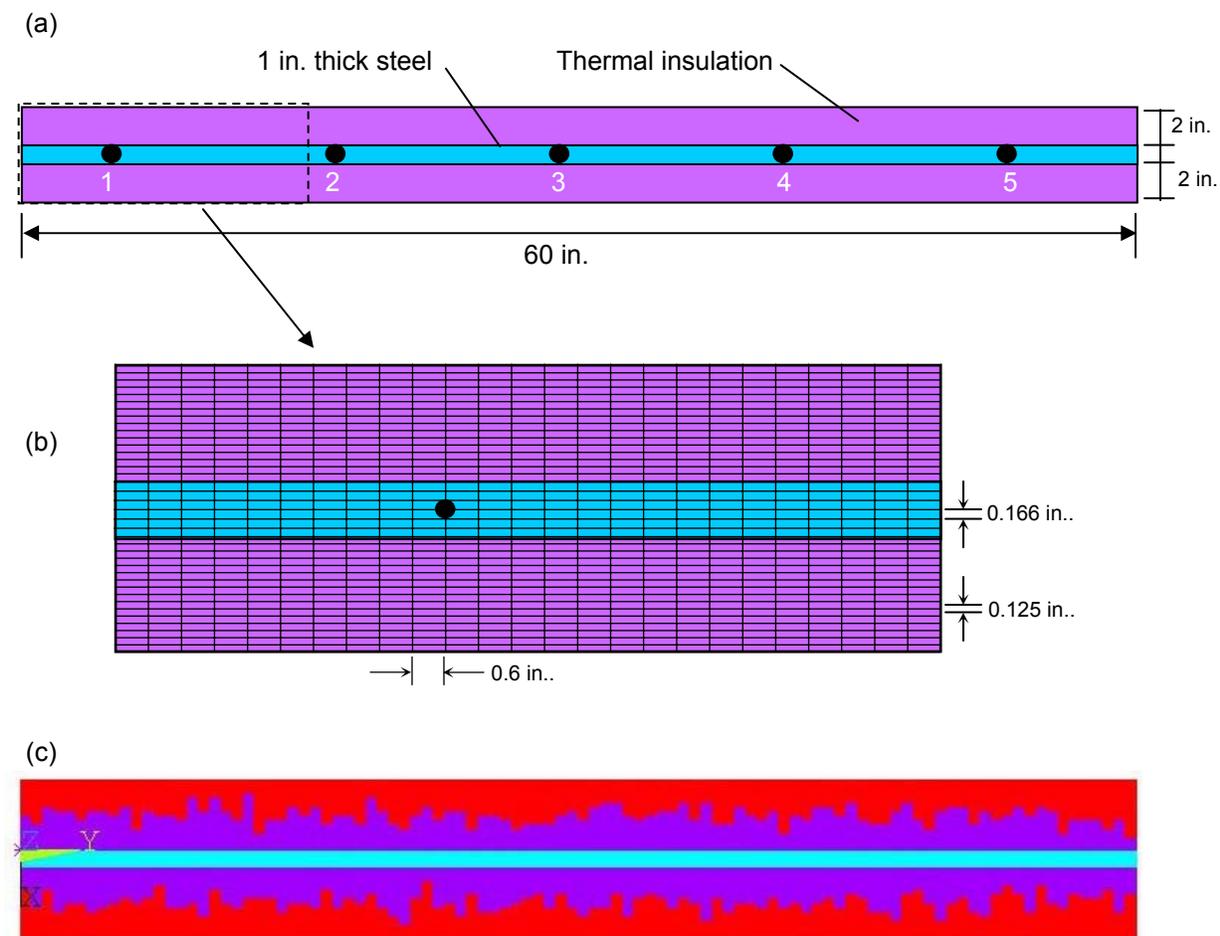
**Figure 5–1. Model used to study effects of SFRM thickness and variability of thickness on steel temperature: (a) physical model used in analyses (points 1 to 5 are locations where temperatures are monitored), (b) finite element mesh used to represent physical model, and (c) finite element model to represent variable thickness of SFRM (purple) (the elements in red represent material of high thermal conductivity).**

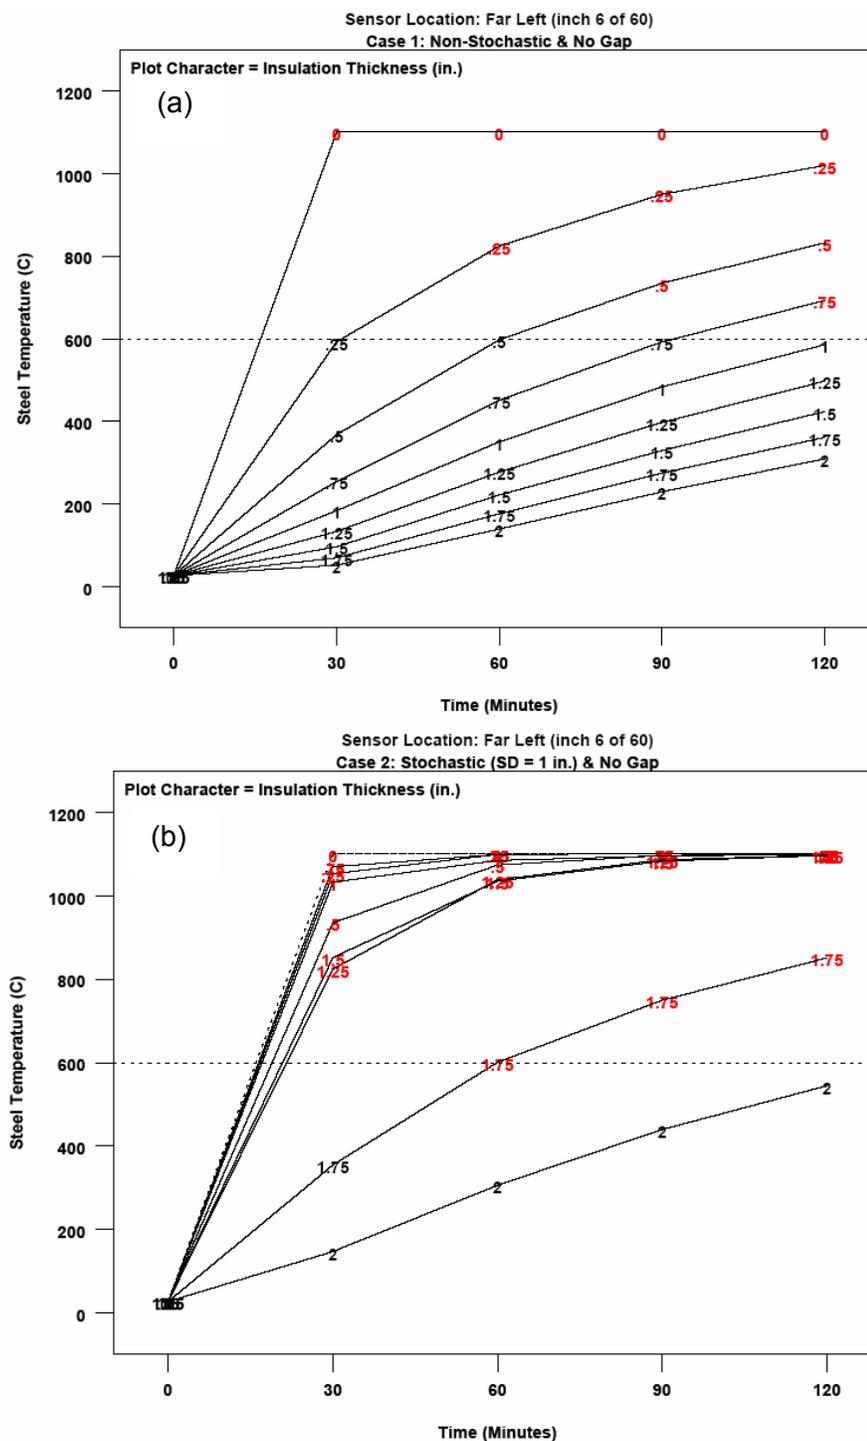
Figure 5–3. Variation of steel temperature (at a point 6 in. from end of plate) with time for different average thicknesses of fire-resistive material (shown as numbers on the curves): (a) uniform thickness, and (b) variable thickness with standard deviation = 1 in.

Fig. 5-3 (b), the thickness varies with a standard deviation of 1 in. The time to reach a temperature of 600 °C is used as a measure of relative performance. It is seen that the presence of high variability in thickness has a detrimental effect on the protection provided by the fire-resistive material. For example, for a uniform thickness of 0.5 in., it takes about 60 min for the steel at point #1 to reach 600 °C, but when the standard deviation of the thickness is 1 in., the average thickness has to be 1.75 for the same level of thermal protection.

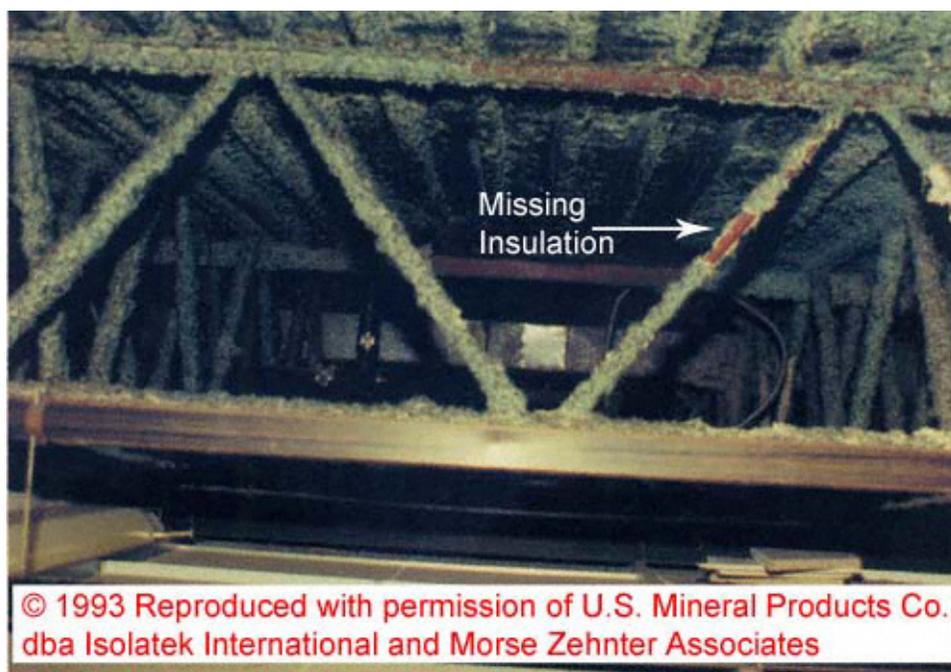
**Figure 5–4. Example of “gap” in fire-resistive material on diagonal member of a bridging floor truss.**

In addition to the effect of variation in thickness, it is important to understand the effect of missing SFRM over a portion of a member. As an example, Fig. 5-4 shows missing SFRM from a diagonal of a bridging truss of the WTC towers floor system. Note that this photograph is from a lower story and may not be representative of conditions in the upper stories, especially following the upgrade of thermal insulation. Figure 5-5 (a) shows an example of a numerical model with missing fire-resistive material. In this case, there is 12 in. of missing SFRM on the steel plate, which is otherwise protected by 2 in. of uniform thickness fire-resistive material. Figure 5-5 (b) shows the temperature contours (isotherms) at time equal to 50 min. For comparison, Fig. 5-5 (c) shows isotherms at the same time in a plate with no gap in the fire-resistive material. As expected, the bare steel at the missing fire-resistive material is at the gas temperature, but more importantly the “gap” in SFRM leads to a “leakage” of heat into the interior steel.

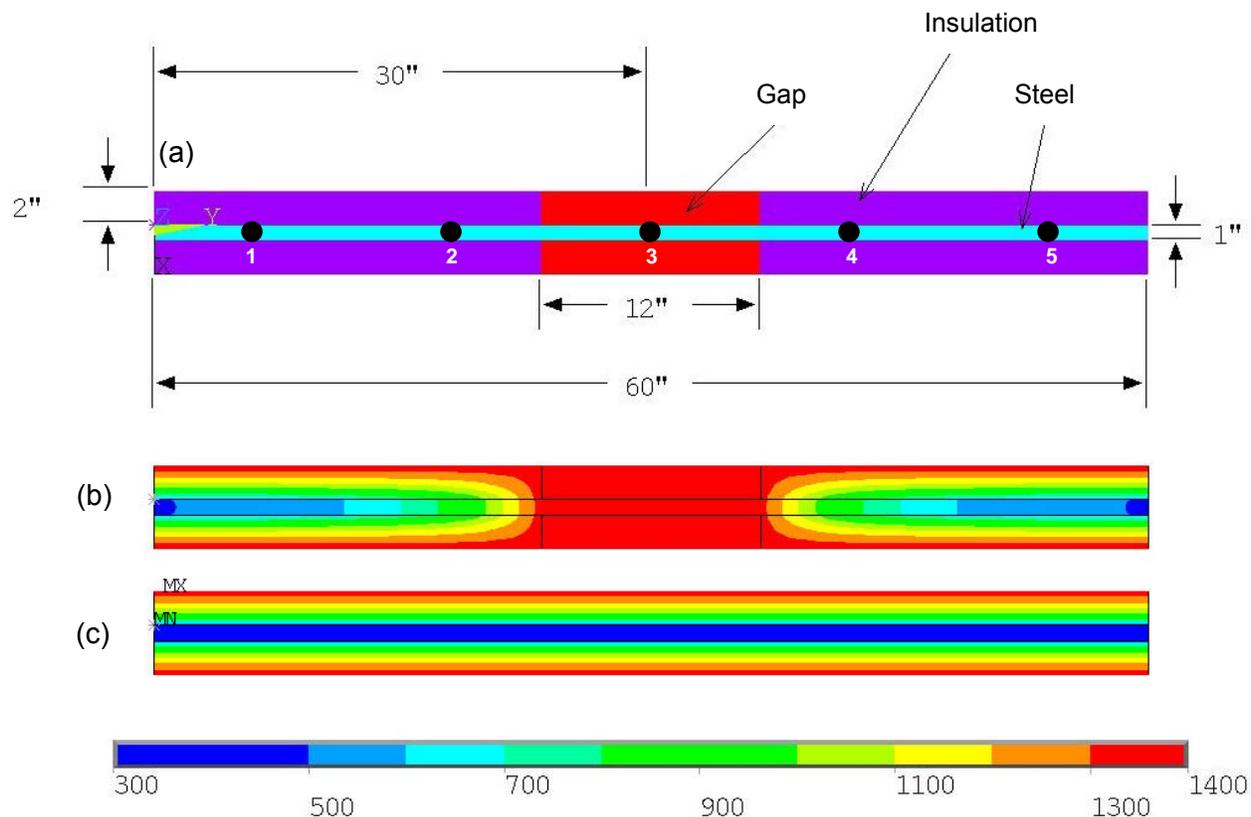
**Figure 5–5. Effects of gap in fire-resistive material: (a) model of plate with SFRM having 2 in. uniform thickness and 12 in. gap, (b) isotherms (K) at time = 50 min with 12 in. gap, and (c) isotherms without gap.**

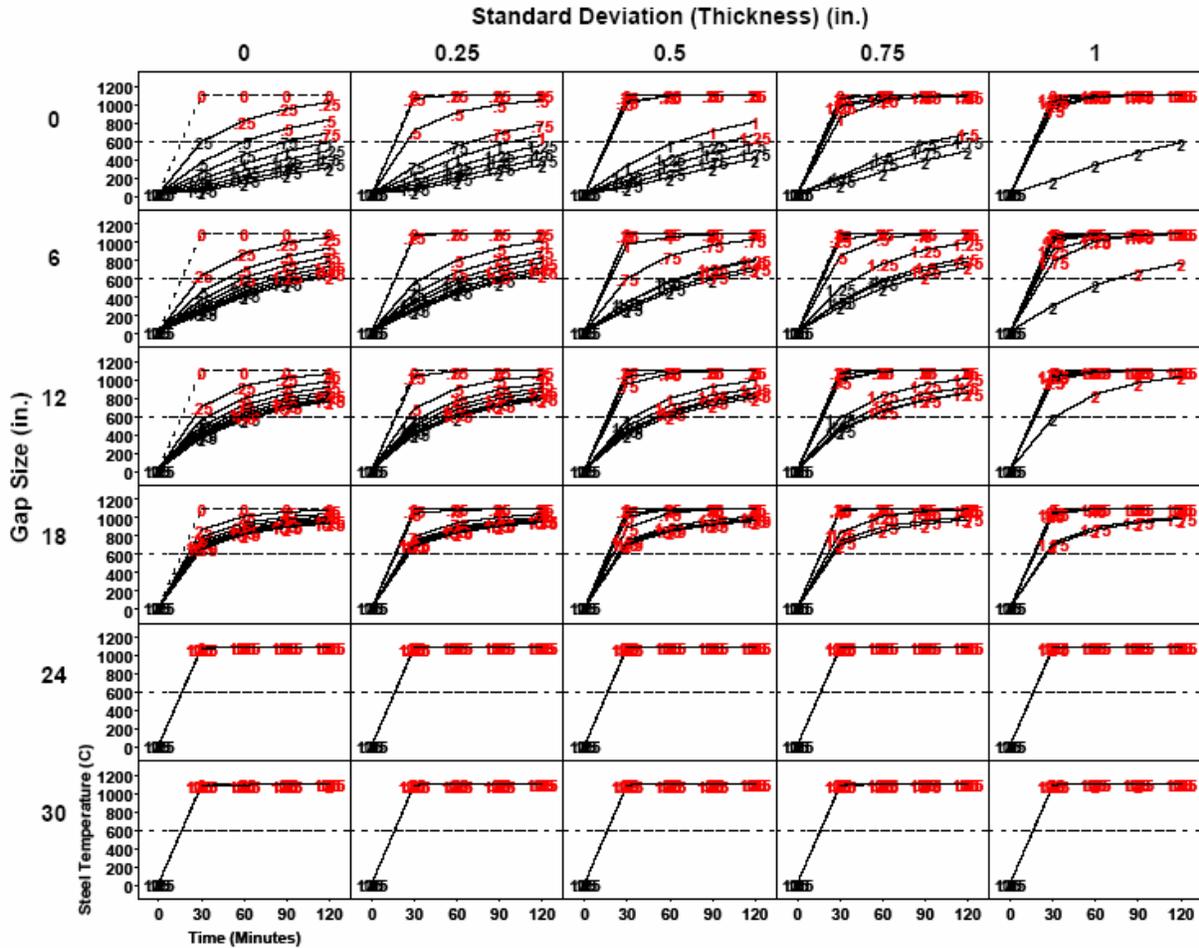
**Figure 5–6. Example of plot matrix from sensitivity study of the effects of missing SFRM and variability of SFRM thickness on steel temperature. Each graph is a temperature history of the steel at point #2 (see Fig. 5-5 for location) for different thicknesses of SFRM.**

trend of the curves in going downward from the top of a column in Fig. 5-6. The National Institute of Standards and Technology (NIST) does not have sufficient information to determine the frequency of occurrence of these gaps or their typical locations within the fire-affected floors. Therefore, gaps in insulation were not considered in the thermal modeling.

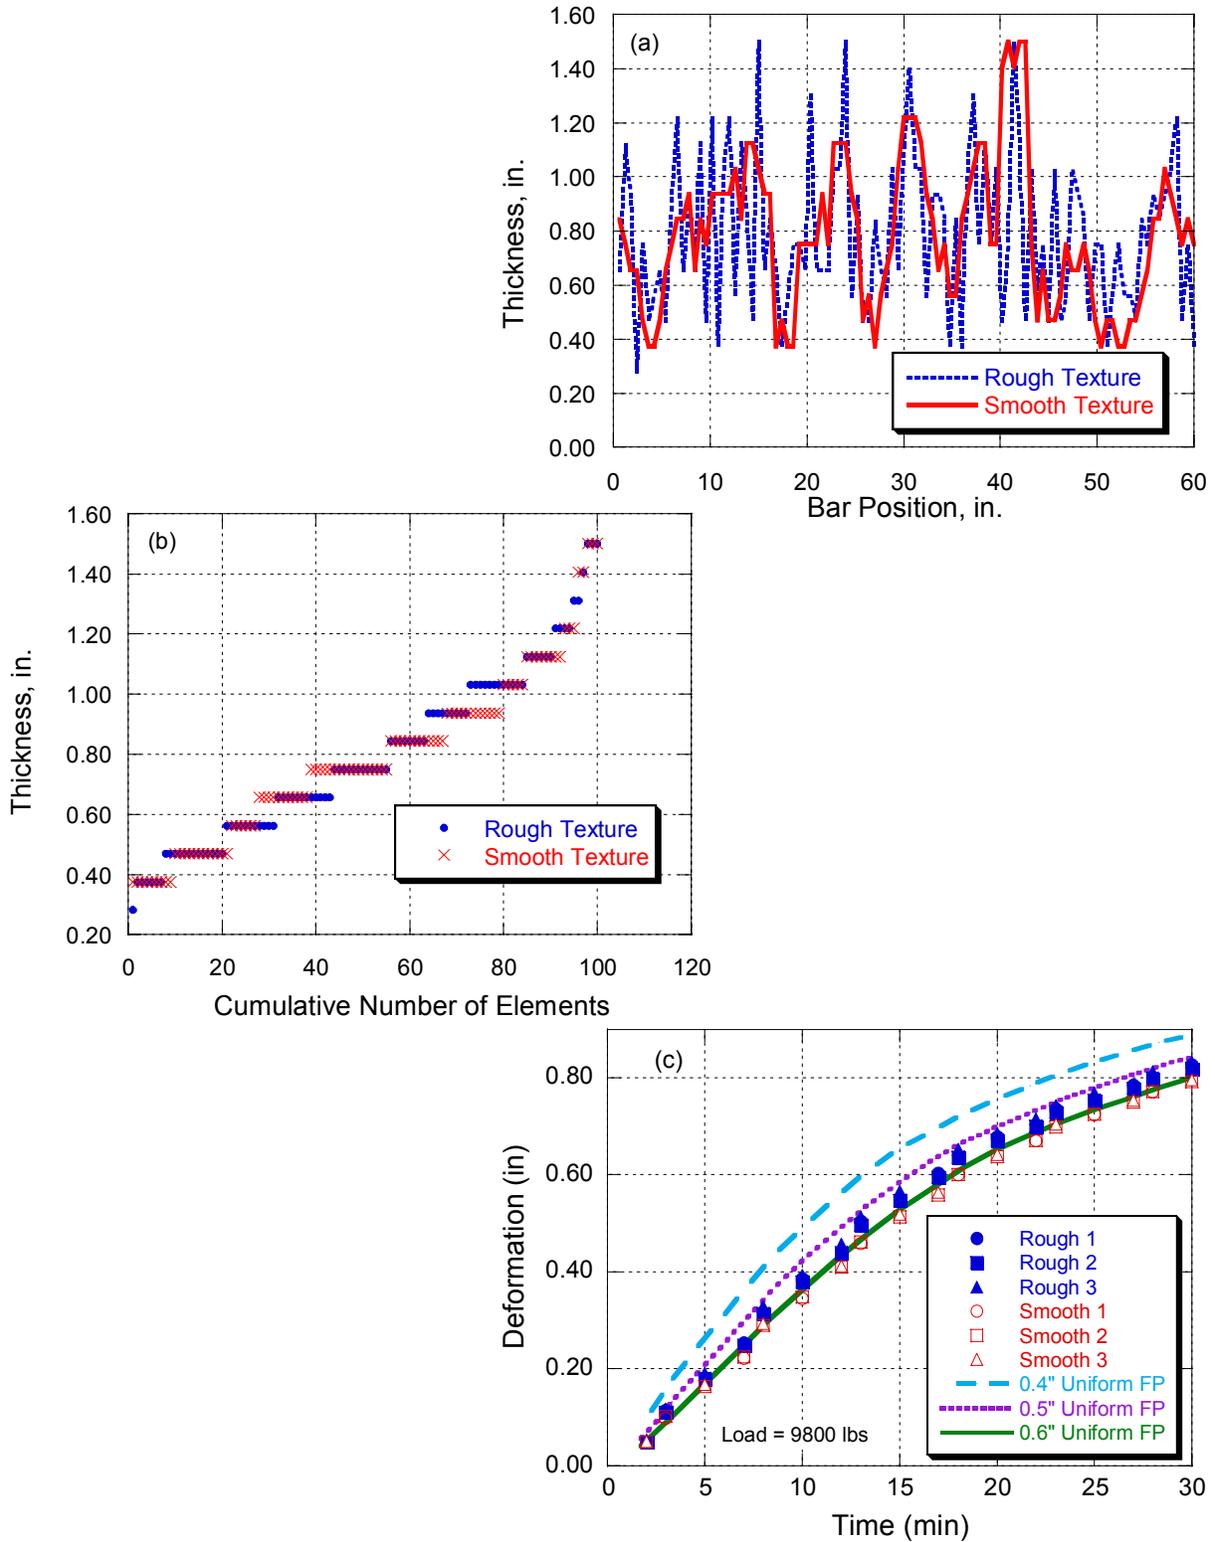
Figure 5-7. (a) Randomly generated thickness profiles with average thickness of 0.75 in. and standard deviation of 0.3 in., (b) cumulative element size, and (c) deformation of 1 in. bar compared with deformation for uniform thickness of thermal insulation.
