**NIST NCSTAR 1-6A**

**Federal Building and Fire Safety Investigation of the  
World Trade Center Disaster**

**Passive Fire Protection**

September 2005

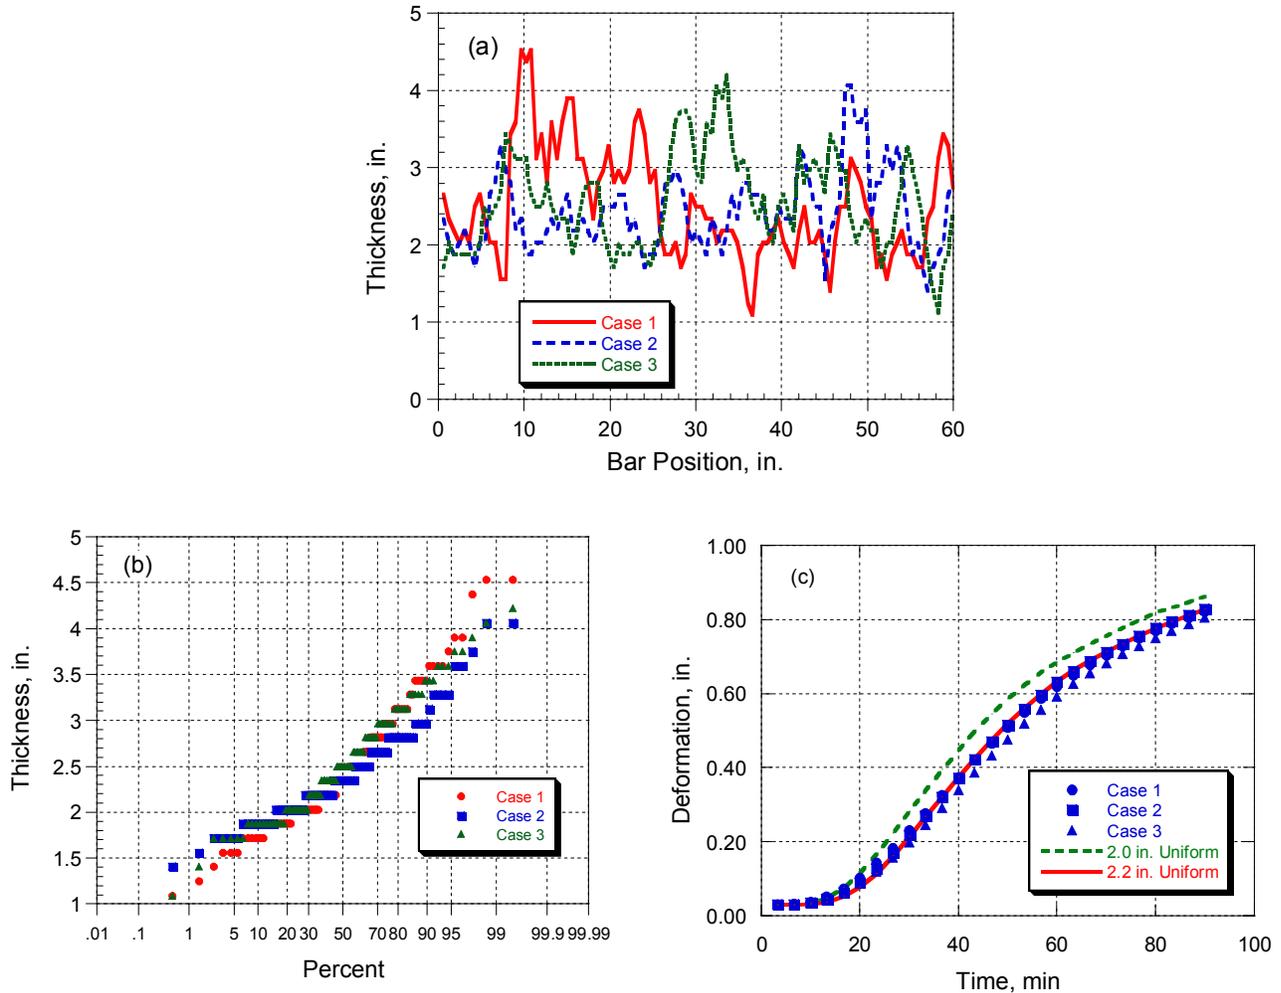
**Figure 5–8. (a) Randomly generated thickness profiles with average thickness of 2.5 in. and standard deviation of 0.6 in., (b) normal probability plots of thickness values, and (c) deformation of 1 in. bar compared with deformation for uniform thickness of thermal insulation.**

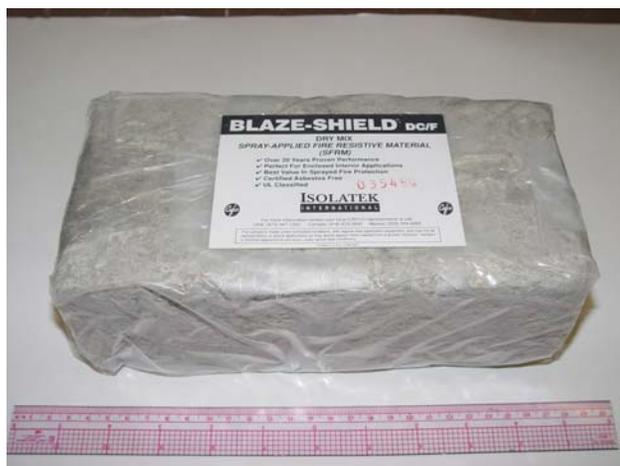
**Figure 6–1. BLAZE-SHIELD DC/F sample used for thermophysical property measurements.**

Samples of BLAZE-SHIELD DC/F and II were purchased from Isolatek, Inc. in Stanhope, New Jersey, and samples of Monokote MK-5 were purchased from W.R. Grace and Co. in Cambridge, Massachusetts, according to their respective application manuals. Since Monokote MK-5 is no longer on the market, it was manufactured specially by W.R. Grace according to the original MK-5 formulation. The samples were made from the same batch of raw materials, shipped to NIST for examination and documentation, and sent to Laboratory A for testing. The samples were 9 in. long, 4.5 in. wide, and 3 in. thick. These dimensions were dictated by the test methods used. Three samples of each material were sent for testing. Two of them were used for the thermal conductivity measurements, and the third was used to prepare specimens for the other measurements involved. Figures 6-1, 6-2, and 6-3 show photographs of samples of BLAZE-SHIELD DC/F, BLAZE-SHIELD II, and Monokote MK-5, respectively.

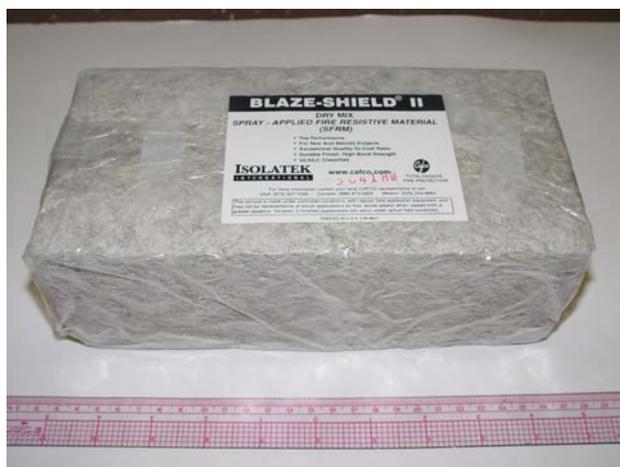
**Figure 6–2. BLAZE-SHIELD II sample used for thermophysical property measurements.**

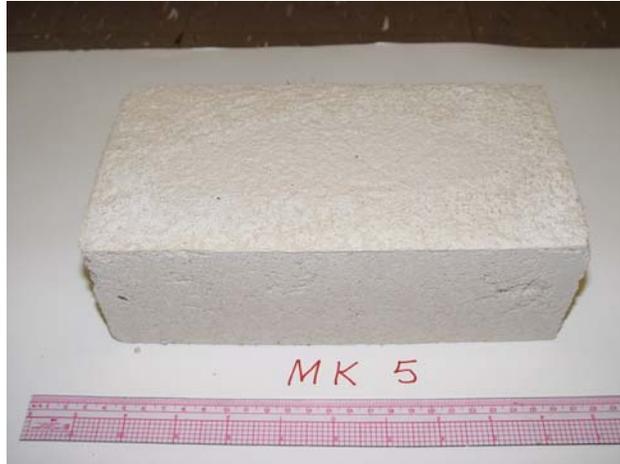
**Figure 6–3. Monokote MK-5 sample used for thermophysical property measurements.**

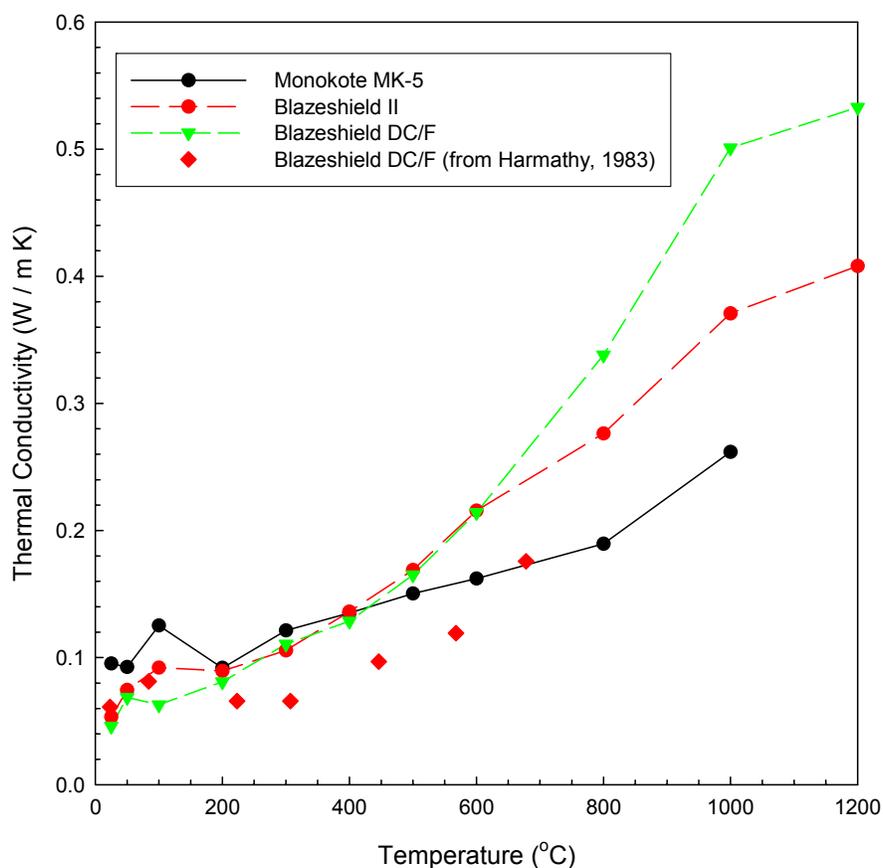
**Figure 6–4. Thermal conductivities of the three SFRMs as a function of temperature.**

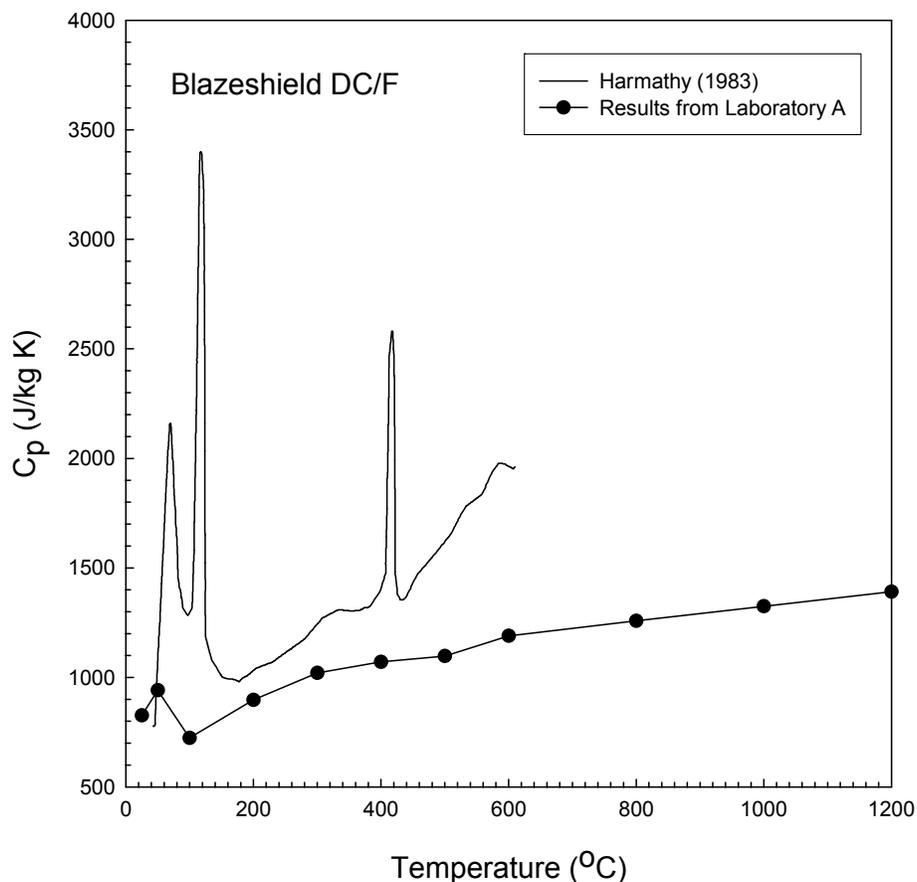
**Figure 6–5. Comparison of BLAZE-SHIELD DC/F specific heat capacity measurements from Harmathy (1983) with present results from Laboratory A.**

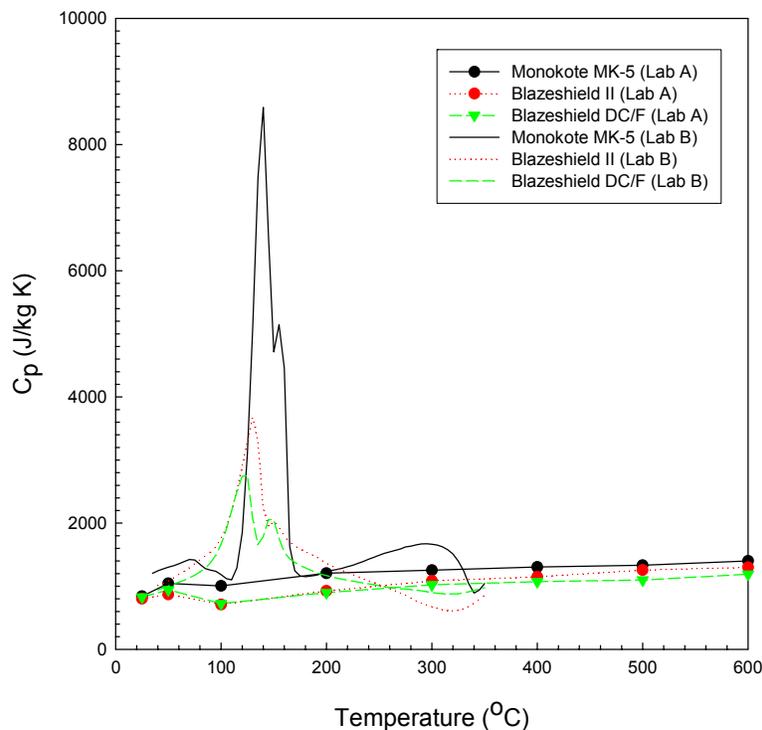
**Figure 6–6. Comparison of specific heat capacity measurements from Laboratory B with results from Laboratory A.**

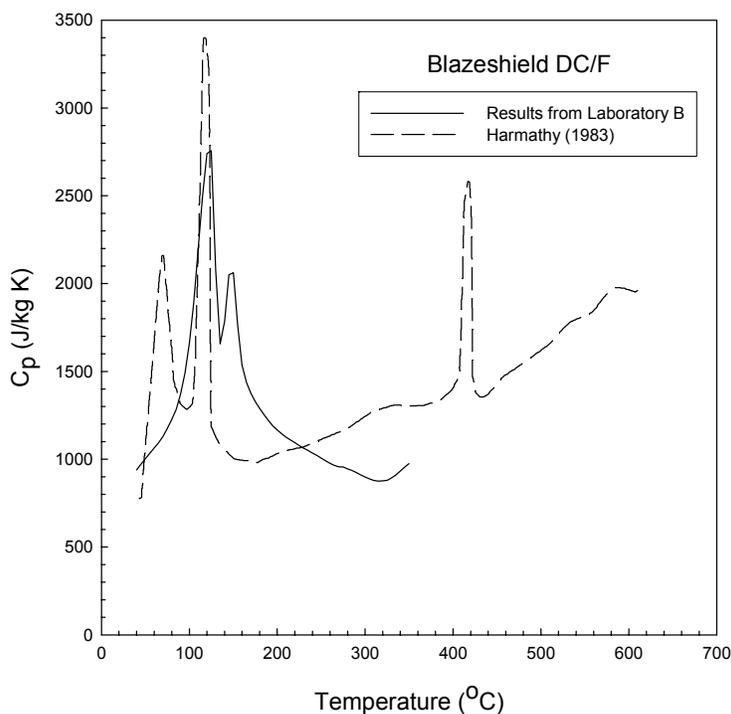
**Figure 6–7. Comparison of specific heat capacity measurements for BLAZE-SHIELD DC/F from Laboratory B with the results from Harmathy (1983).**

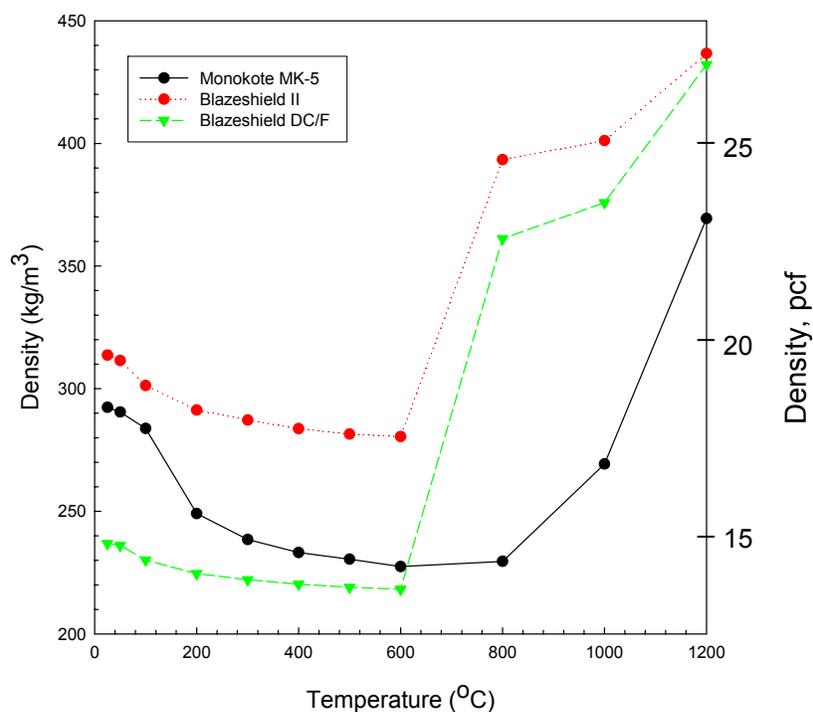
**Figure 6–8. Bulk densities of the three SFRMs as a function of temperature.**

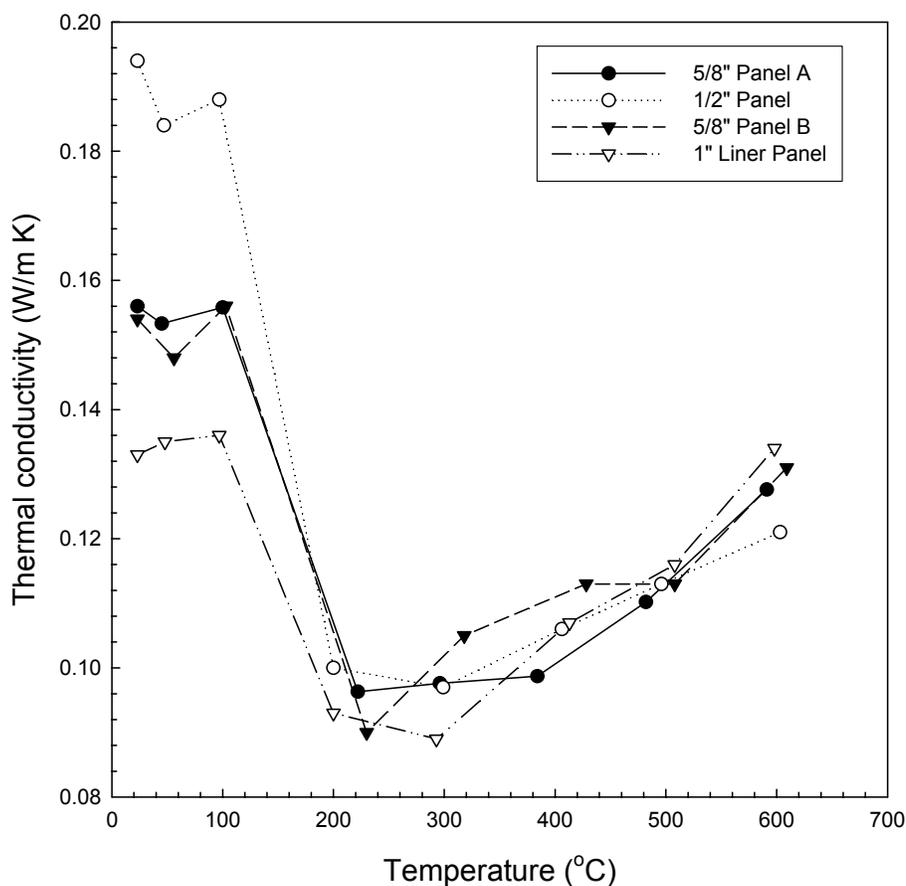
**Figure 6–9. Thermal conductivities of the four gypsum materials as a function of temperature.**

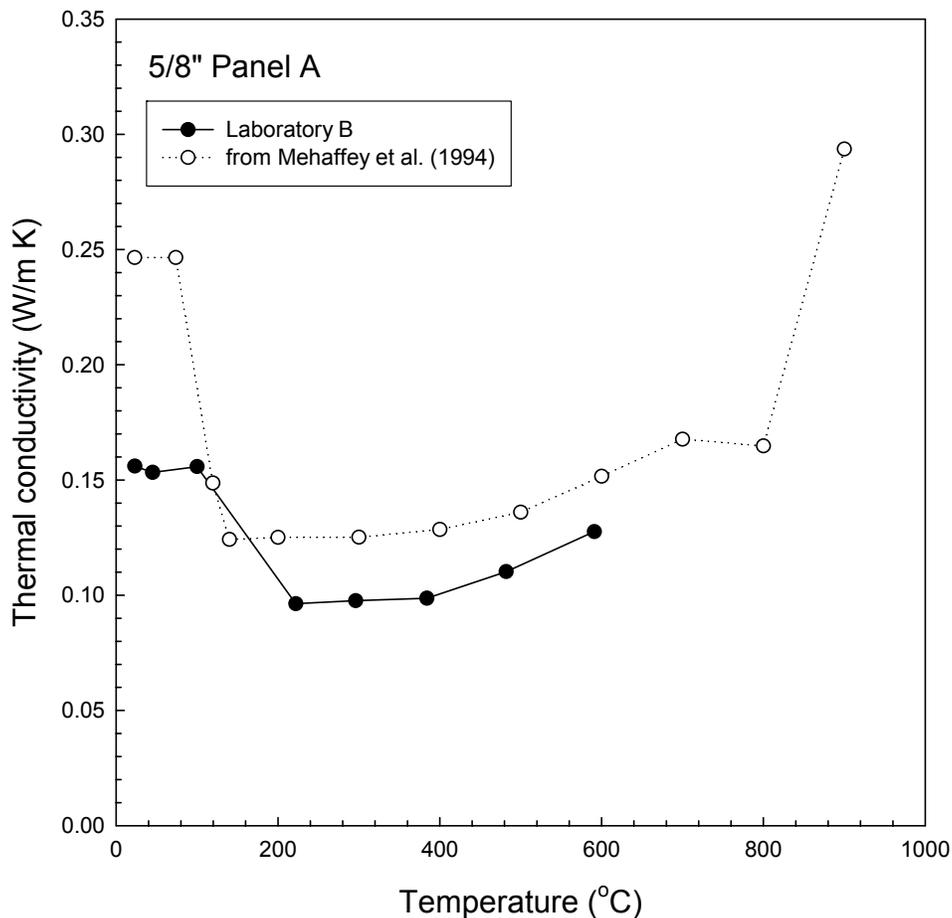
**Figure 6–10. Comparison of the thermal conductivity measurements from Laboratory B with the data from Mehaffey et al. (1994) for 5/8 in. thick gypsum panel A.**

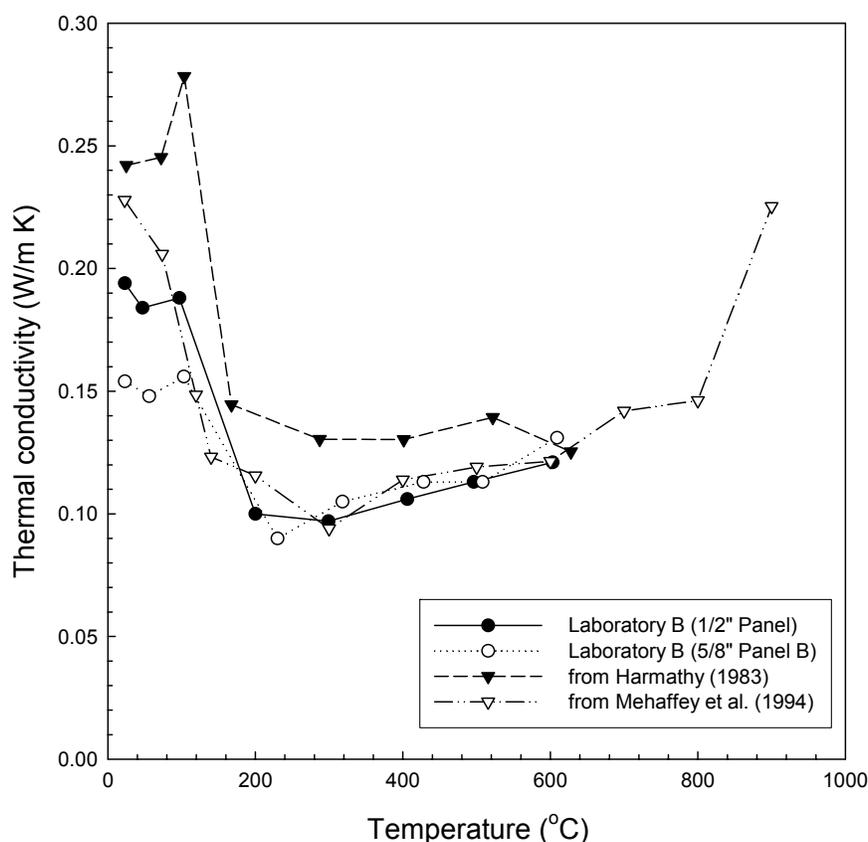
**Figure 6–11. Comparison of thermal conductivity measurements from Laboratory B with other literature values for ½ in. thick gypsum panel and 5/8 in. thick gypsum panel B.**

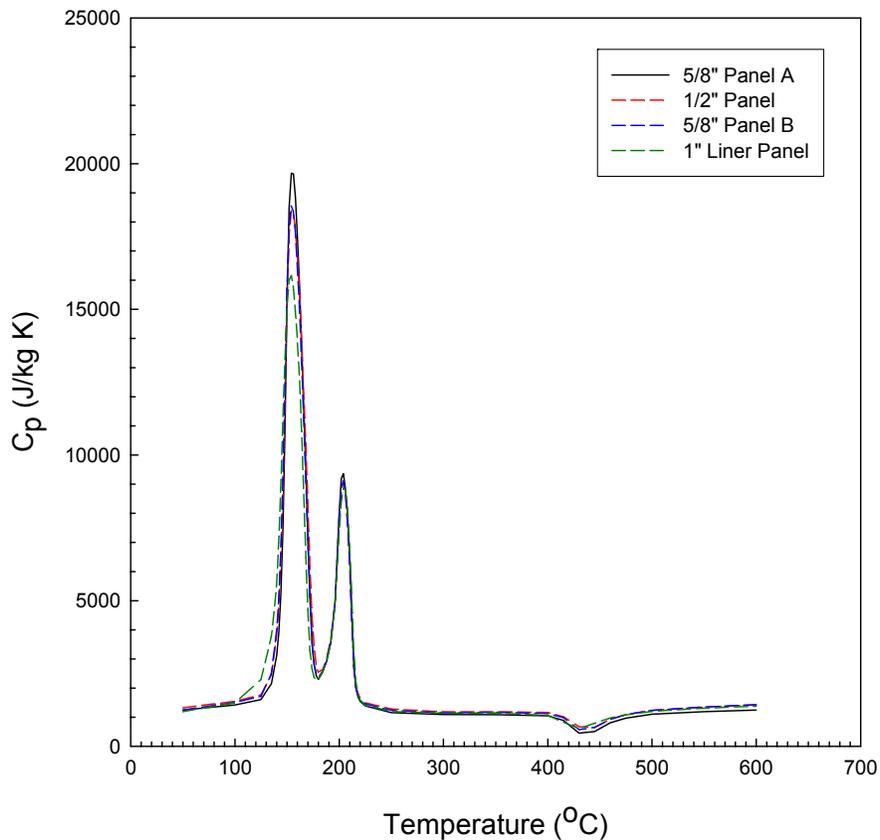
**Figure 6–12. Comparison of specific heat capacities for the four gypsum materials.**

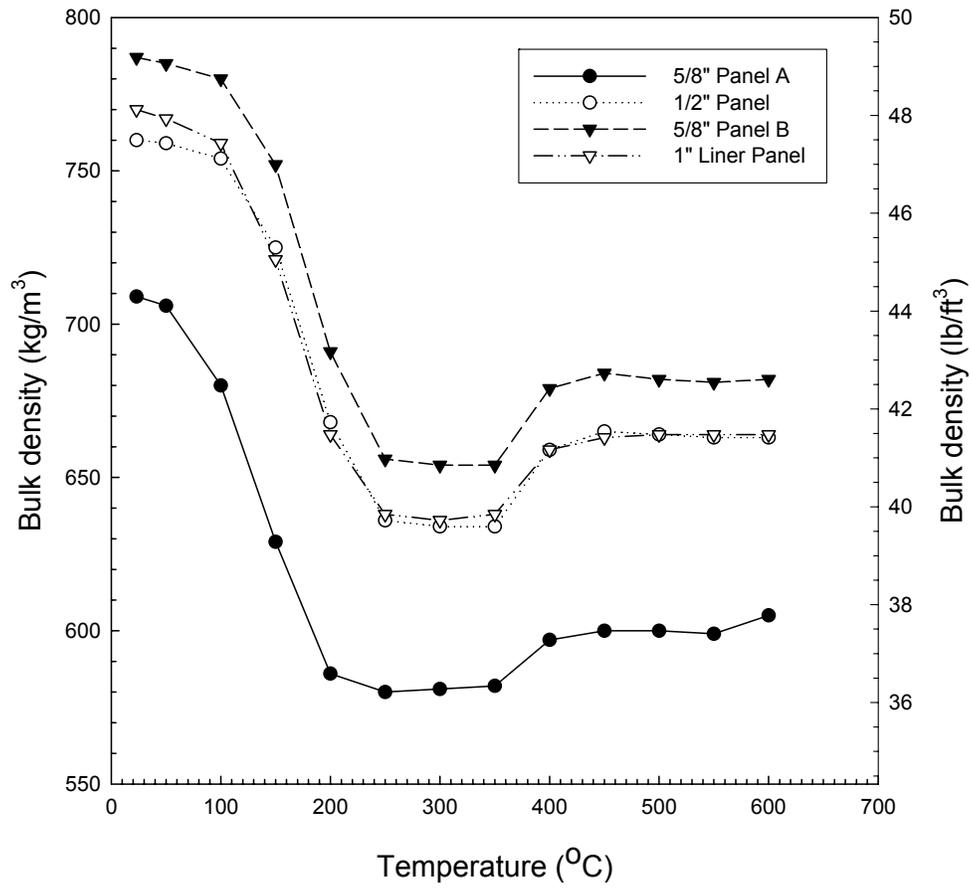
Figure 6–13. Bulk densities of the four gypsum materials as a function of temperature.

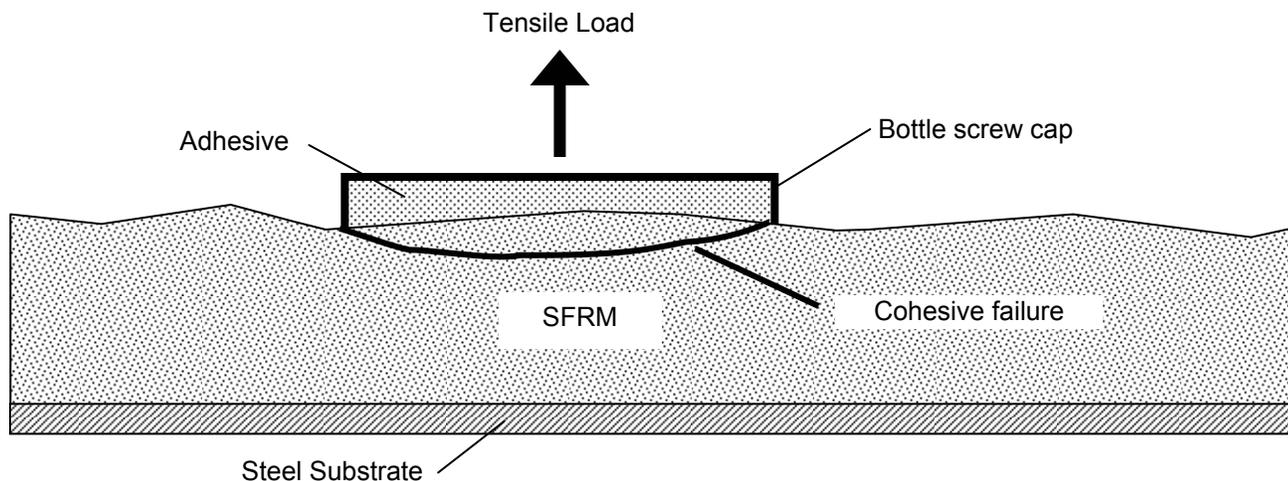
**Figure 7–1. Bond strength test using screw cap in accordance with ASTM E 736.**

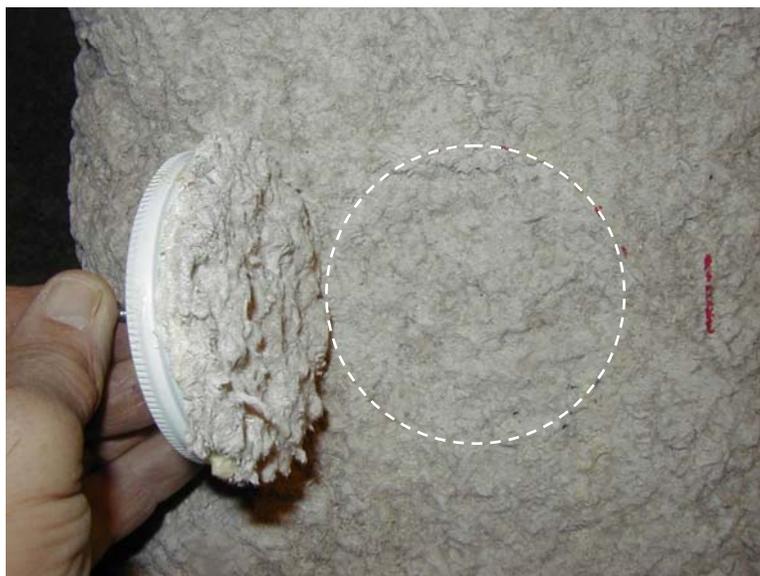
**Figure 7–2. Cohesive failure of SFRM using ASTM E 736 test (dashed circle is approximate location of cap before being pulled off).**

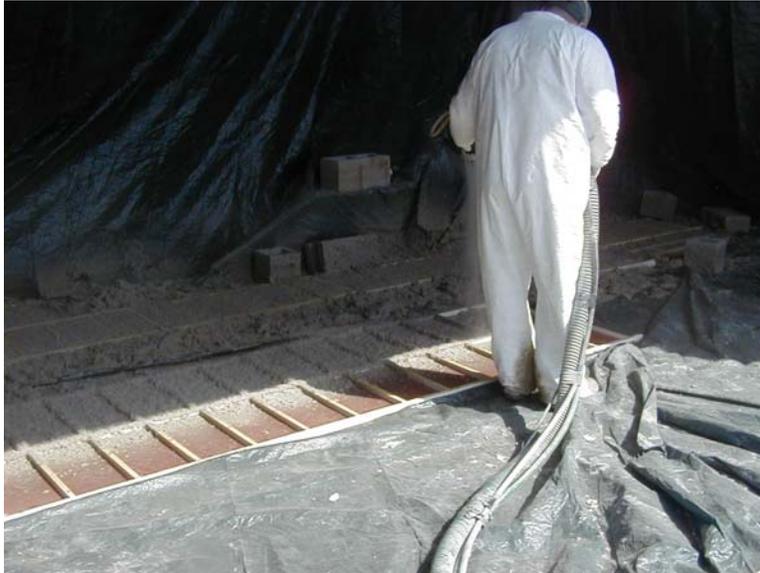
**Figure 7–5. Spraying steel plates with BLAZE-SHIELD DC/F.**

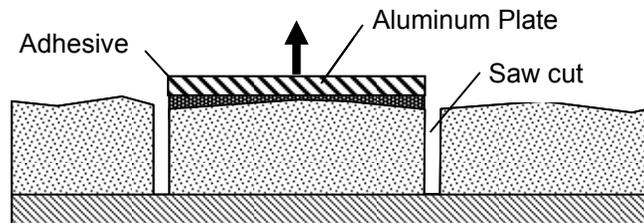
**Figure 7–6. Schematic of “pull-off” test method used to measure cohesive and adhesive strengths.**

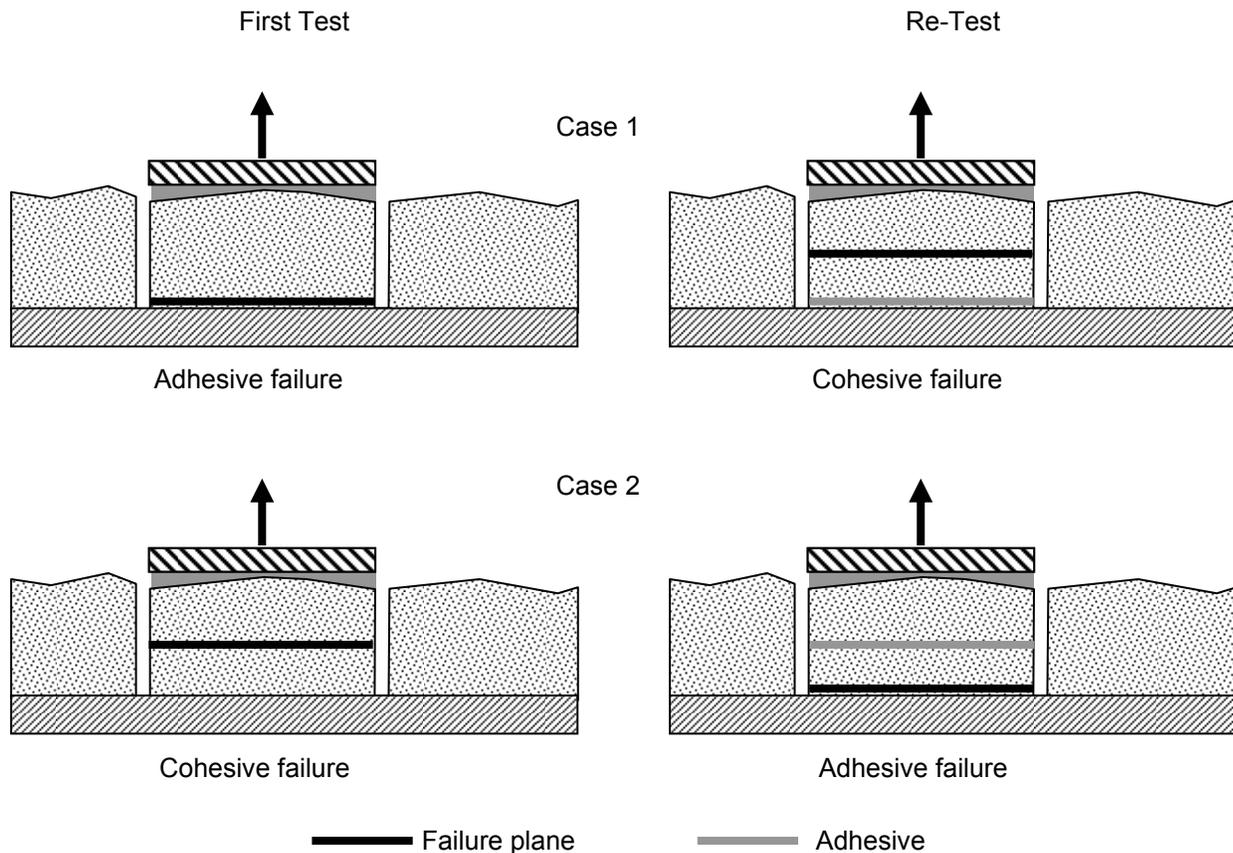
**Figure 7-7. Technique used to measure both “adhesive” and “cohesive” strength in the same specimen.**

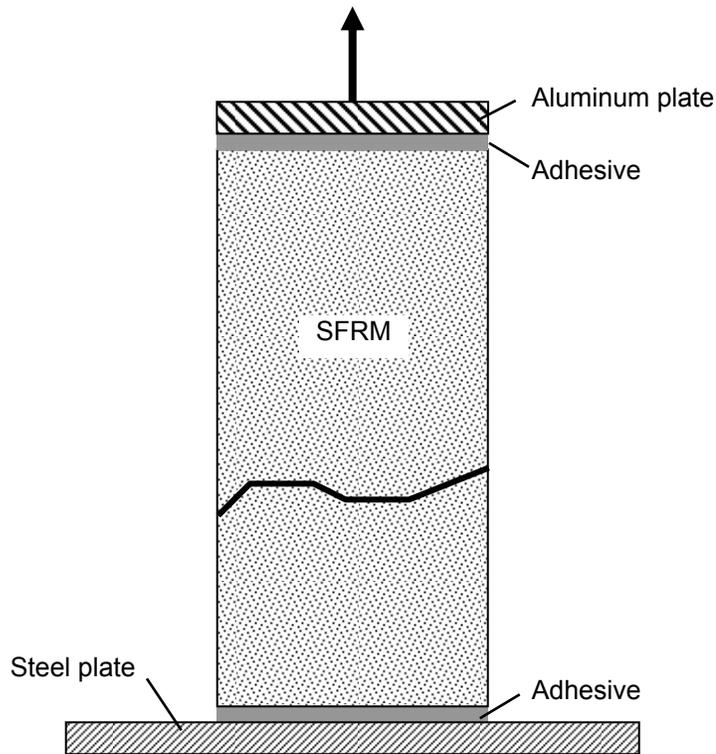
**Figure 7–8. Method to measure cohesive strength parallel to SFRM surface (in-plane cohesive strength).**

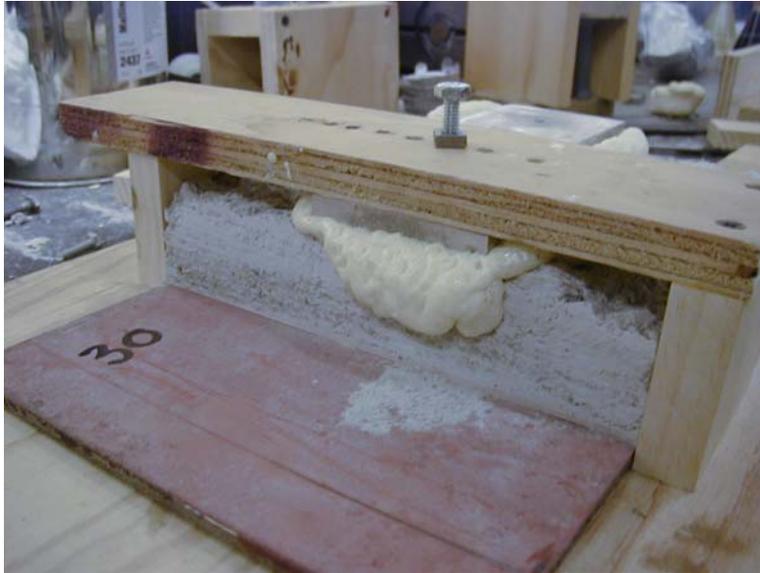
**Figure 7–11. Aluminum plate being bonded to the top surface of SFRM specimen; the wooden fixture is used to maintain the correct alignment of the plate.**

For the adhesive/cohesive strength tests, an aluminum plate was bonded to the top surface using a fast curing, two-component urethane foam adhesive. Fixtures were used to ensure that the bonded plate was parallel to the steel plate (see Fig. 7-11). After the adhesive had cured, the SFRM layer was cut as shown in Fig. 7-12 so as to produce a prismatic test specimen. A hook was screwed into the aluminum plate and a load was applied by hand using a 50 lb digital force gauge (see Fig. 7-13). The force gauge was able to store the peak load attained during the test. During loading, the steel plate was placed on the floor, and a foot was placed at each end of the plate to provide resistance to the applied tensile load. The average length and width of the failure area was measured and used to compute the adhesive or cohesive strength.

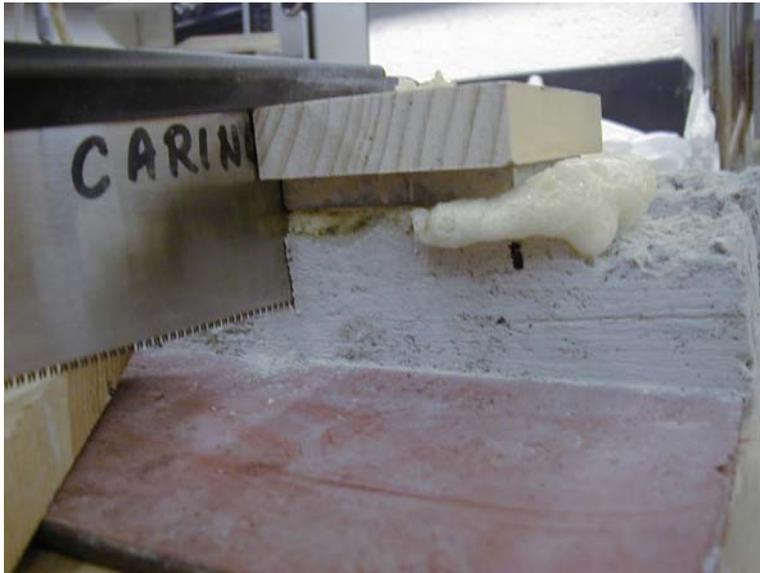
**Figure 7–12. Preparing the SFRM specimen for adhesion/cohesion test.**

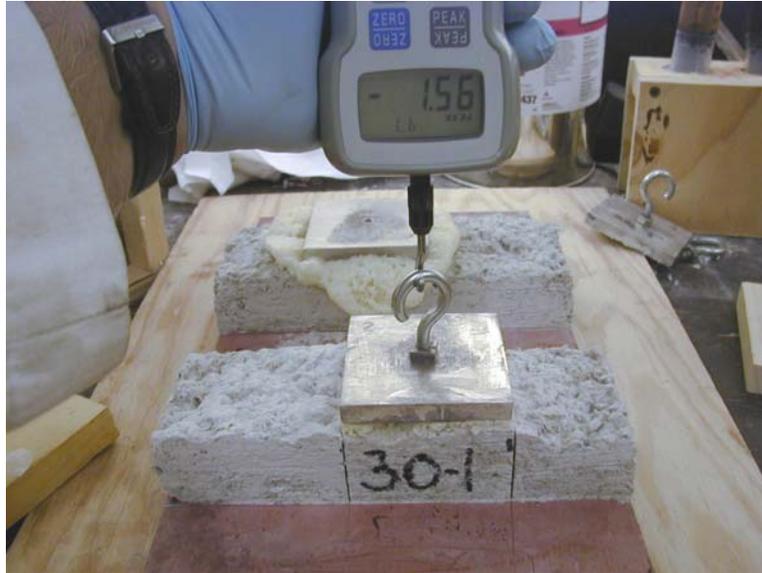
Figure 7–13. Manual application of tensile load using digital force gauge.

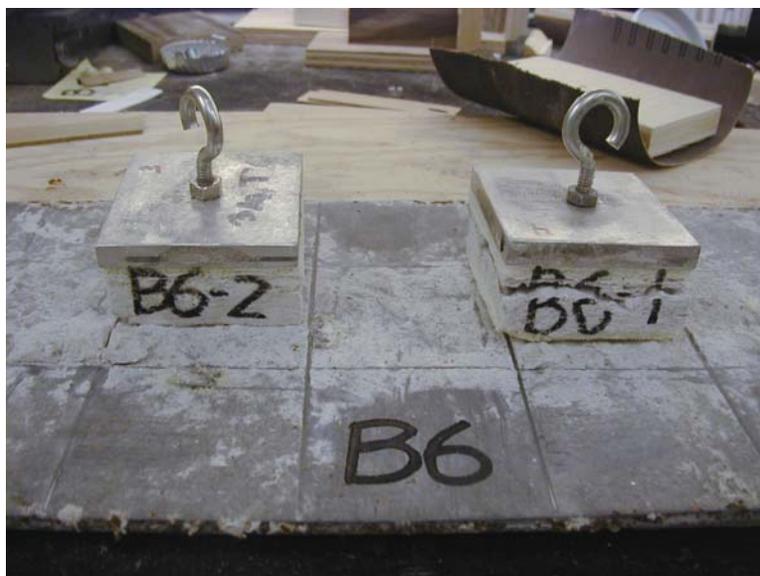
**Figure 7–15. Results of second tests after repair: specimen on left had adhesive failure and specimen on right had cohesive failure.**

After the first test, the specimen was repaired with the same polyurethane adhesive, and the test was repeated as discussed in Section 7.2.2. Figure 7-14 shows two specimens after the first test. The specimen on the left failed in the bulk material, thereby giving a measure of the cohesive strength normal to the surface. The specimen on the right failed near the SFRM/steel interface, which is taken to be the adhesive strength. Figure 7-15 shows the same two specimens after they had been repaired and subjected to the second loading. Now the specimen on the right shows a crack in the bulk material, and the specimen on the left shows separation near the SFRM/steel interface. Note that for the specimen on the right, which had an adhesive failure during the first loading, the failed specimen was bonded to a bare steel plate (not shown) for the second test to measure cohesive strength. In some cases where the first failure was cohesive, the repeated test also resulted in cohesive failure. In these cases, the specimen was repaired as often as needed until an adhesive failure occurred.

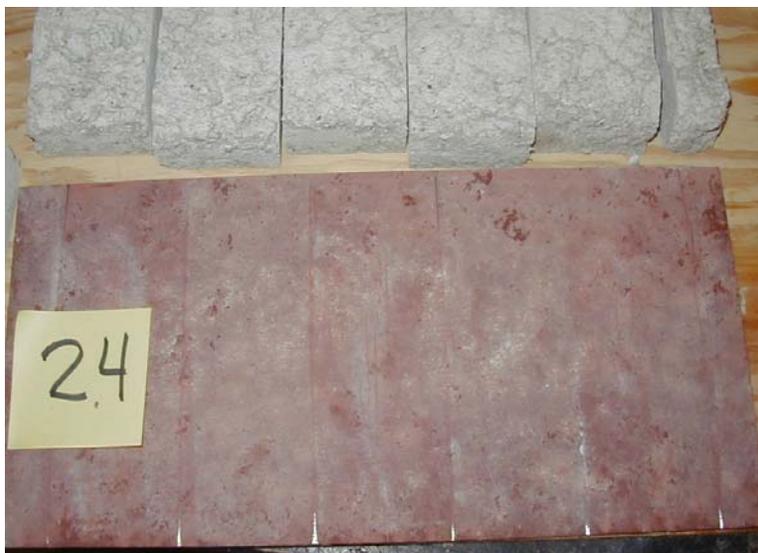
**Figure 7–21. Example of lack of adhesion in 1½ in. SFRM on steel plate with primer.**

The results of these tests show that BLAZE-SHIELD DC/F is not compatible, from an adhesion point of view, with the Tnemec 99 Red Metal Primer used in this study and that was specified for the exterior columns of the WTC towers.

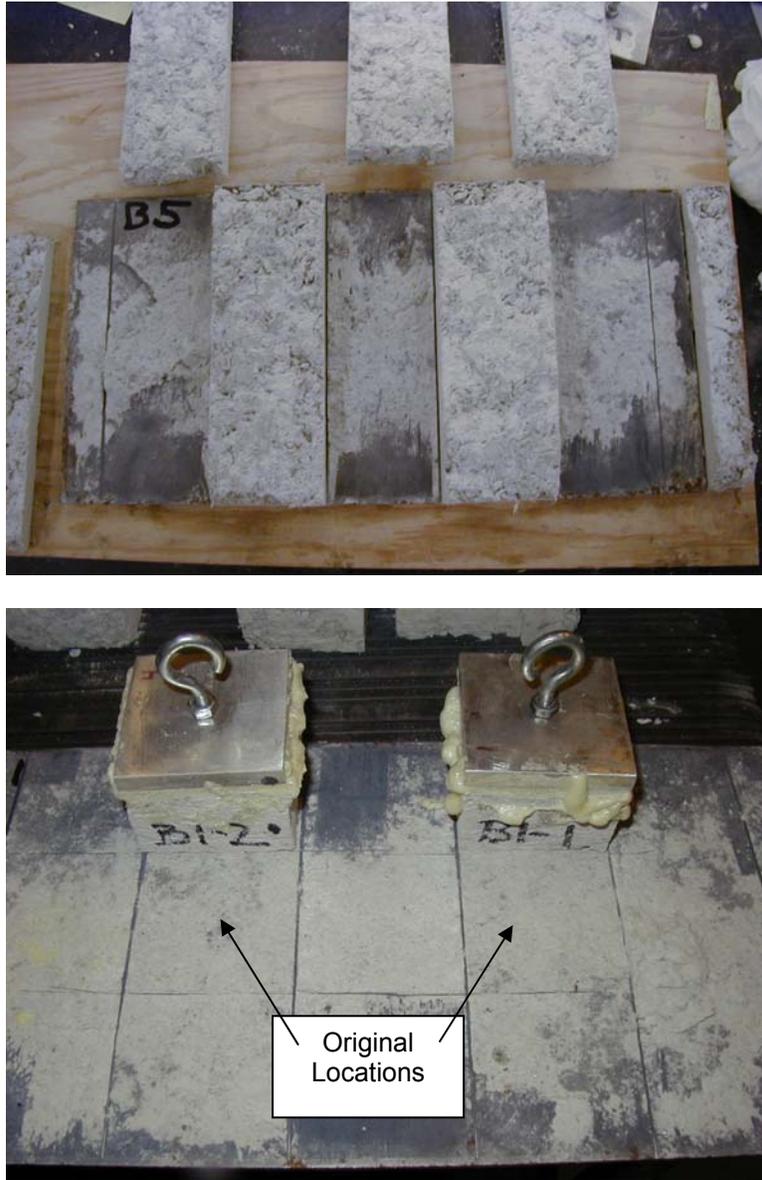
**Figure 7–22. Examples of good adhesion in specimens with unprimed steel plates: (top)  $\frac{3}{4}$  in. SFRM specimen before testing; (bottom)  $1\frac{1}{2}$  in. SFRM specimen after completion of tests.**

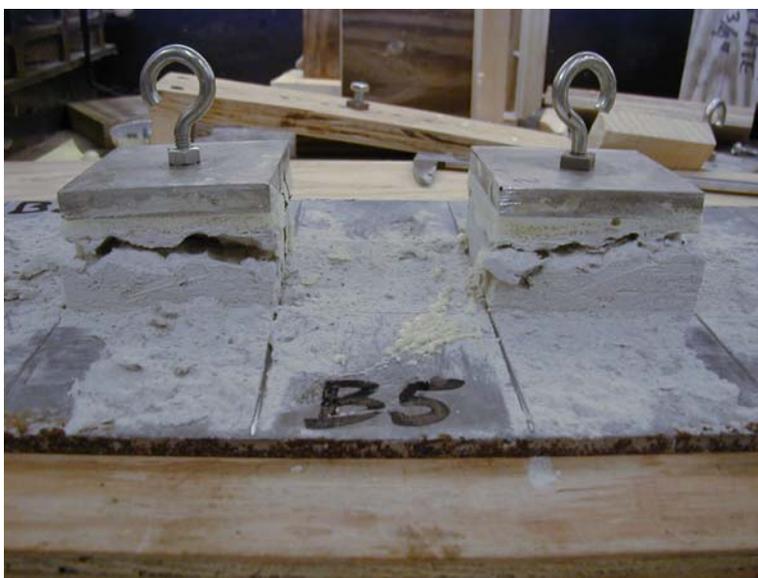
**Figure 7–24. Examples of cohesive failure in 1½ in. SFRM specimens.**

As discussed in Section 7.2.3, the same specimens were tested twice (in some cases three times) so as to determine the adhesive and cohesive strength normal to the surface. Figure 7-24 shows examples of cohesive failures in 1½ in. SFRM specimens. These specimens were subsequently repaired with the polyurethane foam adhesive, and the adhesive strength was then determined. In general, cohesive failures tended to occur close to the surface of the SFRM layer. This is logical because less compaction would be expected near the surface and perhaps less hydration of cement due to drying.

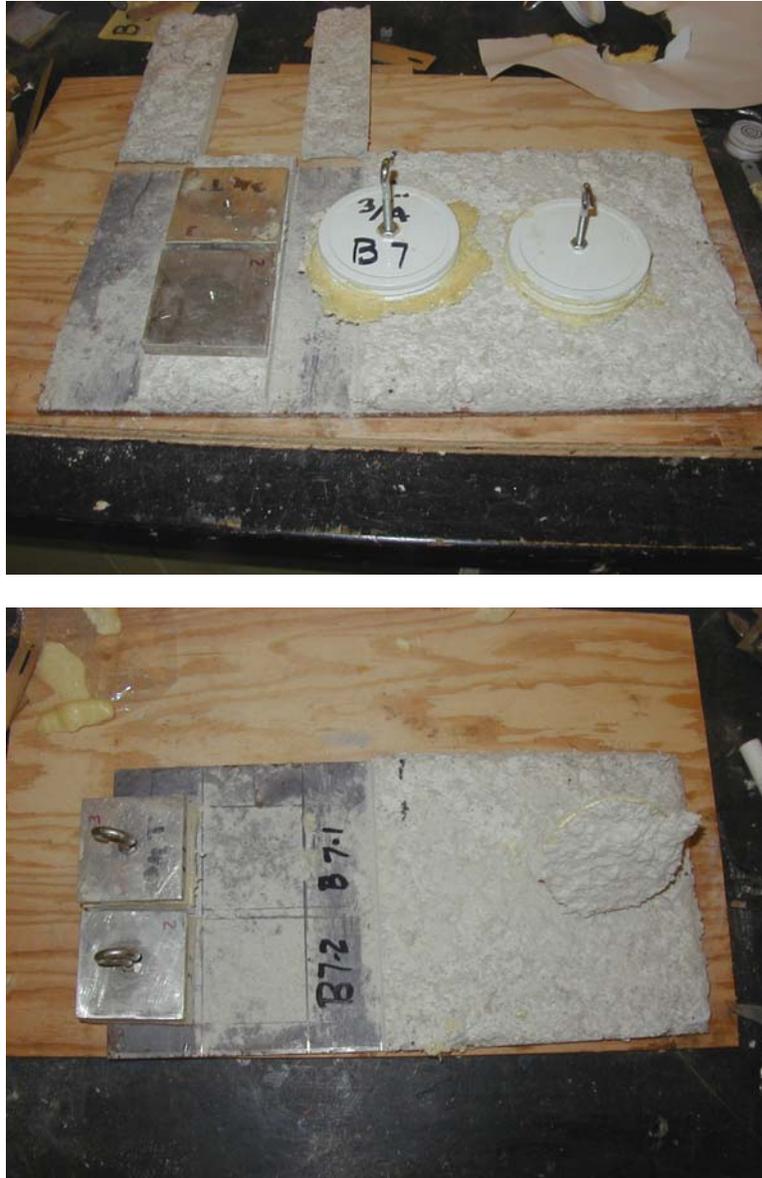
**Figure 7–25. Comparative testing: current method versus ASTM E 736 method: (top) locations of two screw cap tests; (bottom) after completion of tests.**

To compare the results from the current test method, one of the ¾ in. plates with bare steel was also subjected to an ASTM E 736 type test with round screw cap bonded to the top surface. First, a screw-cap test was conducted at the center of the plate, and then three strips were cut as shown in top photo of Fig. 7-25. Another screw cap test was conducted on the right side of the plate, as shown in the bottom photo of Fig. 7-25. Finally, two tests with the current procedure were done on the strip on the left side of the plate. In the bottom photograph it is seen that the screw-cap pulled away in the bulk material near the top surface.

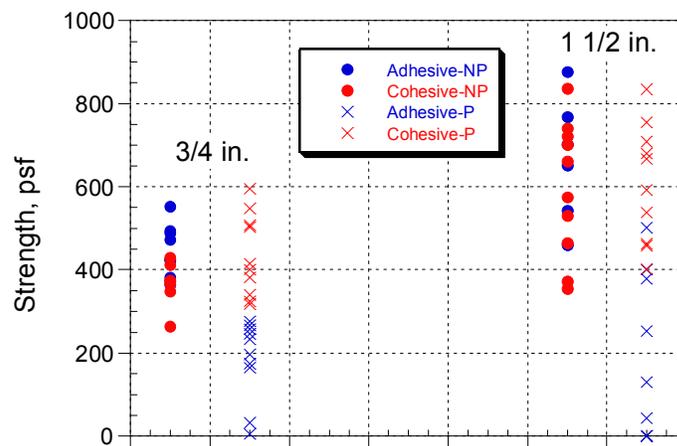
Figure 7–27. Comparison of adhesive strength with cohesive strength normal to surface (P = primed steel, NP = bare steel).

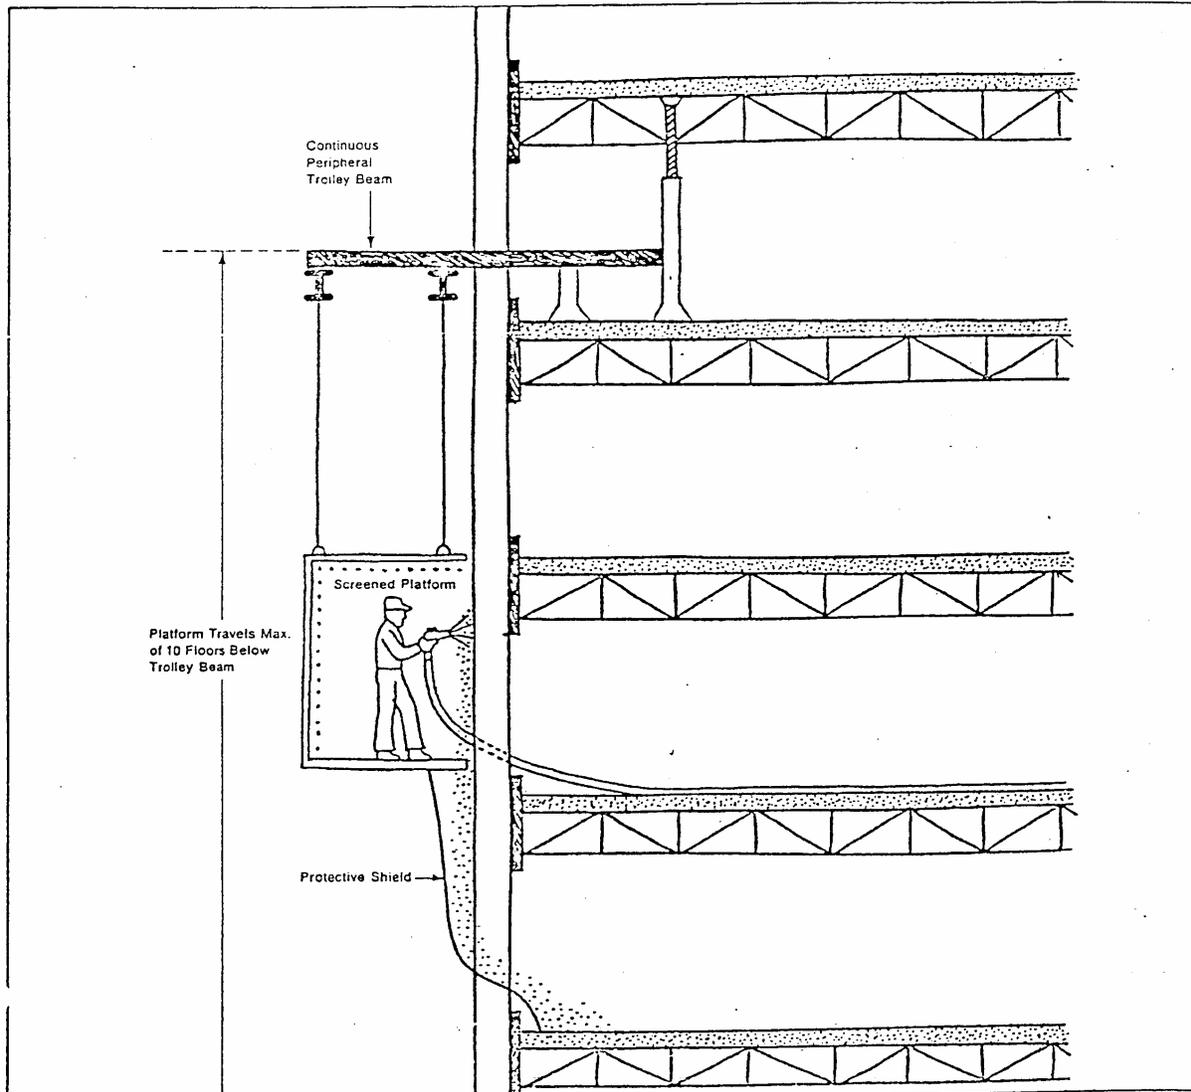
Sketch illustration of spraying of fireproofing from enclosed cage and screen.

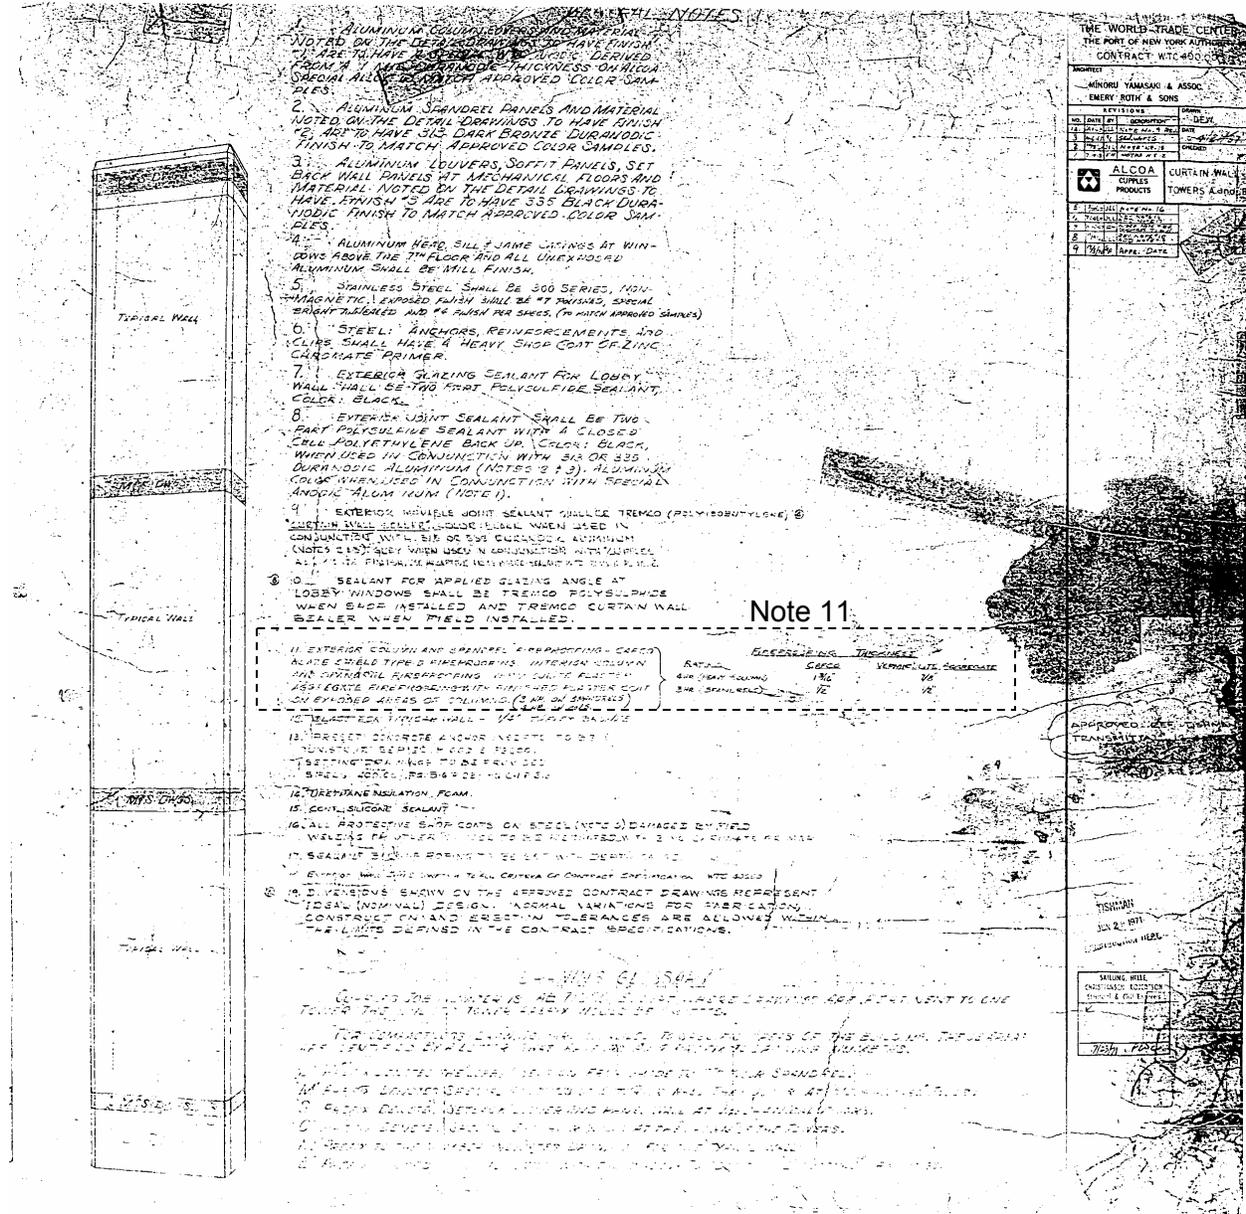
Figure A-25. Portion of "General Notes" page of the Alcoa curtain wall drawings and blow-up of Note 11 indicating the thermal insulation thickness for the exterior columns and spandrels (116-LERA).
