**NIST NCSTAR 1-6A**

**Federal Building and Fire Safety Investigation of the  
World Trade Center Disaster**

**Passive Fire Protection**

September 2005

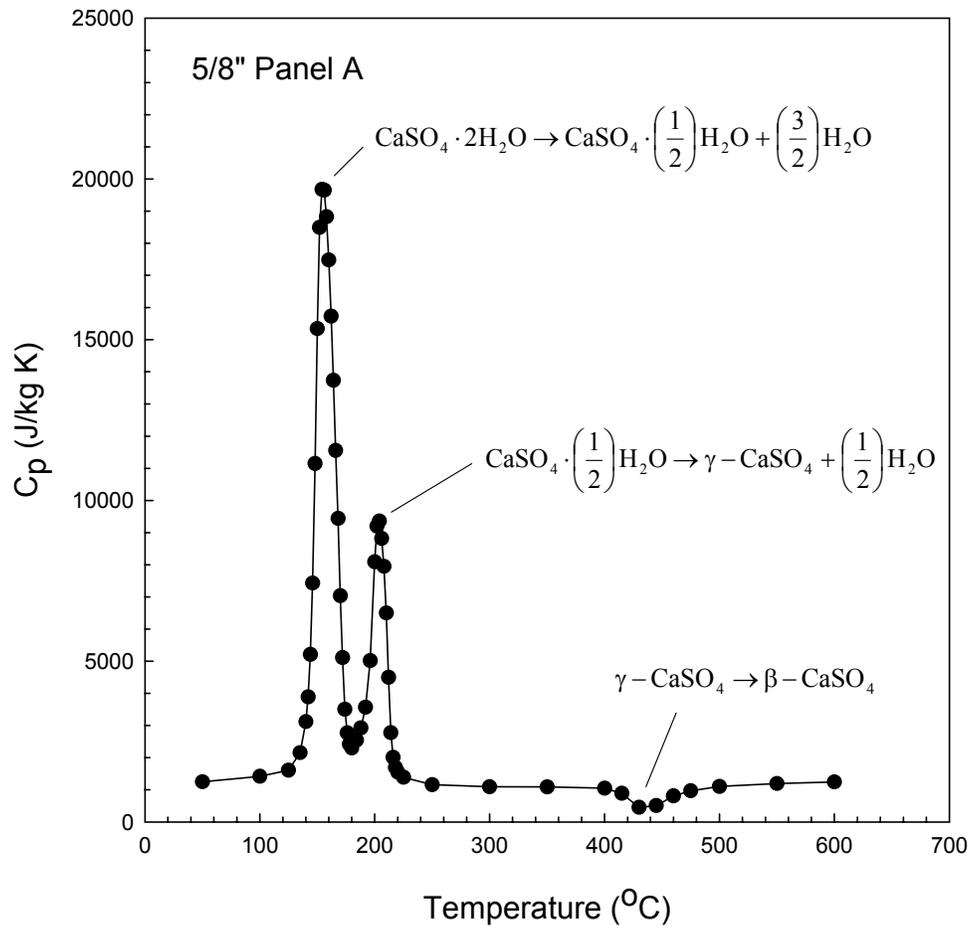
Figure B-1. Specific heat capacity of 5/8 in. gypsum panel A.

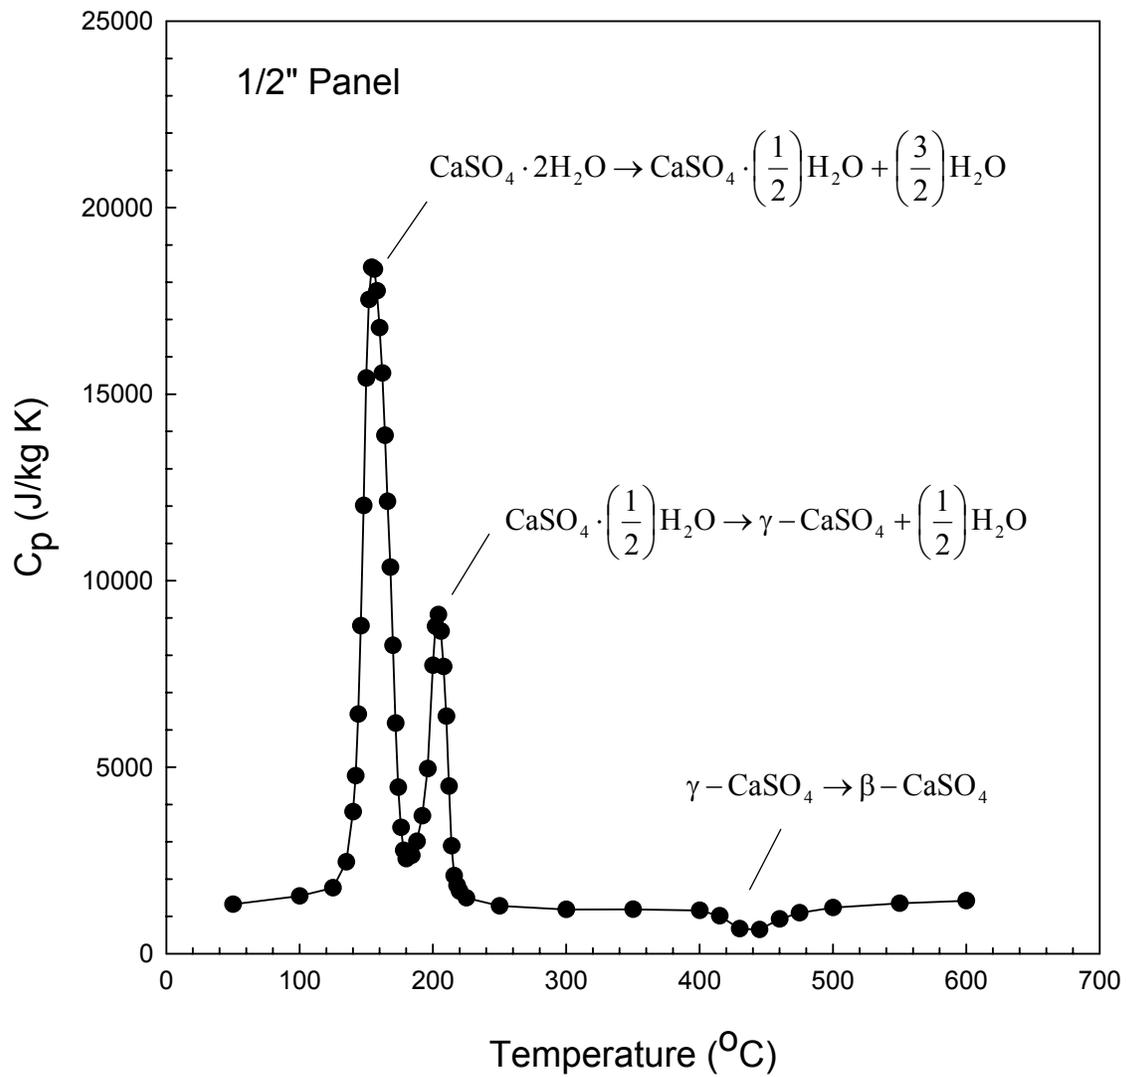
Figure B-2. Specific heat capacity of 1/2 in. gypsum panel.

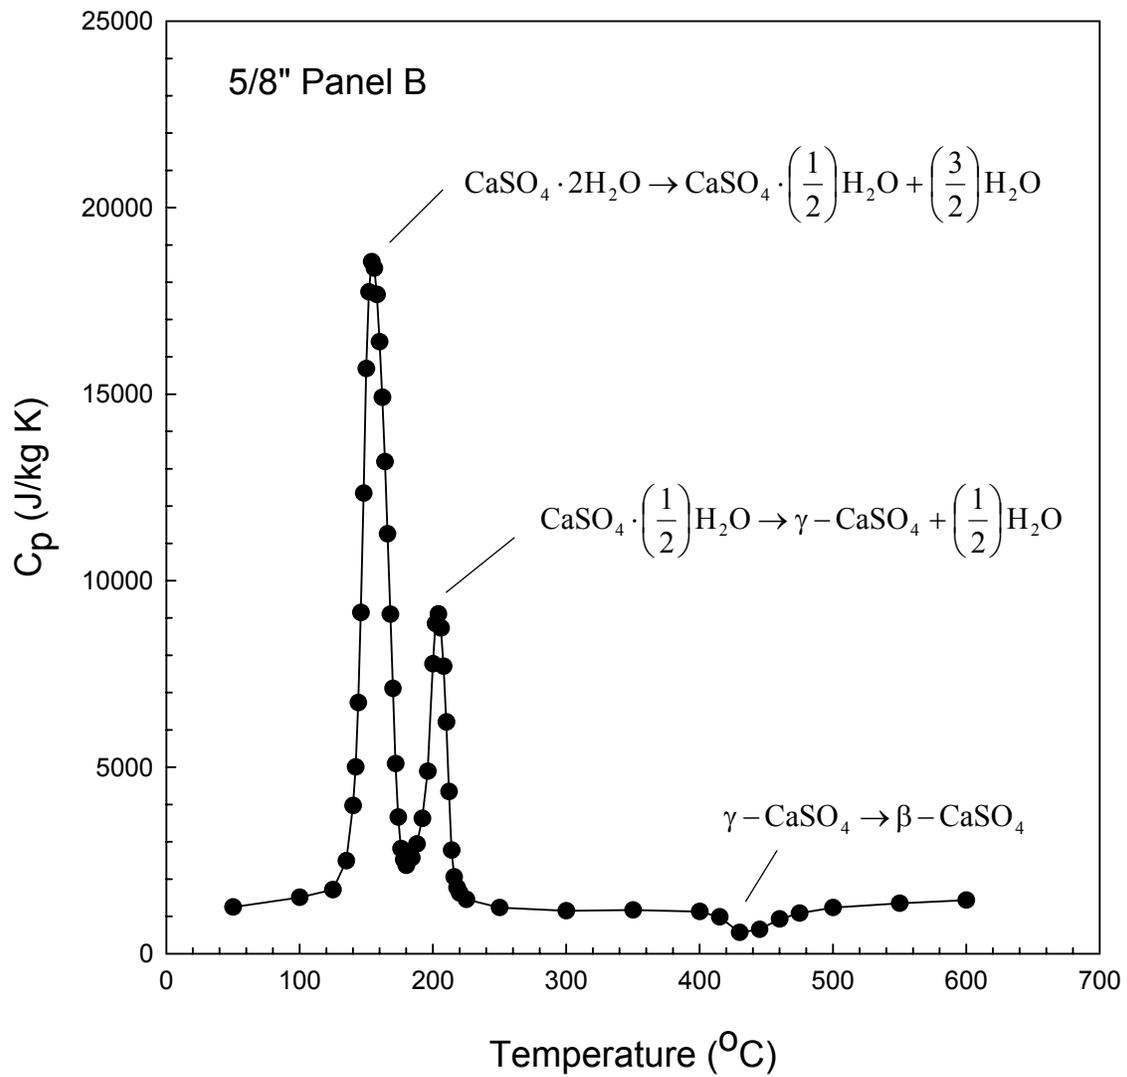
Figure B-3. Specific heat capacity of 5/8 in. gypsum panel B.

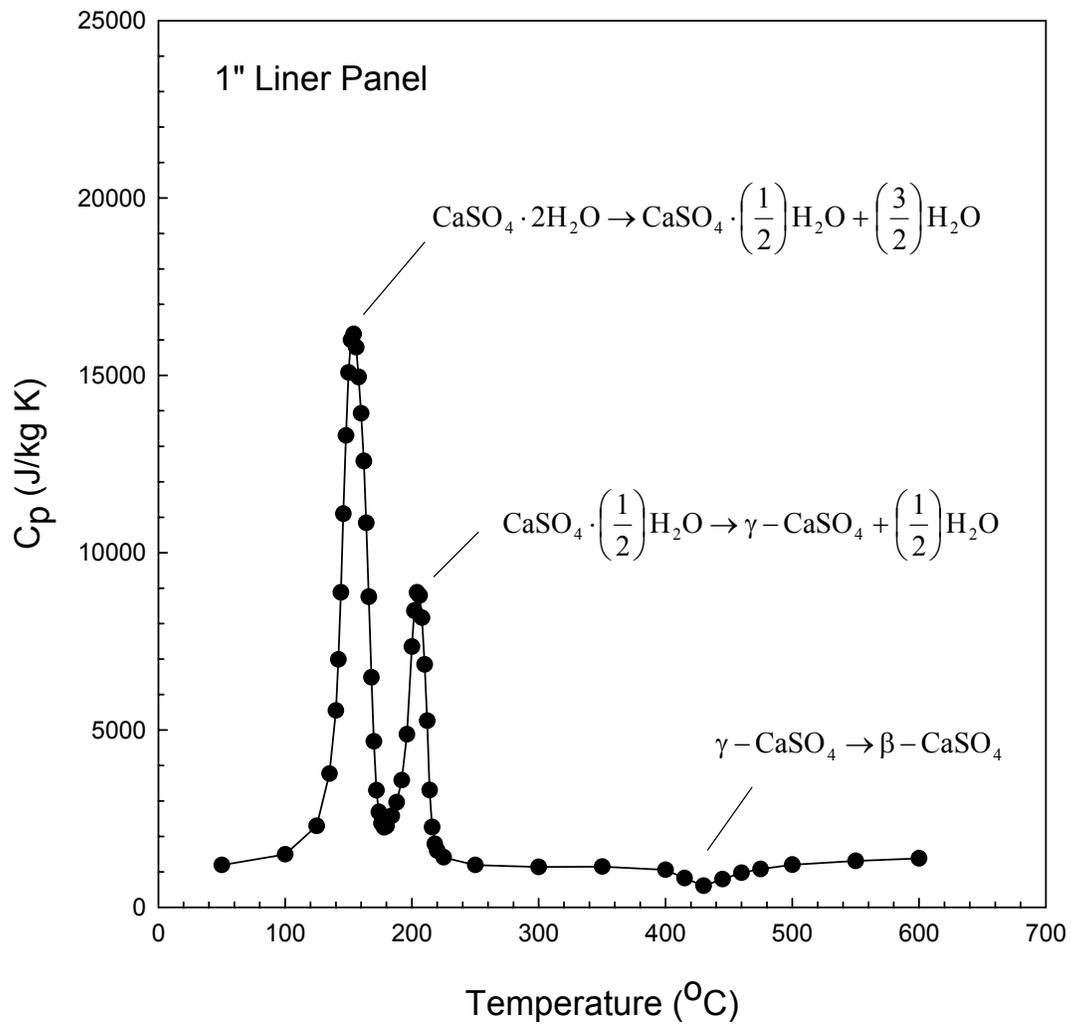
Figure B-4. Specific heat capacity of gypsum 1 in. liner panel.

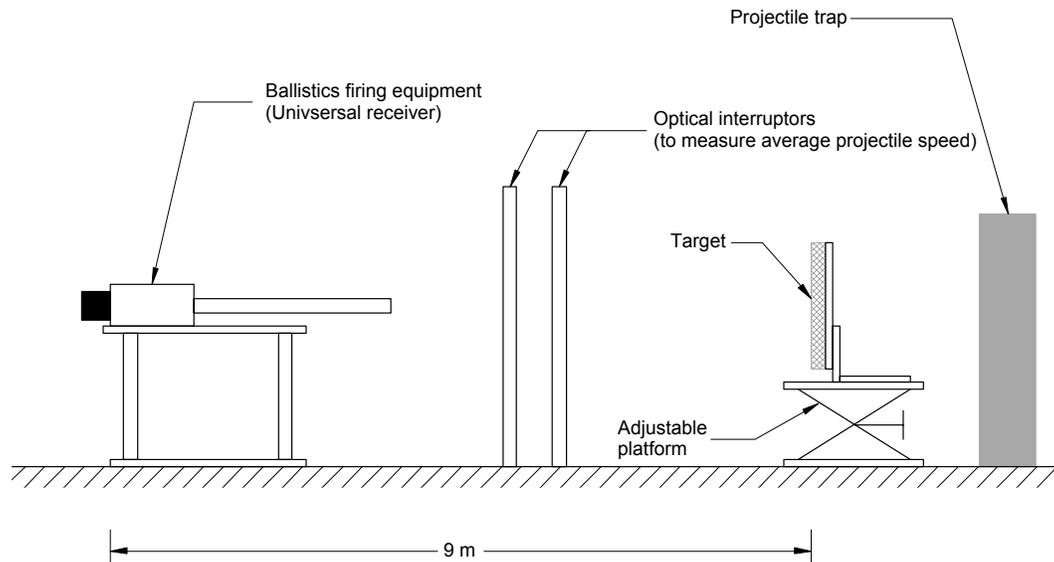
**Figure C-1. Schematic of the ballistic research test facility.**

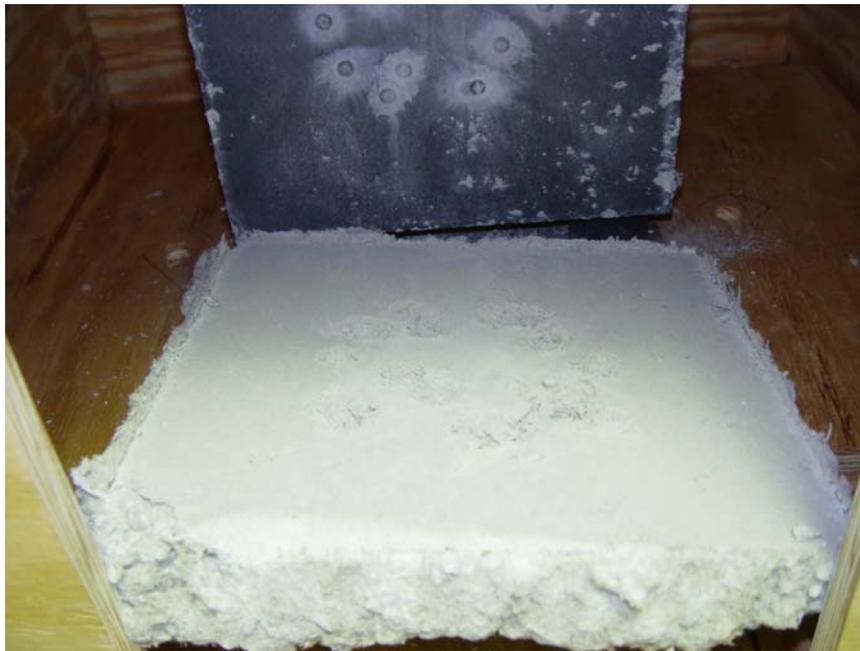
**Figure C-4. Photograph showing damage to the SFRM after a ballistic impact at 0 degree. The SFRM layer completely separated from the steel plate.**

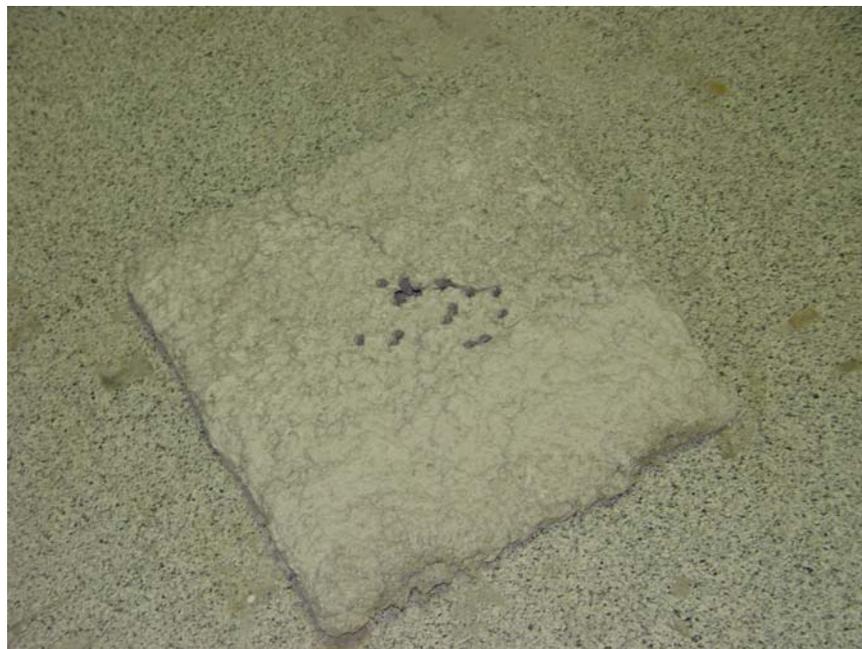
**Figure C-5. Photograph showing damage to the SFRM after a ballistic impact at 20 degree. The SFRM layer completely separated from the steel plate and landed on the floor.**

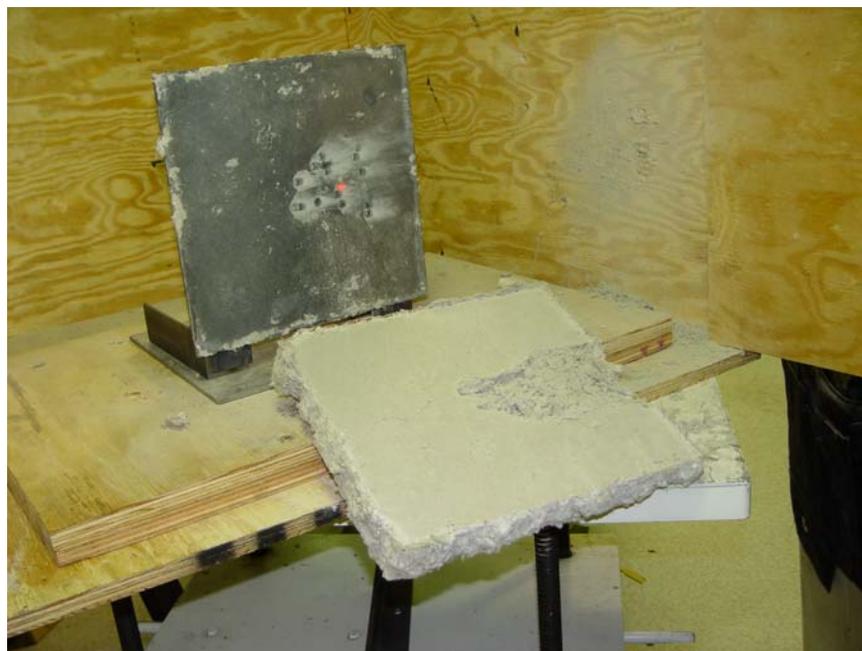
**Figure C-6. Photograph showing damage to the SFRM after a ballistic impact at 40 degree. The SFRM layer completely separated from the steel plate.**

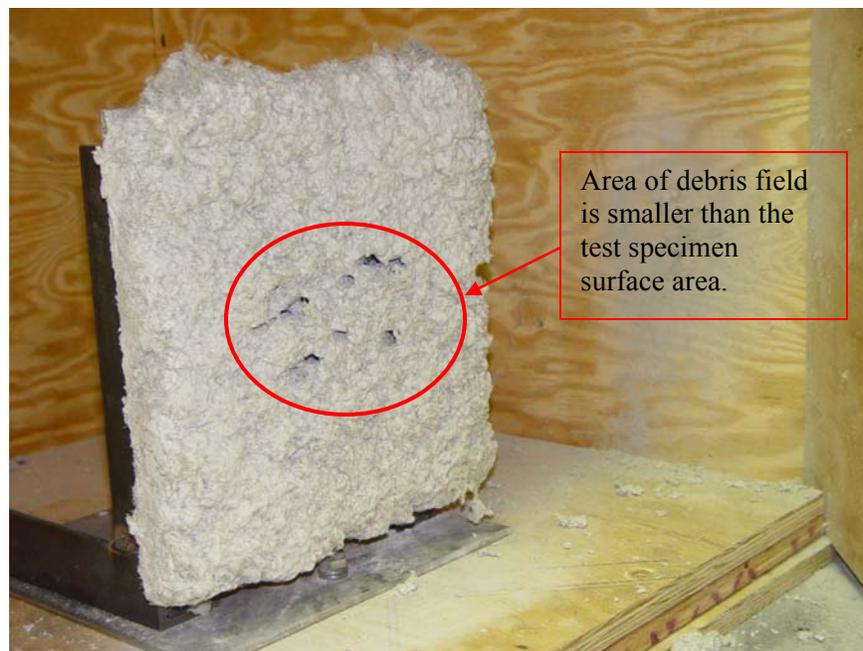
**Figure C-7. Photograph showing damage to the SFRM after a ballistic impact at 60 degree. The SFRM layer did not separate from the steel plate.**

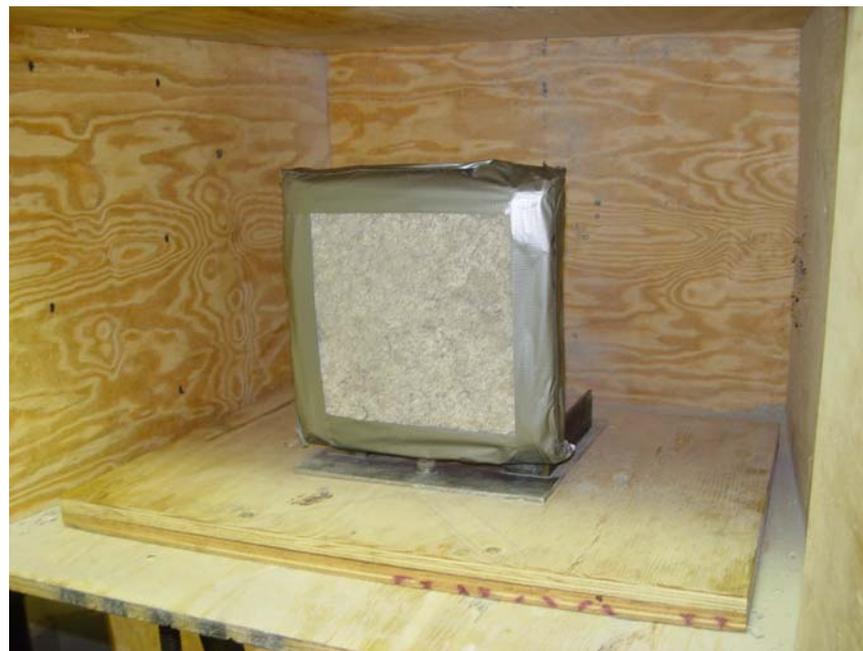
**Figure C-8. Photograph showing the edges of the SFRM duct taped to the steel plate before the ballistic tests at 0 degree.**

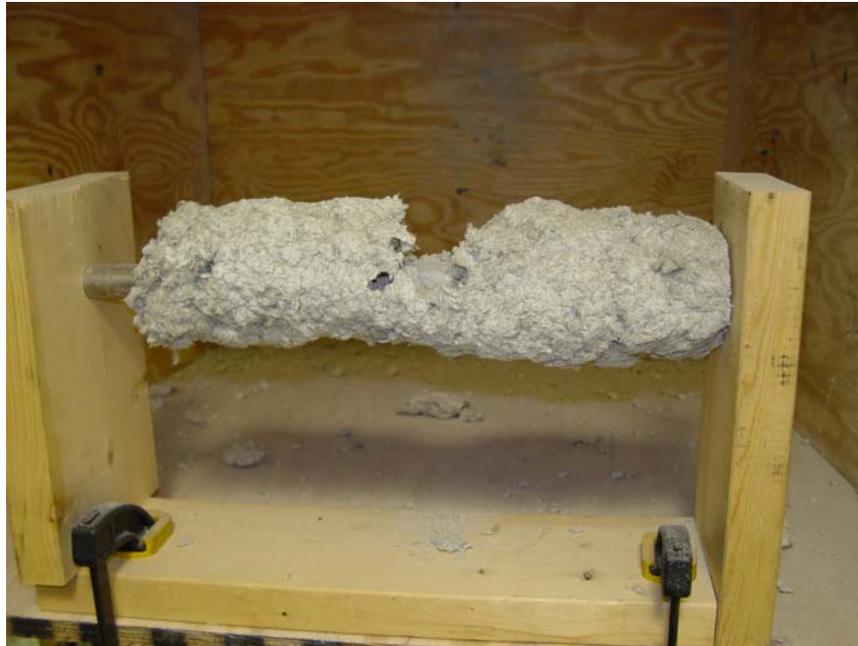
**Figure C-9. Photograph showing damage to the SFRM on an unprimed steel bar (BAR01) after a ballistic impact at 0 degree using the small universal receiver.**

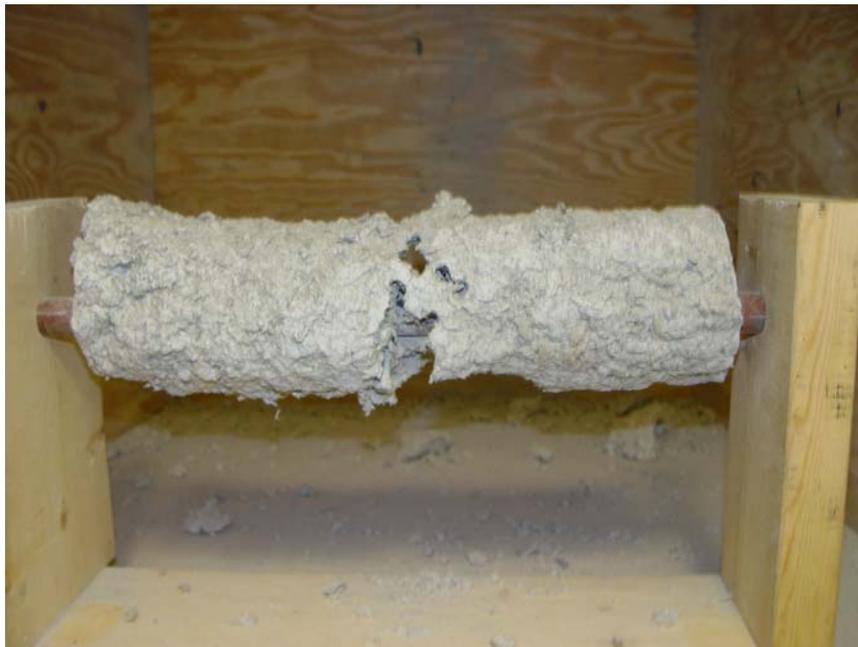
**Figure C-10. Photograph showing damage to the SFRM on a primed steel bar (BAR02) after a ballistic impact at 0 degree using the small universal receiver.**

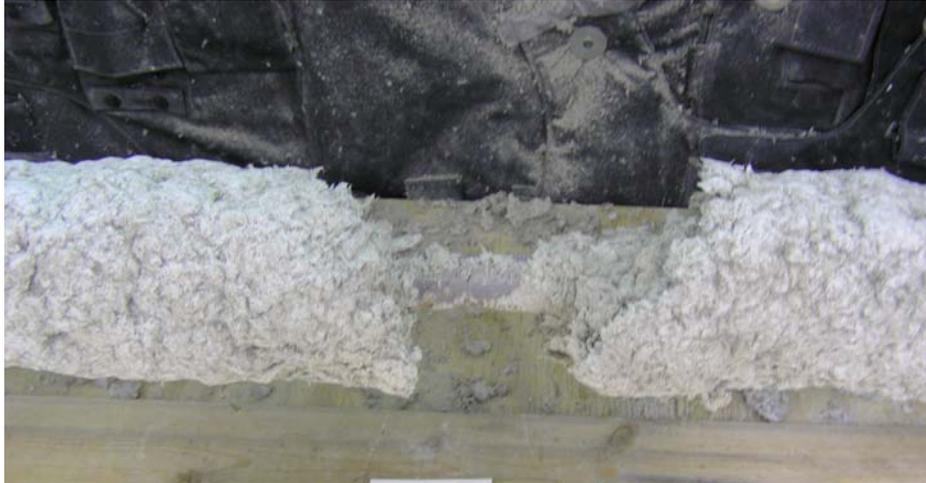
**Figure C-11. Photograph showing damage to the SFRM on unprimed steel bar (BAR04) after a debris impact at 0 degree using the large universal receiver.**

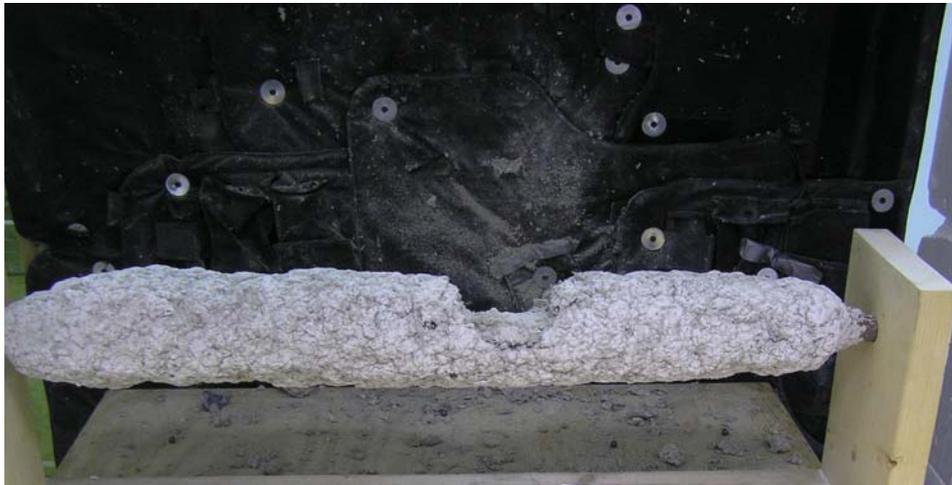
**Figure C-12. Photograph showing damage to the SFRM on unprimed steel bar (BAR05) after a debris impact at 0 degree using the large universal receiver.**
