Electric Current Induced Thermomechanical Fatigue Testing of Interconnects

R. R. Keller, R. H. Geiss, Y. -W. Cheng, and D. T. Read

Materials Reliability Division, NIST, Boulder, Colorado 80305

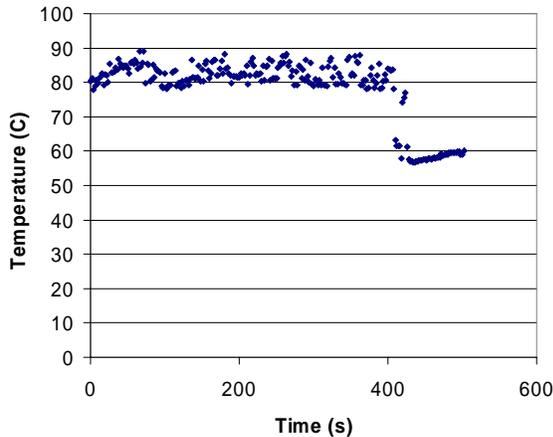
FIGURE 1. Computer processor temperature versus time, during operation of a processor-intensive application. The application was terminated at approximately 400 s.

excursions encountered during processing) by considering what might be viewed as “typical” operation in a business environment: starting up and shutting down 1 power cycle per day, going into energy-saving mode 10 times per day, and running a cpu-intensive application 10 times per day, resulting in 21 thermal cycles per day, or 5460 cycles in a 260 work-day year. Over the course of a “useful” lifetime of 5 years, this results in 27,300 total thermal cycles.

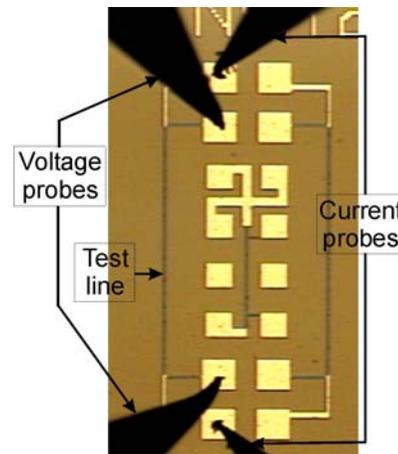
FIGURE 2. Optical microscope image of a NIST-2 test structure with four probes in place for electrical testing.

Most of the AC tests were carried out on non-passivated, single-level structures composed of patterned and etched Al-1Si lines sputtered onto thermally oxidized silicon, using conventional processing parameters. We used a NIST-2 test structure originally designed for electromigration and thermal conductivity measurements. The lines were 800 μm long, 3.3 μm wide, and 0.5 μm thick. Current pads and voltage taps were present at each end of a given line, as shown in Figure 2. We carried out an additional five tests on non-passivated, sputtered Cu lines of length 800 μm , width 2.0 μm , and thickness 0.7 μm .

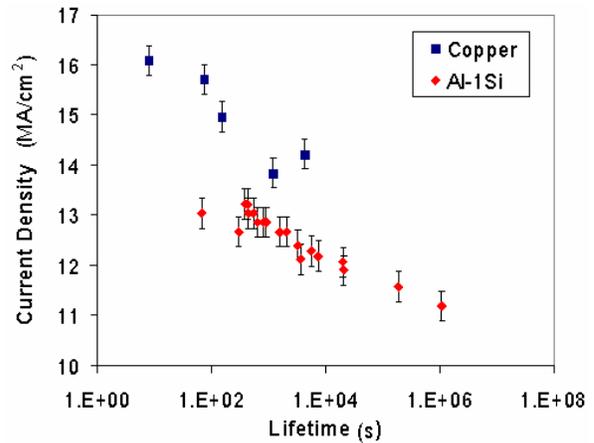
FIGURE 3. Current density versus lifetime for Al-1Si and Cu lines tested under AC conditions at 100 Hz . Vertical bars represent 0.3 MA/cm^2 uncertainties in current density.

Figure 3 shows a plot of rms current density against time to open circuit, for both the Al-1Si and Cu lines. The form of this plot follows the convention used in representing stress-controlled fatigue lifetime data, or S-N curves. Namely, we plot the applied stress (current density, in this case) versus the measured lifetime. Despite the limited data obtained from the copper specimens, a trend is apparent in that copper lines are able to withstand higher current densities than Al-1Si lines, for a given lifetime. Further, for a given current density, copper shows increased lifetime.

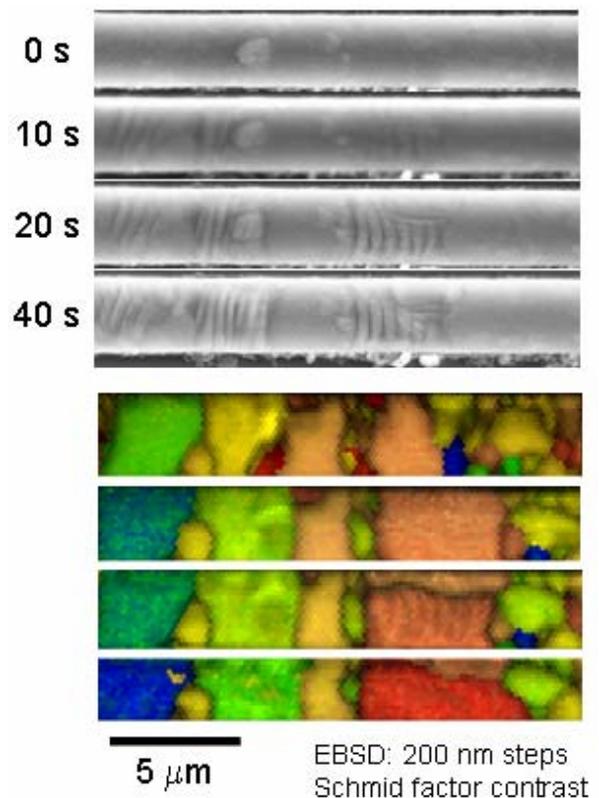
FIGURE 4. Quasi *in-situ* AC test results from Al-1Si line, showing development of surface damage, grain growth, and grain reorientation with increased cycling. Top sequence shows four grayscale SEM images from one region, bottom sequence shows corresponding color EBSD orientation maps from same region. Times represent total accumulated AC cycling times.

All specimens developed damage in the form of surface wrinkling due presumably to plasticity by means of dislocation motion. Transmission electron microscopy studies are underway to confirm this hypothesis. The quasi *in-situ* test involving FE-SEM and automated EBSD revealed an evolution of grain structure and orientations, as shown in figure 4 for the first 40 s of the test. The four grayscale SEM images show localized surface wrinkling, while the color EBSD images show the growth of some grains at the expense of others. All images are taken from the same region, and the four color images represent the same sequence of accumulated time as that indicated for the

grayscale images. In the bottom four images, color changes with time represent changes in crystal orientation with cycling. We used Schmid factor contrast for this particular set of images, to represent the geometric relationship between the local crystal orientation matrix and the longitudinal direction of the line. The sequence of images shows that damage is detectable after only 10 s, or 1000 AC cycles; we note this corresponds to 2000 power or temperature cycles.

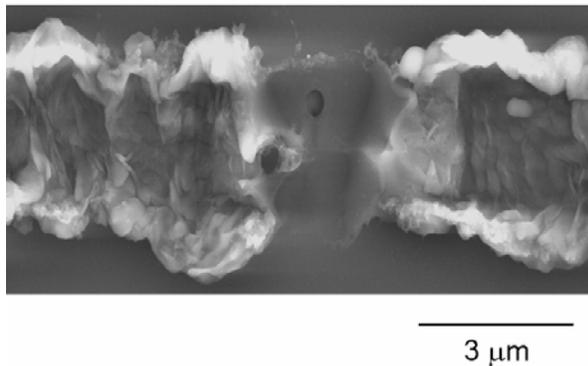
FIGURE 5. SEM image showing open circuit failure at region of severe deformation.

In all cases, failure of both Al-1Si and Cu lines took place in the form of open circuits. These failures occurred at locations of the line where severe changes in structure had taken place, as determined by SEM images of surface topography, and by EBSD determinations of grain structure and orientations. Figure 5 shows an example of an open circuit that developed at a region of severe deformation. Automated EBSD mapping revealed that surface normal orientations exhibited significant rotations in the heavily deformed regions, often in excess of 30°, as shown by the inverse pole figure in figure 6, which indicates the distribution of surface normal directions before and after AC cycling.

We suggest that open circuit occurred after localized deformation caused a severe enough reduction in localized cross-sectional area of the line to drastically increase the localized current density to the point of causing melting.

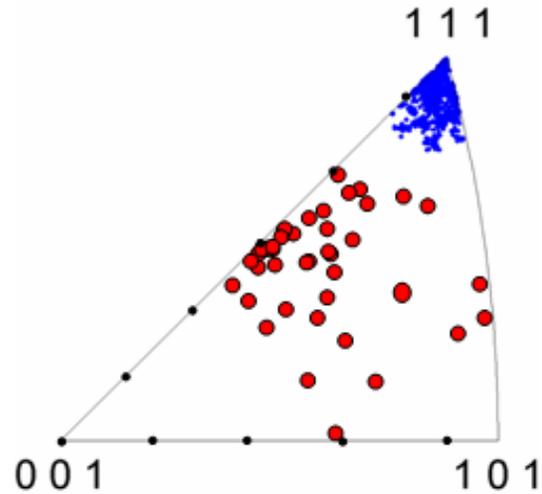
FIGURE 6. Inverse pole figure (IPF) showing crystallographic orientations corresponding to surface normal directions. Blue points represent grain orientations prior to AC testing. Red points represent orientations of severely deformed regions after AC testing. Black dots along IPF edges represent 10° increments.

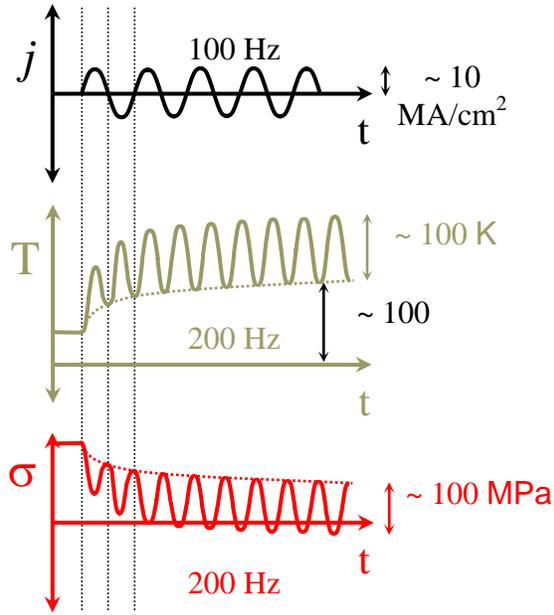
FIGURE 7. Schematic showing relation between low frequency, high current density AC input into an interconnect and resulting temperature and mechanical stress behaviors as a function of time. Values for current density, temperature, and stress are order of magnitude examples.

Thermomechanical fatigue is induced by low frequency, high current density AC stressing due to Joule heating. The power input into an interconnect during each power cycle is completely dissipated in the form of heat into the surrounding substrate and/or passivation (if present). This is because the thermal diffusivity of materials such as silicon or silicon dioxide is of the order of 10^{-4} m²/s, allowing heat to flow over a distance of nearly 0.5 to 1 mm from the current-carrying interconnect into the surrounding materials during the period of one power cycle, or 0.005 s. Figure 7 shows schematically how the cyclic dissipation of heat leads to thermomechanical fatigue, where j = current density, T = temperature, and σ = stress. In terms of fatigue testing, the mechanical stress amplitude depends on the magnitude of the cyclic current density. The ratio of the minimum to the maximum mechanical stresses, often termed the fatigue R-value, can be varied by controlling the rms temperature of the test specimen through substrate heating or cooling. This would allow for tests encompassing tension-tension, compression-compression, or fully reversed tension-compression loading. Analyses of the temperature dependence of cyclic current flow and the frequency dependence of cyclic heat flow have been completed in reference [6].
