Building Stones of America:

Over 50 Years of the NIST Stone Test Wall

By Paul E. Stutzman and Jaime Raz
Inorganic Building Materials Group
National Institute of Standards and Technology

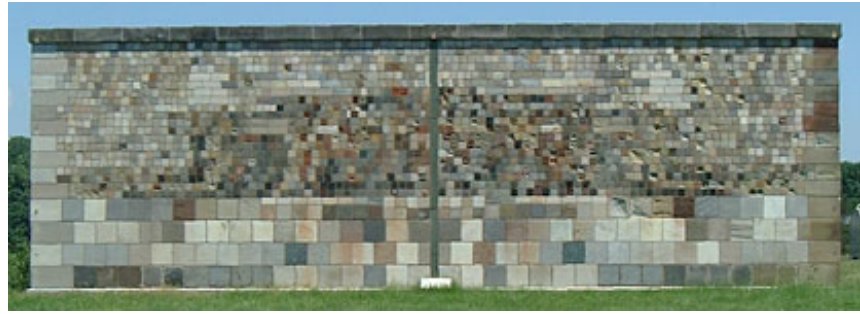
The wall contains 2,352 individual samples of stone: 2,032 domestic stones from 47 states and 320

stones from 16 foreign countries. It is constructed in a mirror-image pattern, with the stone in the left wall set in lime mortar and the stone in the right wall set in Portland cement mortar. Over 30 distinct types of stones are represented, many of which are common varieties used in building, such as marble, limestone, sandstone and granite.

As the left side of the wall is set in lime mortar and the right side of the wall in Portland cement, another area of evaluation is available. Observers were concerned that lime mortars could cause discoloration on masonry, so they replaced lime in the Portland cement mortar with ground limestone. Although this will require a more direct comparison, over time the lime mortars have not held up as well as the Portland cement mortars. Discoloration appears to be affected by the coloration and weathering characteristics of the overlying stone.
