CYCLIC TESTING OF STEEL MOMENT CONNECTIONS REHABILITATED WITH RBS OR WELDED HAUNCH

By Chia-Ming Uang,¹ Member, ASCE, Qi-Song “Kent” Yu,² Student Member, ASCE, Shane Noel,³ and John Gross,⁴ Members, ASCE

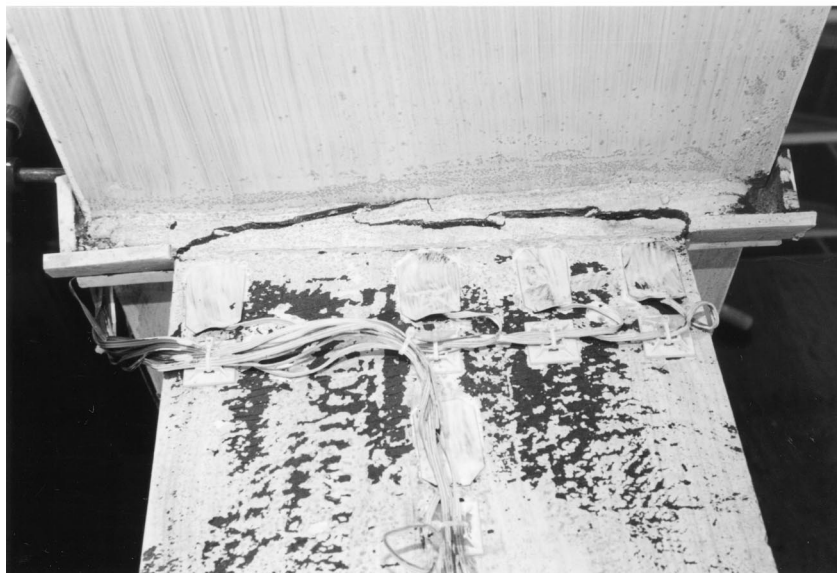
FIG. 6. Yielding Pattern and Fracture of Beam 2 (NIST-1): (a) Yielding Pattern; (b) Brittle Fracture of Top Flange Welded Joint

The yielding pattern and failure mode of both specimens were very similar. Significant yielding was observed during the $2\delta_y$ cycles [story drift ratio (SDR) = 1.7%]. Yielding of beam bottom flanges extended from the column face to the narrowest beam section [Fig. 6(a)], but yielding of the top flange was confined in a narrow region next to the column face. Beam 1 of NIST-1 experienced brittle fracture before the first cycle of $2\delta_y$ was completed. Beam 2 suffered a similar fracture during the next excursion after Beam 1 was unloaded and held at a constant displacement [Fig. 6(b)]. The presence

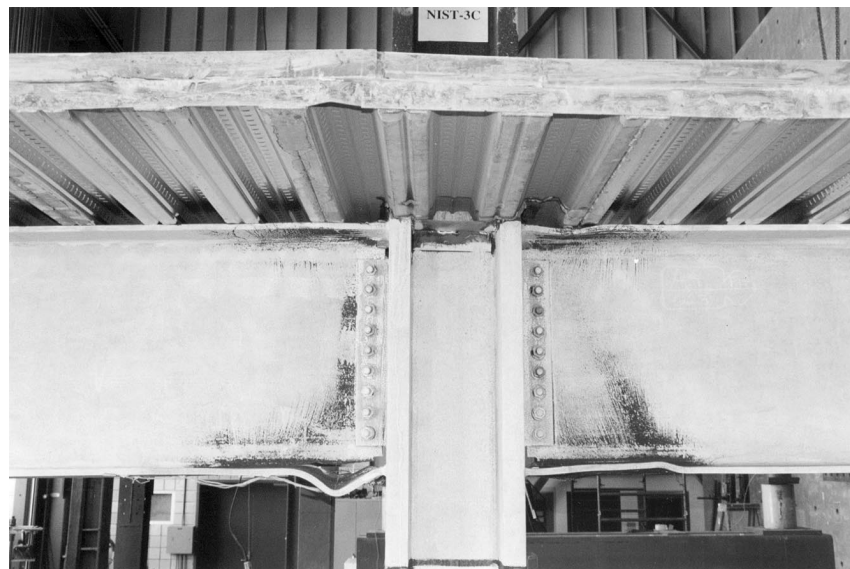
FIG. 9. Failure Mode of NIST-3C

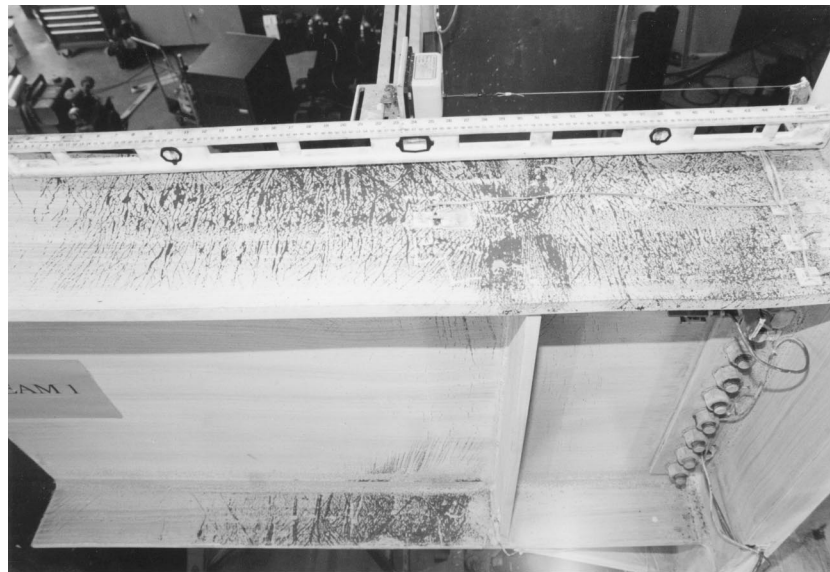
FIG. 11. Buckling and Yielding Modes of Welded Haunch Specimens: (a) NIST-2; (b) NIST-2C

Significant yielding of NIST-2 occurred during the $2\delta_y$ cycles. From the flaking pattern of the whitewash, Fig. 11(a) shows that yielding of the bottom flange occurred outside the haunch region, and a much longer yielded length was developed in the top flange. Buckling of beams occurred during the $3\delta_y$ (SDR = 2.5%) cycles. Nevertheless, the groove weld of Beam 1 top flange fractured in the first negative excursion.

Specimen NIST-2C exhibited excellent performance. Both beams were able to complete the $4\delta_y$ (SDR = 3.3%) cycles without fracturing [Fig. 11(b)]. Both flanges of the beams experienced local buckling. However, the buckling amplitude of top flanges was smaller due to the presence of the concrete slab.

The concrete slab was effective in providing lateral bracing to the top flange so that lateral-torsional buckling would not occur under positive bending. But flange local buckling still could be developed [Fig. 11(b)]. Under negative bending, significant local buckling interacted with lateral-torsion buckling. The presence of a concrete slab had a negligible effect on the buckling mode. Thus, more significant strength degradation in negative bending was observed in the composite specimens.
