Fire Safety Journal

Quantifying the vulnerabilities of ceramic tile roofing assemblies to ignition during a firebrand attack

Samuel L. Manzello^{a,*}, Yoshihiko Hayashi^b, Takefumi Yoneki^c, Yu Yamamoto^c^a Fire Research Division, Building and Fire Research Laboratory (BFRL), National Institute of Standards and Technology (NIST), Gaithersburg, MD 20899-8662, USA^b Department of Fire Engineering, Building Research Institute (BRI), Tachihara 1, Tsukuba, Ibaraki 0305-802, Japan^c Tokyo Fire Department, Otemachi 1-3-5, Chiyoda, Tokyo 100-8119, Japan

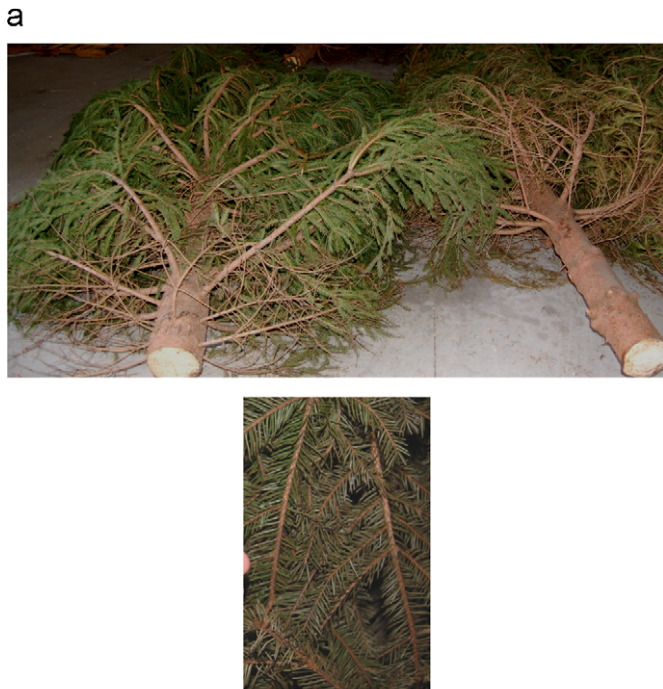
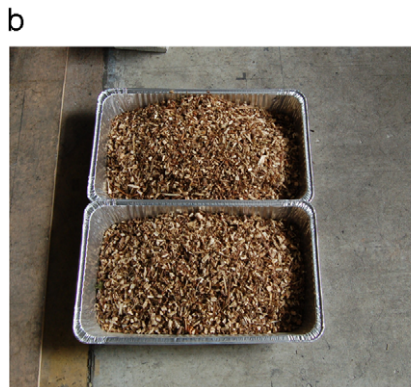
Fig. 2. (a) Digital pictures of Norway Spruce trees used to produce mulch for firebrand generator; details of the tree are shown. (b) Mulch that is produced and used per experiment (2.8 kg).

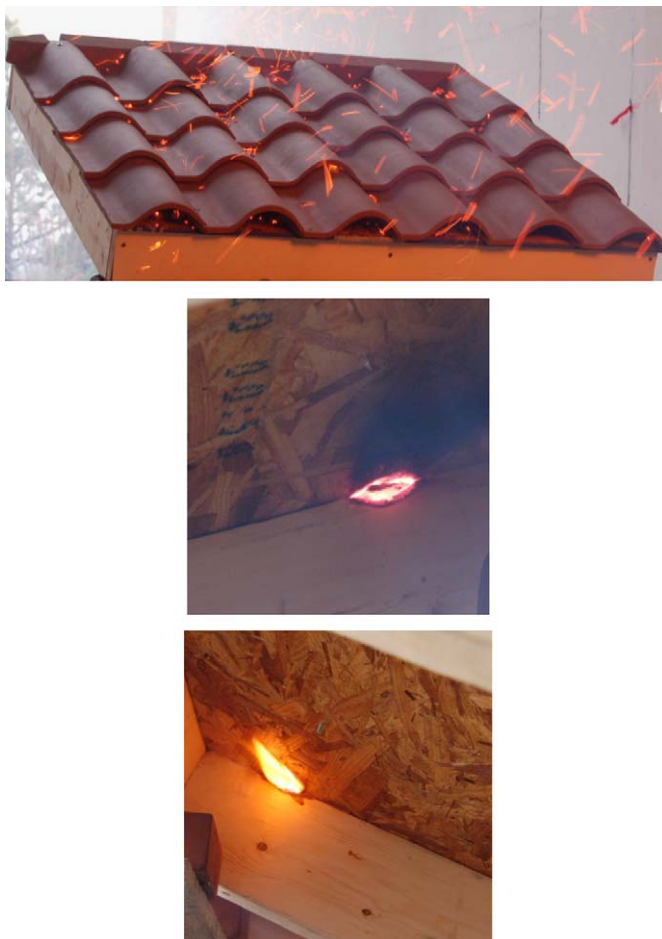
Fig. 6. Images of experiments conducted using OSB/CT without bird stops installed. Intense SI was observed within the OSB base layer and eventually FI was observed.

A full-scale section (122 cm \times 122 cm) of a ceramic tile roof assembly was constructed for testing (shown in Fig. 6). The pitch

Fig. 6 displays a sequence of images obtained from the case of OSB/CT without the installation of bird stops. Bird stops, as the name suggests, are intended to mitigate the construction of nests by birds under the ceramic tiles. Many ceramic tile roofing assemblies found in practice do not have bird stops installed [2]. Without the installation of bird stops, the firebrands were observed to be blown under the ceramic tiles. Eventually, several firebrands would collect and would produce smoldering ignition (SI) within the OSB base layer. With continued application of the airflow, holes were formed within the OSB and eventually the SI would undergo transition to flaming ignition (FI). The same result was observed independent of the applied wind tunnel flow.

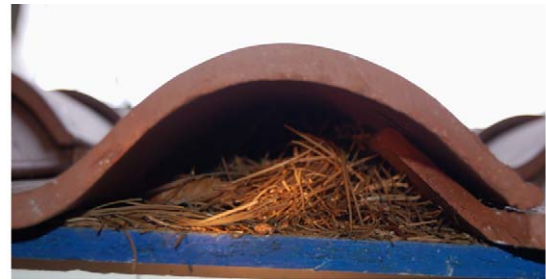
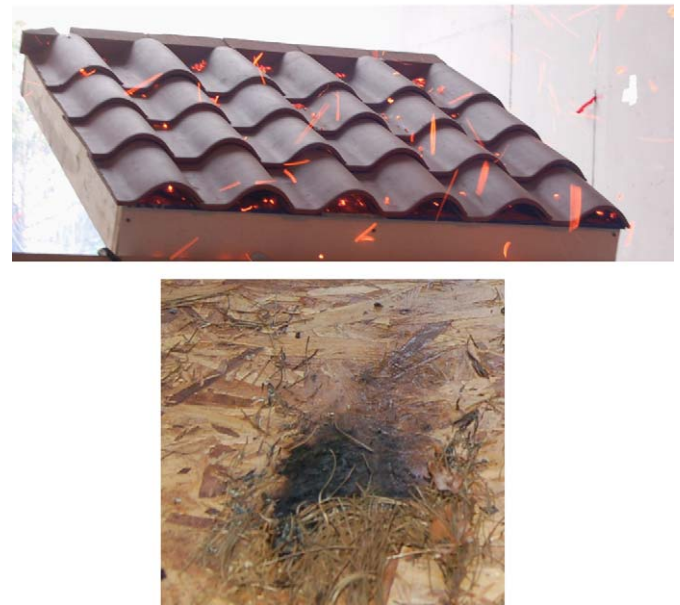
Fig. 9. Images of experiments conducted using OSB/CT without bird stops installed. Dried needles and leaves have been inserted under the tiles. Intense SI was observed within the OSB base layer and eventually FI was observed.

tiles was considered. Even when bird stops are installed, as ceramic tile roof assemblies are exposed to the elements over time, the deposition of dried needles and leaves under the tiles would be expected. Fig. 9 displays a sequence of images from experiments that simulated an aged ceramic tile roofing assembly, OSB/CT, with dried needles and leaves inserted under the tiles. Not surprisingly, under a firebrand attack, the dried needles/leaves ignite via SI and this leads to intense ignition within the OSB base layer. The interesting result found in Table 1, namely that the combination of the bird stop installation coupled with the tar paper application provided a substantial barrier to ignition, does not hold true if dried needles and leaves were placed under the tiles. Fig. 10 clearly demonstrates that if needles and leaves are deposited under the tiles, ceramic tile roofing assemblies were ignitable under all conditions considered in this study. Once again, the current standards have no mechanism of testing these vulnerabilities.

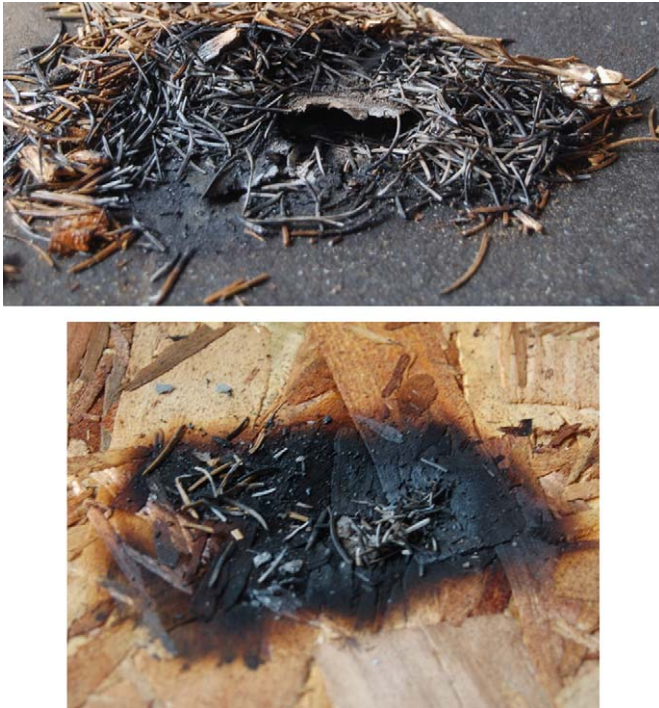
Fig. 10. Images of experiments conducted using OSB/TP/CT with bird stops installed. Dried needles and leaves have been inserted under the tiles. SI was observed within the OSB base layer.

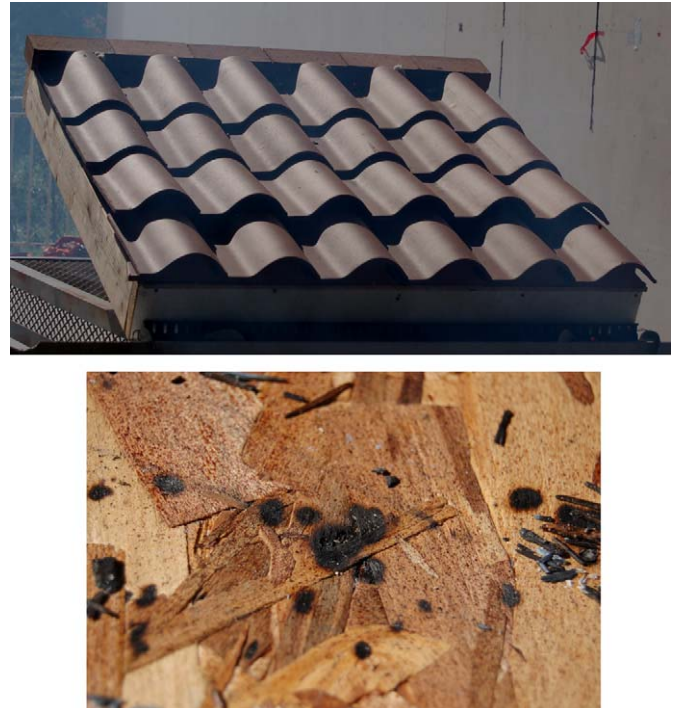
Fig. 11. Images of ceramic tile roof assemblies purposely constructed with gaps within the tiles. Multiple SI observed with OSB base layer.

All of the experiments delineated above considered perfectly aligned roofing tiles. As ceramic tile roof assemblies age, the tile alignment does not remain so closely spaced [2]. In fact, large gaps develop within the tiles themselves leading to openings where firebrands may enter and accumulate. Earthquakes can also produce gaps and can break the tiles; this is often seen in Japan. To quantify this vulnerability, a series of experiments were conducted where the ceramic tiles were not fit together perfectly. An image of this type of construction is shown in Fig. 11. Due to the presence of gaps within the tiles, ignition under the tiles within the OSB base layer was observed: (1) whether or not bird stops were installed and (2) whether or not tar paper was installed. This result is somewhat obvious, in light of findings presented above, and suggests that when gaps exist within the alignment of the ceramic tiles, ignition of the assembly was rather
