**NIST Technical Note 1635**

**A Case Study of a Community  
Affected by the Witch and Guejito  
Fires**

April 2009

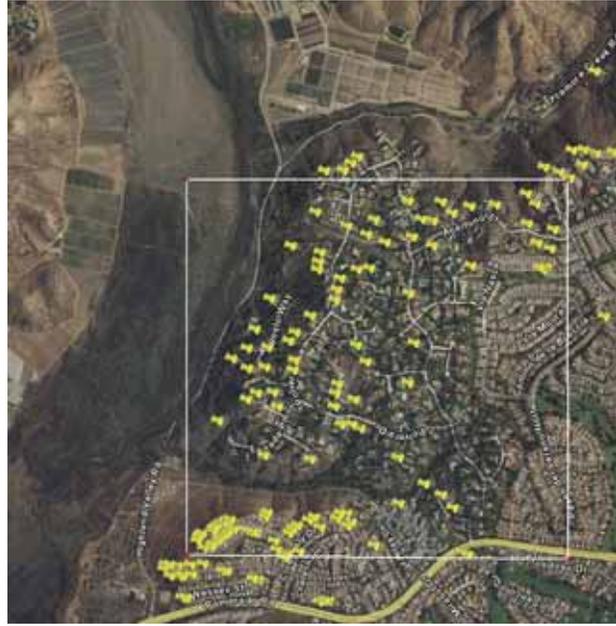
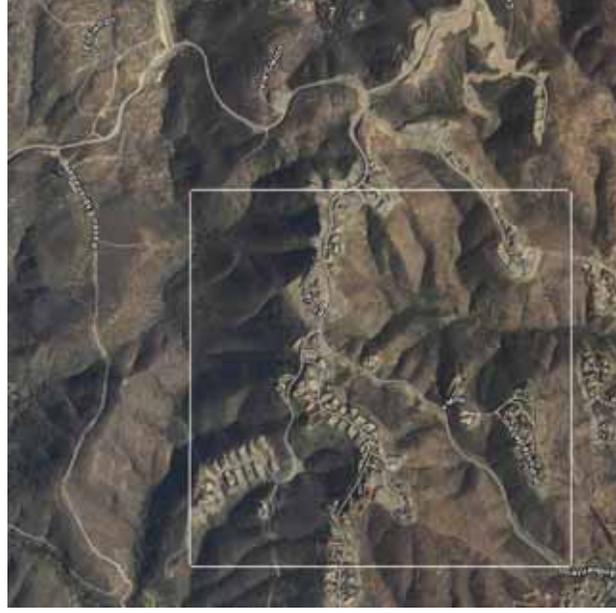
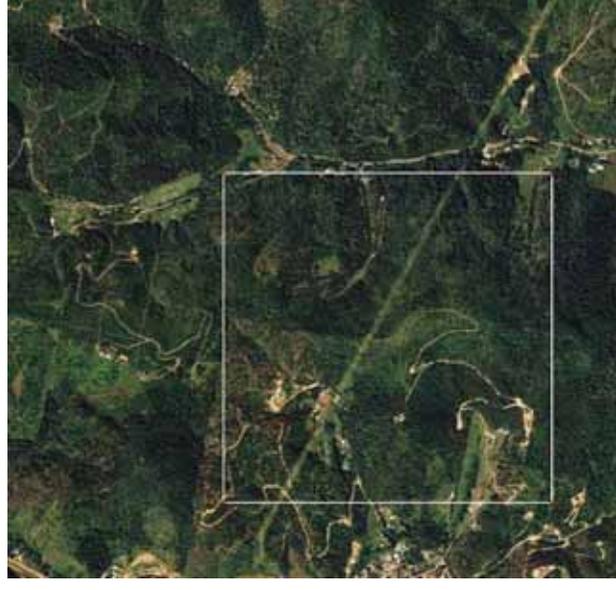
**Figure 3: Structure Densities in Three Different WUI Settings**

The Trails  
116 homes per km<sup>2</sup>  
(300 homes per square mile)

Rancho Santa Fe  
31 homes per km<sup>2</sup>  
(80 homes per square mile)

Rural Setting  
4 homes per km<sup>2</sup>  
(10 homes per square mile)

445 feet). The community is 23 km (14 miles) east of the Pacific Ocean. The community consists of 283 residential lots (Figures 1 and 2). Although some lots on the perimeter of the community are larger, typical lots are approximately 6000 m<sup>2</sup> (1.5 acres). At the time of the fires there were 274 residences. Out of the 245 residences within the fire line, 74 were completely destroyed and an additional 16 sustained various degrees of damage. Housing density is approximately 116 homes per km<sup>2</sup> (300 homes per square mile). Figure 3 illustrates three different housing densities. The Trails is represented on the left, a community in Rancho Santa Fe, California is shown in the middle and a low density housing area is shown on the right. Note that the houses are not evenly distributed as the “density” becomes lower. The housing density within The Trails is greater than the densities seen outside of Rancho Bernardo but lower than the densities seen to the west of The Trails (Figure 2).

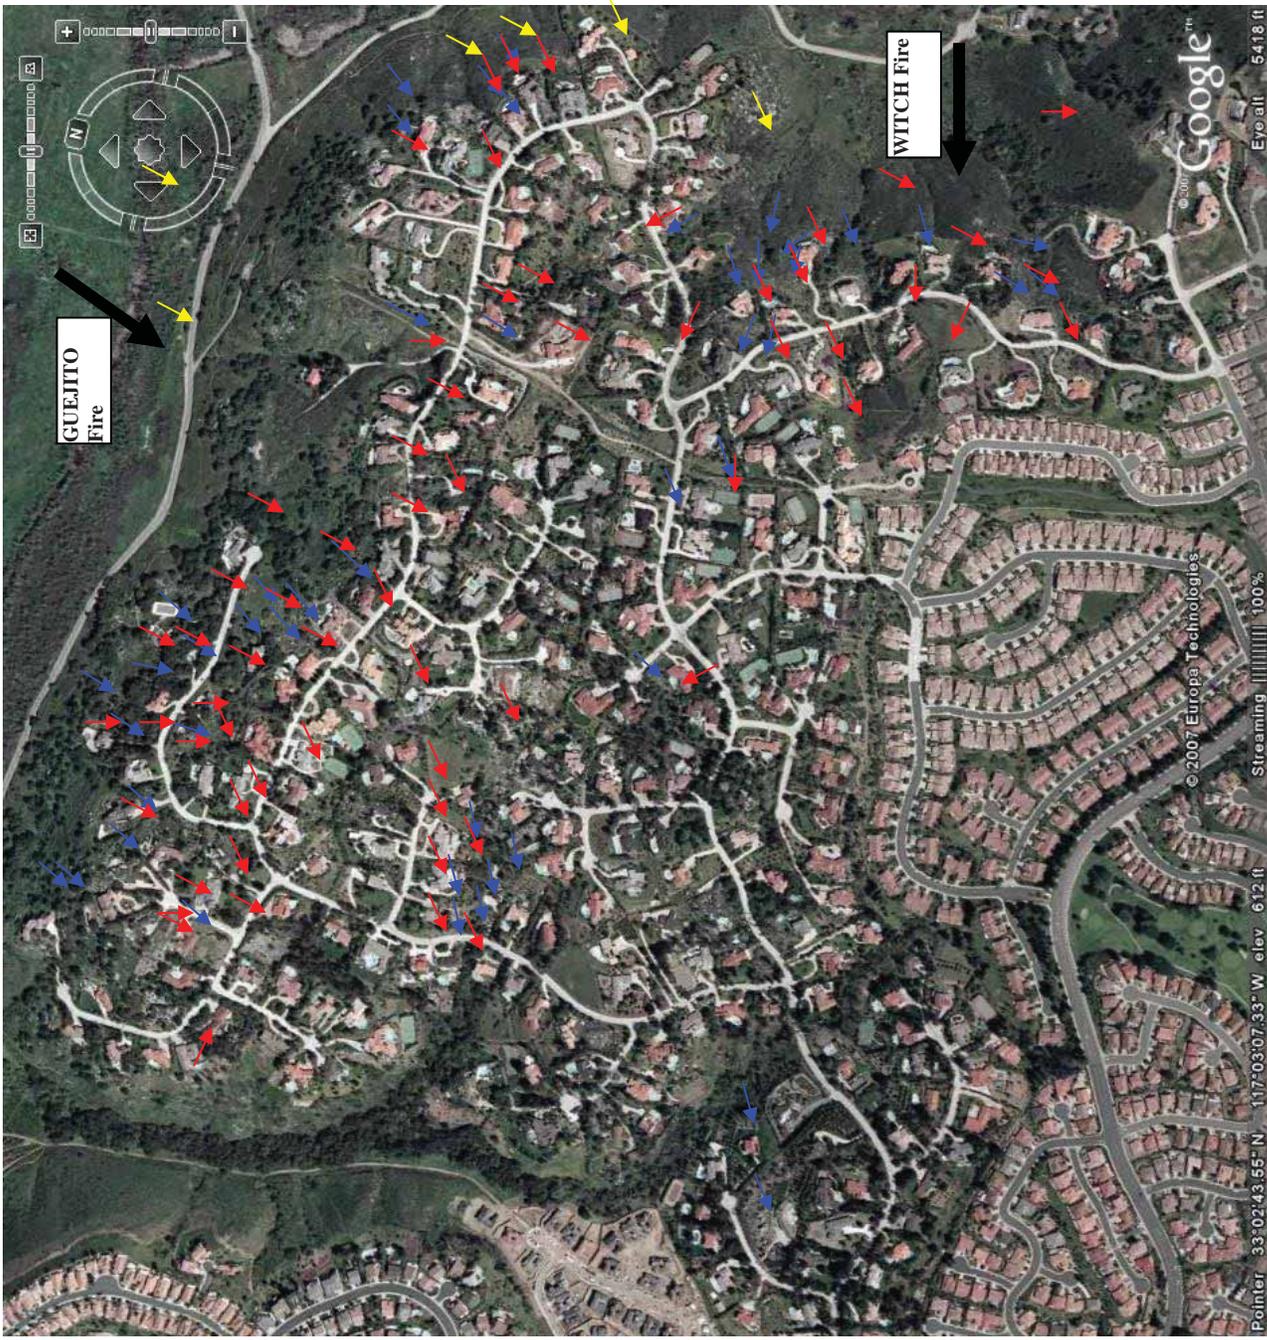
Figure 18: The Trails - Flame Spread and Needle Freeze

Needle Freeze ↑

Flame Spread ↑

Flame Spread from Golf Balls ↑

Different tools were used to document fire spread within The Trails. The extent of burned vegetation was documented along with the locations the fire jumped a road. Several different indicators were used to determine the direction that the fire spread. The use of the different indicators will be explained in this section. In the wildlands, needle freeze as defined below, directional degree of damage to wildland vegetation and the presence of partly damaged golf balls were all used to determine directionality of fire spread. In this document, the perimeter of The Trails is defined by all lots that have direct contact with the wildlands.

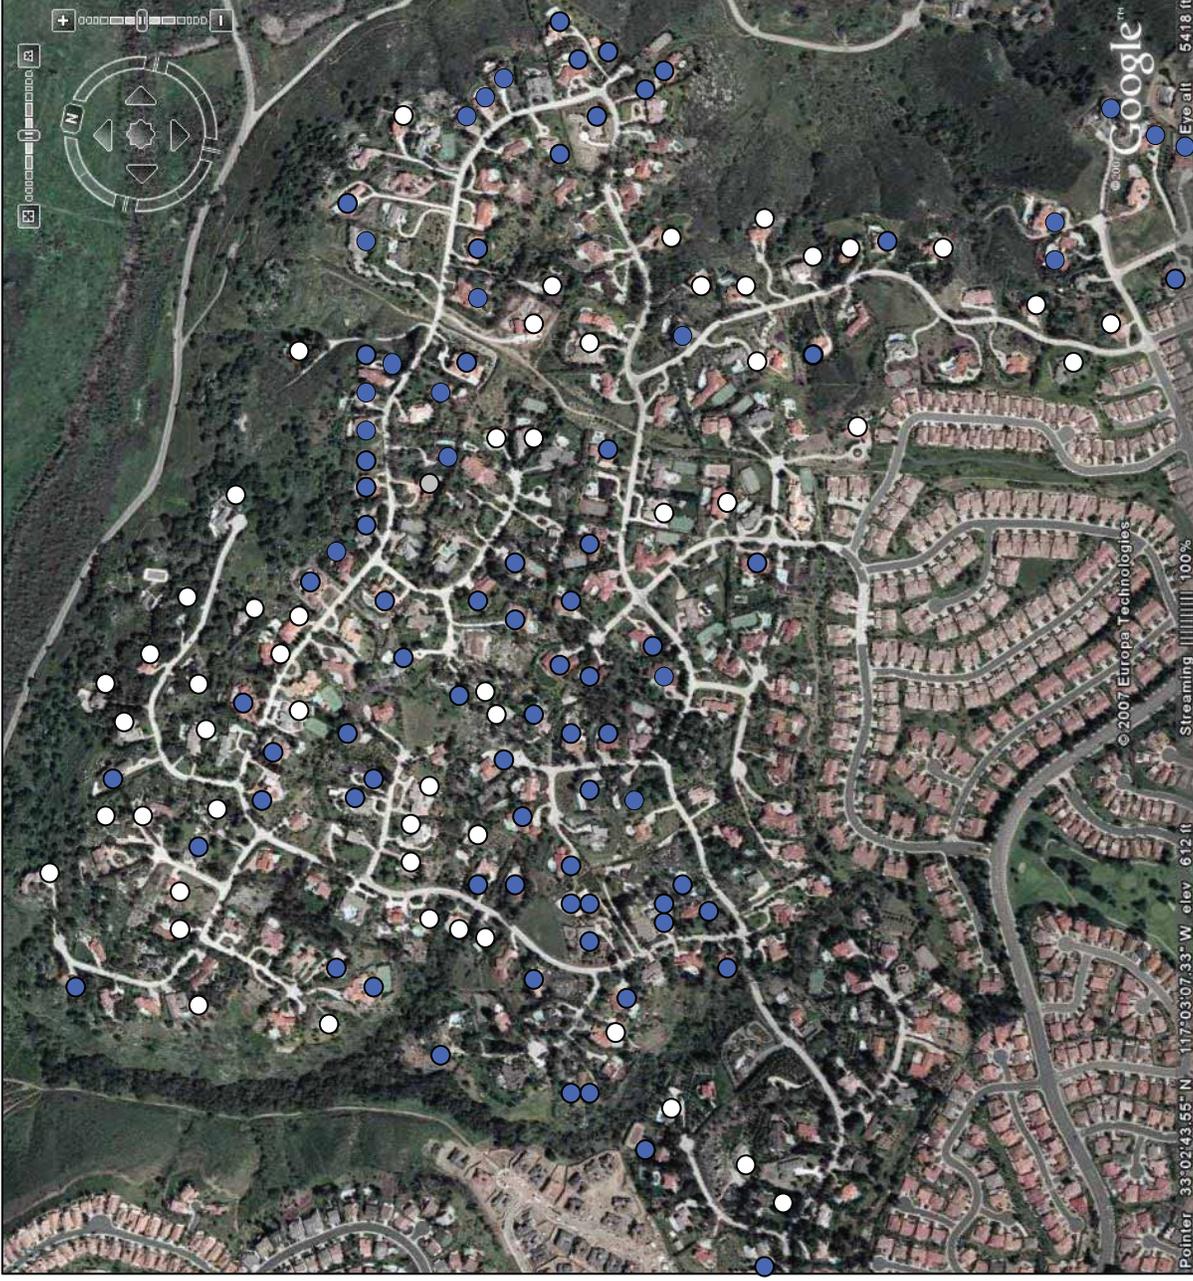
Figure 22: The Trails Defensive Actions

● (85) Defensive actions taken, including on 21 destroyed homes

○ (54) Destroyed home – unknown actions

Table 4 contains information on the timeline of defensive actions. Table 5 contains timeline information on the destroyed homes that were defended. Information on the damaged homes can be found in section 11.0 of this paper. There were 48 separate San Diego Fire Department actions identified, including 30 that were taken before 3:15 pm. Additionally, there were 30 separate actions taken by The Trails residents and San Diego PD, 14 of which were identified as taken before 3:15 pm.

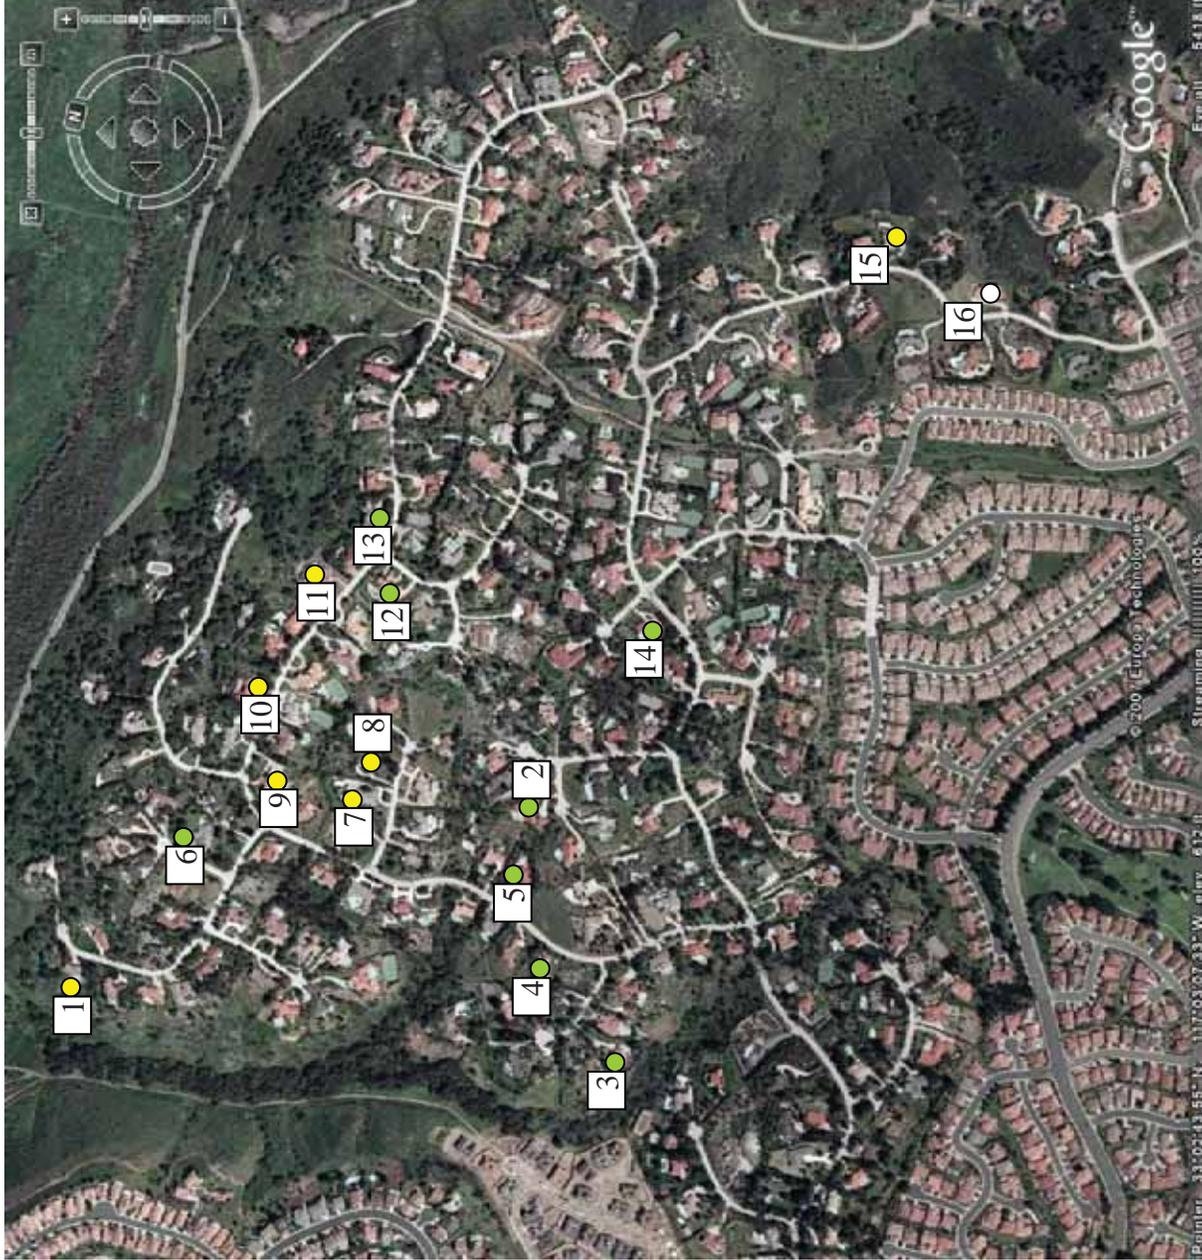
Figure 24: Damaged Structures. See Table 6 for further information on each house according to number on figure.

Damaged structure – SD FD defensive action taken (8)

Damaged structure – defensive action taken (7)

Out of the 245 homes within the fire line, 16 homes (7 %) were damaged compared to 74 homes (30 %) destroyed. Numerous additional properties suffered sometimes extensive smoke damage that is not addressed here. Burned ornamental vegetation, sometimes extensive, is also not covered here. The 16 damaged structures addressed here had varying degrees of damage ranging from burned detached garages to small amounts of burn damage on the main house.

Identified defensive actions were taken on 15 out of the 16 homes. Table 6 lists type of damages and the time, if known, and type of detailed defensive action taken. Out of the fifteen defended structures, eight were defended by SDFD and five by residents or SDPD. For one damaged structure no defensive actions has been reported to date. Four out of the fourteen defensive actions occurred before 6:00 am, while the remaining seven occurred after 8 am, and the times for two defensive actions have not been identified. Figure 24 contains the locations of the damaged homes; numbers on Figure 24 correspond to House Number in Table 6.

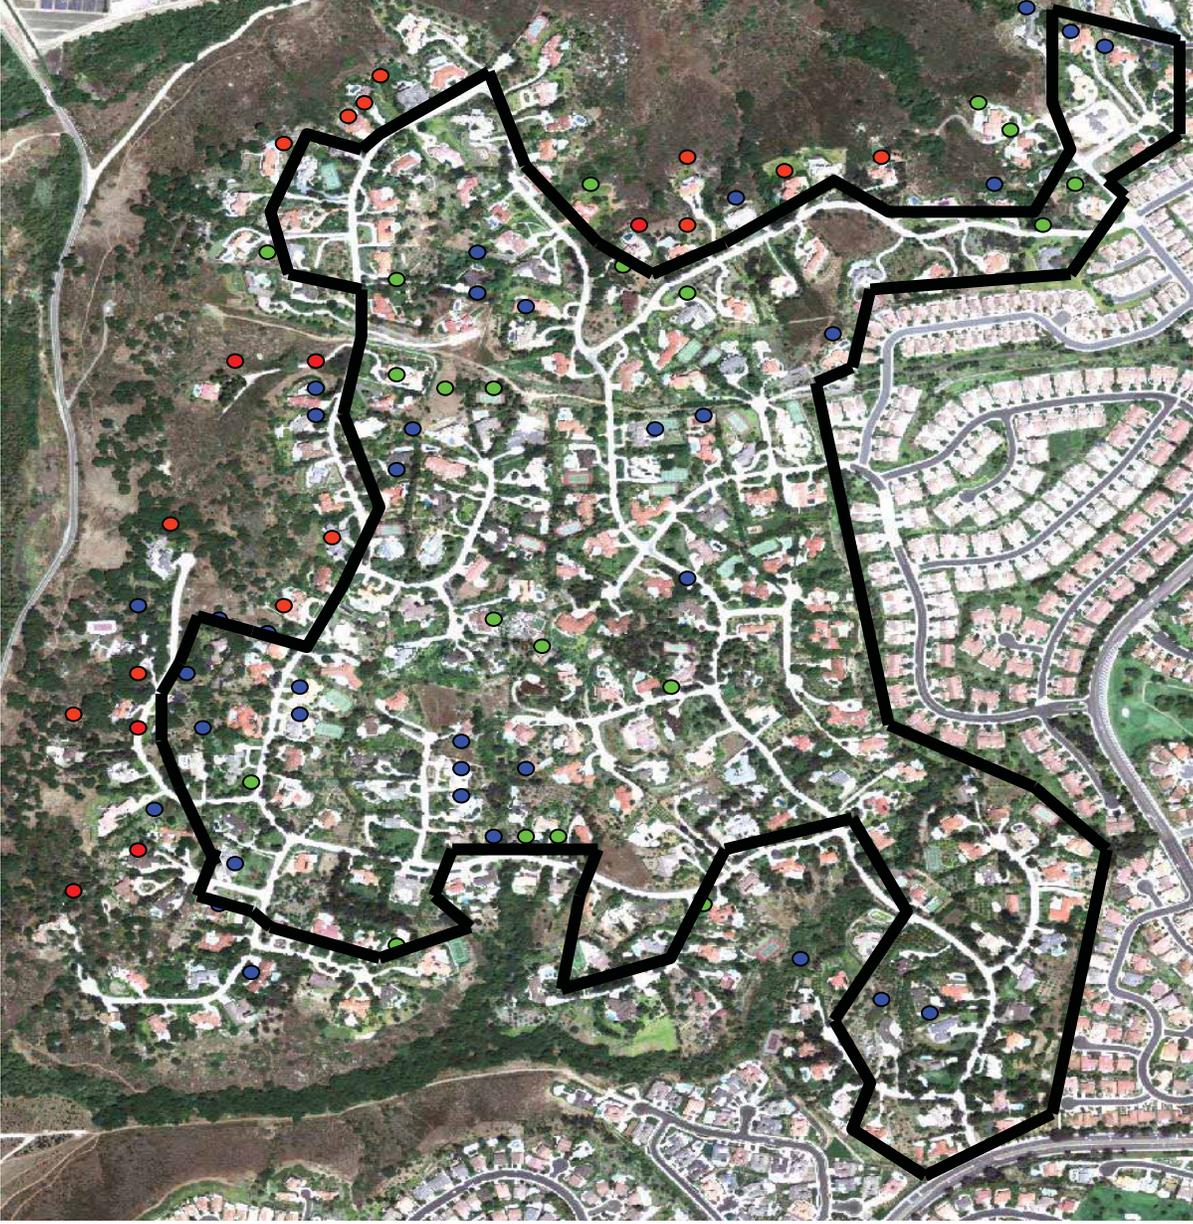
Figure 25: The Trails - Ignition categories of destroyed structures and perimeter/interior outline

- A – Uninterrupted fire to structure
- B – Fire spotting
- C – Structure ignition from Embers

Within The Trails, vegetation was burned on both sides of a road, implying spotting across the road, 21 times. Out of those, 18 were on the perimeter of the community and the remaining three on interior roads. Out of the 18 road jumps along the perimeter region, 15 were located on lots with destroyed structures on the perimeter side of the road and 2 out of the remaining 3 were located at lots adjacent do destroyed structures. Additionally, 10 out the 18 jumps had destroyed homes on both sides. It is not known if the fire jumps occurred before or after the structures on the perimeter were burning. That is, it is not clear whether embers generated by burning vegetation or structures caused the spotting.

The limited data available do show that in the perimeter region, there are two cases were structures in the interior ignited before structures on the perimeter. It is therefore possible that the wildland front ignited interior structures 0.2 km (1/8 mile) from the perimeter. This hypothesis, however, cannot be confirmed because of the limited spatial/temporal resolution of the currently available data. Flame spread information was obtained from direct observation of burned vegetation.

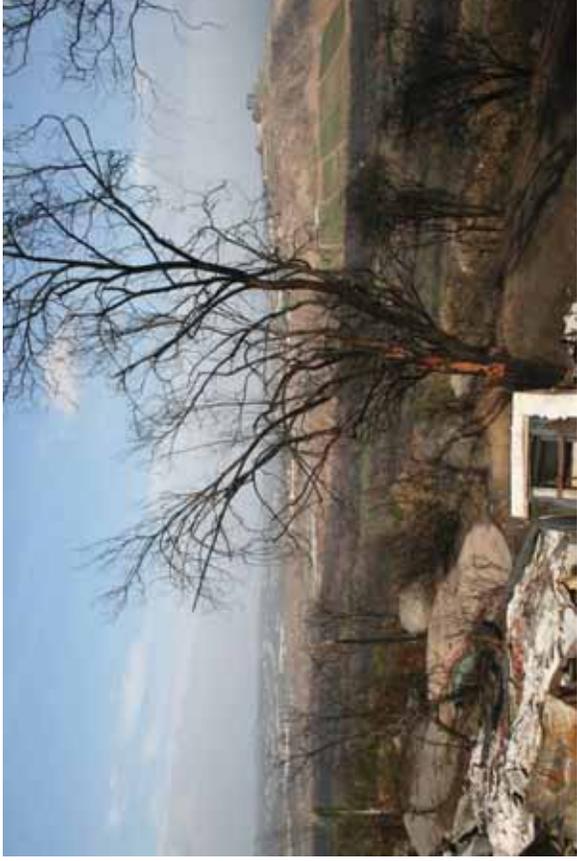
**Figure 26: Structure Ignition Category A Fire from the wildlands burns uninterrupted up to the structure**

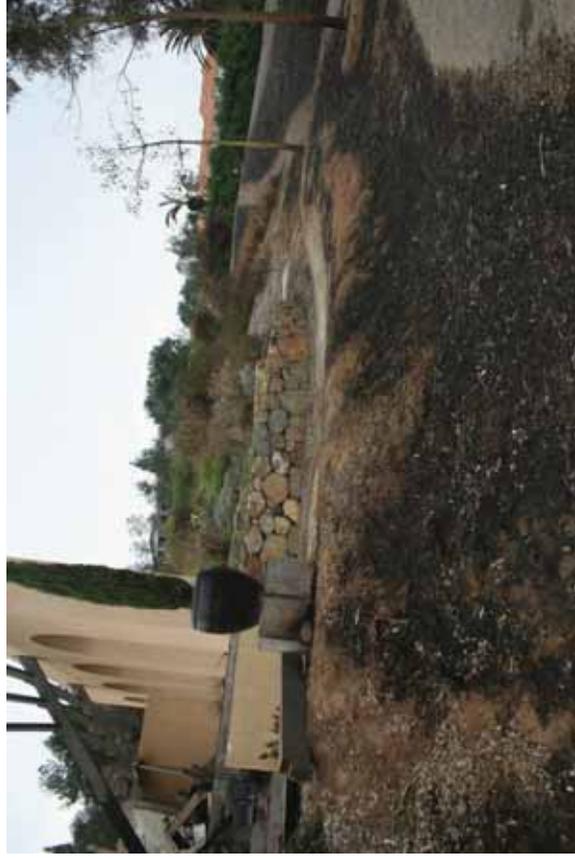
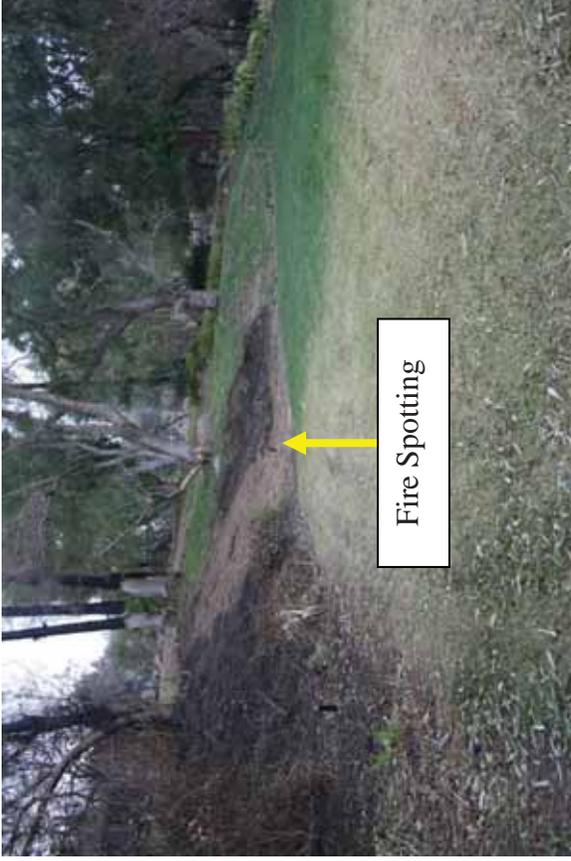
**Figure 27: Structure Ignition Category B**

**Fire spotted to vegetation next to structure and possibly onto structure**

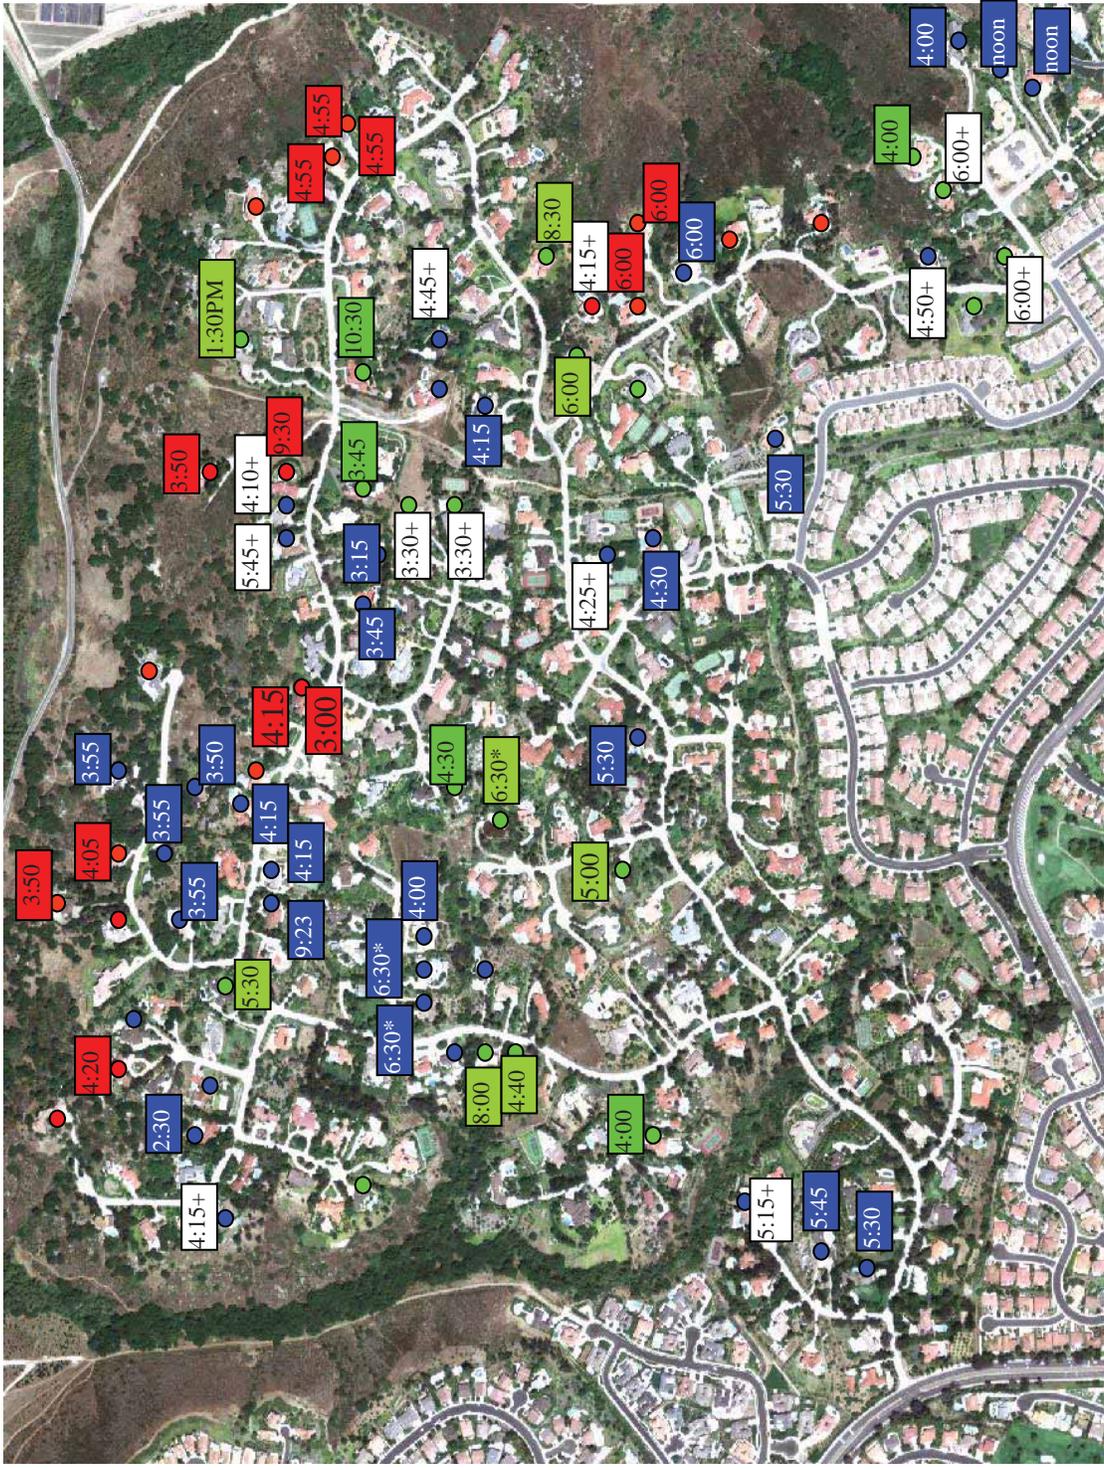
Figure 29: Potential Structure Ignition Categories A, B and C

- A – Uninterrupted fire to structure
- B - Fire spotting
- C – Structure ignition from Embers

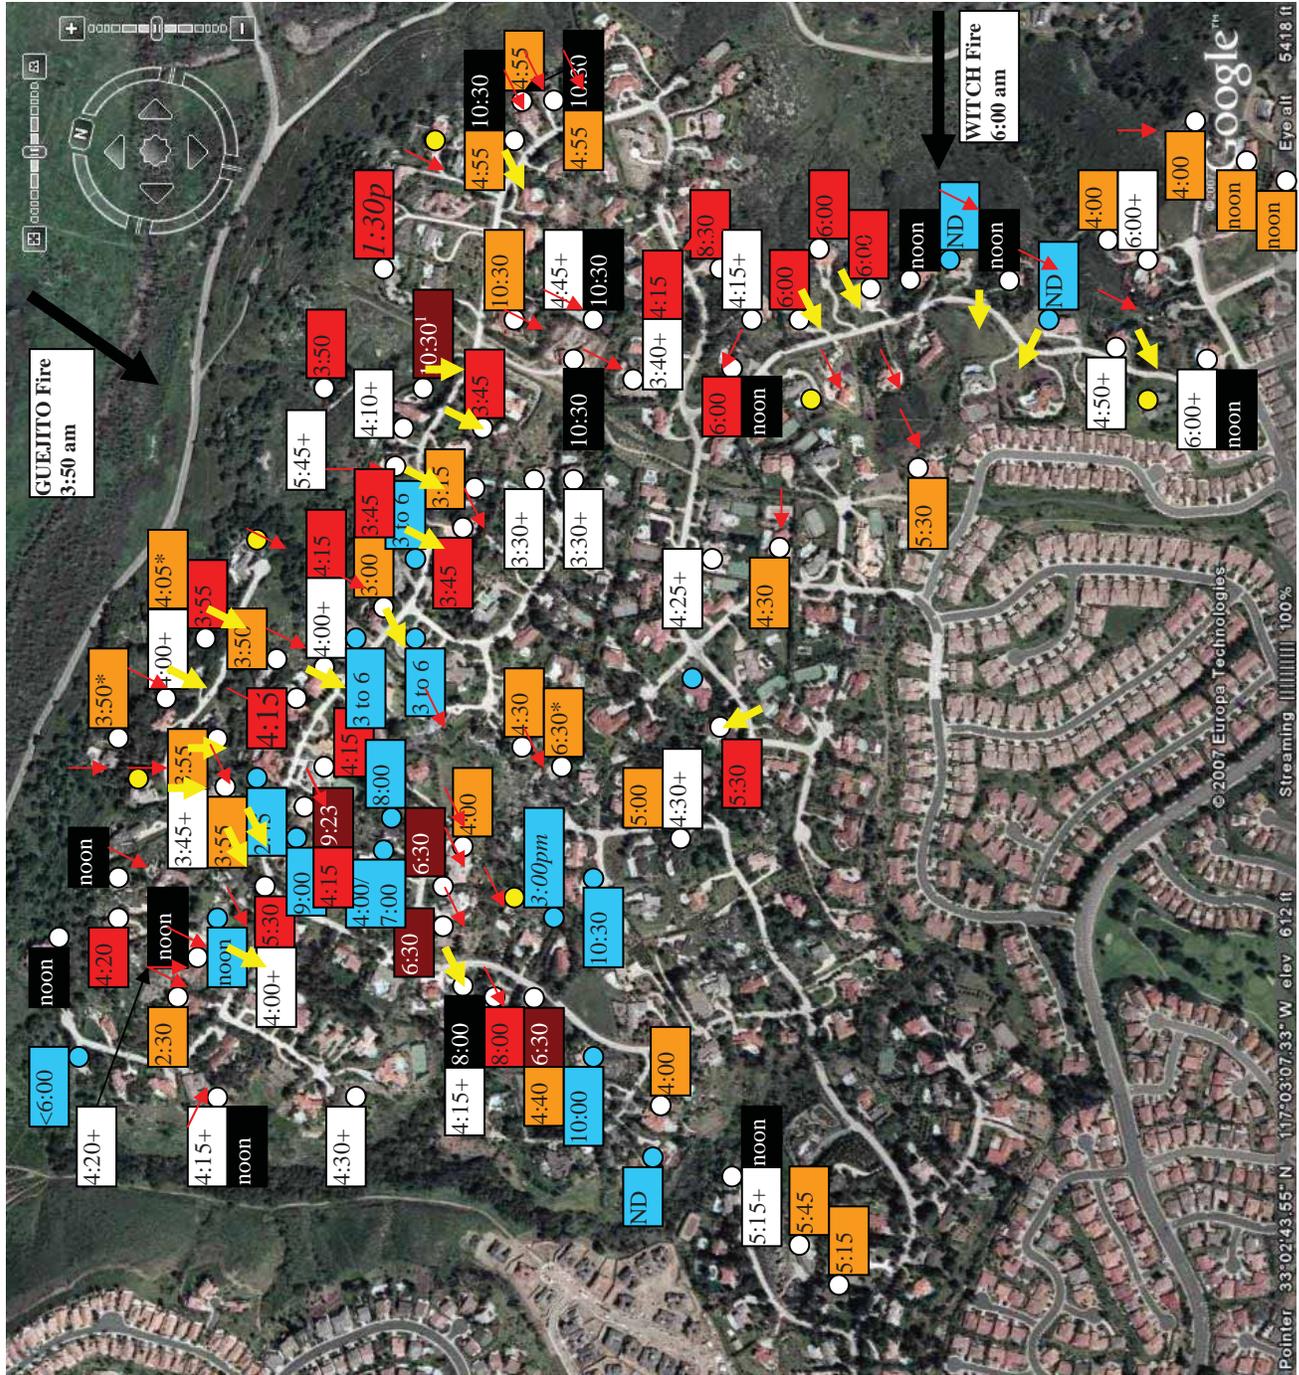
Figure 30: House burning times, fire spread and fire jumps

Fire spread →	* Estimated House Ignition	House burning – visible flames	House almost gone	1 3:45 am deck fires put out by SD FD , 9:30 am deck fires put out by resident
Fire jump ↘	Damaged	House completely in flames	House burned - gone
