# Measuring Airtightness At ASHRAE Headquarters

By **Terry Brennan**, Member ASHRAE; **Andrew Persily, Ph.D.**, Fellow ASHRAE; **Michael Clarkin**; and **Steve Emmerich**, Member ASHRAE

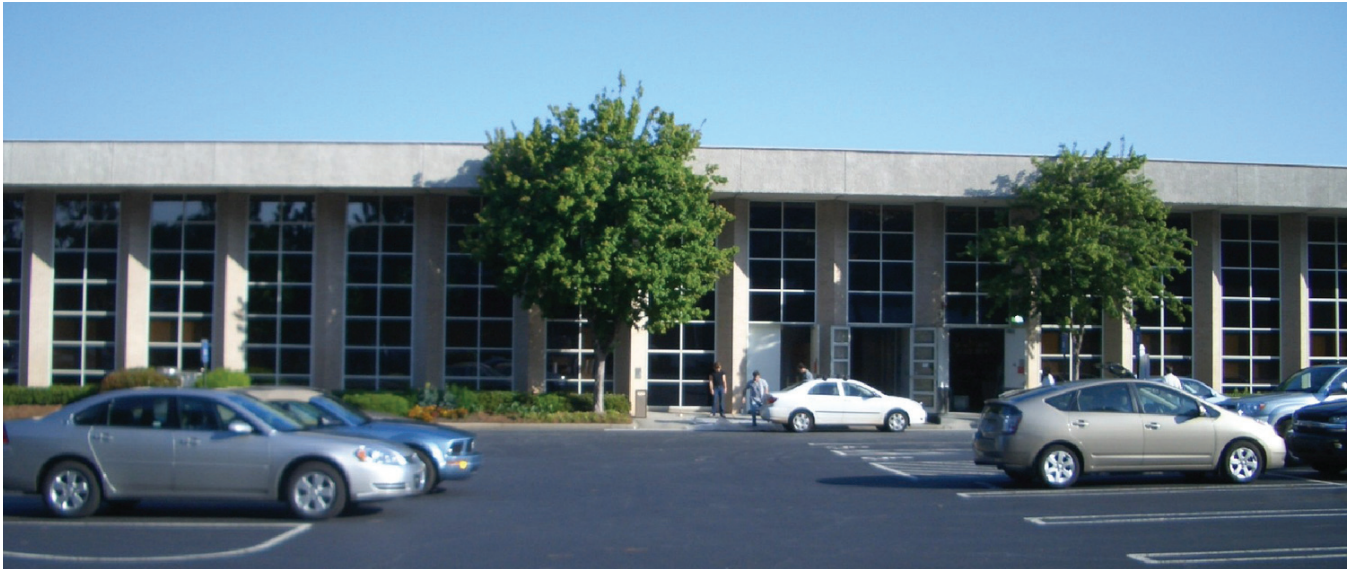
*Photo 1: Rear entrance of the ASHRAE headquarters building.*

a curtain wall system composed of glass and spandrel panels. Two variable air volume (VAV) air handlers and two smaller perimeter units provide heating, cooling and dilution ventilation for the building. Pressure relief for the air-side economizer on the two VAV units is provided by relief dampers located in the return air plenum of each floor. Outlets for the pressure relief are located on the roof. Toilet exhaust is provided by a rooftop exhaust fan. There is 15,160 ft<sup>2</sup> (1408 m<sup>2</sup>) of floor space on each of the two floors. It was originally constructed in 1965 and was last renovated in 1991. A photograph of the building is shown in *Photo 1*, and *Table 1* contains the building dimensions.

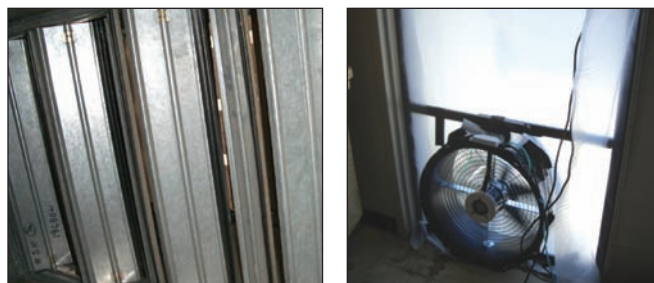
**Photo 2 (left): Relief dampers from the second floor plenum to rooftop did not close. Photo 3 (right): Blower doors installed in exterior doors.**

the relief damper in the second floor plenum were open an inch (*Photo 2*). These were closed manually until the seal was tight. Rooftop openings for the exhaust, relief, and outdoor air intakes were sealed using duct mask. All the interior doors were opened, including the stairway doors between the first and second floors, to better equalize the interior air pressure in the building.

Three blower doors were set in polyethylene shrouds in two of the exterior doors. The blowers were initially set to depressurize the building. One of the blower doors was placed so that it could depressurize the second floor through the fire egress stairs. *Photo 3* shows a blower door in one of the shrouds. *Figure 1* shows the locations of the blower doors on a first floor plan.

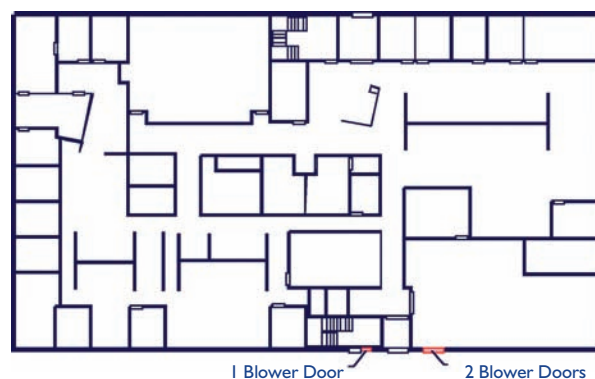
**Figure 1: Building floor plan showing location of blower doors.**

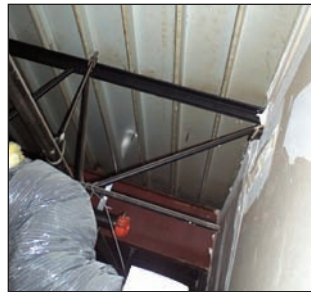
installed (Photo 4). The renovation included using gypsum board and mineral wool insulation board to extend the air and thermal barrier provided by the curtain wall system from the top of the curtain wall to the bottom of the roof deck. Although generally well installed, a few areas exist where air leakage still occurs. For example, the joint between the top of the curtain wall and the gypsum board has not been sealed and shows no sign of the acoustic sealant specified in the drawings (Photo 5). In areas where the wall below jogs, the detail in the soffit area above was not clear and is difficult to seal (Photo 6). It is

**Photo 4: Gypsum board separating the second floor plenum from the soffit has been installed with a good fit around structural steel and sealed with joint compound.**

**Photo 5: Joint at bottom of gypsum board has not been sealed.**

**Photo 6: Sealing detail at a jog in the wall section is incomplete.**

likely that air leaks occur where the flutes of the steel roof deck meet the gypsum board seal.

Although built in 1965, the ASHRAE HQ building just meets the 2002 U.K. requirement of  $10 \text{ m}^3/\text{h}\cdot\text{m}^2$ . With some air-sealing work, it could perhaps meet or exceed the 2006 normal practice of  $5 \text{ m}^3/\text{h}\cdot\text{m}^2$ . It would probably take a lot of effort to reduce enclosure leakage by more than a factor of three to meet the best practice target of  $2 \text{ m}^3/\text{h}\cdot\text{m}^2$ .
