EXPOSING SIDING TREATMENTS AND WALLS FITTED WITH EAVES TO FIREBRAND SHOWERS

Samuel L. Manzello*¹, Sayaka Suzuki¹, and Yoshihiko Hayashi²

National Institute of Standards and Technology (NIST)

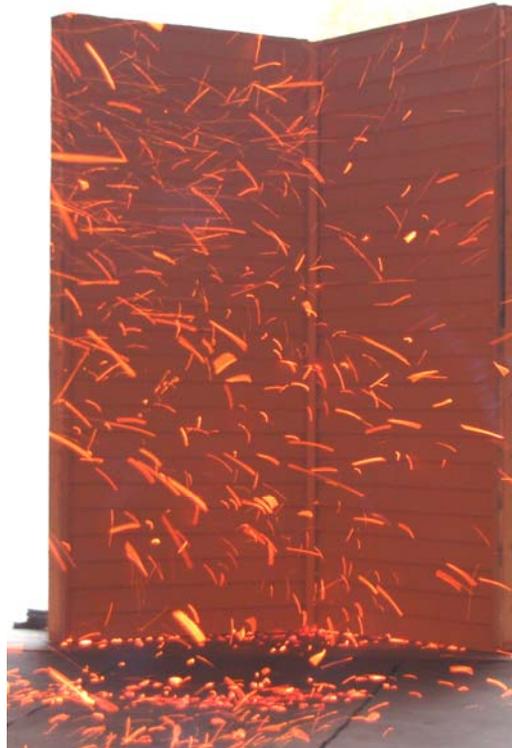
Figure 3 Picture of vinyl siding corner assembly under firebrand bombardment.

A full scale corner section (each side was 122 cm wide by 244 cm high) assembly was constructed for testing (shown in Figure 3). To be able to control the moisture content of the sheathing (OSB) base layer, the experiments were designed in a modular fashion. Specifically, each side of the 122 cm by 244 cm full section was comprised of 12 separate OSB pieces. This allowed each section to be oven dried and simply reassembled inside the custom mounting frame. For each assembly, a moisture barrier was applied (Tyvek; a registered product of DuPont) and then the siding treatments were applied. The frame was constructed using wood studs with a stud spacing of 400 mm (16") on center. Two different types of siding treatments were used. Vinyl siding and polypropylene siding. Polypropylene siding is newer to the market as compared to vinyl and is used since it has the look and feel of cedar siding. The American Vinyl Siding Institute was contacted for proper installation and construction was performed in accordance with their installation manual [30].

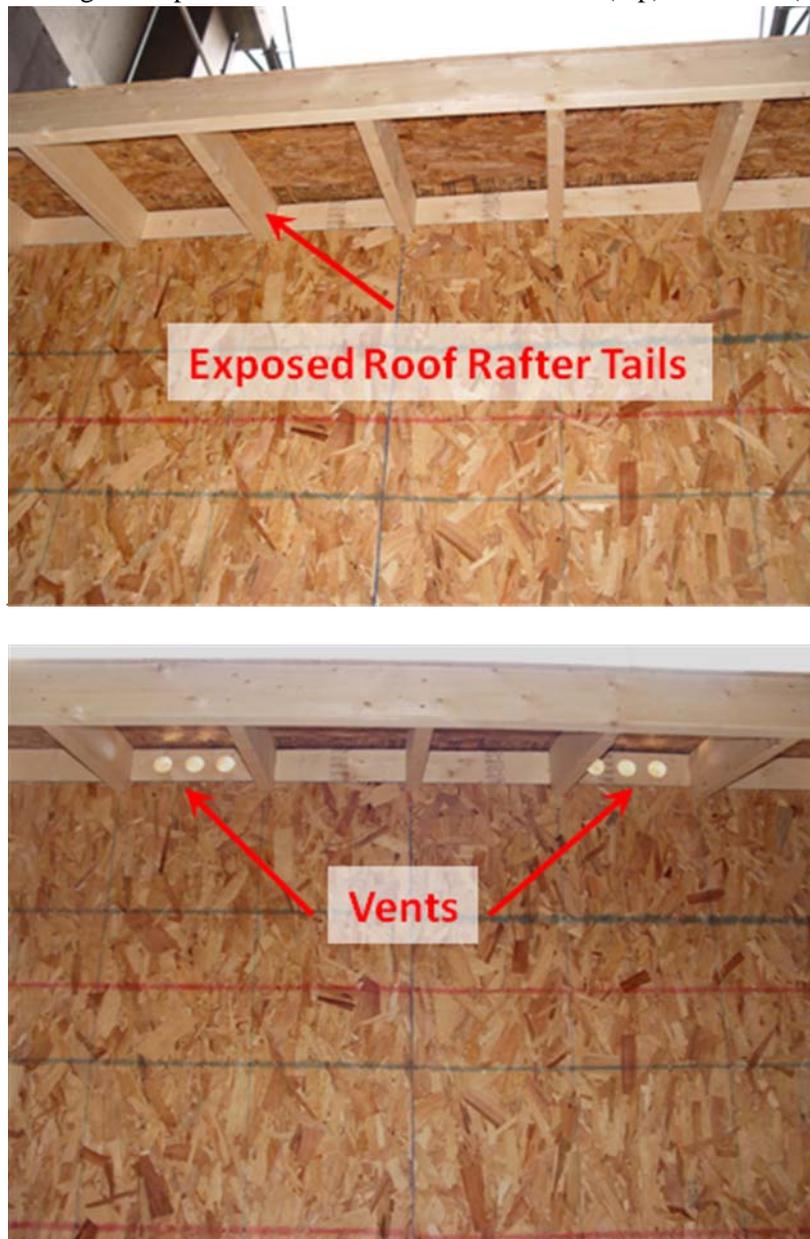
Figure 6 Images of open eave construction with no vents (top) and vents (bottom).

top panel of Figure 5 was followed for testing [29]. In half of the experiments, no vent opening was used to simply observe if firebrands actually accumulated within the exposed rafters and subsequent joints (see Figure 6). In the remaining experiments, vents were installed (see bottom panel) and a mesh was placed within the vent opening (see Figure 6). For the vent openings, 50 mm holes were drilled into the blocking material and an 8 x 8 mesh (2.75 mm opening) was secured, as recommended in the new, 2010 California WUI code [32]. As in the corner tests described above, three replicate experiments were performed. Table II is a summary of the range of parameters used.

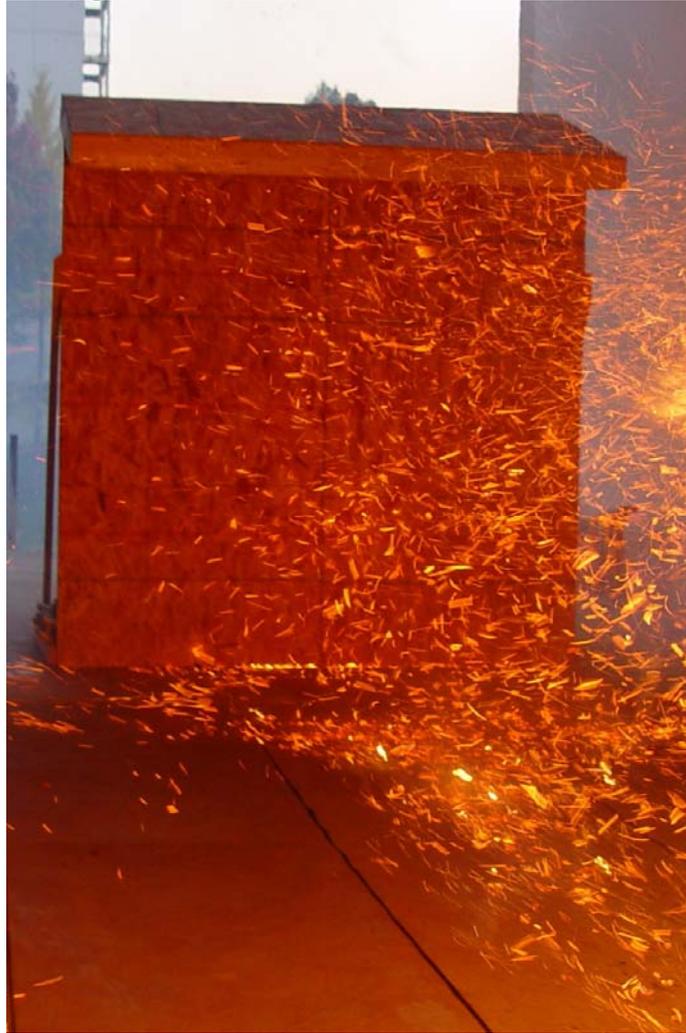
Figure 7 Image of wall fitted with eave under firebrand bombardment.

Figure 7 displays a typical experiment showing a wall fitted with an eave exposed to firebrand showers from the NIST Dragon inside the FRWTF. For the experiments that used no vent opening,

When vents were installed, cameras were placed both in front and behind of the eave assembly in order to quantify the number of firebrands arriving at the vent locations. At 7 m/s, the number of firebrands arriving at the vent location was 10 ± 1 (average \pm standard deviation). As the velocity was increased to 9 m/s, the total number of firebrands arriving at the vent location increased to 28 ± 2 (average \pm standard deviation). While the number of firebrands arriving at the vent locations increased as the wind speed increased, it was very small as compared to the number of firebrands that bombarded the wall/eave assembly (see Figure 7).
