NIST Technical Note 1687

Spent Fuel Cask Seal Performance Testing: Interim Report

*Fire Research Division
Engineering Laboratory*

January 2011

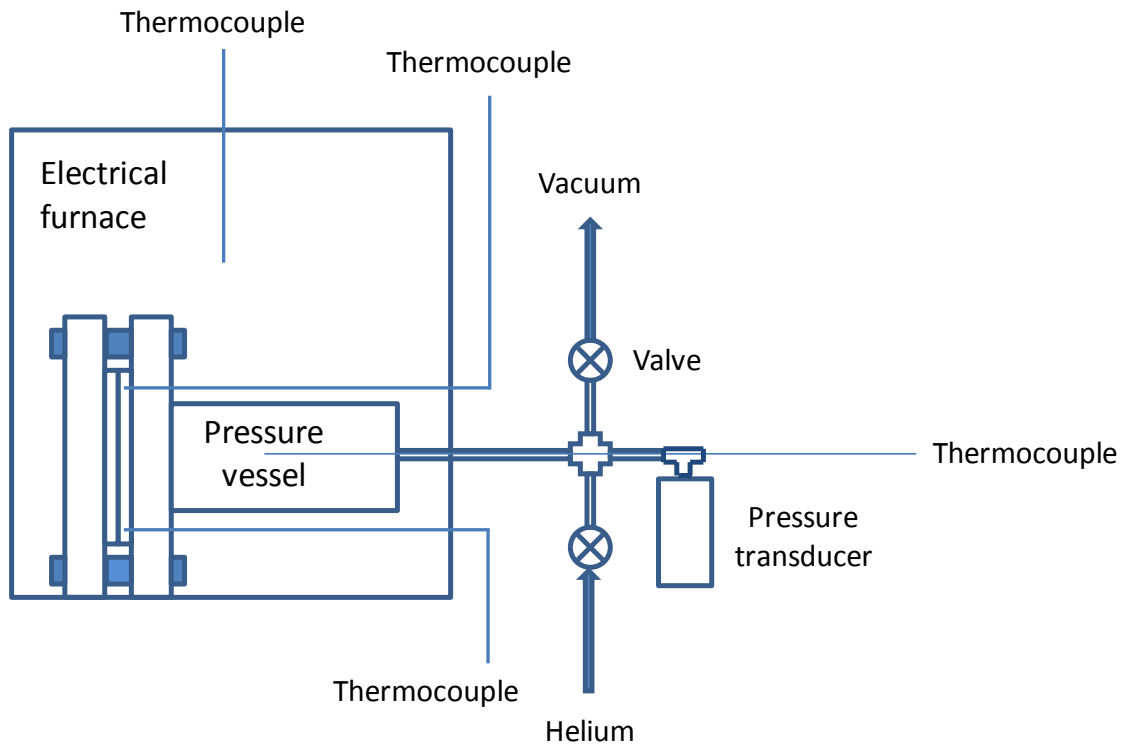
Figure 1. A schematic of the experimental apparatus.

The test fixture consists of a seamless vessel body with a flange machined from a stainless steel (SS 304) cylindrical stock and a removable SS 304 flange (vessel cap) with seal groove machined to O-ring manufacturer specifications. The flange dimensions were made in conformity with the ASME Standard B16.5-2009 [5], Flange Class 2500 with a design pressure rating up to 29.2 bar (Table 2-2.1, ASME Standard B16.5-2009). The vessel cavity had a nominal internal volume¹ of 100 mL. The seal was a Garlock Helicoflex² metal O-ring made of

The vessel body and the cap were joined together using four bolts (SS 304 1-1/8 in. 7 TPI). Each bolt was tightened with a torque of 416 N·m (307 ft·lb) \pm 2 N·m (expanded uncertainty with a coverage factor of 2) using a micrometer torque wrench (KD Tools 2953 3/4 in. drive 100-600 ft·lb; 153-830 N·m, with a resolution of 3.4 N·m). A 24 cm long Stainless steel tubing with an inside diameter of 0.48 cm (0.189 in.) and an outside diameter of 0.953 cm (0.375 in.) was inserted into the bottom of the vessel body flush through a straight-hole with a bevel-groove and was all-around fillet welded to the vessel. The exposed end of the tubing was connected to a union cross equipped with two needle valves (Swagelok SS-1RS4) or bellows valves (Swagelok SS-4BK)³ for filling and evacuating the test vessel and a tee connection for mounting a pressure transducer (Omegadyne, PX01C1-500A5T) and a thermocouple (Omega K-type CAIN-18G-24) to monitor the vessel pressure and temperature. Figure 1 is a schematic of the experimental apparatus, two photographs of which are shown in Figure 2. Five test fixtures with the same dimensional tolerances were constructed and used for this test series.

25.4 cm × 25.4 cm × 40.64 cm (10 in. × 10 in. × 16 in.). The electrical furnace has a maximum operating temperature of 1200 °C. Due to the large mass and thermal inertia of the test fixture, it was anticipated that the test fixture temperature might not be totally uniform. Therefore, four K-type grounded thermocouples (Omega K-type CAIN-18G-24)⁴ were used to monitor the transient temperature distribution; one for vessel interior temperature, one for furnace temperature, and two for temperatures of the vessel cap at two locations 90° apart near the O-ring groove to monitor the temperature experienced by the metallic seal. Two nominal temperatures, 800 °C and 427 °C, were selected for thermal exposure testing of the metallic cask seals; 10 CFR Part 71 uses an exposure temperature of 800 °C and the published maximum operating temperature of the metallic seal used in this study is 427 °C (800 °F)⁵. The thermal exposure time was 9 h after the seal had attained the test temperature.

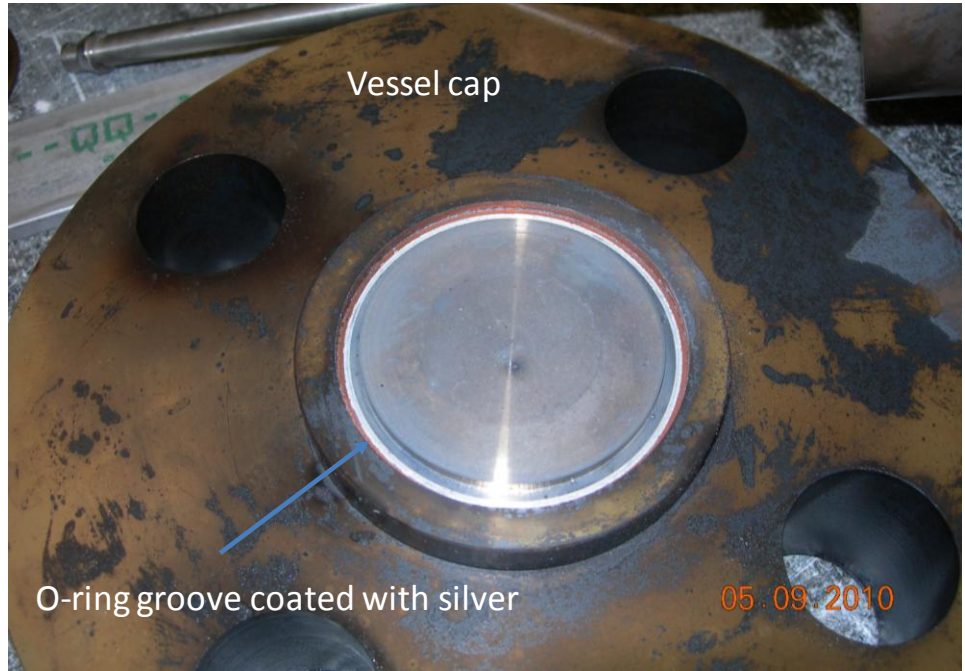
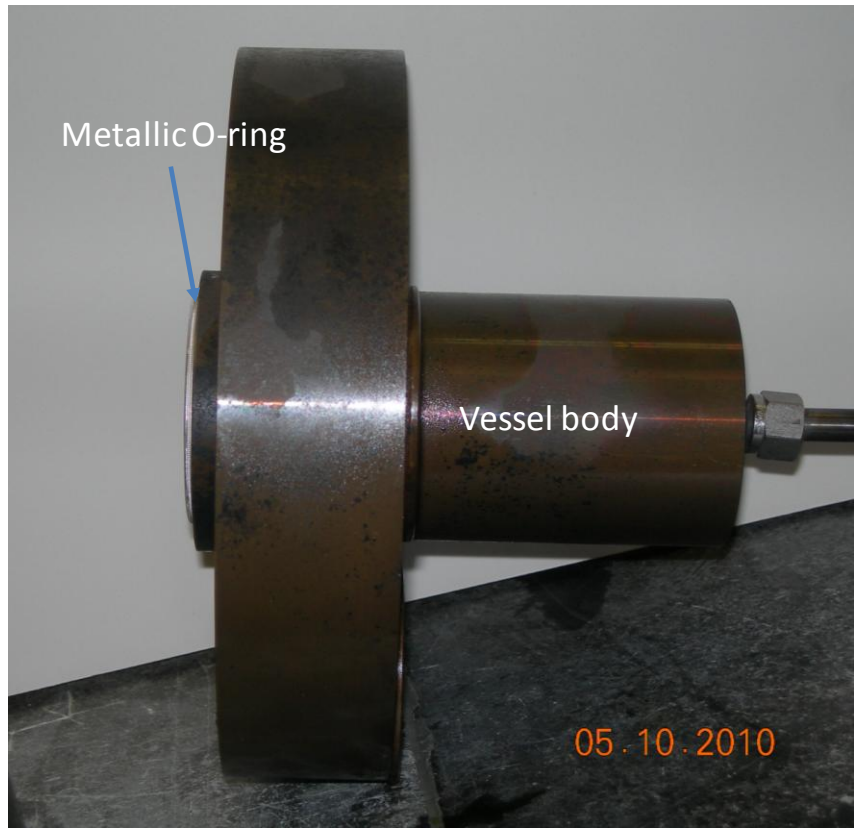
Figure 3. Postmortem photographs showing silver from the metallic O-ring deposited on the O-ring groove and the O-ring bonded to the tested vessel (Vessel #1) body.

A postmortem inspection of the tested vessel revealed that the metallic seal was soldered to the flange of the vessel body and a silver-color coating was imprinted on the surface of the O-ring groove, as shown in Figure 3. The high-temperature exposure also discolored the test fixture.

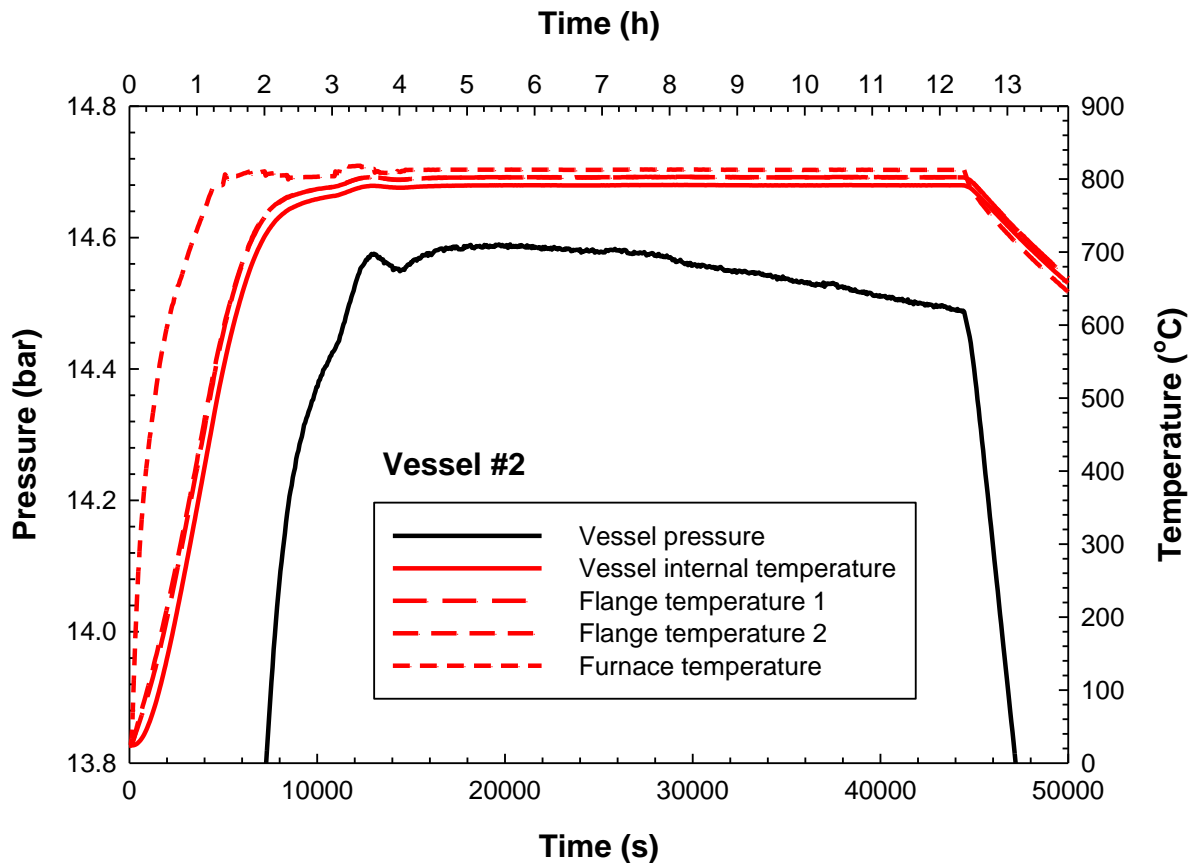
Figure 4. Temporal variations of vessel pressure and temperature in Test #2.

Figure 4 shows the temporal variations of the vessel internal pressure and temperature, two flange temperatures and furnace temperature during the heat-up, the constant-temperature heating (isothermal), and the cool-down phases for Test #2. The entire cool-down phase is not shown in Figure 4 because it normally takes more than several days to naturally cool the test vessel inside the powered-down furnace from 800 °C to room temperature.

The scale of the ordinate for pressure in Figure 4 is magnified to show that the pressure starts to decrease shortly after the vessel temperature has reached 800 °C and continues to decrease during the rest of the 9 h constant-temperature heating phase. Although the decrease in pressure, which is within the expanded measurement uncertainty of the pressure transducer, is not significant in this test, the continuous downward trend does seem to imply the occurrence of a very small leak.

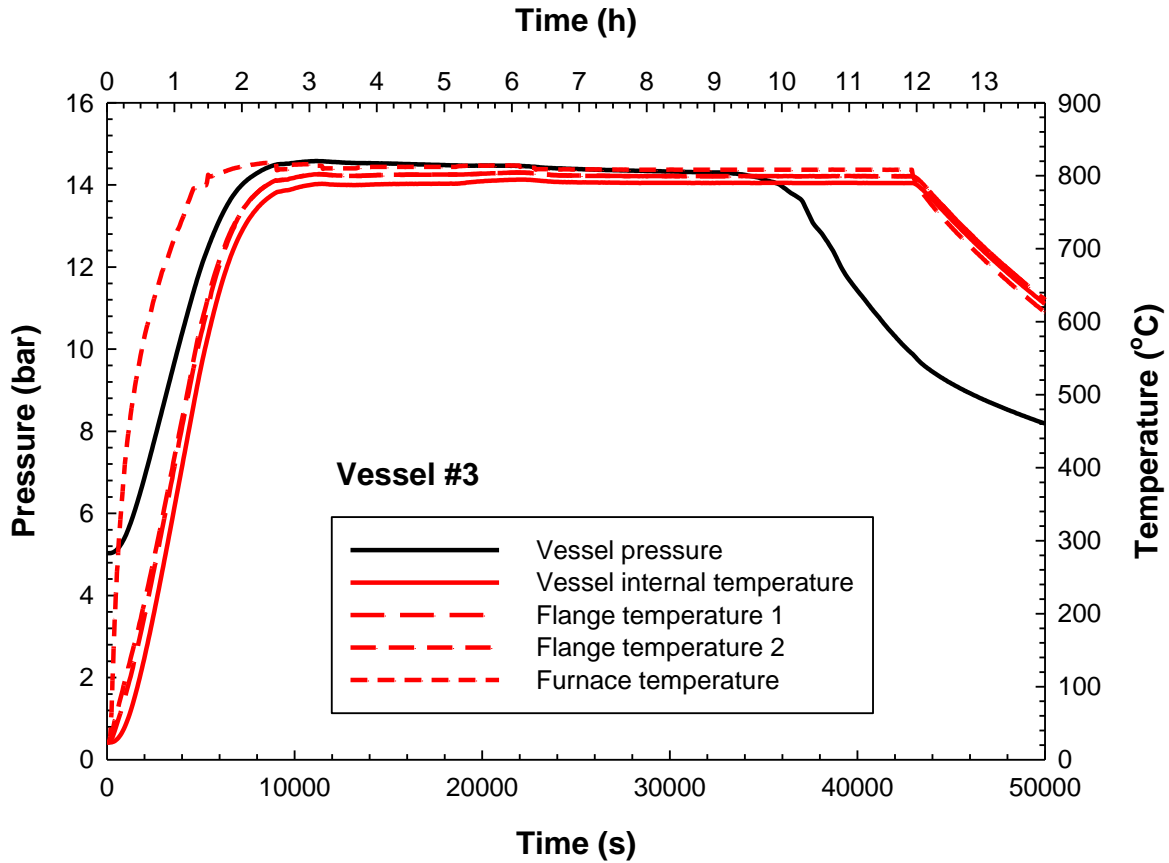
Figure 5. Temporal variations of vessel pressure and temperature in Test #3.

Test #3 is a repeat of Test #2. Figure 5 is the test results and also shows the occurrence of a leak during the 9 h constant-temperature heating phase at 800 °C. In Test #3, the vessel pressure

decreases slowly initially and then significantly after about 25 000 s at 800 °C. Since the leakage rate is directly proportional to the time rate of change of pressure, this two-stage decrease in pressure indicates a slower leak rate (small dP/dt) at first and then a faster leak rate (large dP/dt) at the end.

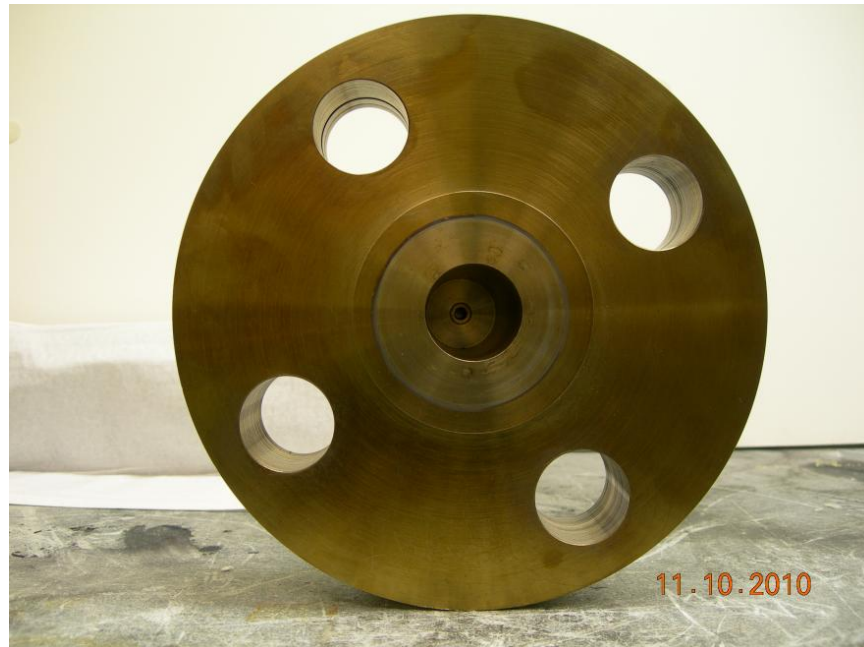
Figure 8. Postmortem photograph of Vessel #5 (vessel body with O-ring removed) after exposure at 427 °C for 9 h.

The results for Test #5 are shown in Figure 7. The vessel pressure remains constant during the entire 9 h constant-temperature heating period at 427 °C. The seal held vessel pressure. This was further confirmed by the fact that the initial pressure at room temperature was recovered after the cool-down phase. In addition, the pressure remained unchanged for over 140 h after the cool-down. A photograph of the exposed vessel is shown in Figure 8. The extent of discoloring of the vessel depends on the test temperature (Figure 3 vs. Figure 8). A postmortem inspection revealed that the metallic O-ring seal was not soldered to either flange surfaces, and no silver coating from the seal was transferred to the O-ring groove.
