EXPOSING GLAZING ASSEMBLIES TO FIREBRAND SHOWERS

An experimental campaign was undertaken to determine vulnerabilities of glazing assemblies to firebrand bombardment using the NIST Dragon installed in the Building Research Institute's Fire Research Wind Tunnel Facility (FRWTF). Results of these experiments are presented.

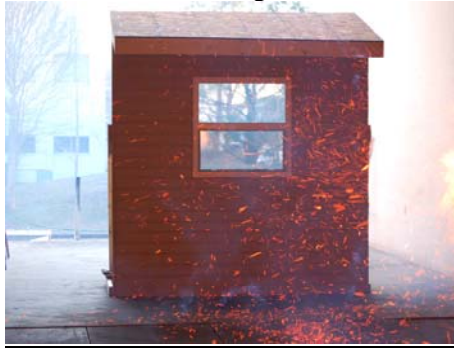
Figure 1 Picture of wall/eave assembly fitted with a vertically sliding, double hung window exposed to firebrand showers at a wind tunnel speed of 9 m/s.

The size of each of the glazing assemblies were the same: 91 cm by 91cm. To mount these assemblies, a 244 cm by 244 cm wall fitted with an open eave was constructed for testing. The wall

was constructed using wood framing members spaced 400 mm (16") on center. Oriented strand board (OSB) was applied over the wood framing members and a moisture barrier was installed over the OSB. Vinyl siding was applied over the moisture barrier. An eave with a total length of 122 cm was constructed and mounted to the wall assembly. For completeness, an image of a typical experiment is shown in Fig. 1.

For, each window assembly considered, two different wind speeds were used. Specifically, the window assemblies were exposed to firebrand showers at wind tunnel speeds of 7 m/s and 9 m/s. It was observed that firebrands accumulated within the framing and this behavior was more pronounced for the vertically sliding glazing assembly; as suspected. Yet, in none of the experiments did the framing sustain sufficient damage for the window assembly to cause glass fallout and/or breakage.

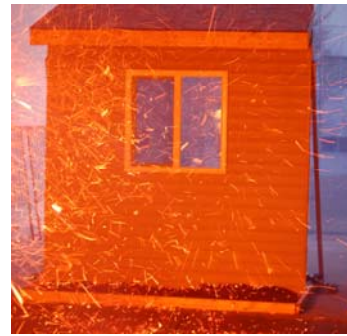
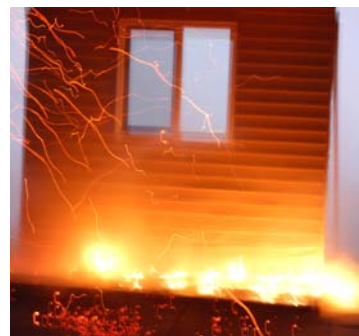
Figure 2 In the top image, firebrands have caused smoldering ignition in the mulch bed. In the bottom image, smoldering ignition has transitioned to flaming ignition and the wall assembly has ignited.

Firebrands were observed to ignite the needle bed via smoldering ignition, the smoldering ignition become self-sustaining, and a transition to flaming ignition was observed (see Figure 2). The flaming ignition in the needles subsequently melted the vinyl siding and produced self-sustaining smoldering ignition at the base of the wall assembly (within the OSB; this OSB was not even dried).
