Spent Nuclear Fuel Transportation Package Seal Performance in Beyond Design Basis Thermal Exposure Scenarios - 11391

Christopher Bajwa, Earl Easton, Felix Gonzalez,
U.S. Nuclear Regulatory Commission, Washington, DC 20005

Jiann Yang, Edward Hnetkovsky,
National Institute of Standards and Technology, Gaithersburg, MD 20878

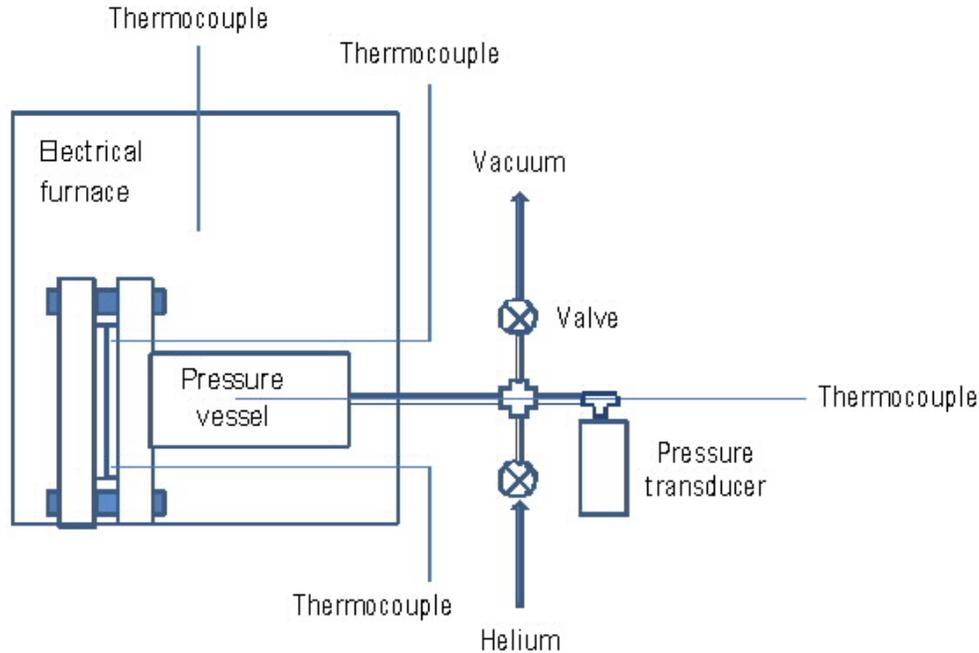
Figure 1: Schematic of experimental apparatus

The test vessels were composed of a cylindrical shell and a flange fabricated from Stainless Steel 304 (SS 304). The flange dimensions were made in conformity with the ASME Standard B16.5-2009, flange class 2500 with a design pressure rating up to 29.2 bar (Table 2-2.1, ASME Standard B16.5-2009) [5]. The vessel cavity had a nominal internal volume of 100 mL. The seal was a metal O-ring made from Inconel 718 and silver with an outer diameter of 6.35 cm (2.5 in) and a cross section of 0.32 cm (0.125 in).

The vessel body and the flange were joined together using four bolts (SS 304 1-1/8 in. 7TPI), each tightened with a torque of 416 N·m (307 ft·lb) \pm 2 N·m using a micrometer torque wrench. A 24 cm long SS tubing with an inside diameter of 0.48 cm (0.189 in) and an outside diameter of 0.953 cm (0.375 in) was inserted into the bottom of the vessel body flush through a straight-hole with a bevel-groove and was all-around fillet welded to the vessel. The exposed end of the tubing was connected to a union cross equipped with two needle valves or bellow valves for filling and evacuating the test vessel and a tee connection for mounting a pressure transducer and a thermocouple to monitor the vessel pressure and temperature.

The exposure of the seal to high temperature environment was achieved using a programmable temperature-controlled electrical furnace with an internal capacity of 25.4 cm x 25.4 cm x 40.64 cm (10 in x 10 in x 16 in). Four Type K grounded thermocouples were used to monitor the transient temperature distribution of the test fixture.

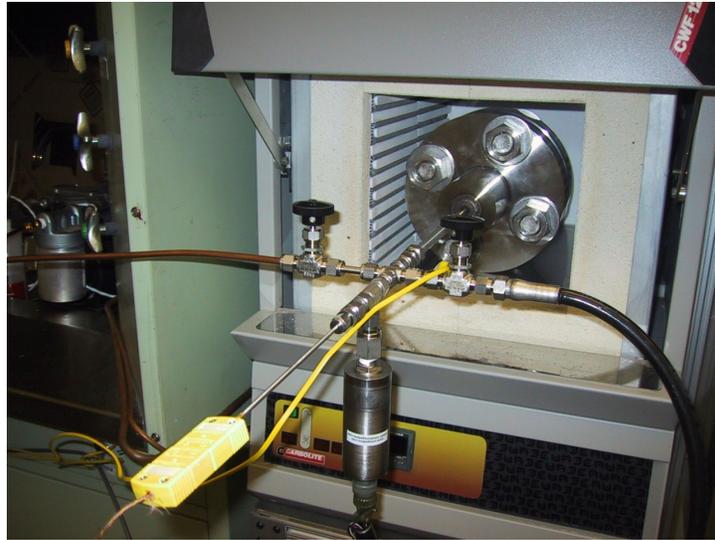
Figure 2: Test rig: test vessel inside the furnace with thermocouple and pressure transducer in place

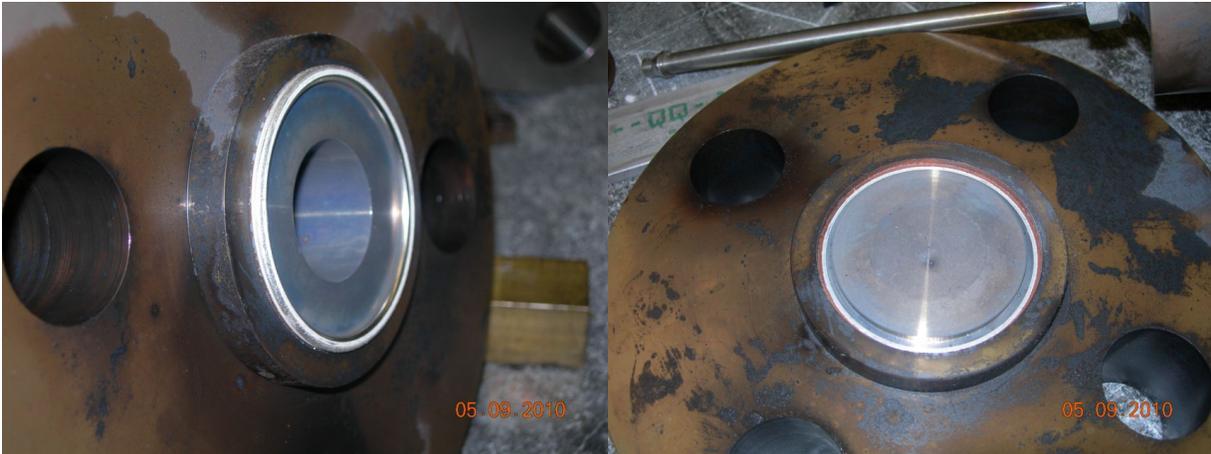
Figure 3: Postmortem photographs showing the O-ring bonded to the tested vessel body (left) and showing silver from the metallic O-ring deposited on the O-ring groove (right)

A postmortem inspection of the tested vessel revealed that the metallic seal was soldered to the flange of the vessel body and a silver-colored coating was imprinted on the surface of the O-ring groove, as shown in Figure 3. The high-temperature exposure also discolored the test fixture.

It is interesting to note that despite the consistent occurrence of a leak in these three tests, the vessel pressure remained above atmospheric pressure at the end of the cool-down-phase, which took several days. This seems to indicate the possibility that during the heat-up phase, the silver coating on the metallic seal (with a melting point of 962°C) softened and “flowed” in the O-ring groove. At that point it may not have been able to hold the system pressure and a slow leak commenced. During the cool-down phase, the softened silver hardened, bonded to the flange surface, and left a silver coating on the O-ring groove surface. The re-hardening of silver might have resealed the vessel. While it cannot be verified experimentally, the test results discussed below appear to indicate the

possibility of re-sealing. The ability of the vessel to maintain pressure following the exposures provides further support, in addition to the photographic evidence described above, to the possibility that re-sealing could potentially occur as the silver in the seal cools.

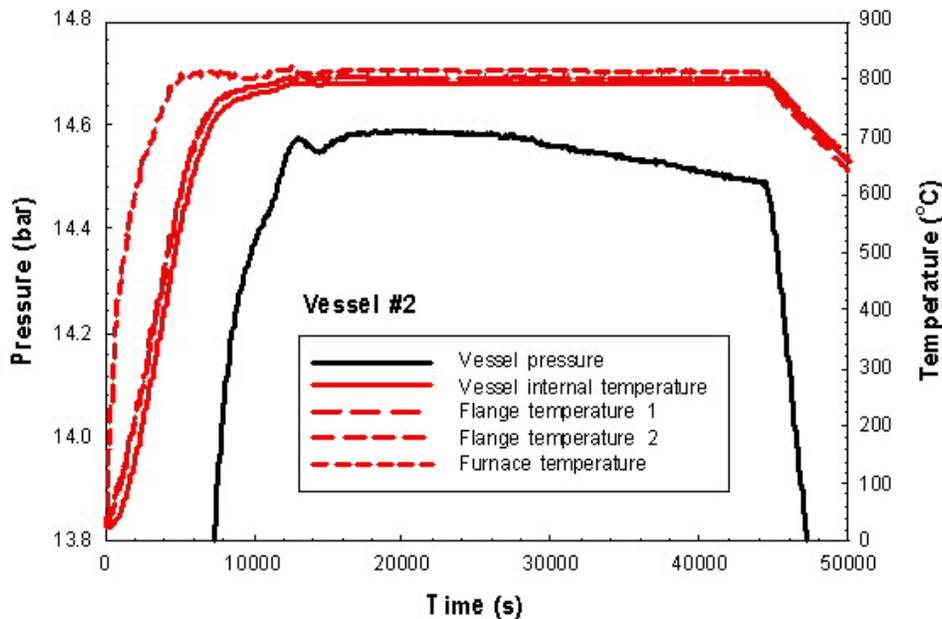
Figure 4: Temporal variations of vessel pressure and temperature in Test #2 (note: y-axis [pressure] has been magnified to show the small pressure decrease)

Figure 4 shows the temporal variations of the vessel internal pressure and temperature, two flange temperatures and furnace temperature during the heat-up, the constant-temperature heating (isothermal), and the cool-down phases for Test #2. The entire cool-down phase is not shown in Figure 4 because it normally takes more than several days to naturally cool the test vessel inside the powered-down furnace from 800°C to room temperature.

The scale of the ordinate for pressure in Figure 4 is magnified to show that the pressure starts to decrease shortly after the vessel temperature has reached 800°C and continues to decrease during the rest of the 9 hour constant-temperature heating phase. Although the decrease in pressure, which is within the expanded measurement uncertainty of the pressure transducer, is not significant in this test, the continuous downward trend does seem to imply the occurrence of a very small leak.

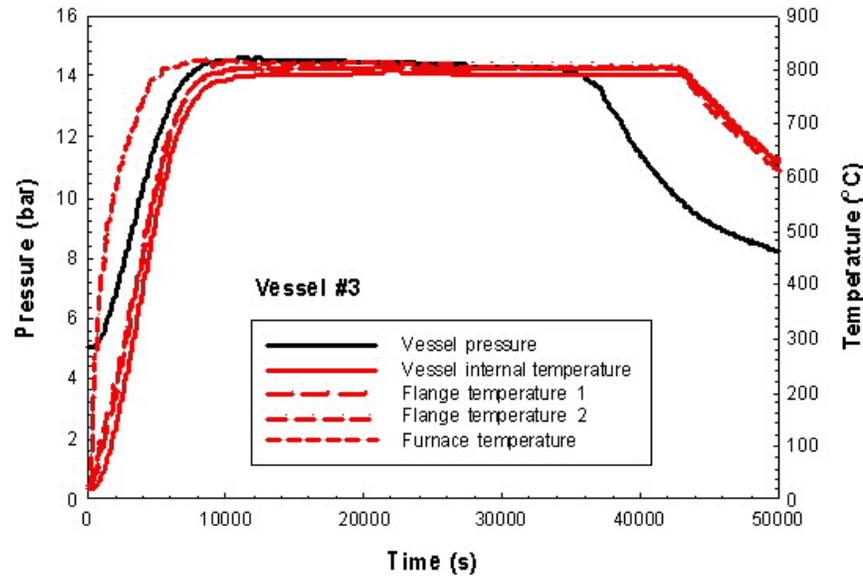
Figure 5: Temporal variations of vessel pressure and temperature in Test #3

Test #3 and #4 are the repeats for Test #2. Figure 5 and Figure 6 are the test results and also show the occurrence of a leak during the 9 hour constant-temperature heating phase at 800°C. In Test #3, the vessel pressure decreases

slowly initially and then significantly after about 25000 sec at 800°C. Since the leakage rate is directly proportional to the time rate of change of pressure, this two-stage decrease in pressure indicates a slower leak rate at first and then a faster leak rate at the end. In Test #4, the pressure remains relatively constant for about 10000 sec initially during the 9-hour constant-temperature heating phase, begins to drop significantly for about 15000 sec, and decreases slowly for the remaining duration.

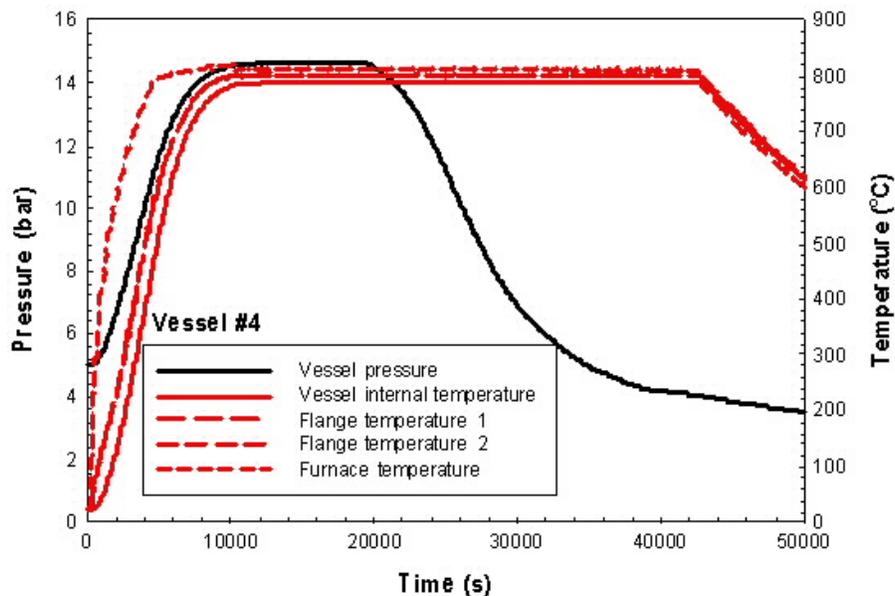
Figure 6: Temporal variations of vessel pressure and temperature in Test #4

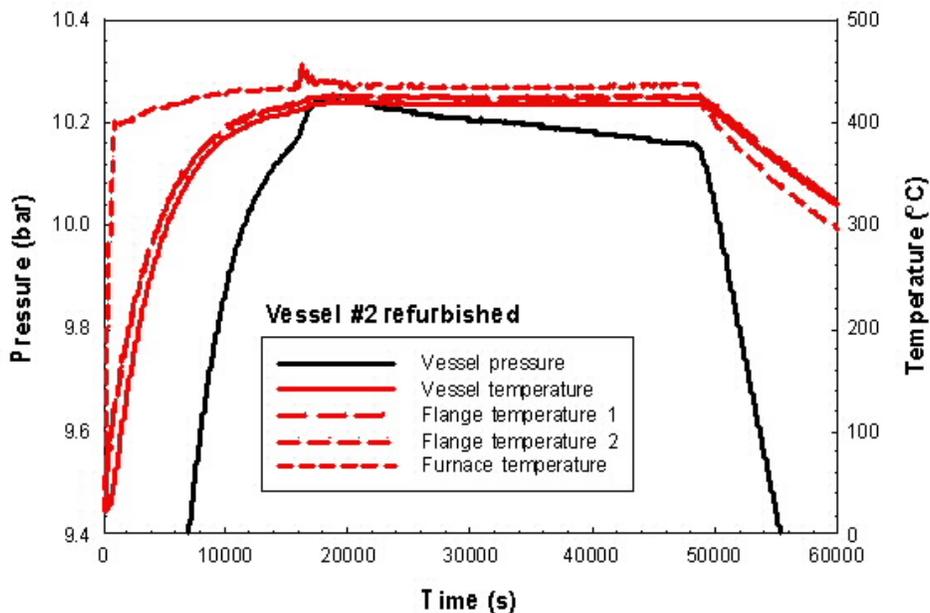
Figure 7: Temporal variations of vessel pressure and temperature in Test #6

The results for Test #6 using the refurbished Vessel #2 are shown in Figure 7. The refurbishment only involved the re-facing of the surfaces of the flanges and the O-ring groove to the specified tolerances. For this test, the vessel pressure started to decrease very slowly during the constant-temperature heating period. The scale of the ordinate pressure is magnified in Figure 7 to elucidate the small pressure drop, which is within the expanded measurement uncertainty of 0.11 bar; however, the continuous decrease in pressure does seem to imply that a very small leak might have occurred during the test.

It is not known if the leak in the refurbished Vessel #2 was caused by a different thermal response of the vessel, which had previously been exposed at 800°C for 9 hrs. Although Vessel #1 was also refurbished, the previous exposure time at 800°C was much shorter than that of Vessel #2 (30 min vs. 9 hrs).
