NIST NCSTAR 1-6D (Draft)

**Federal Building and Fire Safety Investigation of the
World Trade Center Disaster**

Global Structural Analysis of the Response of the World Trade Center Towers to Impact Damage and Fire (Draft)

Simpson Gumpertz & Heger Inc.

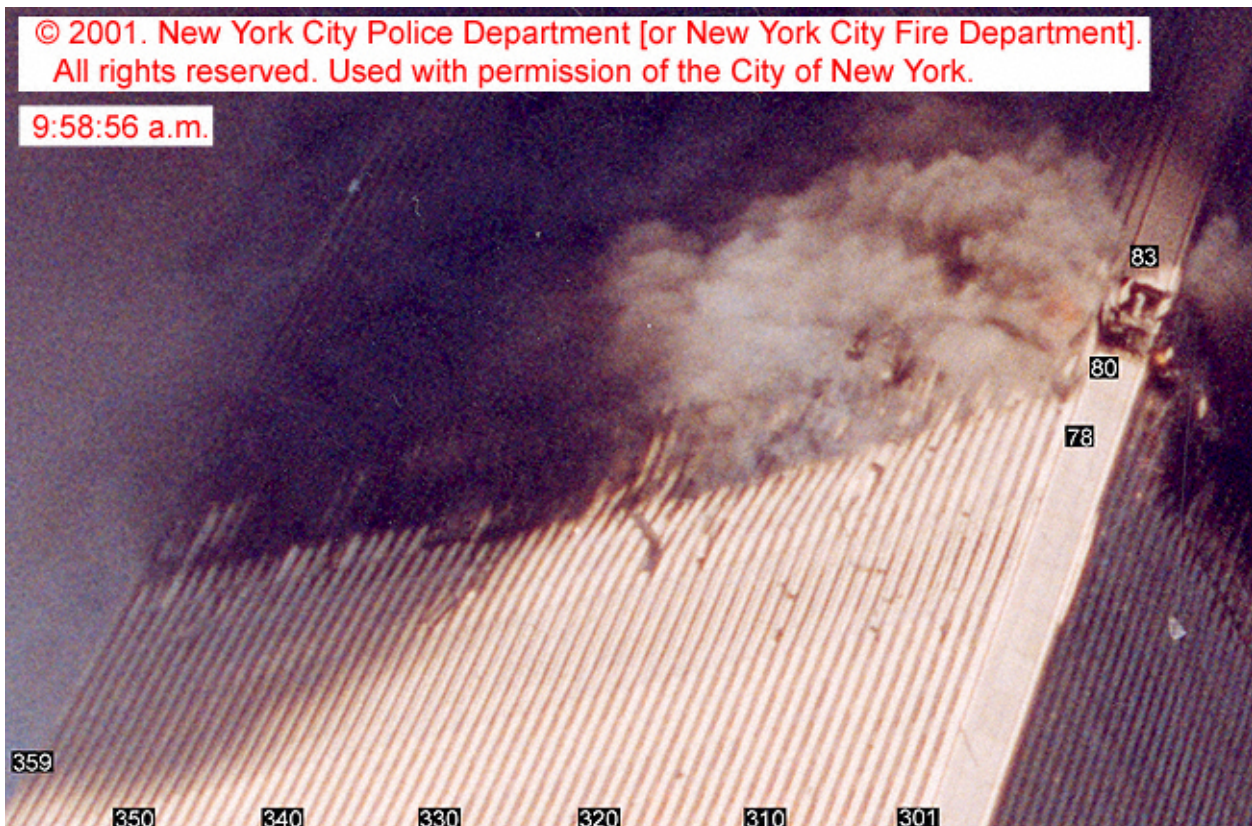
Figure E-13. Inward bowing of the east wall of WTC 2 global model for Case D conditions at 43 min at the instant of collapse initiation (deformed shape scaled four times).

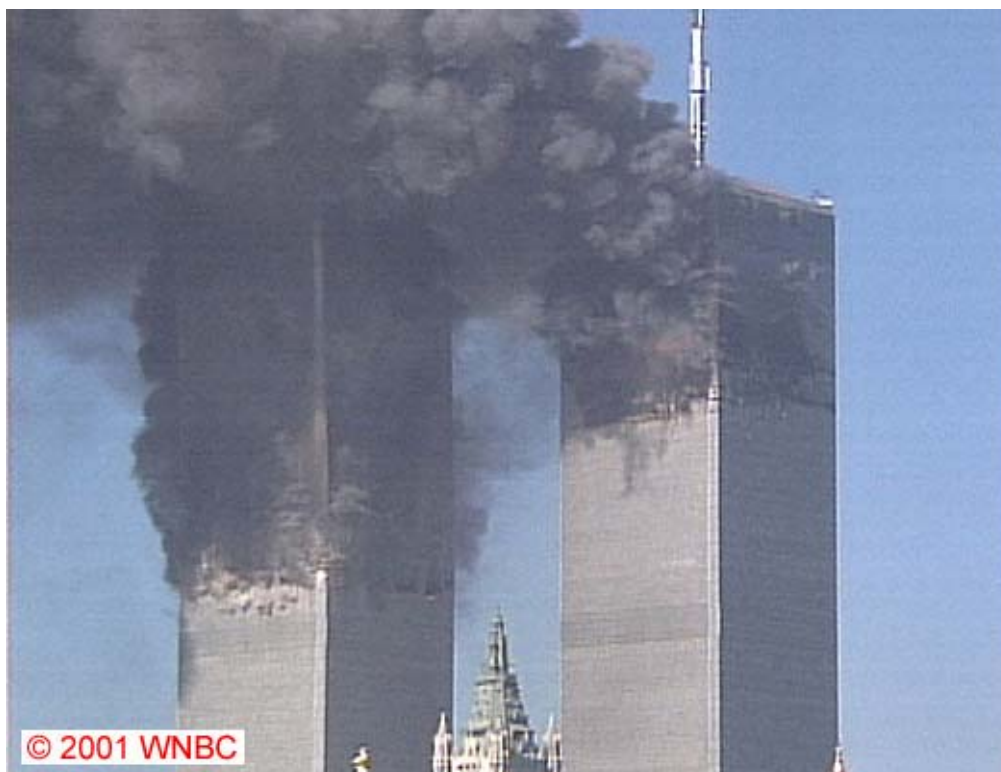
Figure E-15. Total displacements of WTC 2 global model above Floor 86 for Case D conditions at 43 min at collapse initiation (note the tilt toward east and south; deformed shape magnified 20 times).

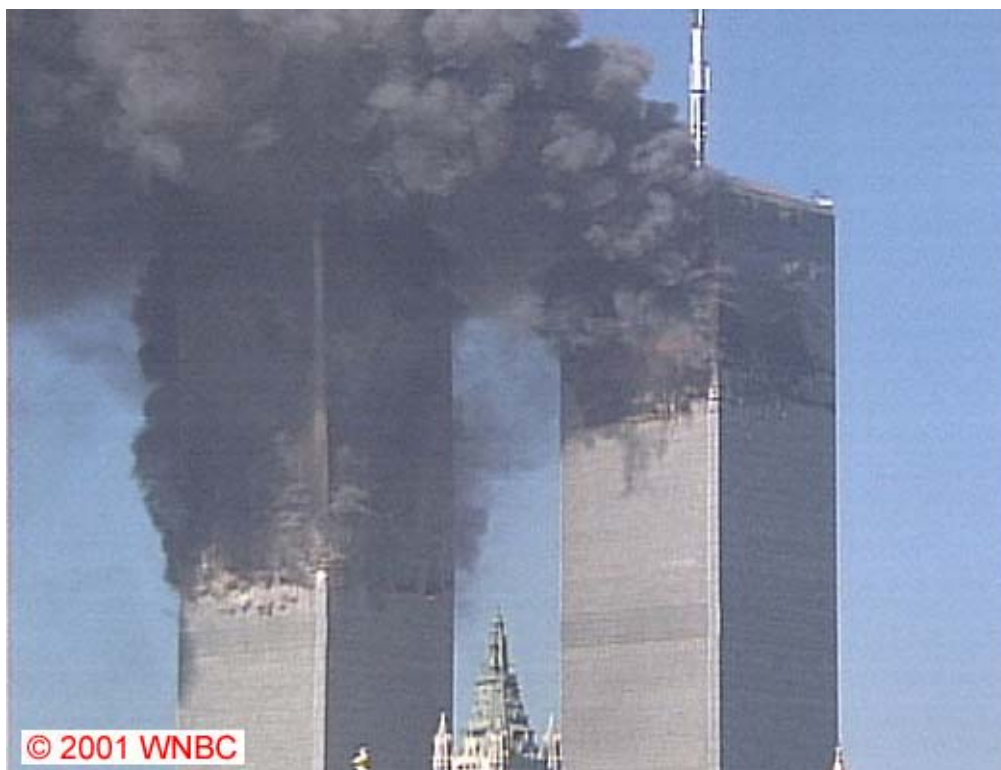
Figure 5–16. Initiation of Collapse of WTC 2. Note the tilt toward east and south.
