Cumulative Seismic Damage of Circular Bridge Columns: Benchmark and Low-Cycle Fatigue Tests

by Ashraf El-Bahy, Sashi K. Kunnath, William C. Stone, and Andrew W. Taylor

ACI Structural Journal, V 96, No. 4, July-August 1999.

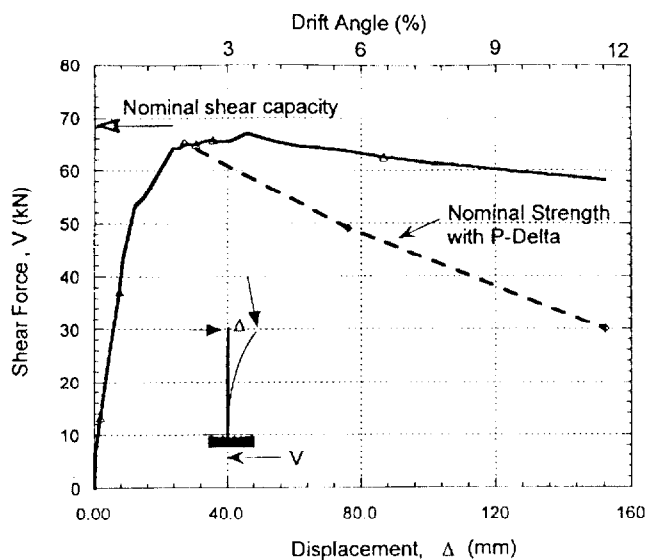
Fig. 6—Response of column to monotonic loading.

Monotonic test—Specimen A1 was tested under a monotonically increasing lateral load until failure. Spalling of the concrete cover was observed at approximately 3.5-mm (2.5 percent drift) lateral displacement. The maximum lateral load reached 66 kN before additional displacement caused a gradual softening of the column stiffness. Two longitudinal bars showed signs of buckling as the lateral load capacity of the specimen began to drop at a drift of approximately 4.0 percent. The definition of failure in a monotonic test is difficult to establish; while it is conceivable that large lateral displacements (without reversals) can strain the longitudinal bars to fracture, such a level of displacement was not possible in the present test, given the limitation of stroke capacity of the hydraulic actuator. Additionally, at these large displacements, P-delta effects are significant and the resulting secondary moments can result in collapse of the structure. Again, the test setup, consisting of hydraulic actuators mounted directly onto the specimen, will prevent this from happening. Given these circumstances, it was decided to stop testing at a lateral drift of 11 percent, at which state P-delta collapse was considered to be the possible failure mode. Fig. 6 shows the resulting force-deformation envelope.

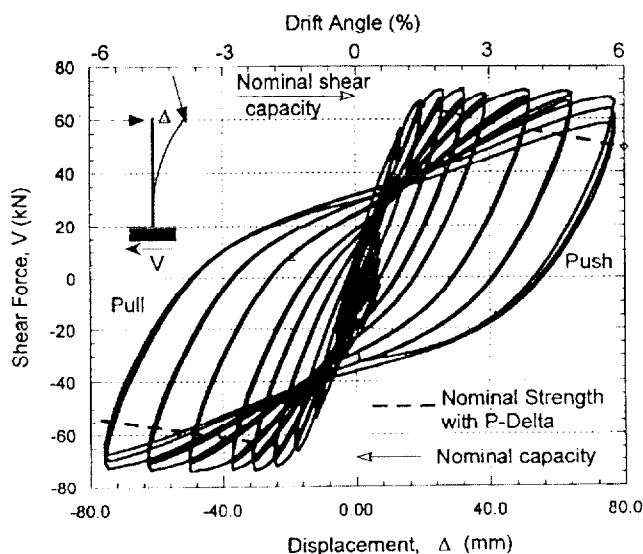
Fig. 7—Response of bridge column to standard cyclic loading: (a) imposed displacement history; and (b) load-deformation behavior.

Standard cyclic test—Specimen A2 was subjected to three cycles each at lateral displacement amplitudes of 1.0, 1.5, 2.0, 2.5, 3.0, 4.0, 5.0, and 6.0 percent until failure [Fig. 7(a)]. A smaller displacement cycle of 0.5 percent drift was applied between each increase in amplitude to monitor changes in the specimen stiffness. Crack widths up to 1.5 mm were measured at Cycle 19 when the drift was approximately 3 percent. Yielding of the extreme longitudinal bar was estimated at a displacement of 20 mm when the lateral load reached approximately 65 kN. Spalling of the concrete cover was observed at Cycle 15 at a drift of approximately 3 percent. Significant cracking propagated up to 225 mm beyond the base of the column at this stage. Minor bar buckling and significant spalling was evident by the end of Cycle

22 at an imposed drift of 4.0 percent. Failure of the specimen occurred at a drift of approximately 5.5 percent following rupture of the confining spiral in the plastic hinge zone. The plastic hinge length was estimated as 180 mm, though cracking propagated beyond this region. The recorded shear force versus lateral displacement of the specimen is displayed in Fig. 7(b).

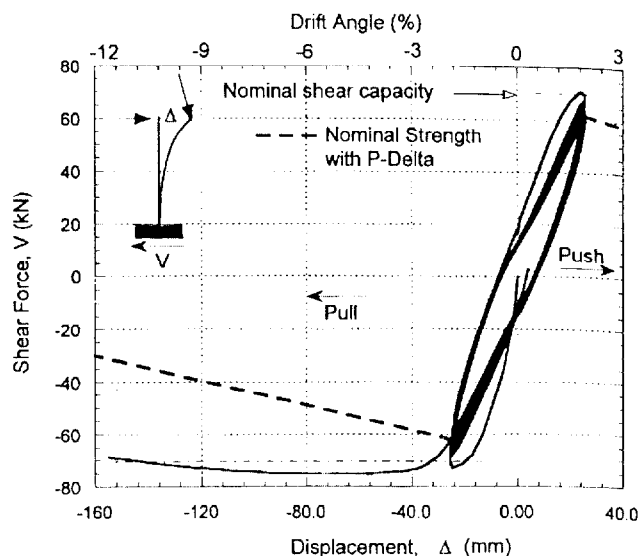
Fig. 8—Shear versus deformation response of specimen subjected to 2 percent constant amplitude cycling followed by monotonic push to failure.

Specimen A3 was subjected to constant amplitude cycles at a displacement amplitude corresponding to 2 percent lateral drift. After 40 complete cycles at a constant displacement amplitude of ± 26 mm, no visible deterioration of the specimen was observed. The maximum measured crack widths on either side were approximately 0.8 to 1.0 mm. Loading of the specimen continued over a two-day period for 150 cycles without any further visible damage. Later, it was analytically estimated that this specimen would have sustained approximately 400 or more cycles. Since one of the objectives of the test program was to evaluate different damage models, it was decided that the cyclic loading could be discontinued and a monotonic load applied until failure. This would provide information on reserve capacity that is crucial to many damage modeling theories. The specimen sustained a final drift amplitude of almost 10 percent. Results of the observed force-displacement response are presented in Fig. 8.

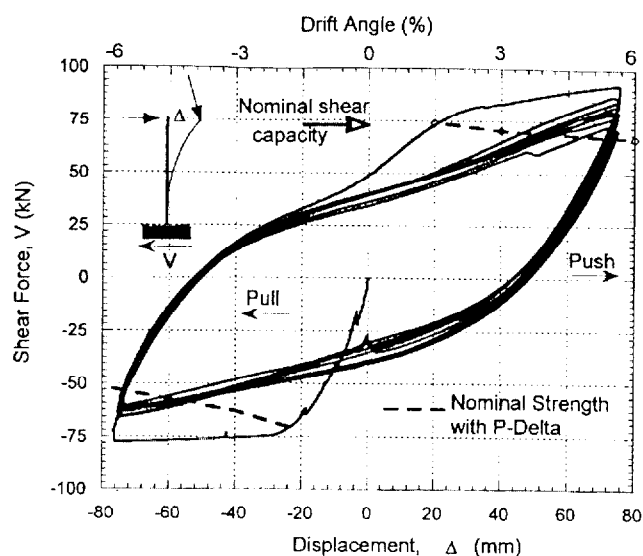
Fig. 10—Shear displacement response of column to 5.5 percent constant amplitude cycling.

crete were all observed in the very first push to the peak displacement. Significant buckling of longitudinal bars was observed on both sides of the specimen at Cycle 9. The plastic hinge length was approximated as 175 mm. The specimen failed through fracture of a longitudinal bar before the completion of Cycle 10. The complete load-deformation history of the specimen is plotted in Fig. 10.

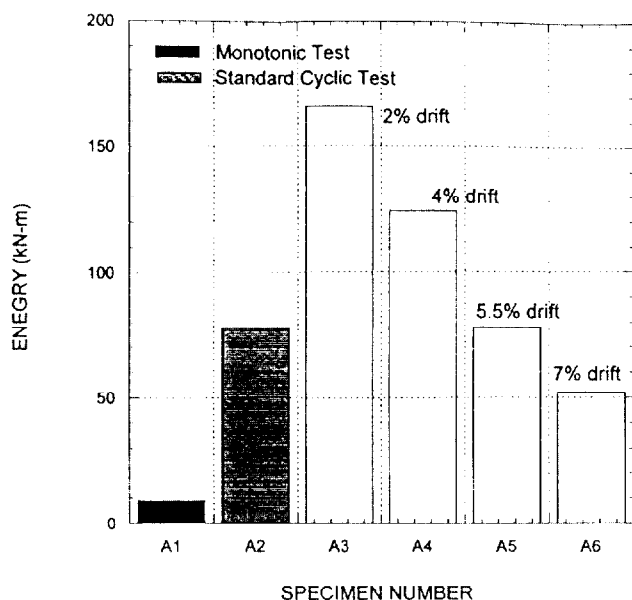
Fig. 14—Energy capacity of specimens at failure.

4. The tests also revealed that the energy capacity of a member at failure is dependent on the drift amplitude. Fig. 14 summarizes the dissipated hysteretic energy of each of the six specimens. The energy capacity clearly decays with drift amplitude.
