Performance of Metal and Polymeric O-Ring Seals in Beyond-Design-Basis Temperature Excursions

Manuscript Completed: November 2011
Date Published: April 2012

Prepared by
Jiann C. Yang
Edward J. Hnetkovsky

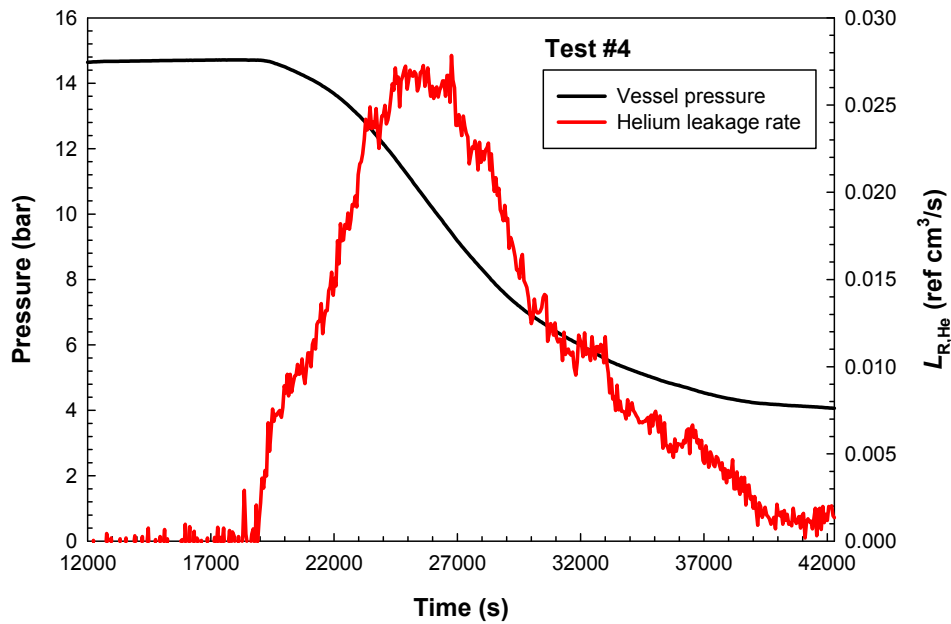
Figure 3-10. Isothermal reference helium leakage rate during the 9 h heating in Test #4.

Test #4 is another repeat of the thermal exposure condition used in Test #2. Figure 3-8 shows the test results from Test #4. In this test, the pressure remained relatively constant for about 10 000 s (2.8 h) initially during the 9 h constant-temperature heating phase, begins to drop significantly for about 15 000 s (4.2 h) with large dP/dt , and decreases slowly with small dP/dt for the remaining duration. Figure 3-9 shows the complete time-pressure and time-temperature histories of the test. The calculated reference helium leakage rates are shown in Figure 3-10.

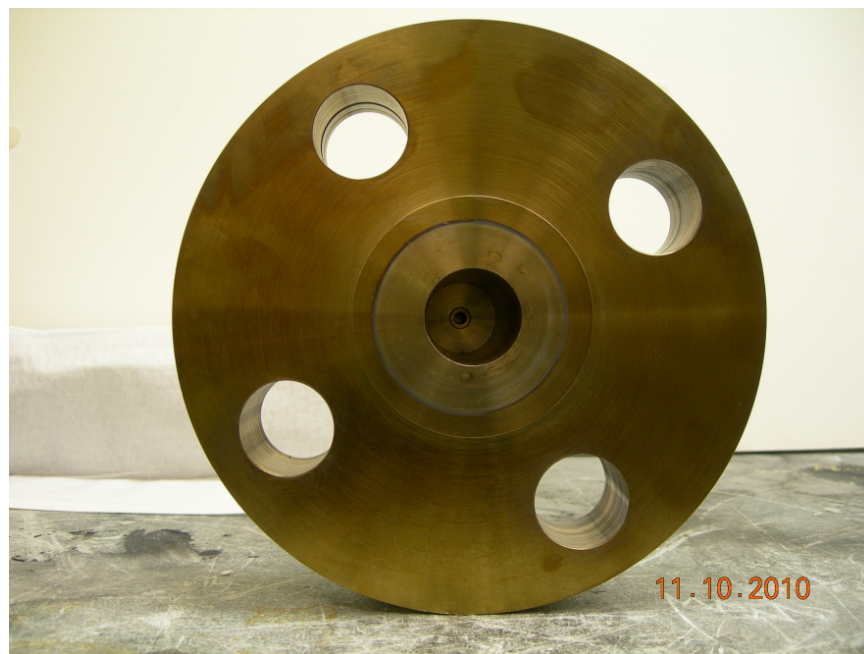
Figure 3-13. Post-test photograph of Vessel #5 (vessel body with O-ring removed) after exposure at 427 °C (800 °F) for 9 h.

A photograph of the exposed vessel is shown in Figure 3-13. The extent of discoloration of the vessel depends on the test temperature (Figure 3-1 vs. Figure 3-13). A post-test inspection revealed that the metallic O-ring seal was not soldered to either flange surfaces, and no silver coating from the seal was transferred to the O-ring groove.

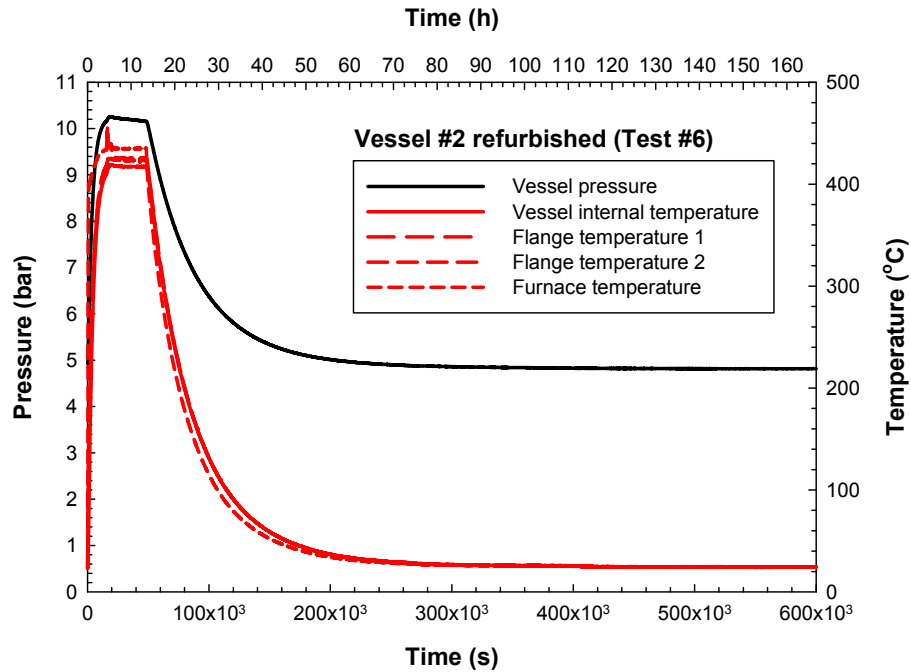
Figure 3-15. Temporal variations of vessel pressure and temperature in Test #6 (time scale extended, including the complete cool-down phase).

The results for Test #6 using the refurbished Vessel #2 are shown in Figure 3-14. The refurbishment only involved the re-facing of the surfaces of the flanges and O-ring groove to the specified tolerances. For this test, the vessel pressure started to decrease very slowly during the constant-temperature heating period. The scale of the ordinate is magnified in Figure 3-14 to elucidate the continuous decrease in pressure. However, the small pressure drop is within the pressure measurement uncertainty of 0.11 bar. Although the continuous decrease in pressure does seem to imply that a very small leak might have occurred during the test, the initial charge pressure was restored when the vessel was cooled to room temperature after the thermal exposure (as shown in Figure 3-15), an indication of no leakage.

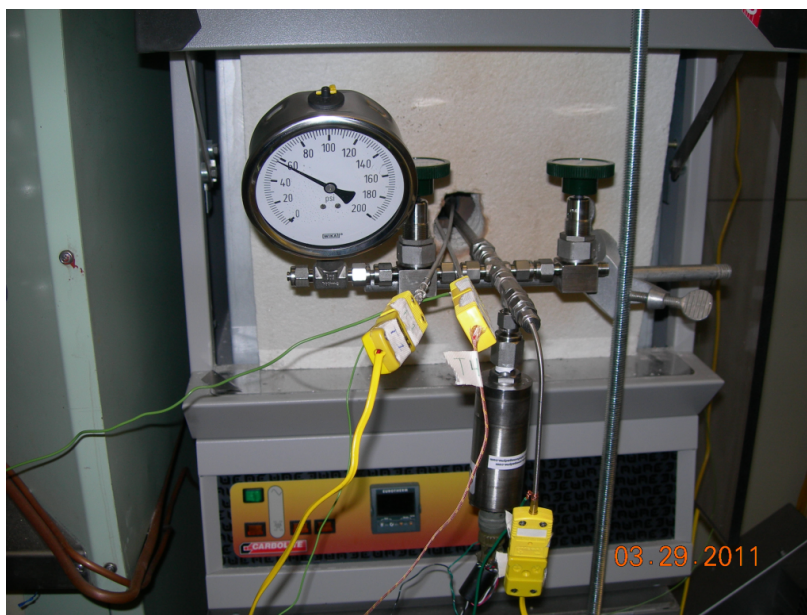
Figure 3-21. A photograph showing the pressure gauge used to check the pressure transducer performance.

The test protocol involved the heating of the vessel to 427 °C (800 °F). Once the vessel reached 427 °C (800 °F), the furnace temperature was raised to 800 °C (1472 °F), and the vessel was heated at 800 °C (1472 °F) for a little more than 3 h. Figure 3-22 and Figure 3-23 show the pressure and temperature data using different time scales respectively. No leak is indicated in the figures since the attainable pressure at 800 °C (1472 °F) remained constant. However, the pressure at 800 °C (1472 °F) was lower than those recorded in previous tests under similar conditions (≈ 12 bar vs. ≈ 14.5 bar). This is due to the increase of the measurement volume with the addition of the pressure gauge which used a C-shape Bourdon tube with a surprisingly large volume and was located outside the furnace at room temperature (see Appendix D for theoretical volume and pressure calculation) as shown in Figure 3-21. The gauge was disassembled and the internal volume of the Bourdon tube, which had a nearly elliptical cross section, was estimated to be more than 12 mL. Figure 3-24 correlates the pressure readings from the pressure transducer with those from the pressure gauge at different times during the heating phase. The pressure transducer clearly functioned properly, and the transducer readings correspond, within the measurement uncertainties, to those obtained from the pressure gauge.

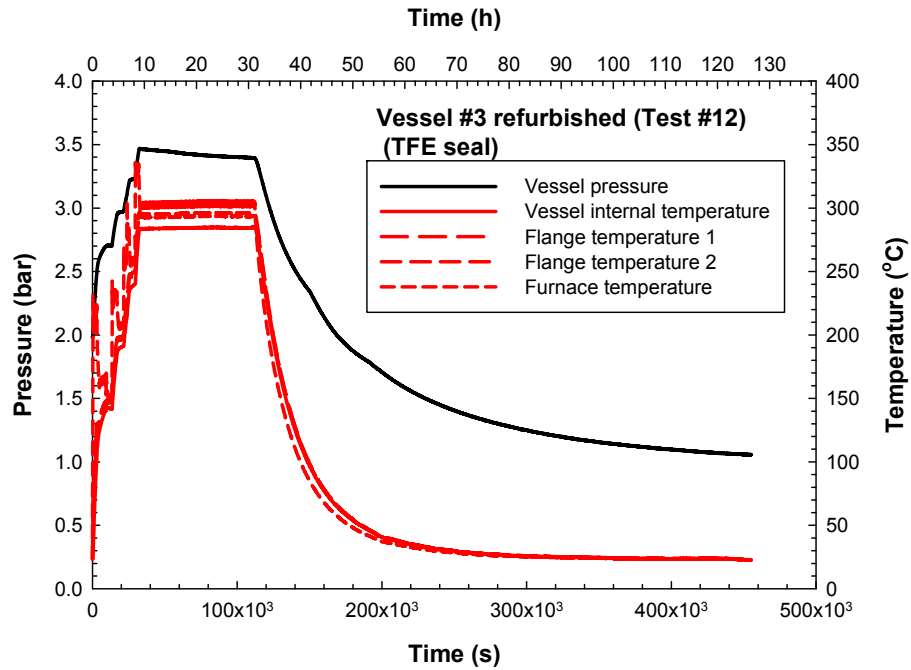
Figure 3-30. Temporal variations of vessel pressure and temperature in Test #12 (time scale extended, including the complete cool-down phase).

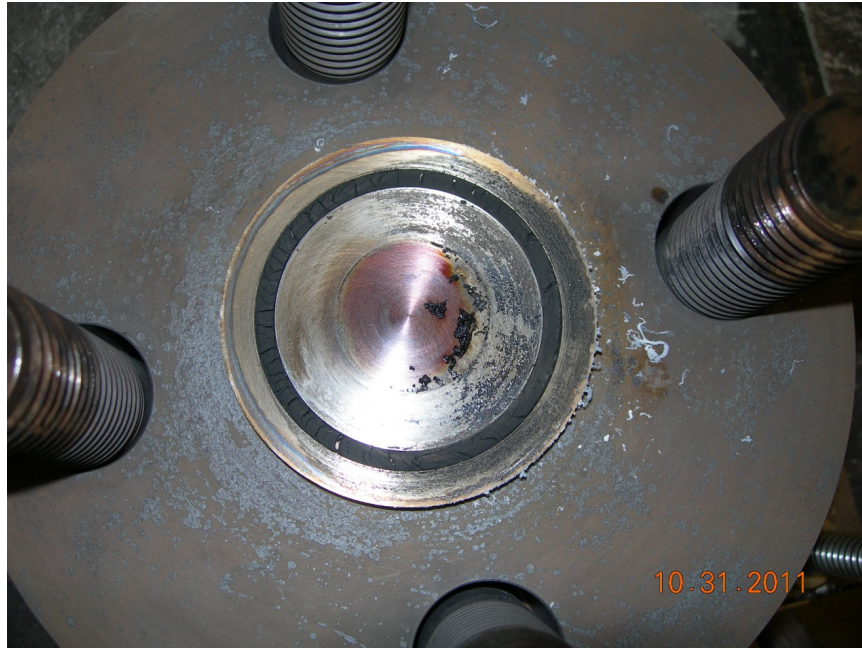
Figure 3-39. Photograph of the ethylene-propylene compound O-ring after thermal exposure.

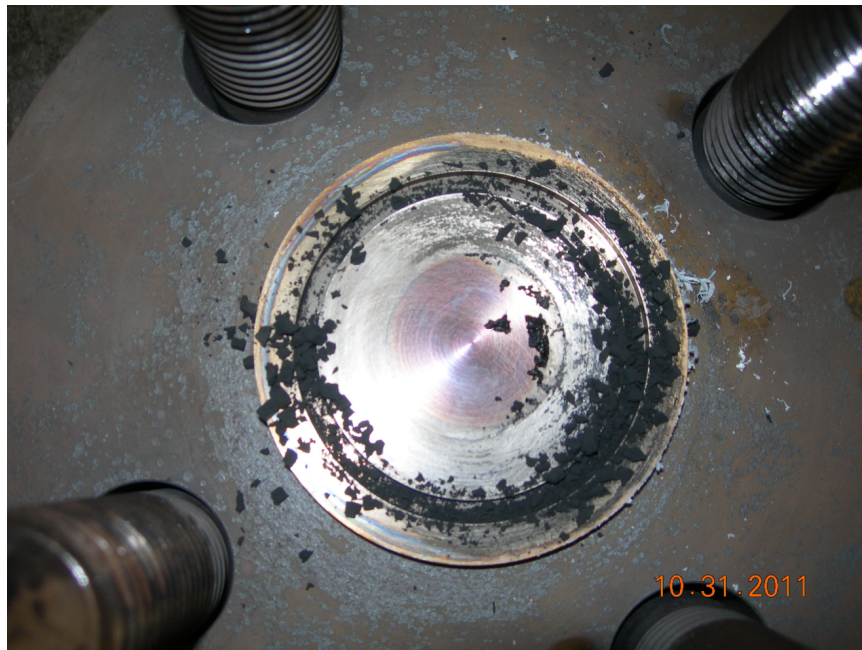
Figure 3-40. Photograph showing the disintegration of the tested ethylene-propylene compound O-ring when an attempt was made to remove the O-ring from the groove.
