FATAL TRAINING FIRES: FIRE ANALYSIS FOR THE FIRE SERVICE

Daniel Madrzykowski
Building and Fire Research Laboratory
National Institute of Standards and Technology
Gaithersburg, Maryland, USA 20899-8661

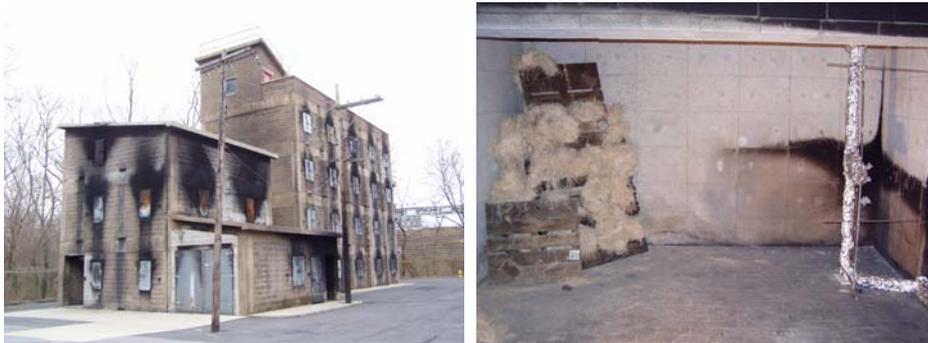
Figure 7. Exterior of residential fire training building and basement burn room.

The residential burn building is a three story structure above grade, with a basement, below grade, Figure 7. The exterior plan dimensions of the building are 11.0 m by 7.9 m. The first level is composed of 4 rooms and a garage area. An interior stair provides access to the basement and the second floor. The area of the second floor is approximately 7.5 m by 7.5 m. The second floor has two rooms, a hallway and interior stair access to the third floor. The third floor is designed as an open attic area with an sloped ceiling. The basement area has an “L” shaped hallway with a burn room inside the “L”. The interior stair leads to the basement at one end of the hallway and a stair that leads to the exterior is on the opposite end of the “L” shaped hallway. The floor plan for the basement is provided in Figure 8.

The building is supported with reinforced concrete columns and beams. The floors and ceilings are concrete. Most of the interior walls within the structure are composed of cement block. These walls are not load-bearing. Areas in the building where training fires are conducted, have been protected with a 25 mm thick layer of calcium silicate insulation, which is covered by a 50 mm thick concrete tile. Significant portions of the basement are protected with these materials. The north and east wall and the ceiling of the basement burn room are covered. A portion of the south wall and the hallway ceiling outside the room are also covered. The floor of the burn room is protected with fire brick. All of the training evolutions/experiments for this series of measurements were conducted in the basement.
