SURFACE ANALYSIS AND MATERIALS CHARACTERIZATION FOR THE STUDY OF THE CERAMIC TILES HRSI FROM THE SPACE SHUTTLE THERMAL PROTECTIVE SYSTEMS

Hanna M. Szczepanowska¹, Thomas B. Renegar²

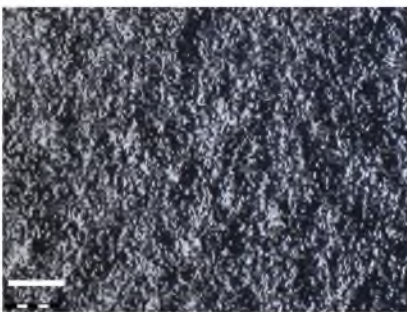
Fig.4

Figure 4. Micrograph showing features of the surface topography of black coating on the unflown tile, captured with an Olympus DX100 digital microscope, in the extended focus imaging mode, at 45° angle; scale: 200 μm .

The intended purpose of the coating on the STS tiles was to minimize the effect of solar heat absorptance [6] which made the analysis of the samples with light-based instrumentation particularly challenging. The surface topography of the surfaces on the unflown sample was compared to that of the flown tile. Although the surface features of the coating on the flown tile indicated changes, as expected (fig.4,5) they were not significant. Furthermore, this applies to changes of the surface only; the body of the coating below the surface showed unchanged macro-features (fig.6).

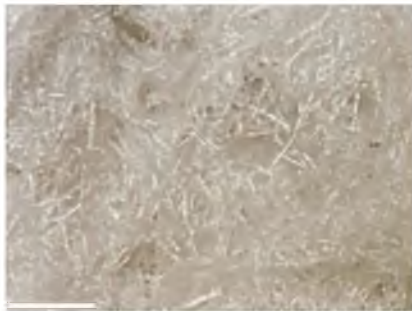
Fig.9

Figure 9. The bulk material in the interior of the Atlantis flown tile was not changed during reentry, it showed well preserved fibrous features. Micrograph taken with an Olympus DX100 Digital Microscope, in the extended focus imaging mode, scale: 200 μm .

The bulk material of the unflown and flown tiles below the top surface coatings, showed well defined refractory silica-based fibers. Their fibrous characteristics appeared to be unchanged in the flown tile. (fig.9, 10). The material alterations were observed on the burnt surfaces where the fibers were directly exposed to additional heating during post-flight testing (fig.11).

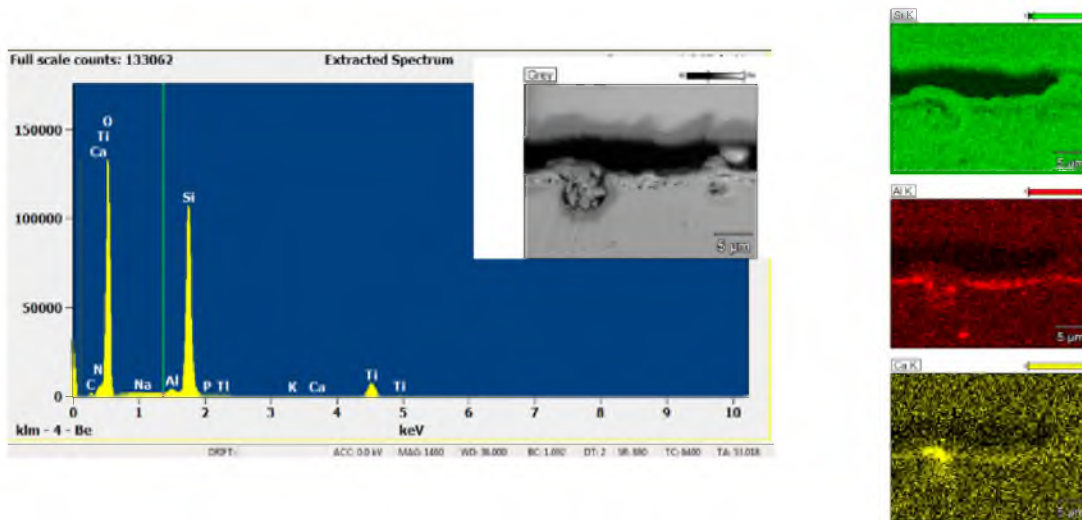
Figure 12. Spectral mapping of elements present in a sample taken from the Atlantis flown tile. The inset shows the cross-section of the examined samples', black coating and white bulk material. On the right is mapping of the most prominent elements Al and Si in the examined sample. The presence of Ca, prominent on the spectrum, is attributed to artifacts acquired during sample preparation.

The elemental qualitative analysis carried out using the SEM-EDS of the flown sample of Atlantis tile was in agreement with technical NASA references pointing to the presence of Si and Al in the bulk material (fig.12).
