Firearm Serial Number Restoration with Electron Backscatter Diffraction

Ryan M. White¹, Robert R. Keller¹

¹ National Institute of Standards and Technology, Boulder, CO USA.

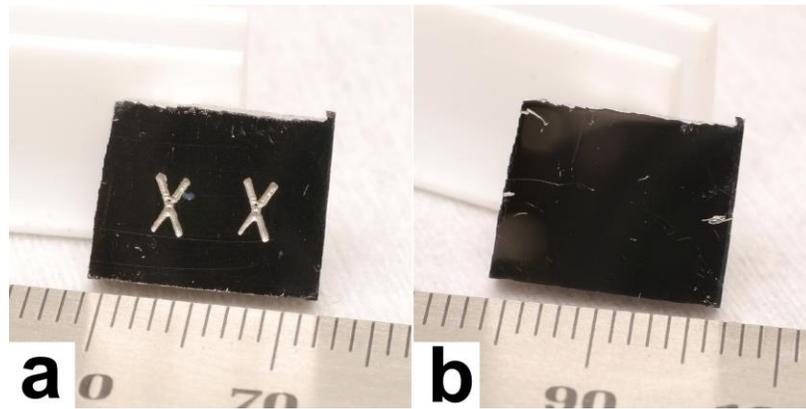
Figure 1. The letter “X” was a) die stamped into a piece of 316L stainless steel and b) ground/polished away to simulate destruction of a firearm serial number. The scale shown in the images is in millimeters.

In this work, a letter “X” was die-stamped into a polished piece of 316L stainless steel (Fig. 1a) and then polished away such that the imprint was no longer visible (Fig. 1b). After the surface was polished, the sample was imaged with multiple techniques (FSI, EBSD) in the SEM.

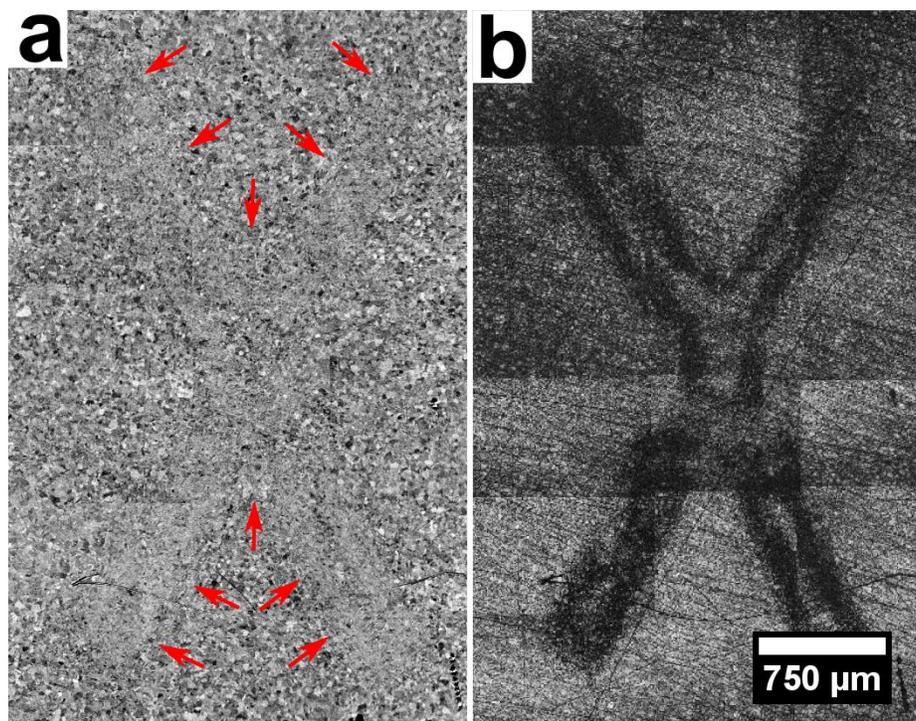
Figure 2. The imprinted/polished area visualized with tessellations of a) forward scattered electron images and b) EBSD pattern quality maps. While the “X” imprint is lightly visible in the forward scattered images, the EBSD pattern quality images produce an unambiguous reconstruction.

A tessellation of forward scattered images produced a faint reconstruction of the stamped imprint, outlined by arrows in Fig. 2a. While the change in microstructure is apparent in the FS image, it is difficult to interpret the “X” shape without previous knowledge of what to expect. Conversely, EBSD pattern quality maps, which can provide qualitative information about the localized deformation produce a clear and unambiguous reconstruction of the original imprint, shown in Fig. 2b.

Unfortunately, the technique is currently time consuming. With hardware-based limits of EBSD pixel sizes (6.72 μm), reconstruction of a single character requires up to nine hours of microscope time. Undersampling of the data in Fig. 2d provides a virtual pixel size increase, indicating that an unambiguous reconstruction can be performed with pixel sizes as large as 67.2 μm , decreasing acquisition time to approximately 5.4 minutes for a single character, and less than 1 hour for an 8-character serial number.
