Performance of Metal and Polymeric O-Ring Seals in Beyond-Design-Basis Temperature Excursions

Date Published: November 2015

This report documents the beyond-design-basis thermal exposure test results of the performance of metallic and polymeric seals typically used in radioactive material transportation packages. The overall objective of the project is to provide test data and insights regarding the performance of these O-ring seals (metallic or polymeric) when exposed to beyond-design-basis temperature conditions that could result due to a severe fire. Tests were conducted using a small-scale test package (pressure vessel) made of stainless steel SS 304 filled with helium initially pressurized at either 5 bar or 2 bar at room temperature. The test package was then exposed in an electric furnace to temperatures equal to, or above the specified maximum operating temperatures of these seals (up to 900 °C) for a pre-determined period (typically 8 h to 9 h). These O-ring temperatures and test periods are more severe than the 800°C for 30 minutes hypothetical accident conditions described in 10 CFR Part 71. In addition, the 800°C and 900°C seal temperatures are much higher than would

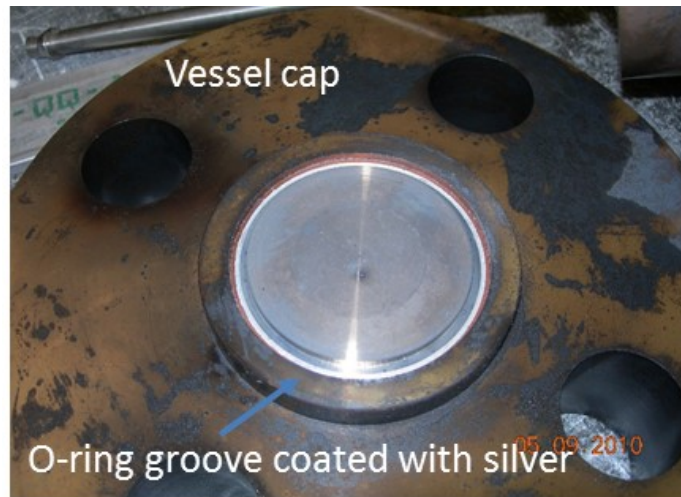
A post-test inspection of the test vessel revealed that the metallic seal was soldered to the flange of the vessel body and a silver-color coating was imprinted on the surface of the O-ring groove, as shown in Figure 3-1. The high-temperature exposure also discolored the test fixture.

Figure 3-1. Post-test photographs showing silver from the metallic O-ring deposited on the O-ring groove and the O-ring bonded to the test vessel (Vessel #1) body.

A photograph of the exposed vessel is shown in Figure 3-13. The extent of discoloration of the vessel depends on the test temperature (Figure 3-1 vs. Figure 3-13). A post-test inspection revealed that the metallic O-ring seal was not soldered to either flange surfaces, and no silver coating from the seal was transferred to the O-ring groove.

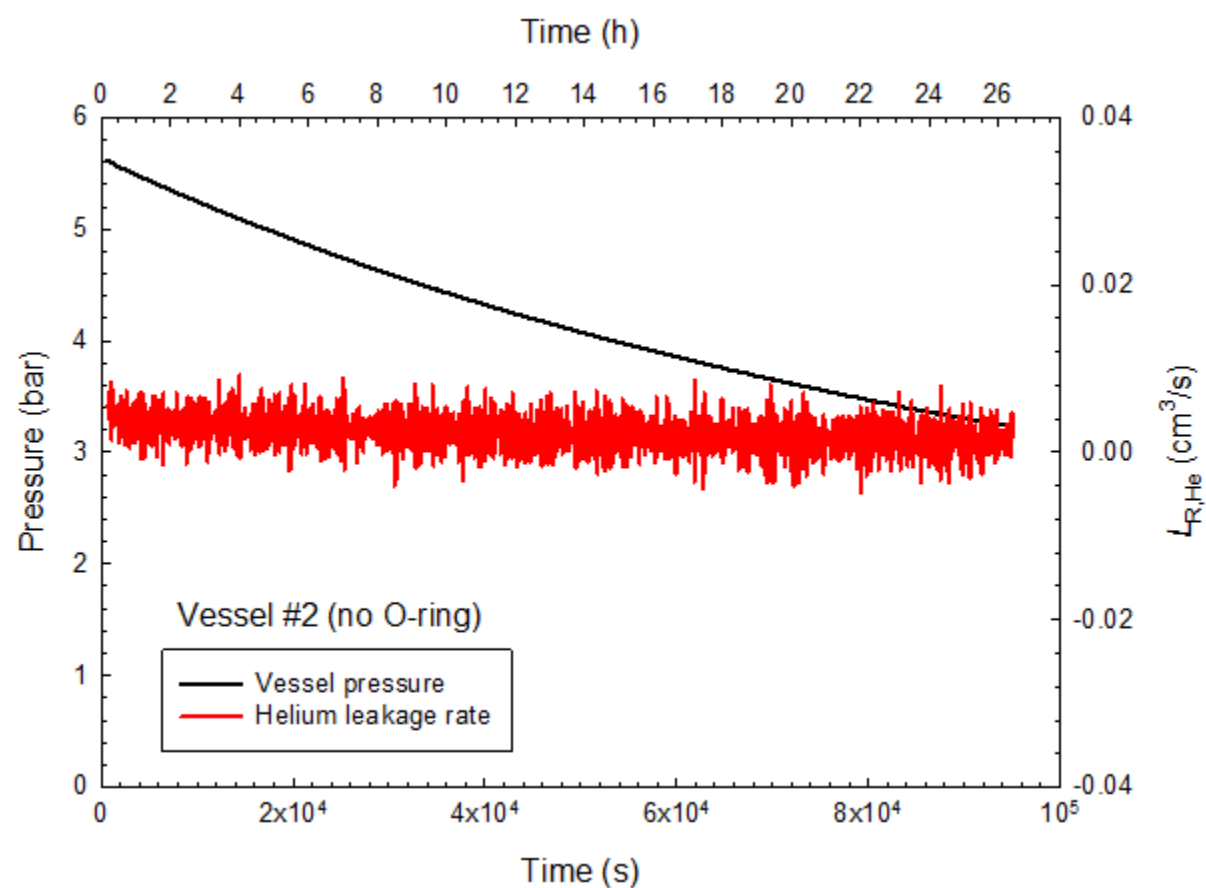
temperature. Figure 3-2 is the test result, which indicates that the vessel pressure began to drop and leakage occurred immediately at the start of the test and continued slowly over the entire experimental run-time (26.43 h). The reference helium leakage rates $L_{R,He}$ (ref·cm³/s) were estimated based on the method described in Appendix D. The time-averaged leakage rate is estimated to be 2.4×10^{-3} ref·cm³/s.

Figure 3-2. Temporal variations of vessel pressure at 24 °C without metallic O-ring.

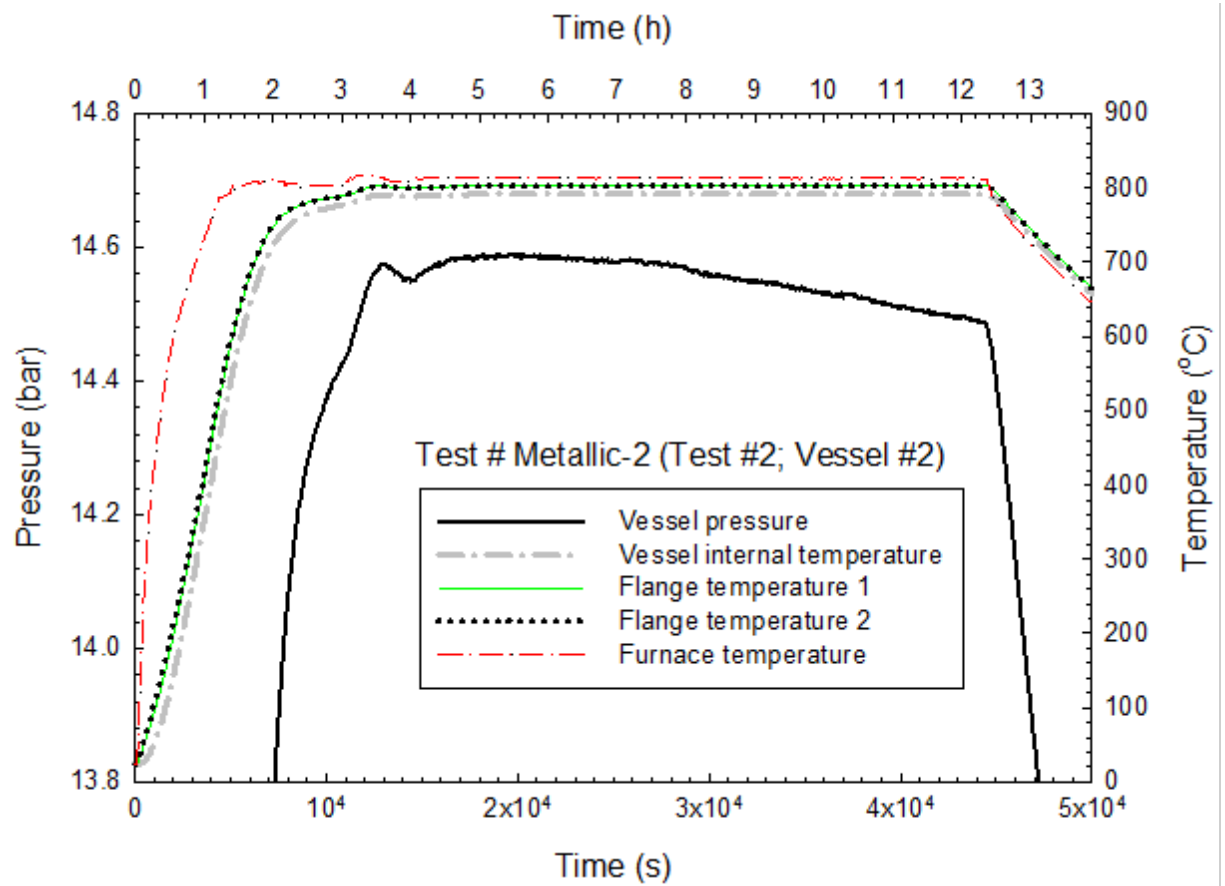
transducer (0.11 bar) and is not considered significant in this test. However, the complete thermal exposure history, shown in Figure 3-4, indicates that the vessel pressure is restored to its original charge pressure (≈ 5 bar) after the thermal exposure, indicating no leakage. For this test, the occurrence of a leak is inconclusive based only on the small pressure drop.

Figure 3-3. Temporal variations of vessel pressure and temperature in Test # Metallic-2 (Test #2).

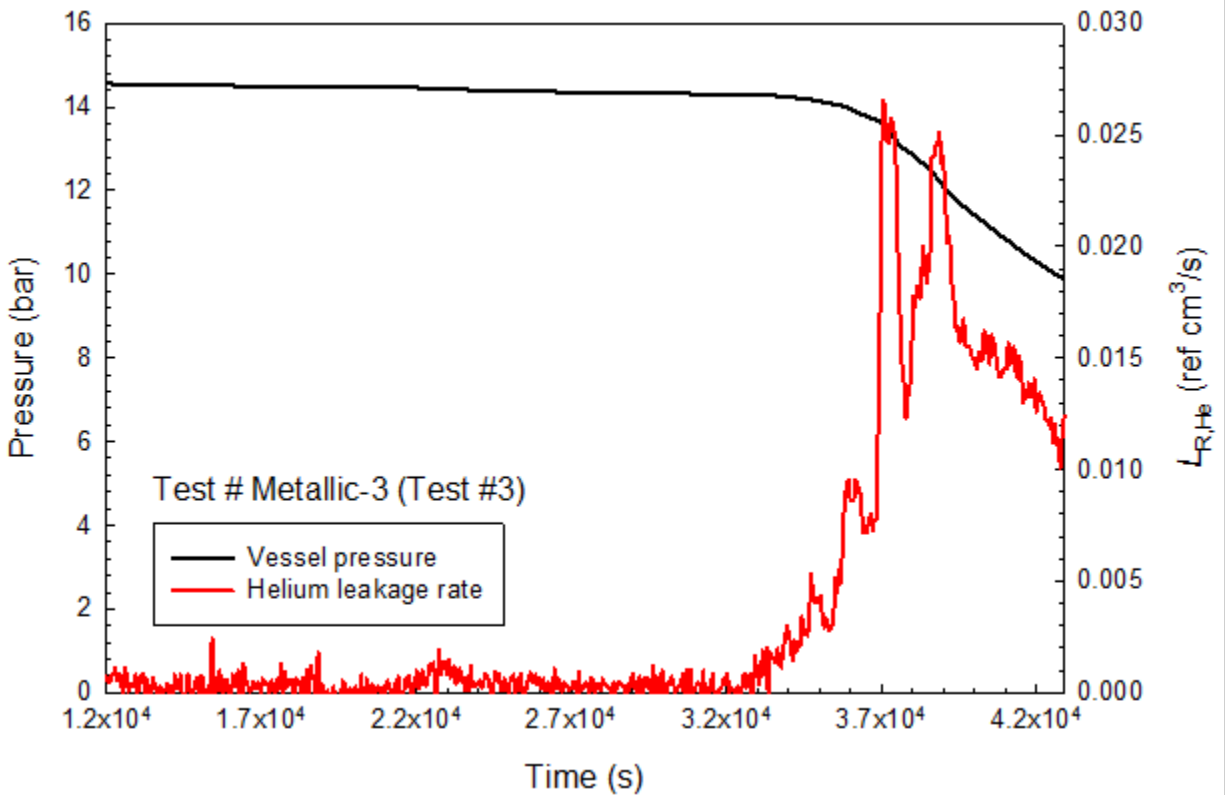
Figure 3-7. Isothermal reference helium leakage rate during the 9 h heating in Test # Metallic-3 (Test #3).

Test # Metallic-3 (Tests #3) is a repeat of Test # Metallic-2 (Test #2). Figure 3-5 presents the test results which show the occurrence of a leak during the 9 h constant-temperature heating phase at 800 °C (1472 °F). In Test # Metallic-3, the vessel pressure decreases slowly initially and then significantly after about 25,000 s (6.9 h) at 800 °C (1472 °F). Since the leakage rate is directly proportional to the time rate of change of pressure, this two-stage decrease in pressure indicates a slower leak rate (small time derivatives of vessel pressure [dP/dt]) at first and then a faster leak rate (large dP/dt) at the end. Another leak indicator is revealed in Figure 3-6, which shows the entire time history of the test. After cooling to room temperature, the vessel does not recover its initial charge pressure of approximately 5 bar because of the leak. Isothermal reference helium leakage rates ($L_{R,He}$) during the 9 h heating in this test are shown in Figure 3-7.

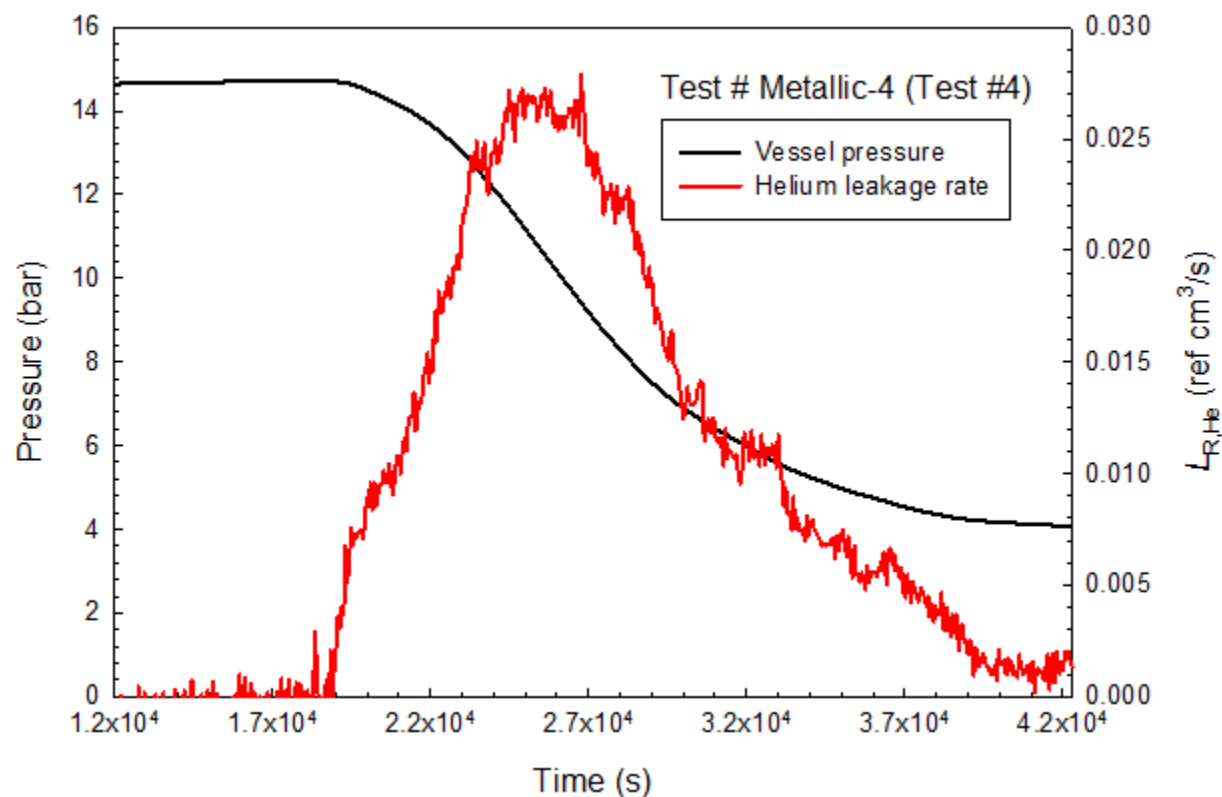
Figure 3-10. Isothermal reference helium leakage rate during the 9 h heating in Test # Metallic-4 (Test #4).

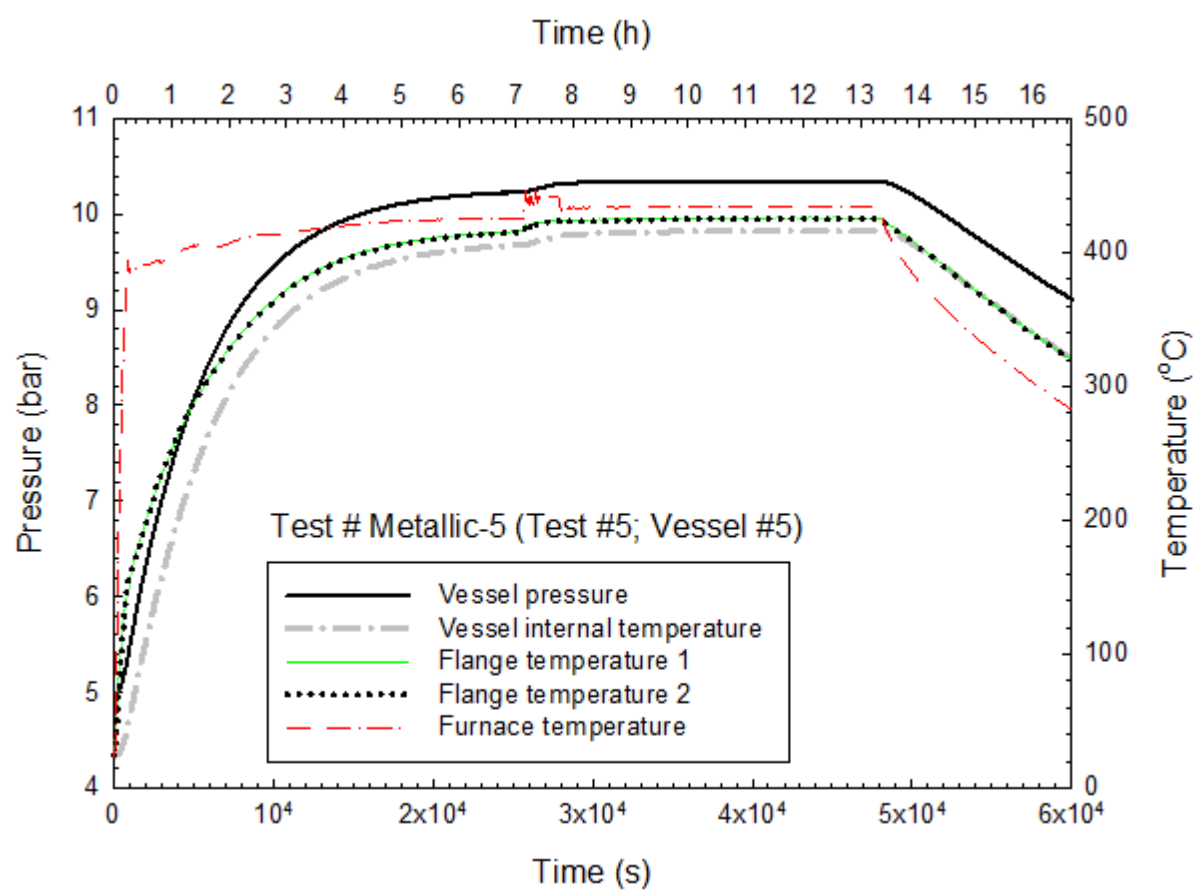
Figure 3-11. Temporal variations of vessel pressure and temperature in Test # Metallic-5 (Test #5).

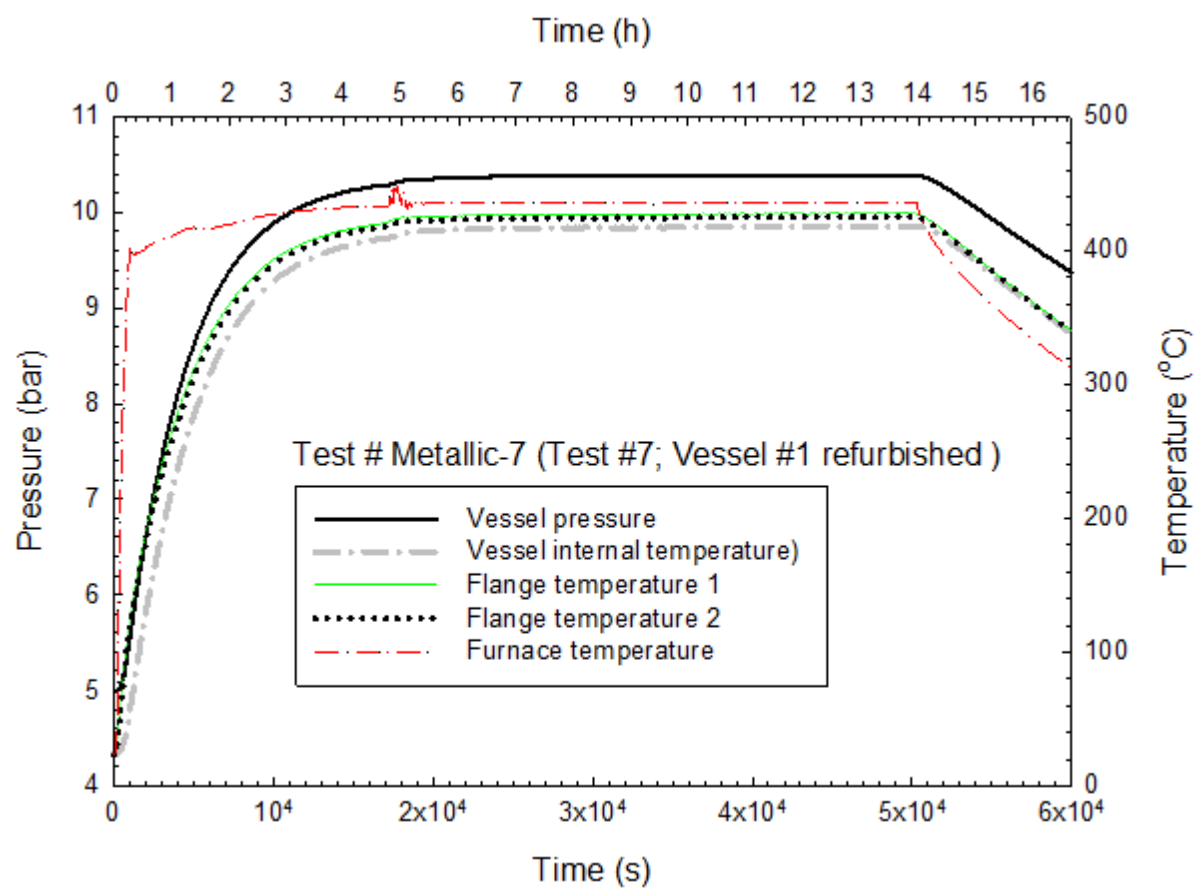
Figure 3-16 shows the results for Test # Metallic-7 (Test #7) using the refurbished Vessel #1. The same refurbishing process used in Vessel #2 was applied to Vessel #1. As indicated in the figure, the vessel pressure remained unchanged during the 9-h constant-temperature heating period. No leakage was observed during Test # Metallic-7. Figure 3-17 is the complete thermal exposure history of Test # Metallic-7.

Figure 3-16. Temporal variations of vessel pressure and temperature in Test # Metallic-7 (Test #7).

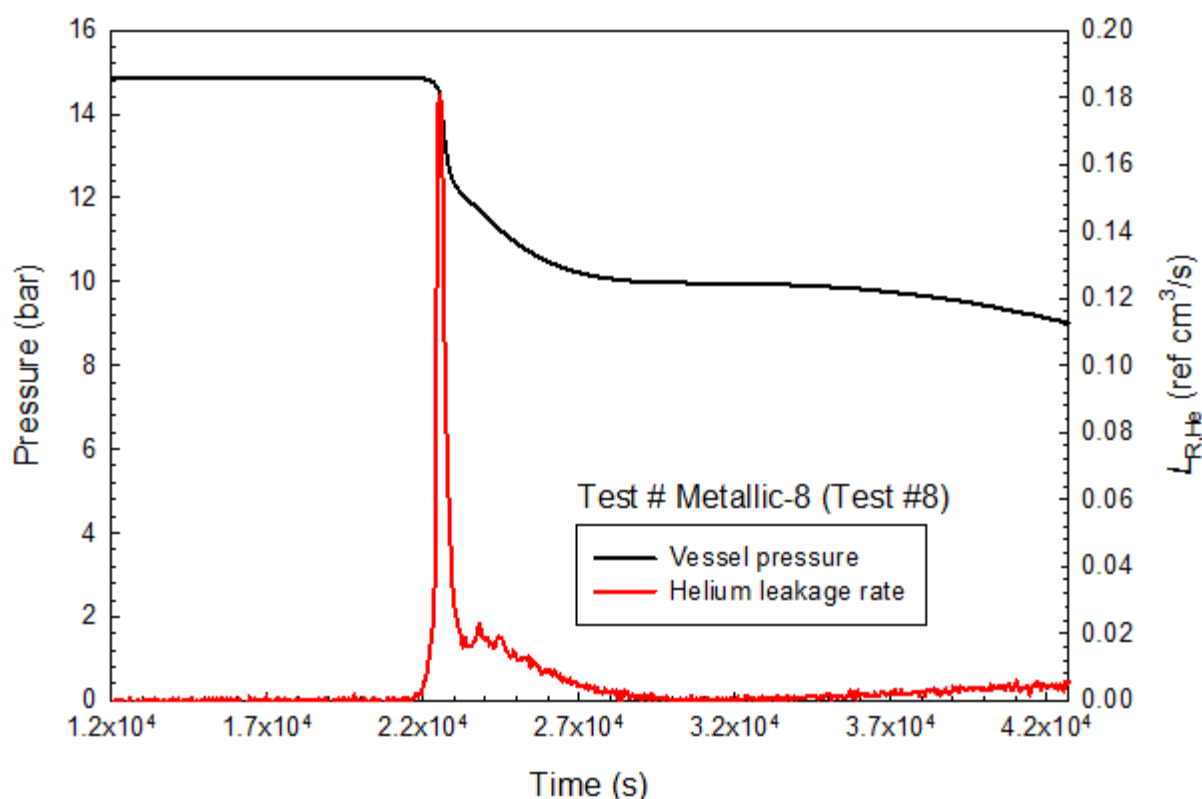
Figure 3-20. Isothermal reference helium leakage rate during the 9 h heating in Test # Metallic-8 (Test #8).

The test conditions were similar to Tests # Metallic-2, Metallic-3, and Metallic-4. Figure 3-18 shows the thermal exposure results for Vessel #6. The pressure trace indicates that leakage occurs after about 3-h exposure to 800 °C (1472 °F). For this test, the pressure initially decreases very rapidly, followed by a gradually decrease in vessel pressure. However, the pressure never dropped below 2 bar, indicating that the seal had some residual sealing capacity. Figure 3-19 is the complete time-pressure and time-temperature histories of Test # Metallic-8 (Test #8). Figure 3-20 shows the calculated isothermal reference helium leakage rates during the 9-h heating.

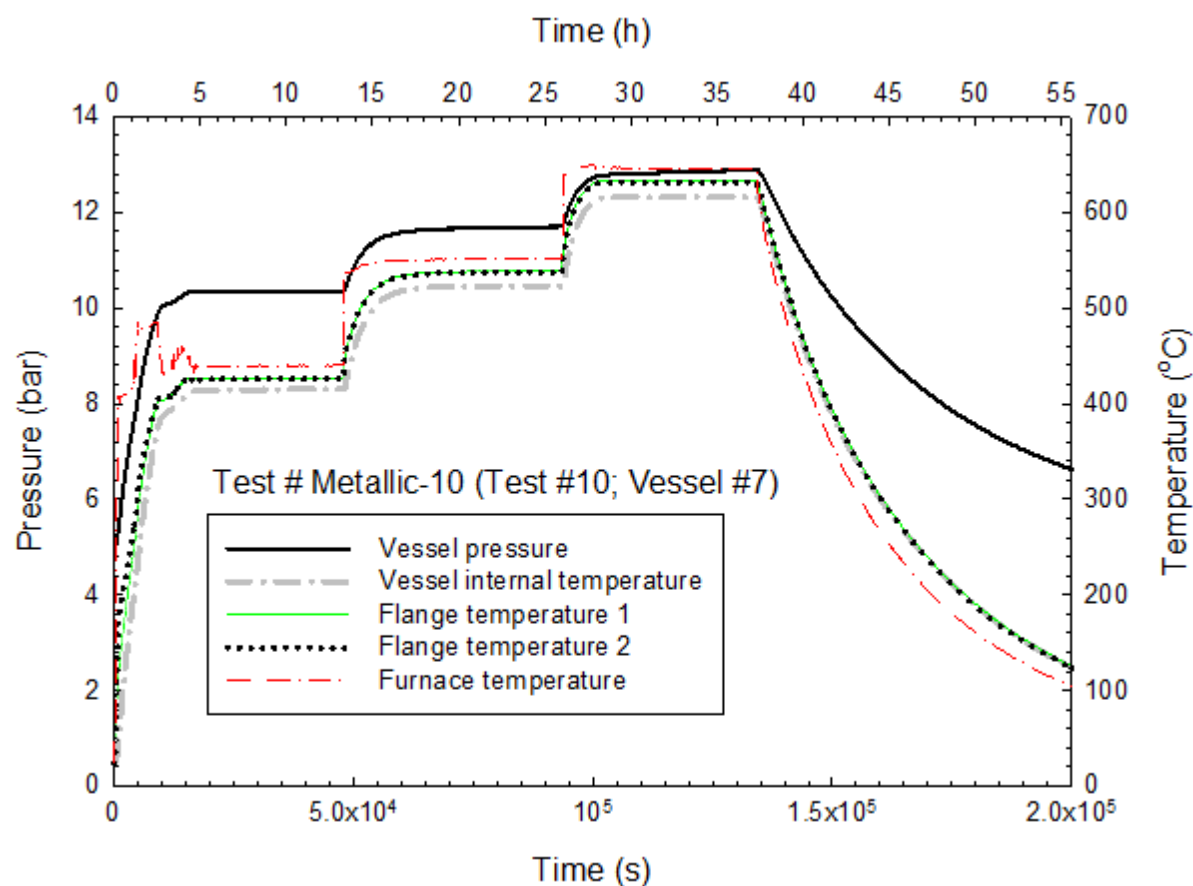
In Test # Metallic-10 (Test #10), an incremental heating protocol was used to assess the metallic seal performance. The vessel was initially heated to 427 °C (800 °F) and held for 9 h at this temperature. Then, the furnace temperature was raised to 527 °C (981 °F), and the vessel was heated at 527 °C (981 °F) overnight (more than 9 h). The vessel was then heated to 627 °C (1161 °F) for 9 h. Figure 3-25 and Figure 3-26 show the test results. No leak was observed based on the pressure traces at the test temperatures, 427 °C (800 °F), 527 °C (981 °F), and 627 °C (1161 °F), and the recovery of the initial pressure at room temperature. Post-test removal of the O-ring from the groove was very easy. A post-test inspection of the vessel indicated that the metallic seal did not bond onto the O-ring groove.

Figure 3-25. Temporal variations of vessel pressure and temperature in Test # Metallic-10 (Test #10).

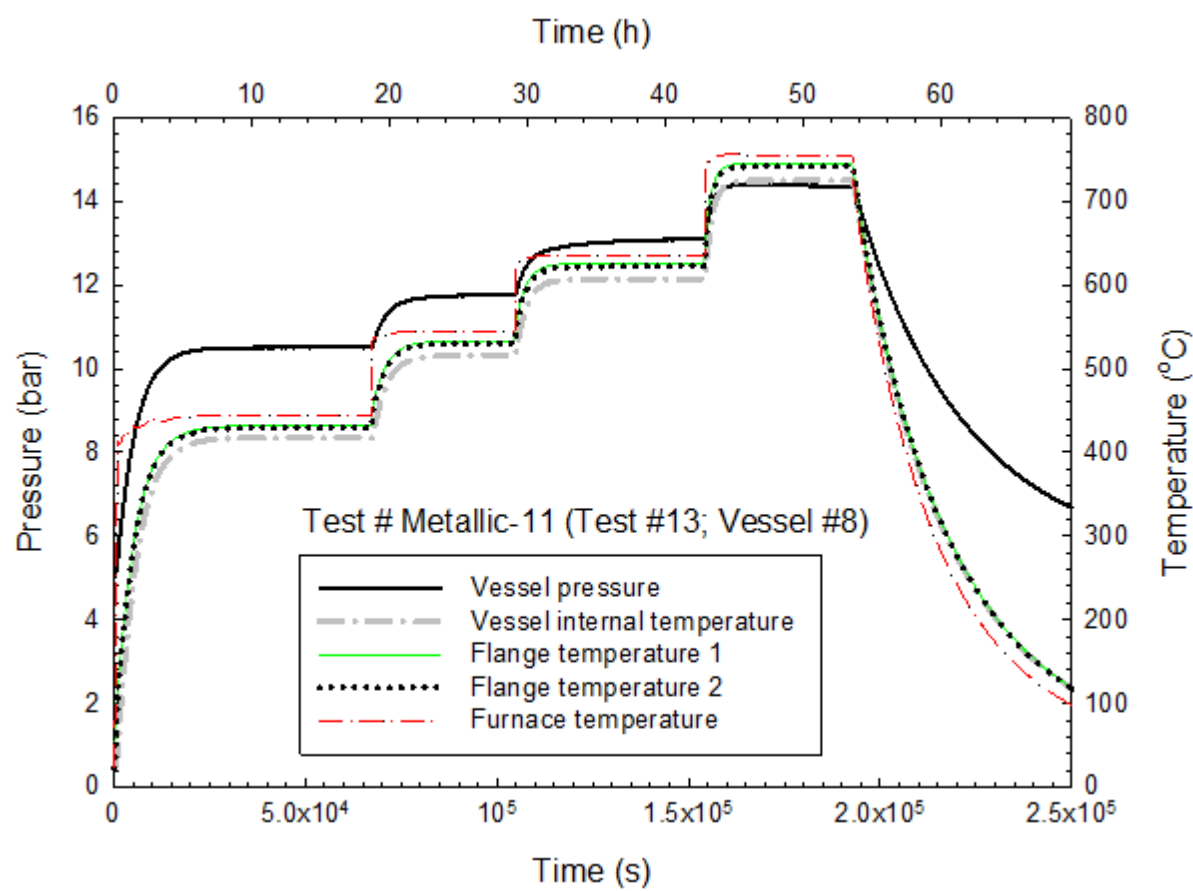
Figure 3-27. Temporal variations of vessel pressure and temperature in Test # Metallic-11 (Test #13).

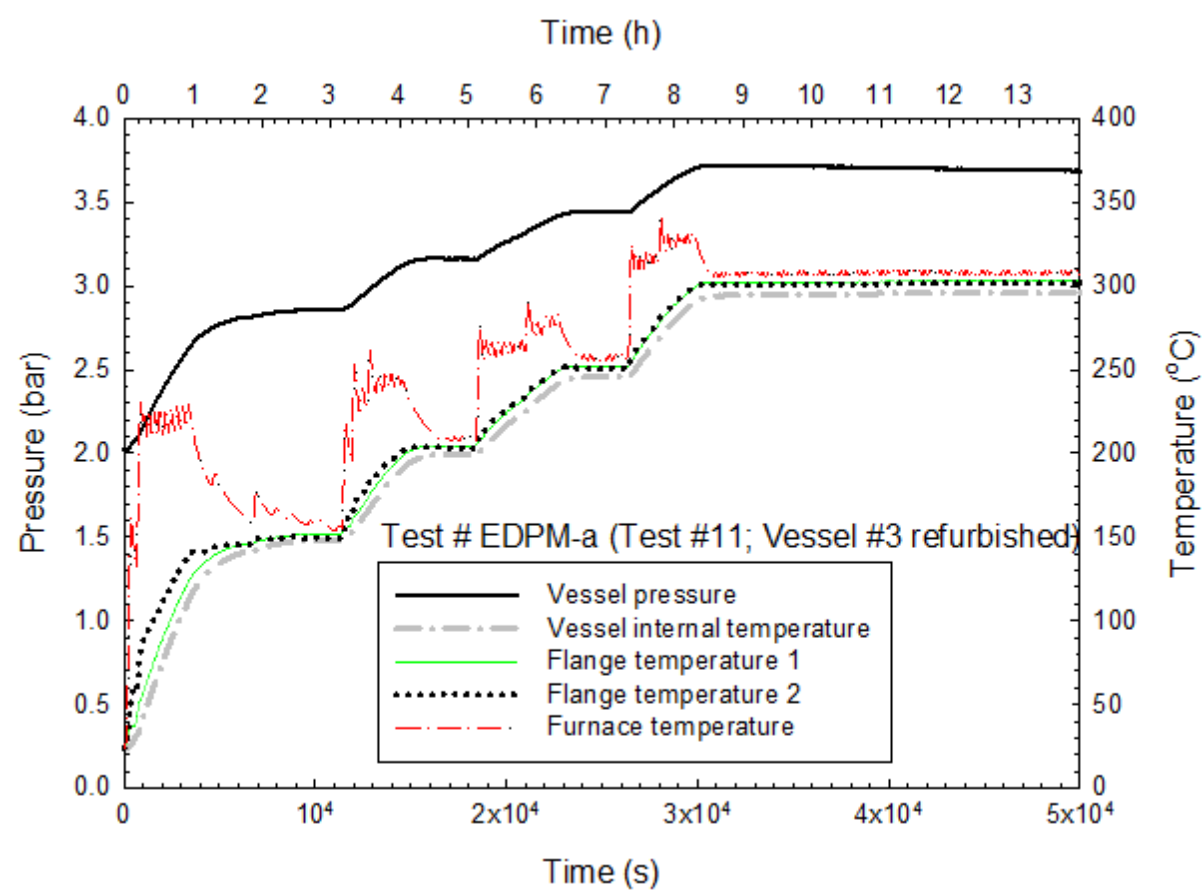
Figure 3-31. Temporal variations of vessel pressure and temperature in Test # EDPM-a (Test #11).

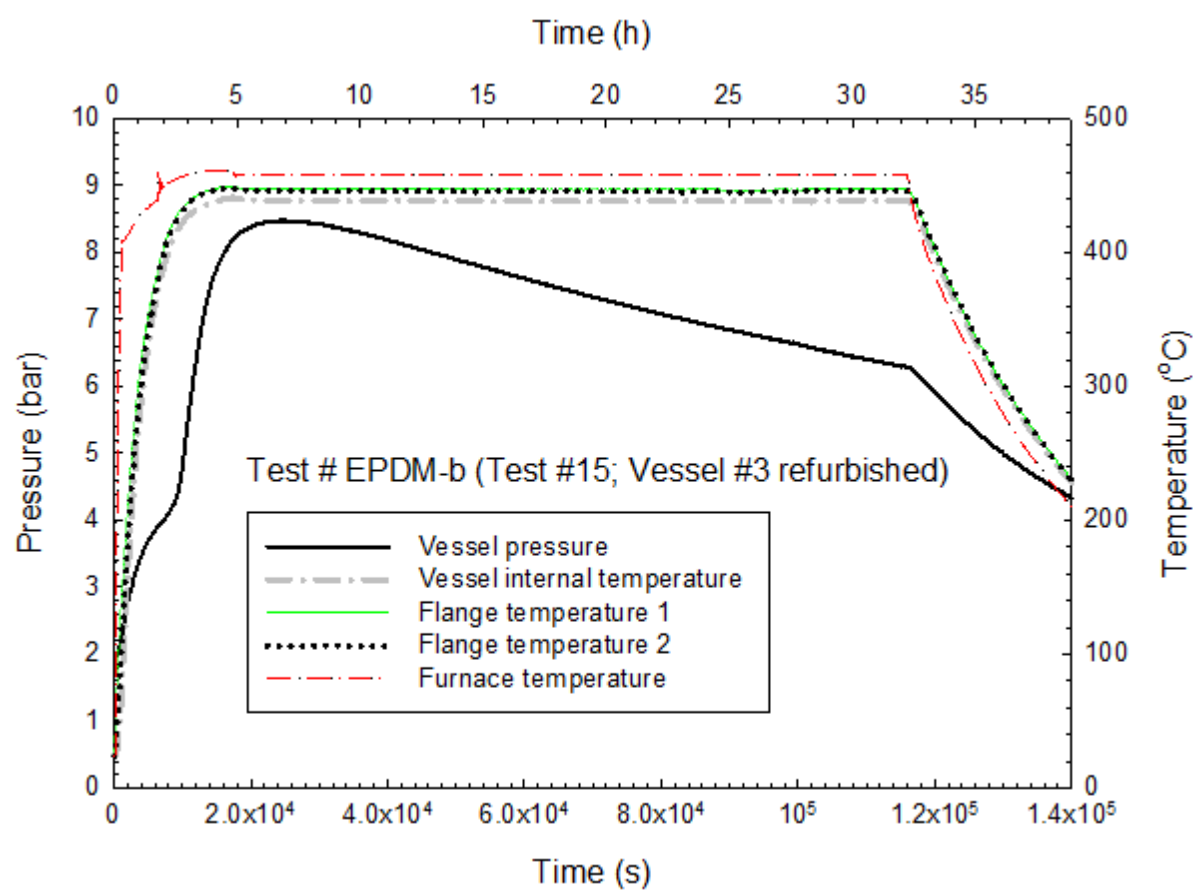
Figure 3-33 shows the first 39 h of the pressure-time and temperature-time histories obtained from this test. The pressure and temperature histories for the complete heating and cooling cycle are given in Figure 3-34. The pressure trace in Figure 3-33 clearly indicates a leak occurred soon after the vessel had attained the nominal target temperature of 450 °C (842 °F). Figure 3-35 shows the calculated reference helium leakage rates over the 25 h isothermal heating period at 450 °C (842 °F) with a time-averaged reference leakage rate of 9.2×10^{-4} ref·cm³/s.

Figure 3-33. Temporal variations of vessel pressure and temperature in Test # EPDM-b (Test #15).

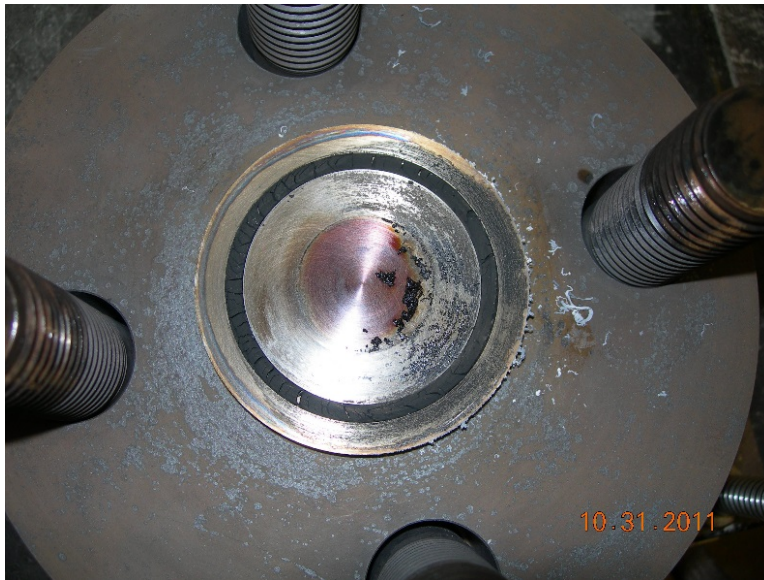
Figure 3-36. Photograph of the EPDM O-ring after thermal exposure.

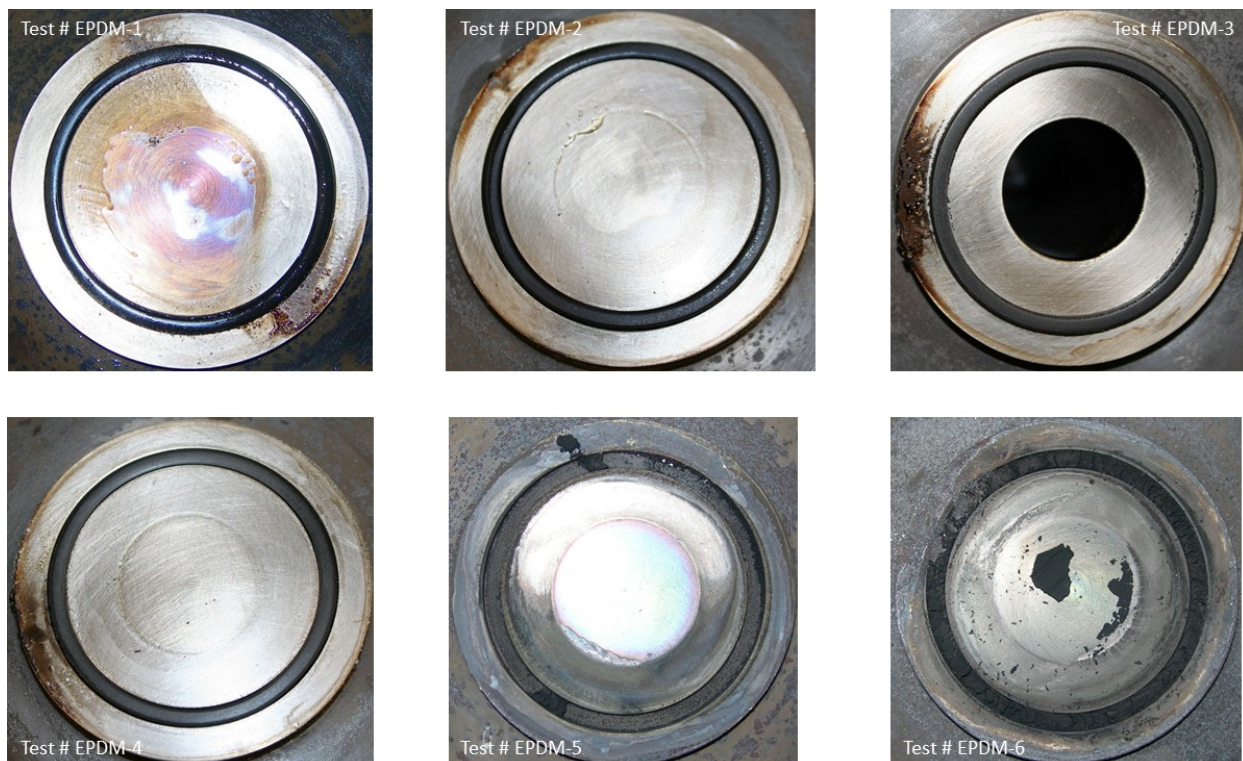
Figure 3-47. Photographs showing the thermally degraded EPDM O-ring after 8-h thermal exposure at 316 °C (600 °F) from the four EPDM O-ring tests (Tests # EPDM-1, EPDM-2, EPDM-3, and EPDM-4). Tests # EPDM-5 and # EPDM-6 were conducted at 900 °C for 9 h.

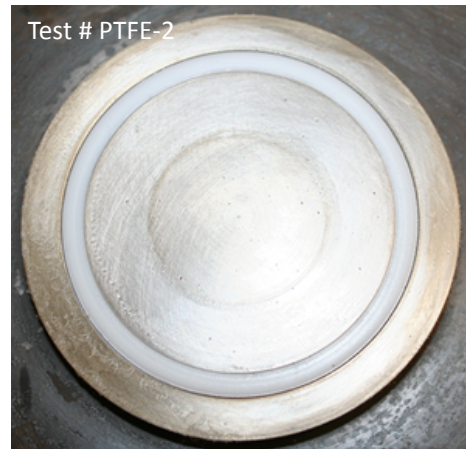
Figure 3-67. Photographs showing the thermally degraded PTFE O-ring after 8-h thermal exposure at 316 °C (600 °F) for the three PTFE O-ring tests.
