1 **Applying a biodeposition layer to increase the bond of a repair mortar on a mortar**
2 **substrate**

17 **Abstract**

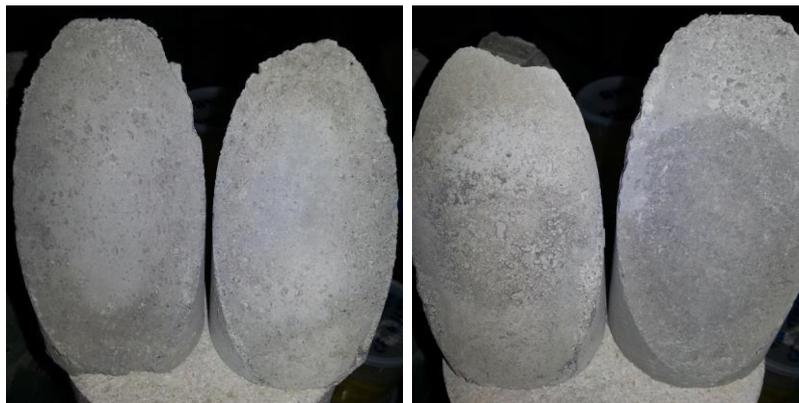
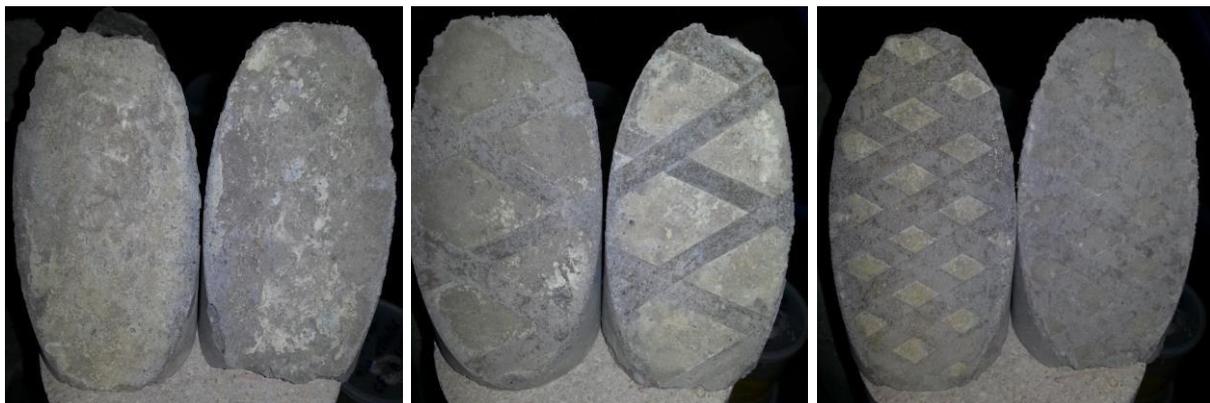
Figure 6. Elliptical interface surfaces after performing the slant shear tests of the studied specimens. (one representative example per treatment)

274 Figure 6 shows the elliptical surface of one specimen per series after performing the slant
275 shear test. The surfaces of the smooth and reference samples are clean and debonding of the
276 repair material layer from the mortar surface occurred. Conversely, a clear whitish layer was
277 observed on the bacterially treated specimens and was still observable after testing the
278 specimens. This resulted from the calcium carbonate biodeposition due to the bacterial
279 treatment, as mentioned previously. Partial debonding of the calcite layer deposited by the
280 bacteria is seen by comparing the bonding surfaces after the compression test of the
281 composite cylinder (Figure 6). Some biodeposition adhered to the repair mortar. The found
282 rougher surface is thus possibly primarily responsible for the increase in slant shear bond
283 strength. A combination of both the mortar surface and the biodeposition interface can be

284 seen for the partially bio-treated specimens where a biodeposition pattern was applied. The
285 grey mortar is interrupted by diamond-shaped biodeposition. The further increase in slant
286 shear strength is possibly due to the stepwise formation of the calcium carbonate layers due to
287 the use of the aluminium tape. This may cause a higher mechanical interlocking through the
288 shear plane during slant shear testing.

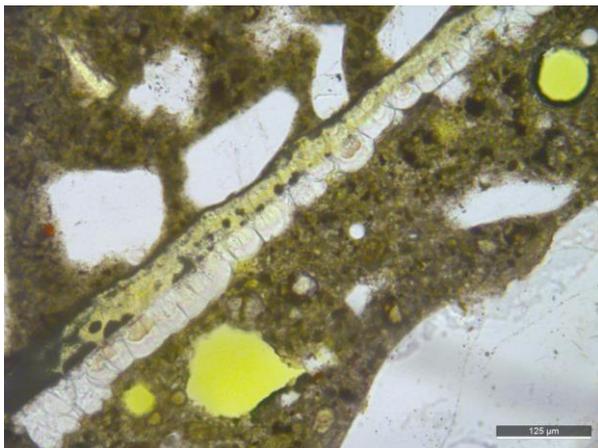
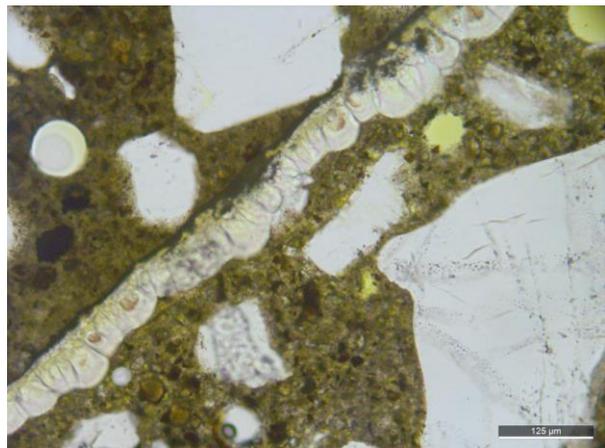
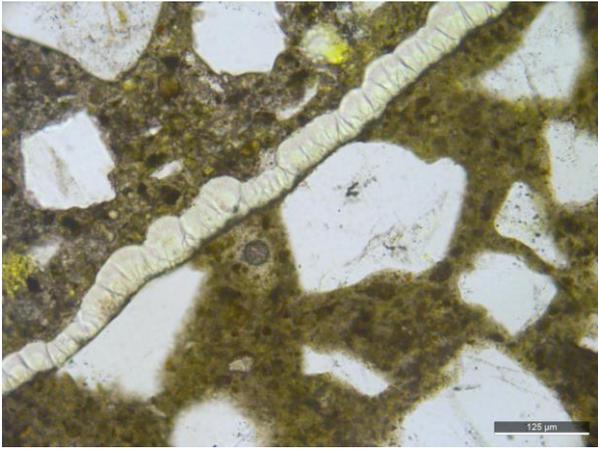
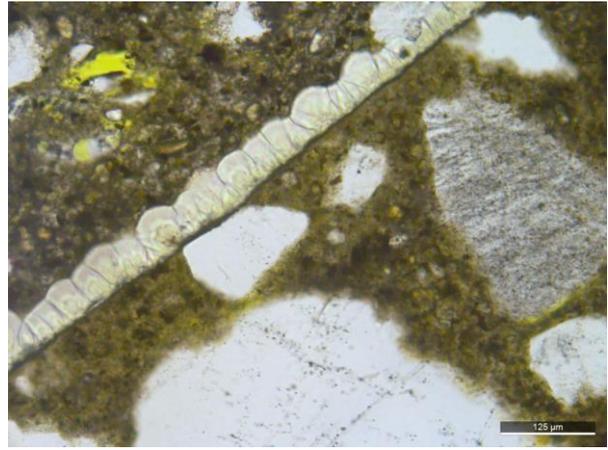
Clean shear failure in the reference mixture

Crack near interface CaCO_3 and repair mortar

Crack in the repair mortar

Debonding of CaCO_3 near substrate

Slight debonding of CaCO_3 layer

No debonding

Figure 11. Different forms of crack propagation in the reference samples (top) and the bacterially treated specimens (other). The scale bar indicates 125 μm.

344 Thin-section analysis is useful in effectively investigating the interlayer between the mortar
345 substrate and the repair material in case of the reference samples and the interlayer between
346 the mortar, calcium carbonate (biodeposition) layer and the repair material, respectively, for
347 the bacterially treated specimens (Figure 11). In the case of the reference sample, the crack
348 (yellow-green region) propagated through the interface of the mortar substrate and the repair
349 material. A clean and smooth cracking pattern along the interface is found. This seems to be
350 the weakest link when applying the repair material on the mortar surface with only a manual
351 roughening procedure using sandpaper, as was the case for this research. That is why this
352 biodeposition layer seems to be a promising avenue to increase the overall bond between the
353 mortar substrate and the repair material.

355 The formed CaCO_3 layer has a rough surface due to the formation of irregular crystals (Figure
356 4 and Figure 11). Both the repair material and the mortar substrate tend to show a good
357 adherence to that layer. This roughness could also partially lead to the increase in observed
358 bond strength. In the case of the bacterial treated specimens, it could be seen that debonding
359 takes place in the repair material near the vicinity of the CaCO_3 layer or in the interface
360 between the layer and the substrate. Both the bonding with the mortar substrate and the repair
361 material seems to be sufficient to increase the bond strength. Furthermore, locations are noted
362 where the crack was found in the repair material further away from the interface (no
363 debonding in Figure 11). This shows the beneficial effect that the biodeposition layer has in
364 terms of the slant-shear strength increase.
