# MITIGATING IGNITION OF JAPANESE STYLE TILE ROOFING ASSEMBLIES

Sayaka Suzuki<sup>1</sup> and Samuel L. Manzello<sup>2</sup>

<sup>1</sup>National Research Institute of Fire and Disaster, Japan

<sup>2</sup>National Institute of Standards and Technology, USA

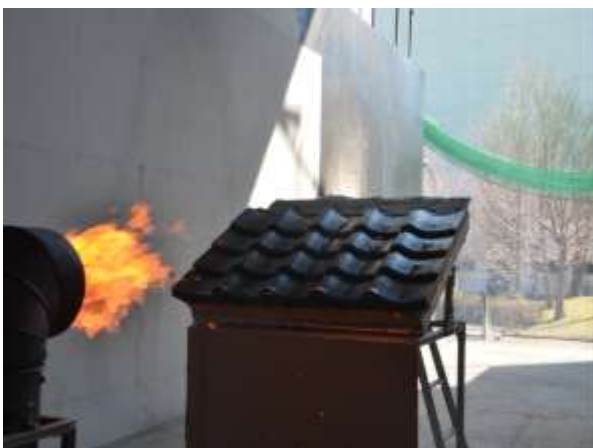
**Figure 2** Image of a typical experiment. Applied wind speed of 6 m/s. 2 kg of water was sprayed onto the tiles just prior to the start of the experiments.

wind were applied were 1 kg or 2 kg. **Figure 2** displays a typical experiment for an applied wind speed of 6 m/s and 2 kg of water applied to the tiles. It is important to note the water did not remain uniform on the surface due to the unevenness of the Japanese roof tiles, even though the water was evenly applied. During the the experiments, it was observed that water gradually dried out from wind and possibly accumulated firebrands absorbed water as they landed on the roof tile surface. Firebrands were also observed to be trapped in the water, on the surface, and extinguished.

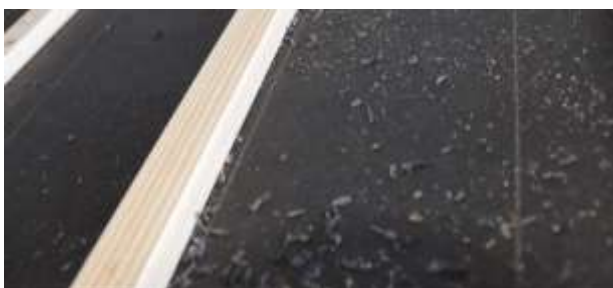
**Figure 3** Battens and underlayment after the time have been removed. Applied wind speed of 6 m/s and 2 kg of water was applied before an experiment.

After the desired firebrand exposure, either 10 min or 20 min, the roof tiles were removed and the number of firebrands that penetrated under the roof tiles was counted, for each case. Firebrands penetrated under the tiles, yet the battens were not charred, and no smoldering ignitions were observed as shown in **Fig. 3**.
