**NIST Technical Note 2165**

**Fire Resilience of a Steel-Concrete  
Composite Floor System: Full-Scale  
Experimental Evaluation for U.S.  
Prescriptive Approach with a 2-Hour  
Fire-Resistance Rating (Test #1)**

October 2021

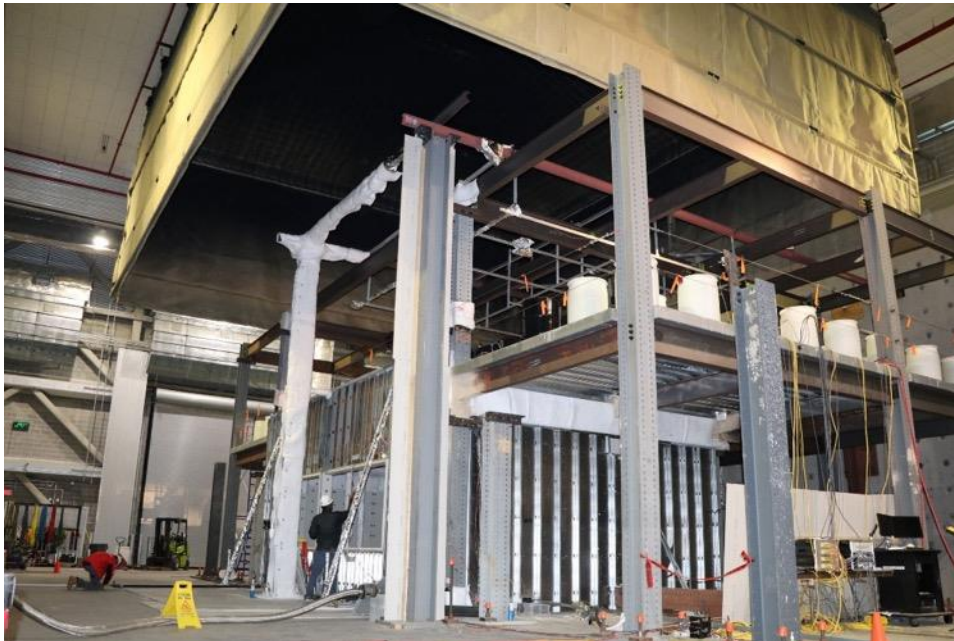
**Fig. 2-2. NFRL two-story test frame prior to fire experiment.**

A photograph of the test frame is shown in Fig. 2-2. For this study, the support columns were protected from fire so that they could provide a reliable load path during the experiment. Further, the same steel beam framing was assembled at the second story level without concrete slabs, providing support conditions of the steel columns continuous over two stories. This design decision was based on pre-test analyses in which the presence of a second-floor slab had negligible effect on the fire behavior of the test floor assembly on the first-floor level. In addition, this configuration (i.e., no concrete slabs on the second floor) allowed to expedite replacement of the test floor assembly (on the first-floor level) for subsequent fire tests. Details of the test frame design are presented in the following subsections.

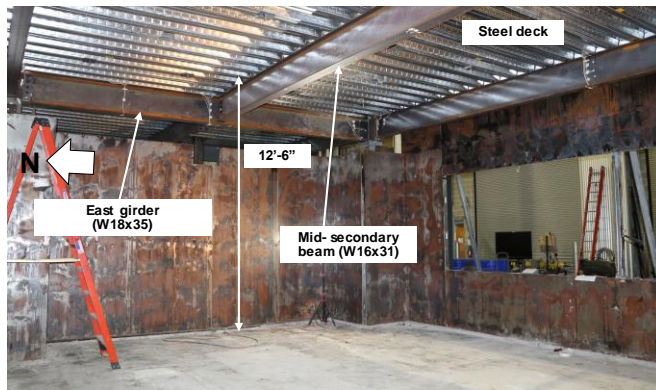
**Fig. 2-10. Steel framing (a) test bay (b) north surrounding bay (c) west surrounding bay. Note that red post shoring was removed prior to fire test. Top of the specimen catch system was 10 cm below the beam.**

Fig. 2-10 shows photographs of the first story steel framing and the composite floor soffits at various locations. The 1st floor steel framing was erected at 380 cm (150 in.) above the strong floor. The flutes of metal deck units were continuous in the north-south direction, perpendicular to the secondary beams.

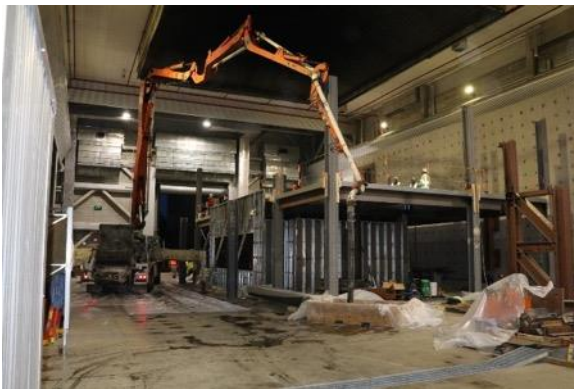
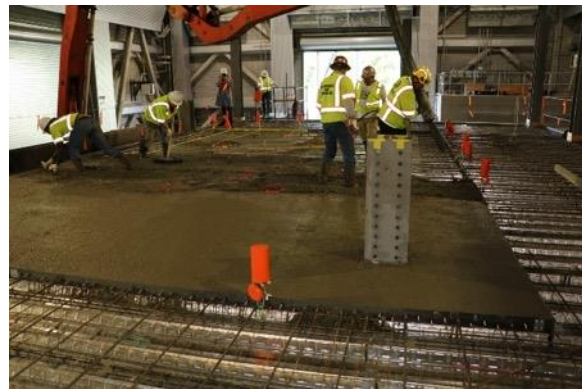
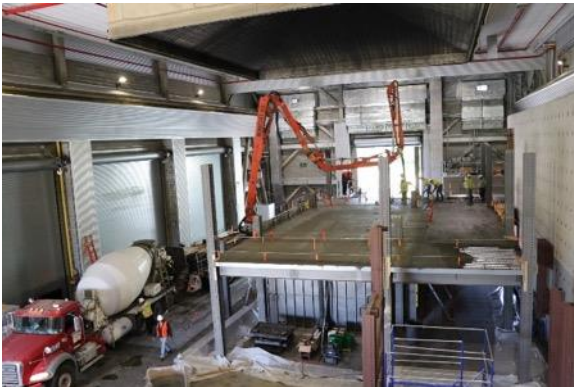
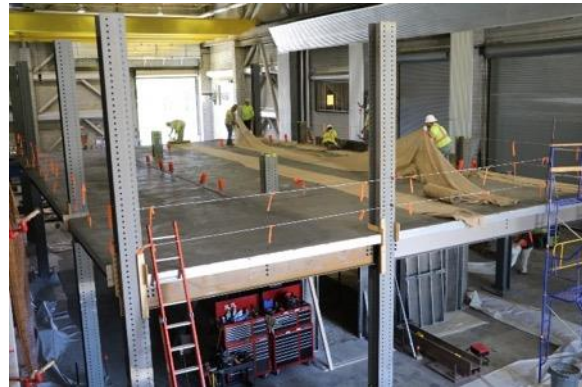
**Fig. 2-24. Casting of the concrete: (a) Pump truck in National Fire Research Laboratory test hall; (b) concrete placement in test specimen; (c) concrete placement in surrounding bays; (d) initial curing with wet burlap.**

The concrete was batched at a local ready-mix concrete plant and trucked to NIST for casting. A total of four trucks were used. Although the design mixture proportions were the same for all batches (trucks), small adjustments were made by adding superplasticizer (for low moisture and pumpability) prior to the concrete placement. The concrete was cast indoors (Fig. 2-24a) in the test hall. Trucks 1 and 2 provided the concrete for the test slab (Fig. 2-24b) and Trucks 3 and 4 provided the concrete for the surrounding bays (Fig. 2-24c). Immediately after casting, the concrete was covered with wet burlap to maintain a wet surface condition (Fig. 2-24d). The burlap was re-wet, as necessary, for the first 7 days of curing, after which the burlap was removed.

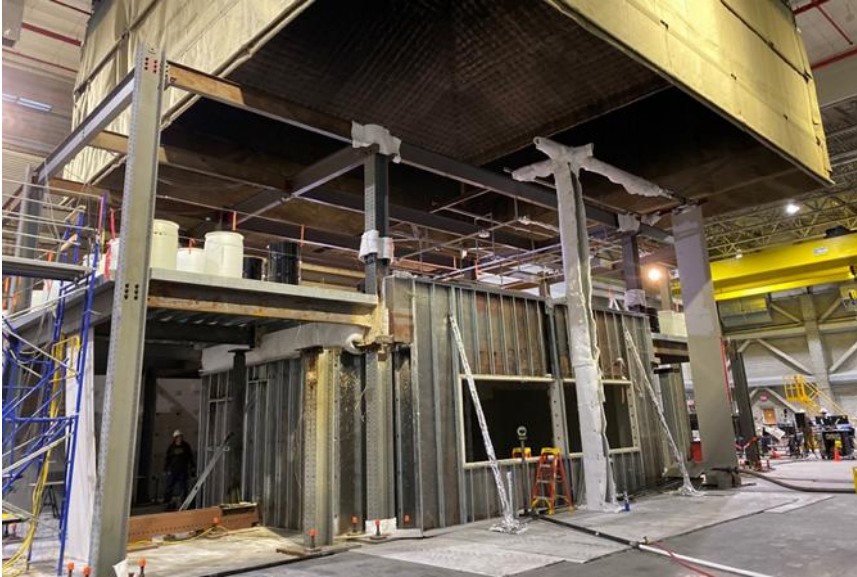
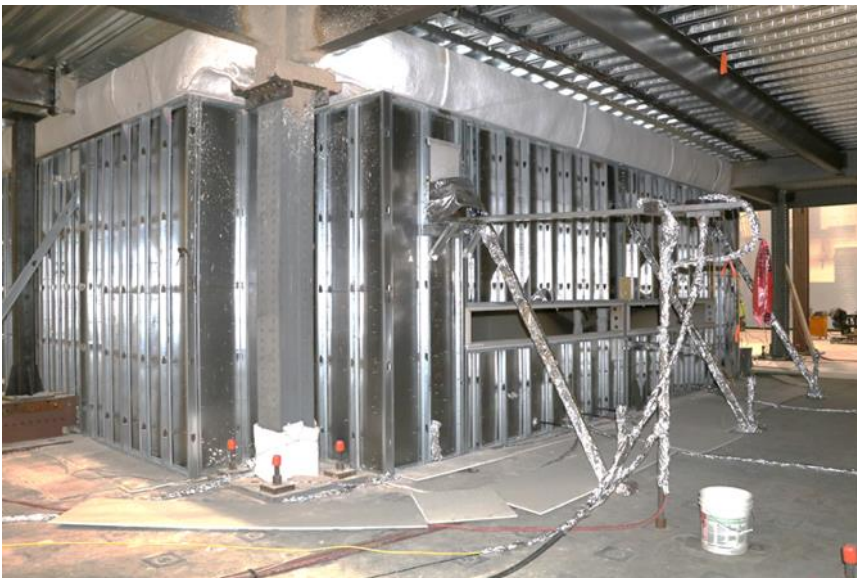
**Fig. 2-33. Photographs of the outside of the fire test compartment: (a) the south wall with a main vent opening and (b) the north wall with a slit.**

The compartment walls were considered as non-load bearing walls so that the heated floor assembly above could move freely downward during a test fire. All enclosing walls were constructed using cold-formed steel framing with wall sheathing made of 0.8 mm (22 gauge) sheet steel. As shown in Fig. 2-33, the main ventilation opening was on the south wall, approximately 150 cm tall  $\times$  582 cm wide. There was a 30 cm tall  $\times$  582 cm wide slit on the north wall. This slit was designed for air intake only. The height of the windowsill was 100 cm from the strong floor. The scaled drawings of the fire test enclosure are presented in Appendix A.

In contrast, the other three (north, east, and west) walls were 77 cm shorter than the height of the composite floor soffit, as shown in Fig. 2-33b. The gap between the ceiling and the top edges of the walls was enclosed by two layers of Kaowool blanket (25 mm thick each), Fig. 2-35.

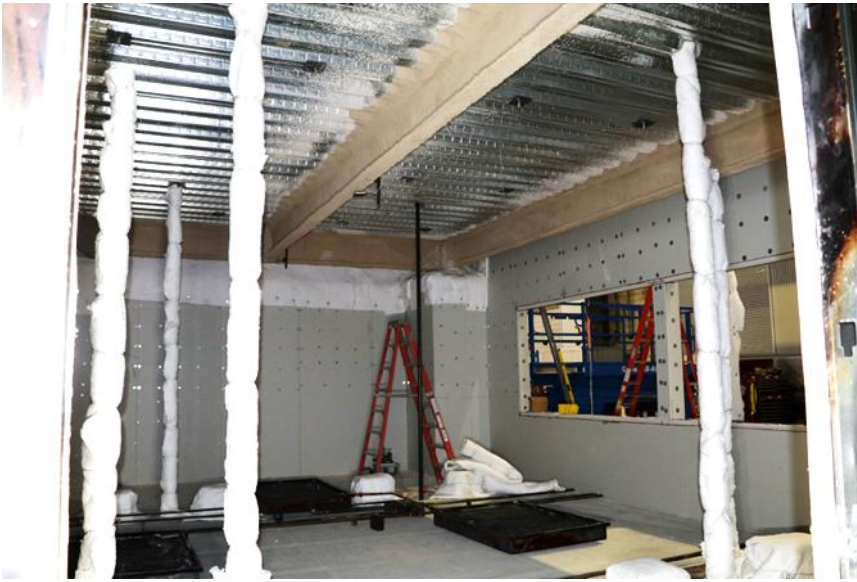
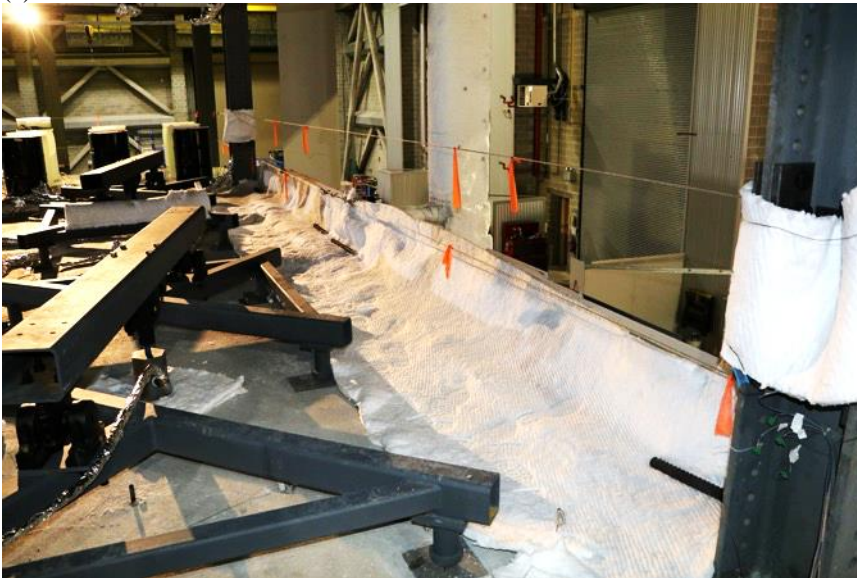
**Fig. 2-34. Photographs of (a) inside of the test compartment and (b) south edge of the test floor assembly.**

The strong floor inside the test compartment was protected with two 16 mm thick layers of Type-X gypsum boards and a 13 mm thick concrete board, Fig. 2-34a. The height of the ceiling (the composite floor soffit), measured from the top surface of the compartment floor, was 377 cm. Refer to Appendix A for detailed 2D drawings of the test compartment. The exposed surfaces of the walls were lined with three layers of Type-C gypsum boards (16 mm thick each), as shown Fig. 2-34a. The south wall was extended beyond the top surface of the slab but its exposed surface was kept 7.6 cm away from the slab edge (Fig. 2-33a and Fig. 2-34a). A strip of ceramic fiber blanket was used to block the gap between the south slab edge and the wall lining (Fig. 2-34b).

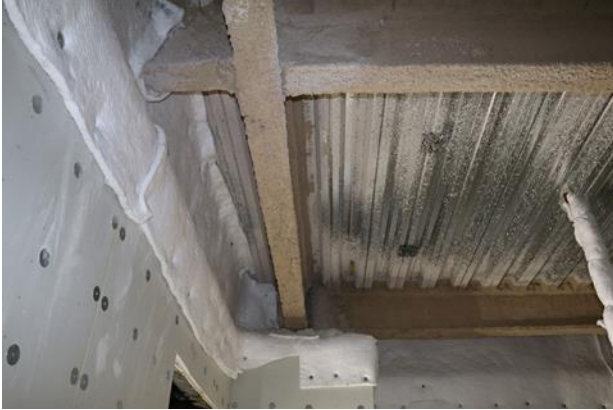
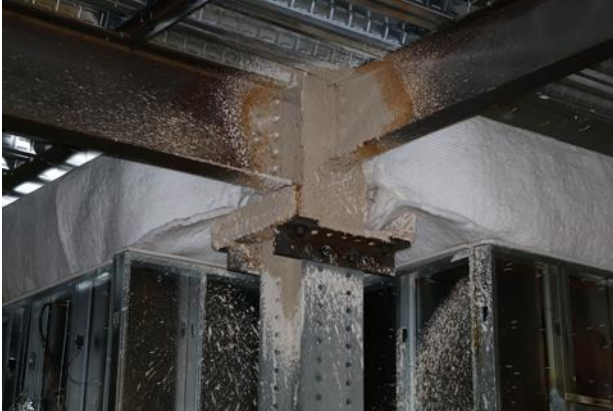
**Fig. 2-35. Photographs of (a) enclosure around the beam-to-girder connection region; (b) enclosure around column (outside of the compartment).**

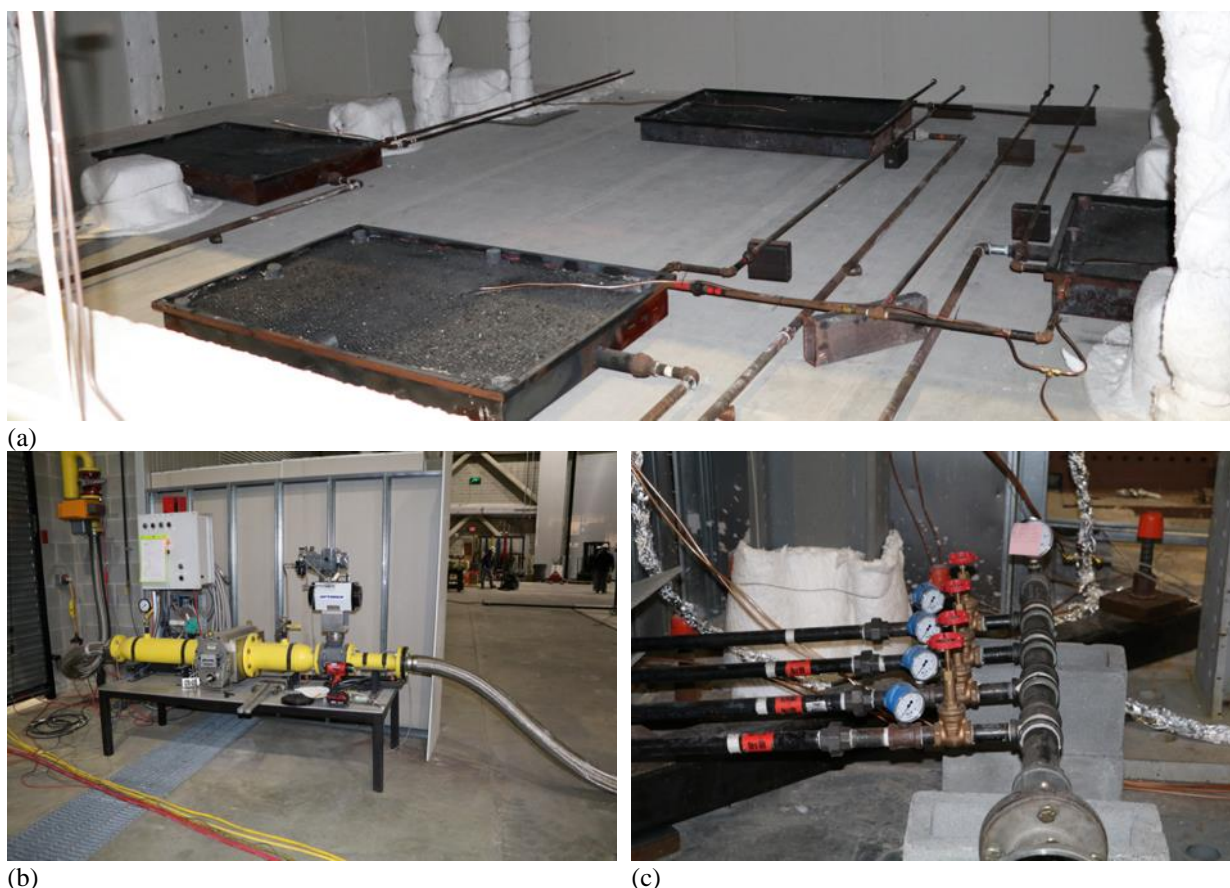
**Fig. 2-36. Photographs of (a) burners placed inside of the fire test compartment, (b) NFRL's natural gas fuel delivery system; (c) balancing valves at upstream of the burners.**

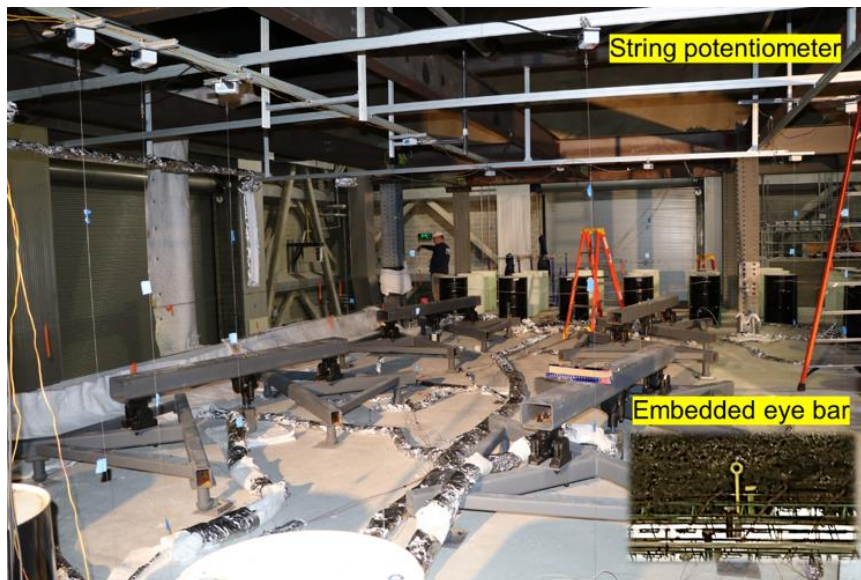
**Fig. 3-2. String potentiometers used for the vertical displacement measurements. Measuring strings were directly attached to the eye bars partially embedded in the concrete slab.**

In order to measure the vertical displacement of the test floor assembly, a total of fifteen string potentiometers (Model: PA-30) were mounted to isolated aluminum frames approximately 2 m high from the test floor slab (Fig. 3-2). The measurement strings were directly connected to embedded steel eye bars anchored to the steel deck or the top flanges of steel beams or girders in the test bay. The total expanded uncertainty ( $k = 2$ ) of the vertical displacement measurements was estimated to be 2 %.

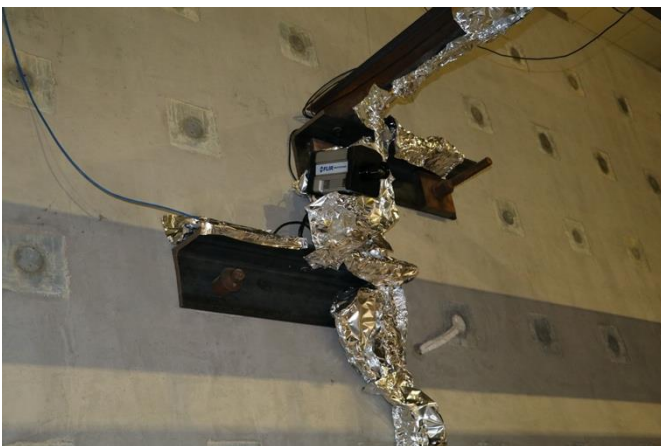
**Fig. 3-8. Infrared camera mounted on the strong wall.**

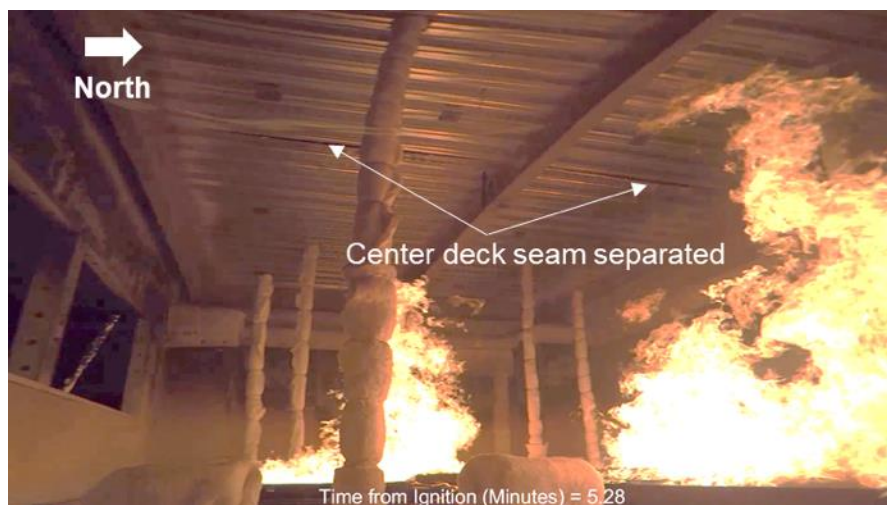
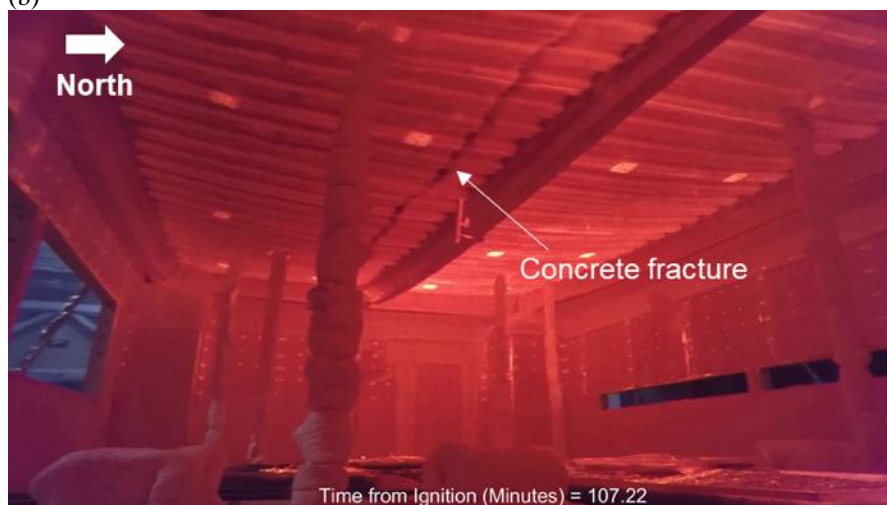
**Fig. 4-24. Snapshots from the test video viewing inside the test compartment at about (a) 5 min, (b) 9 min, and (c) 107 min after the burner ignition.**

| Time (min) | Observations | Figures |
|---|--|--|
| 5 | A center seam of the steel decking began to separate, indicating failure of deck fasteners in the mid panel. | Fig. 4-24a |
| 106 to 107 | Both fire and mechanical loading were removed. | Fig. 4-24c<br>Fig. 4-28b<br>Fig. 4-29c |

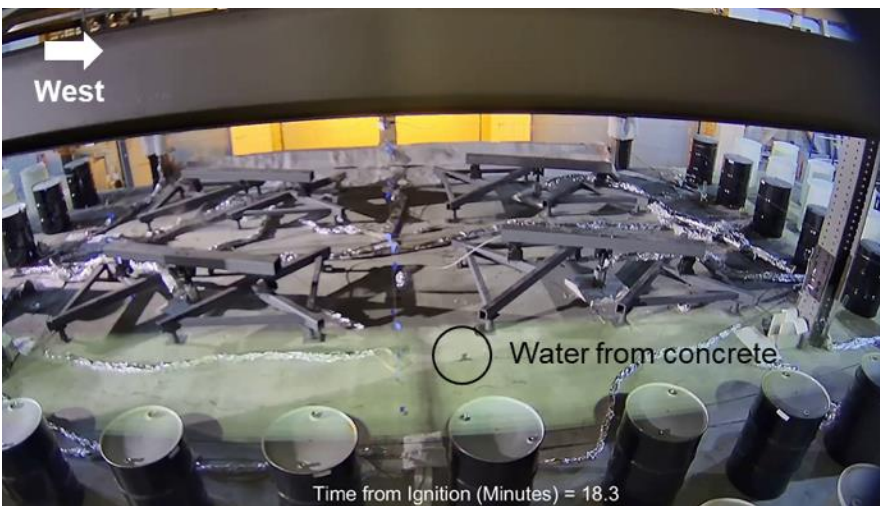
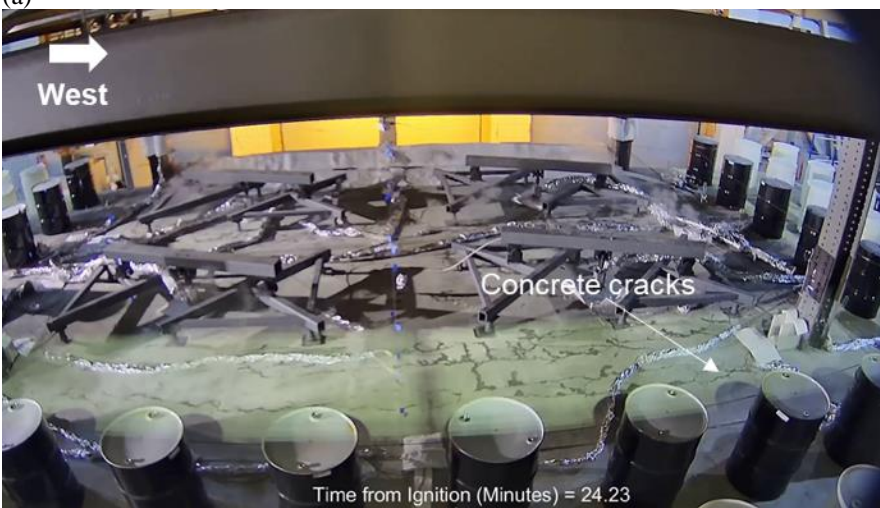
**Fig. 4-26.** Snapshots of the test video looking down on the top of the test floor assembly at about (a) 18 min and (b) 24 min.

| Time (min) | Observations | Figures |
|---|--|--|
| 18 | Water appeared on top of the slab through concrete cracks. | Fig. 4-26a |
| 24 | Concrete cracks became clearly visible north of the north primary beam. | Fig. 4-26b |

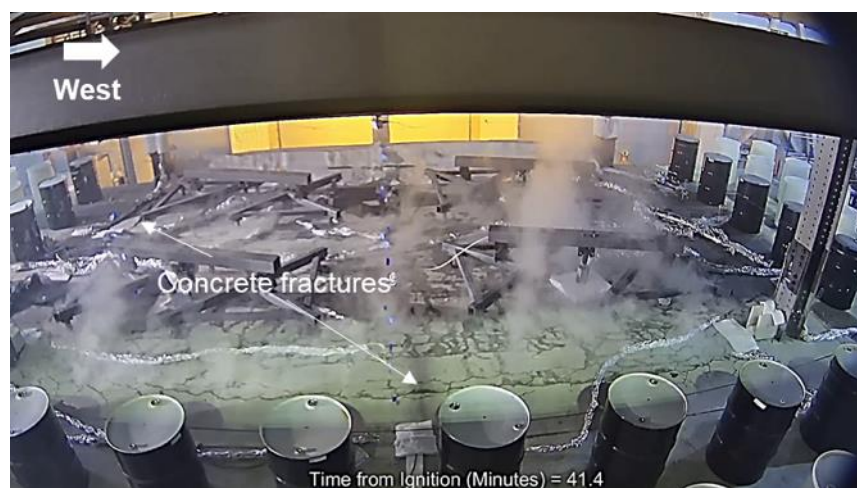
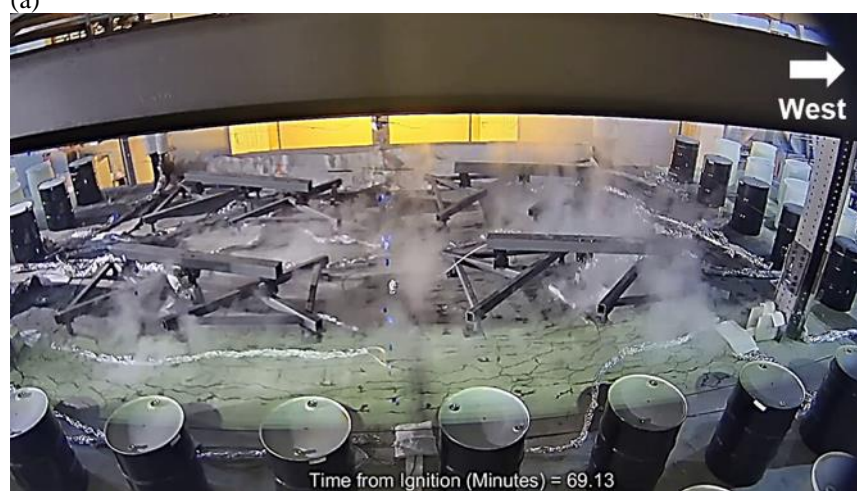
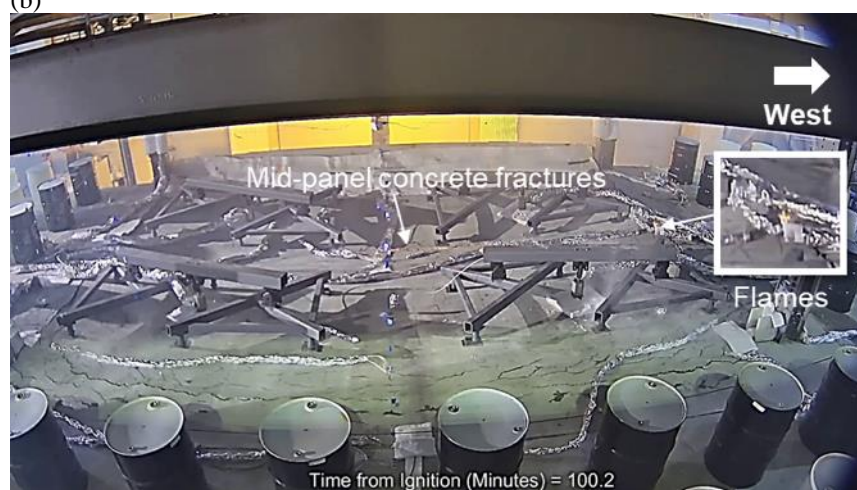
**Fig. 4-27.** Snapshots of the test video looking down on the top of the test floor assembly at about (a) 41 min, (b) 69 min, and (c) 100 min.

| Time (min) | Observations | Figures |
|---|--|--|
| 41 | A loud report was heard; several water-filled drums placed on the east surrounding bay trembled; some strain and displacement data were shifted up or down, simultaneously; concrete fractures around the perimeter of the heated slab were visible; heavy (wet) steam appeared on top of the heated concrete. | Fig. 4-27a |
| 69 | A loud report was heard; some strain and displacement readings were shifted up or down; concrete cracks appeared south of the secondary beam, propagating from the midspan toward the east or west direction. | Fig. 4-27b<br>Fig. 4-29a |
| 95 to 100 | Steam from the concrete was almost disappeared; intermittent flames appeared on the concrete atop the beam-to-girder joints, indicating local deck and concrete fractures. | Fig. 4-27c |

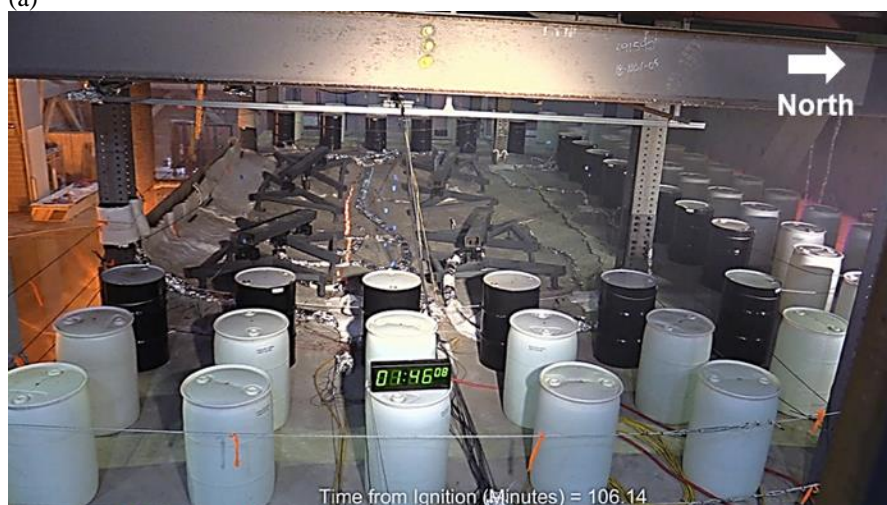
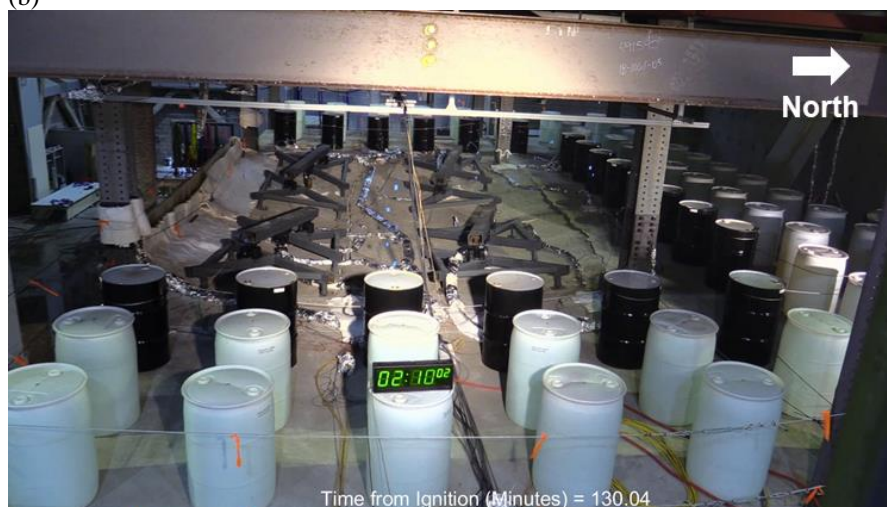
**Fig. 4-28. Snapshots of the test video displaying the view from the east surrounding bay at (a) 87 min, (b) 106 min, and (c) 130 min (cooling).**

| Time (min) | Observations | Figures |
|---|--|--|
| > 107 | The test floor assembly did not collapse during cooling. | Fig. 4-28c |

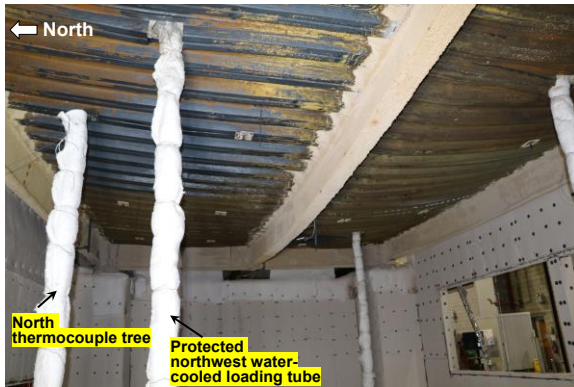
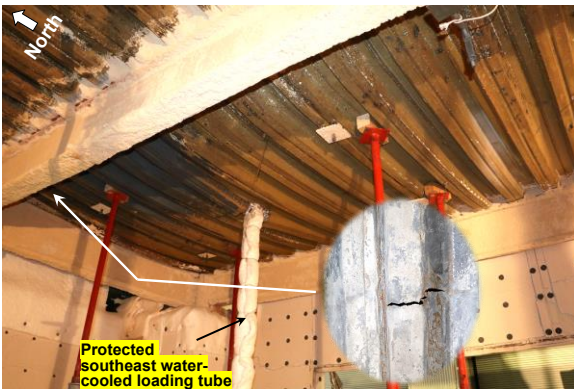
**Fig. 4-42. Post-test photographs: (a) overall deflected shape and color of the exposed decking; (b) closeup of the steel decking south of the secondary beam; (c) southeast corner of the steel decking.**

The fire-exposed steel deck after cooling is shown in Fig. 4-42. The color of the north side of the exposed deck was different from that of the south side. Overall, the decking exhibited good integrity and ductility (Fig. 4-42b). There were only localized ruptures below the east end of the longitudinal concrete crack (Fig. 4-38b). These ruptures were approximately 140 mm long (Fig. 4-42c). As reported in Sect. 4.5.1, a small flame was penetrated through concrete cracks in the region where localized deck rupture was visible.

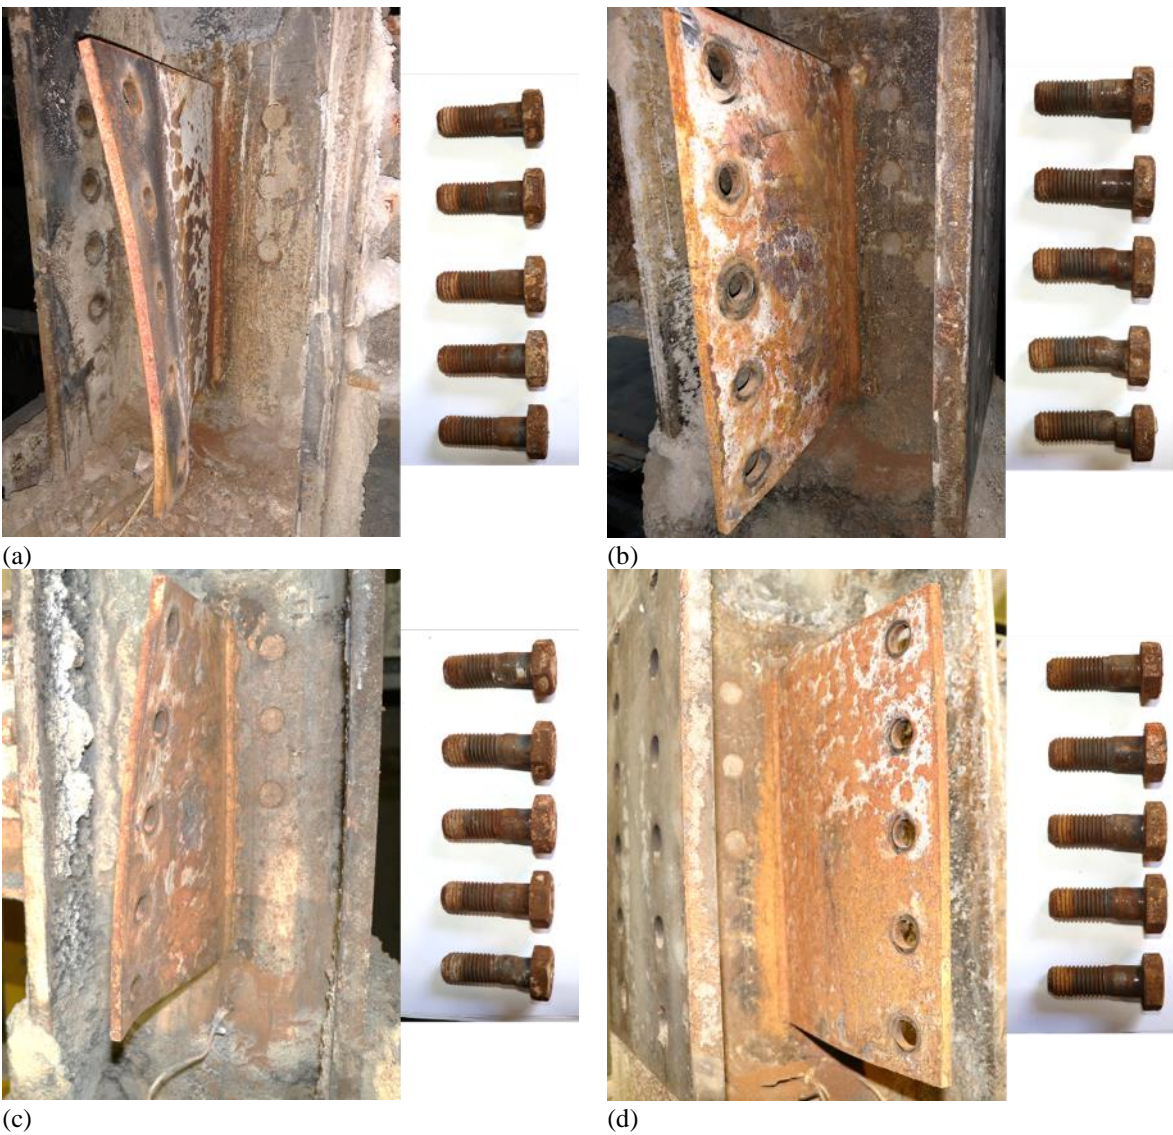
**Fig. 4-48. Post-test photographs of extended shear tab (girder-to-column) connections: (a) north end of the east girder; (b) south end of the east girder; (c) north end of the west girder; (d) south end of the west girder.**

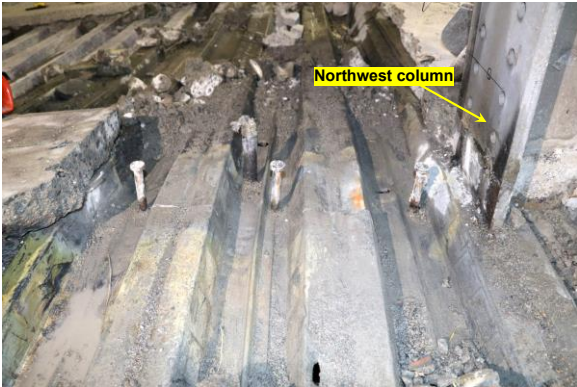
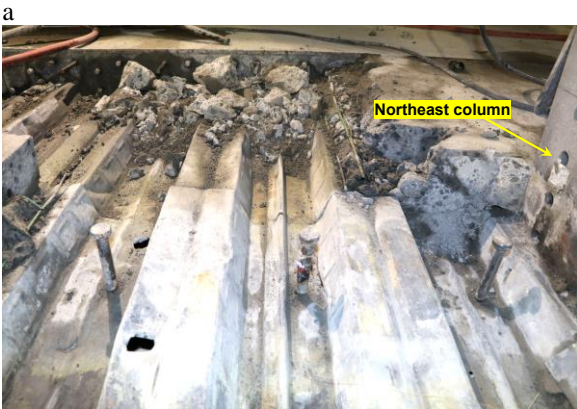
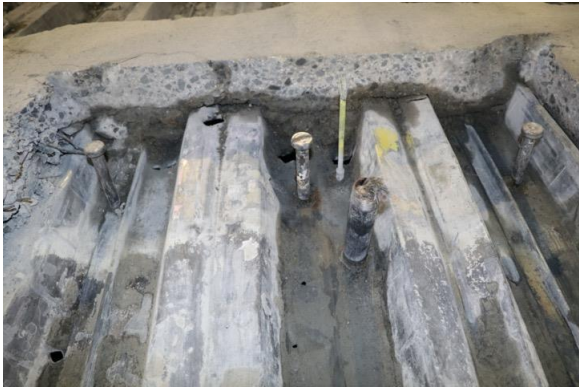
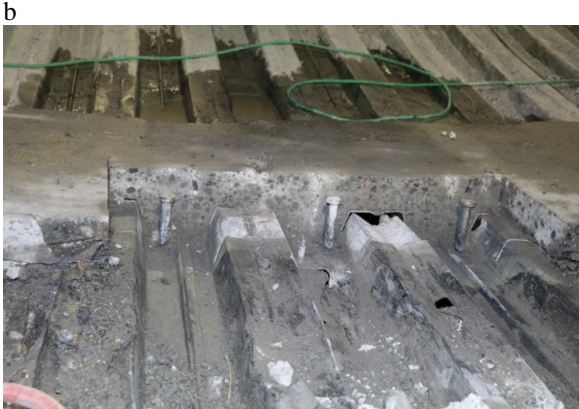
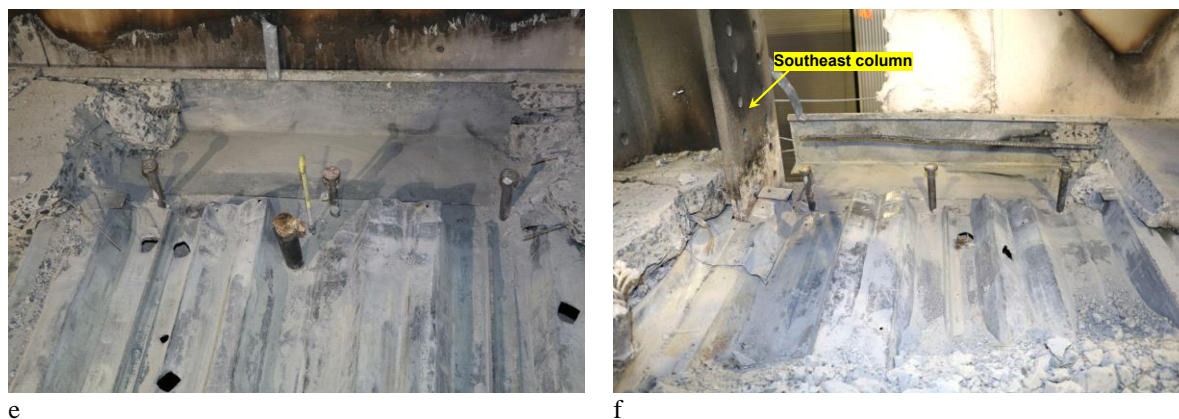
**Fig. B-23.** Post-test photographs of headed stud anchors in the test bay.

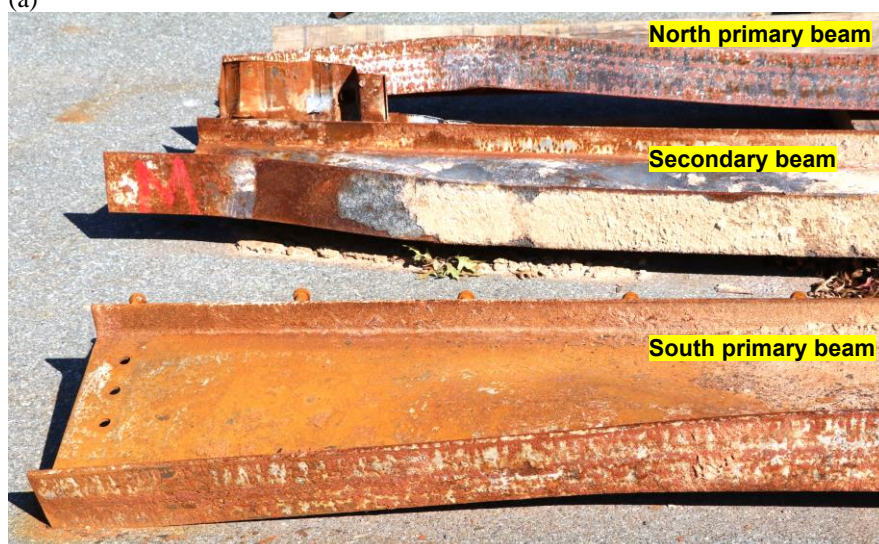
**Fig. B-24.** Post-test photographs of W16×31 beams in the test bay; (a) east end and (b) west end.

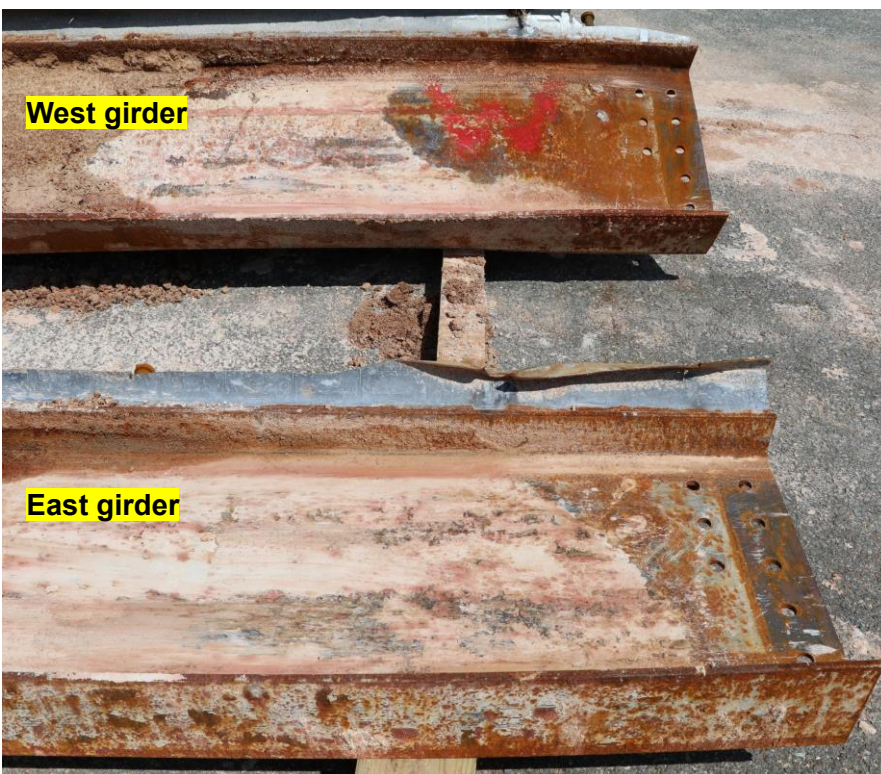
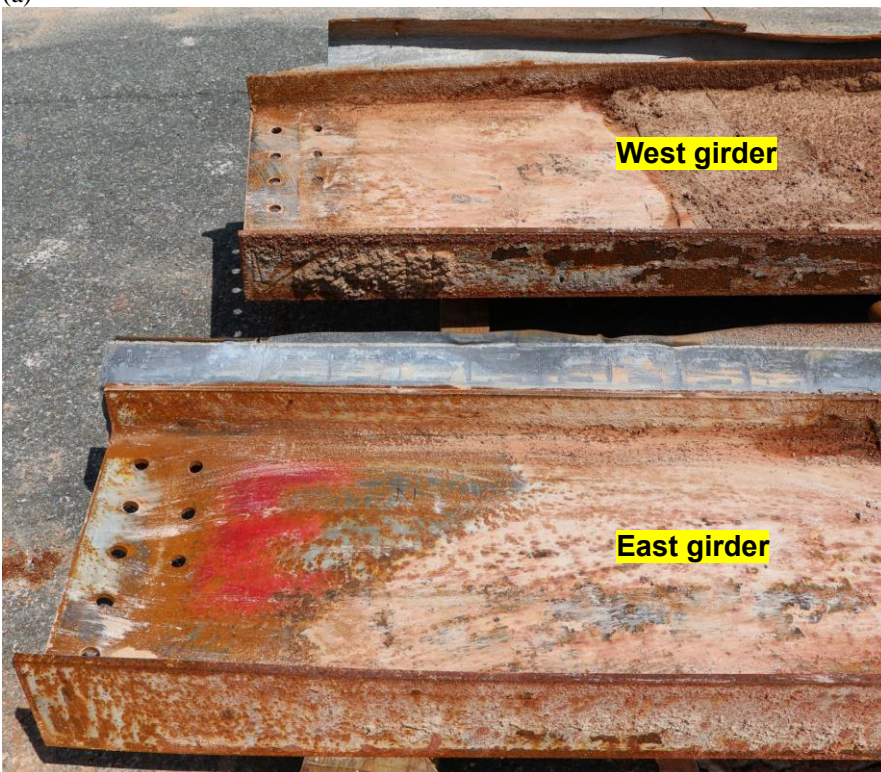
**Fig. B-25.** Post-test photographs of W18×35 girders in the test bay; (a) north end and (b) south end.

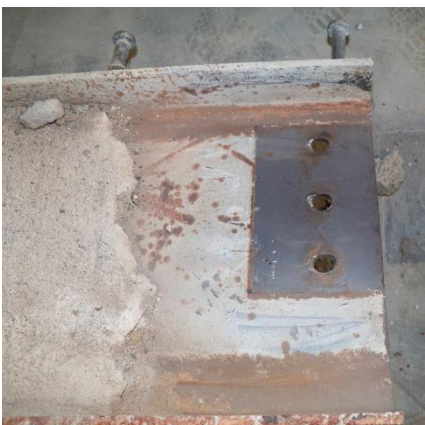
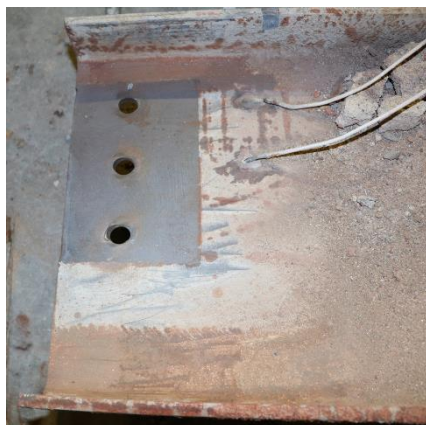
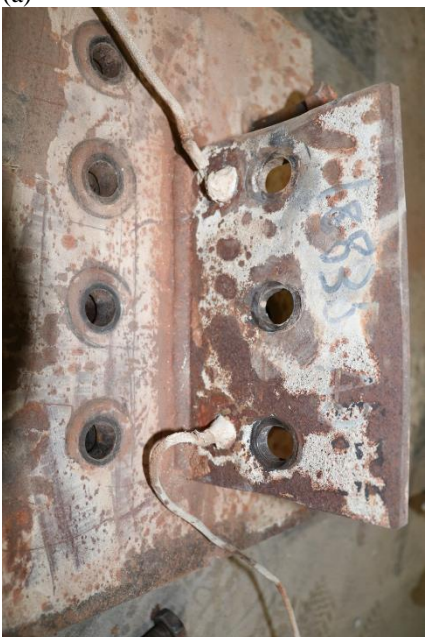
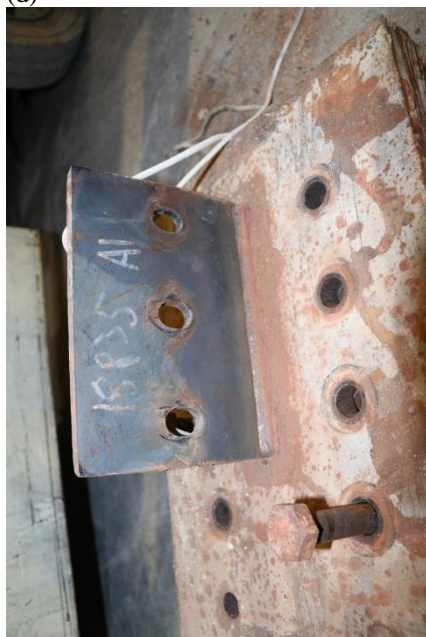
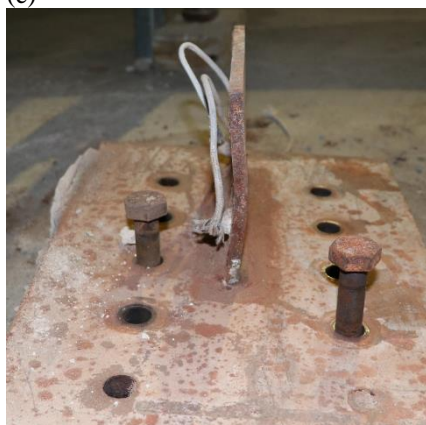
**Fig. B-26. Beam-end connections of north primary beam; (a, b, c) east end and (d, e, f) west end.**

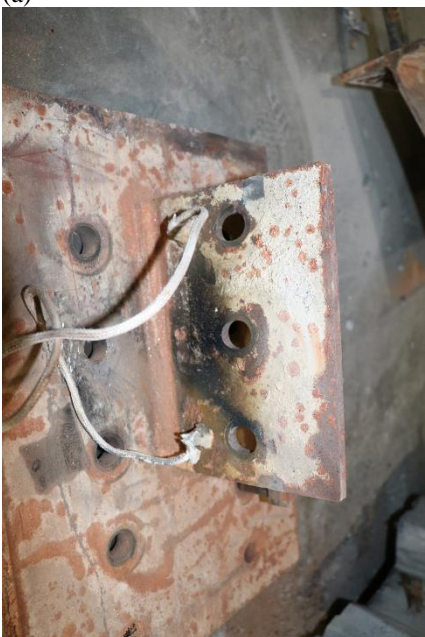
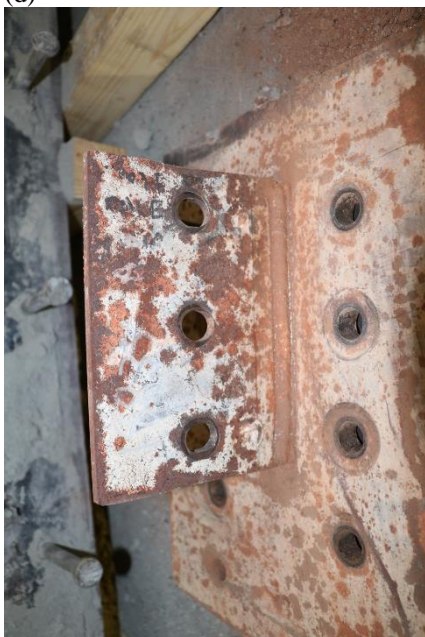
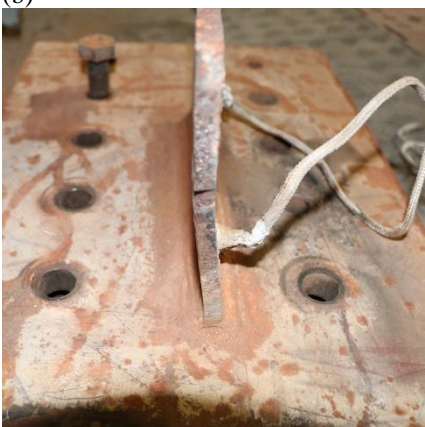
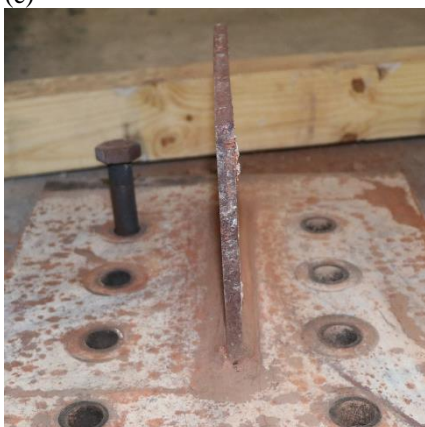
**Fig. B-27. Beam-end connections of south primary beam; (a, b, c) east end and (d, e, f) west end.**
