Assessment of the reason for the vitrification of a wall at a hillfort. The example of Broborg in Sweden

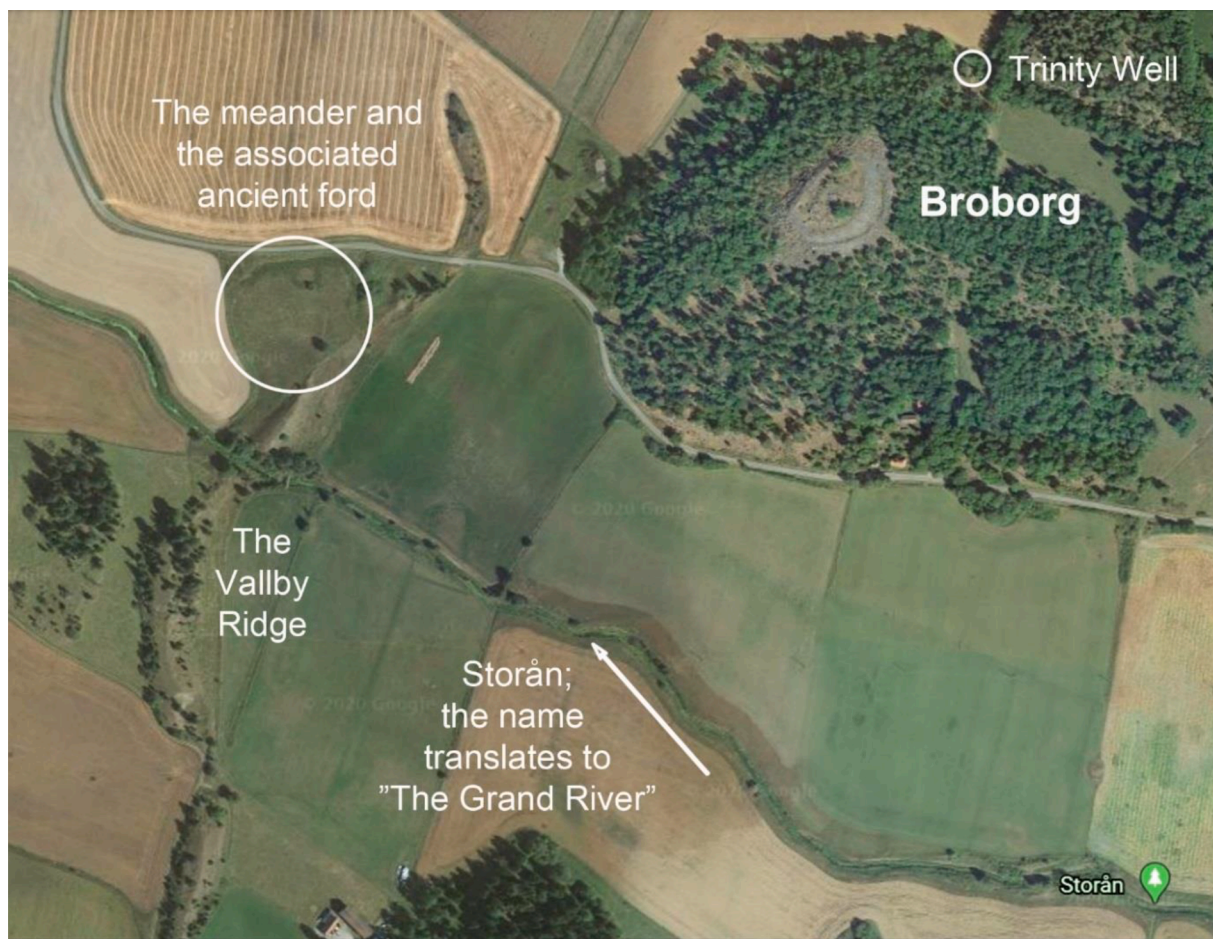
Fig. 2. The hillfort Broborg together with the river Storån and the Vallby Ridge as well as the remains of the meander and the associated ford. The river got its straight course during drainage operations in the 19th century. Copyright Lantmäteriet (the Swedish mapping, cadastral and land registration authority).

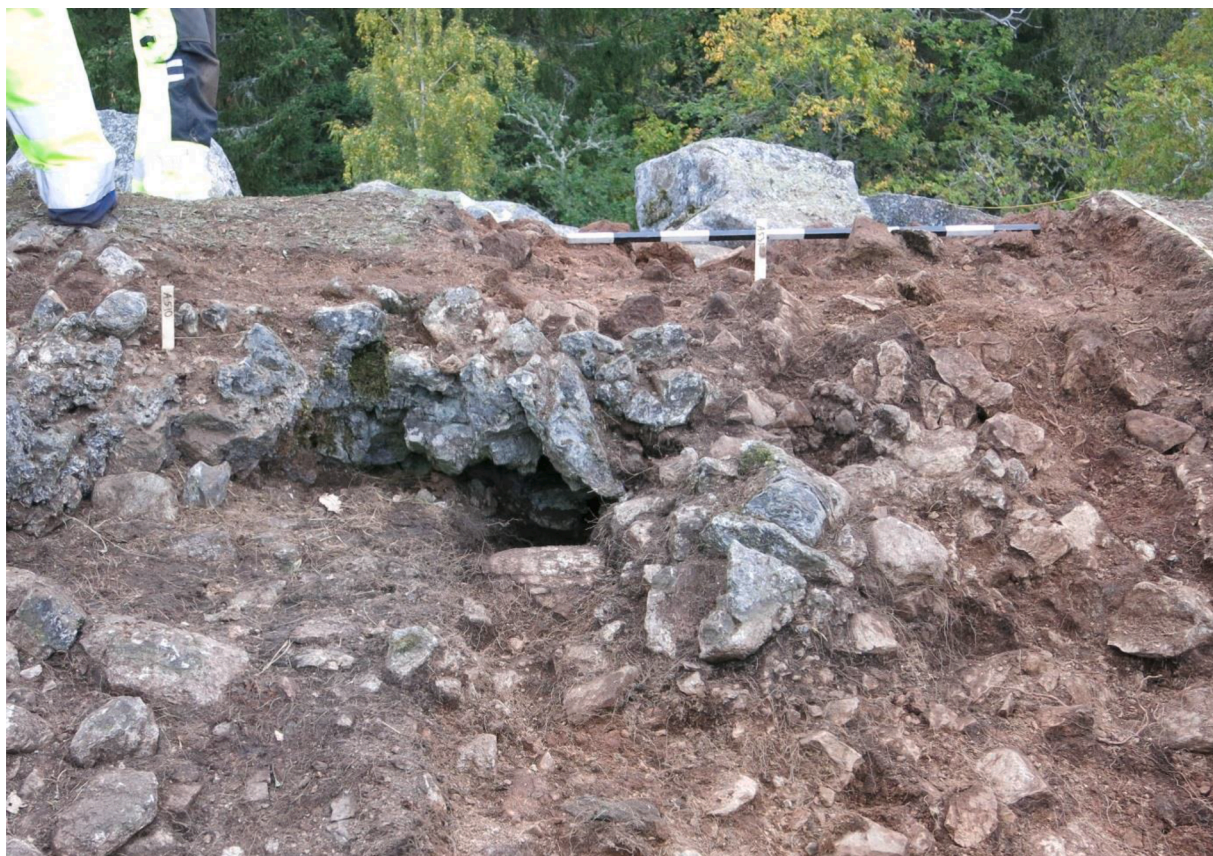
Fig. 3. A part of the inner wall at Broborg at the beginning of the excavation in October 2017. The picture shows the vitrified part and its even upper surface as well as some empty space underneath. Photographer Rolf Sjöblom.

After the topsoil overlying the vitrified wall was removed during the first excavation, it could be seen that the surface is quite flat and that the wall consists of a series of ‘boxlike’ structures, ≥ 1 m in length (Kresten, Kero and Chyssler 1993).

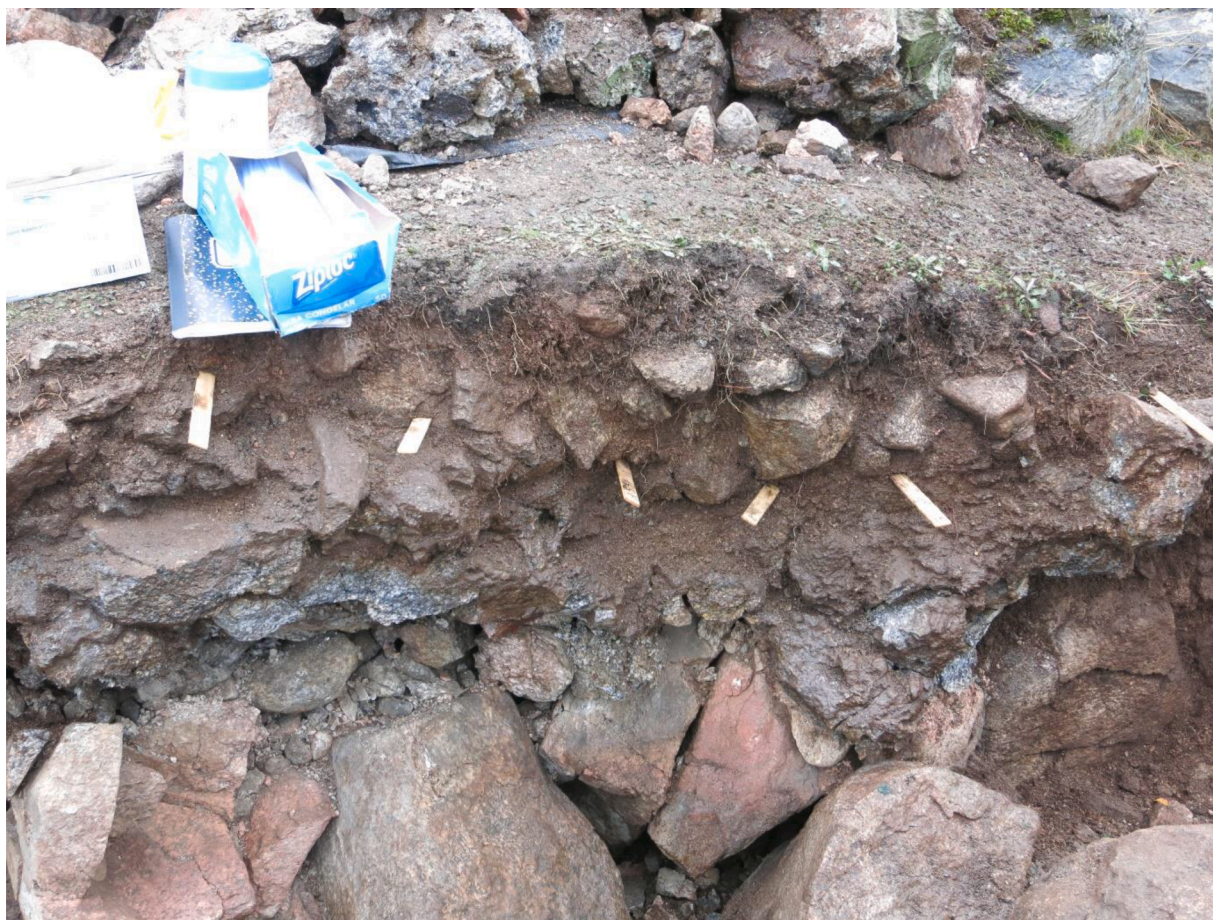
Fig. 4. The cross section of the inner wall at Broborg. Profile to the east as in Fig. 5a. The photograph was taken by Rolf Sjöblom during the excavation in October 2017. The markers represent sampling points for the pulverized fire-cracked rock material.

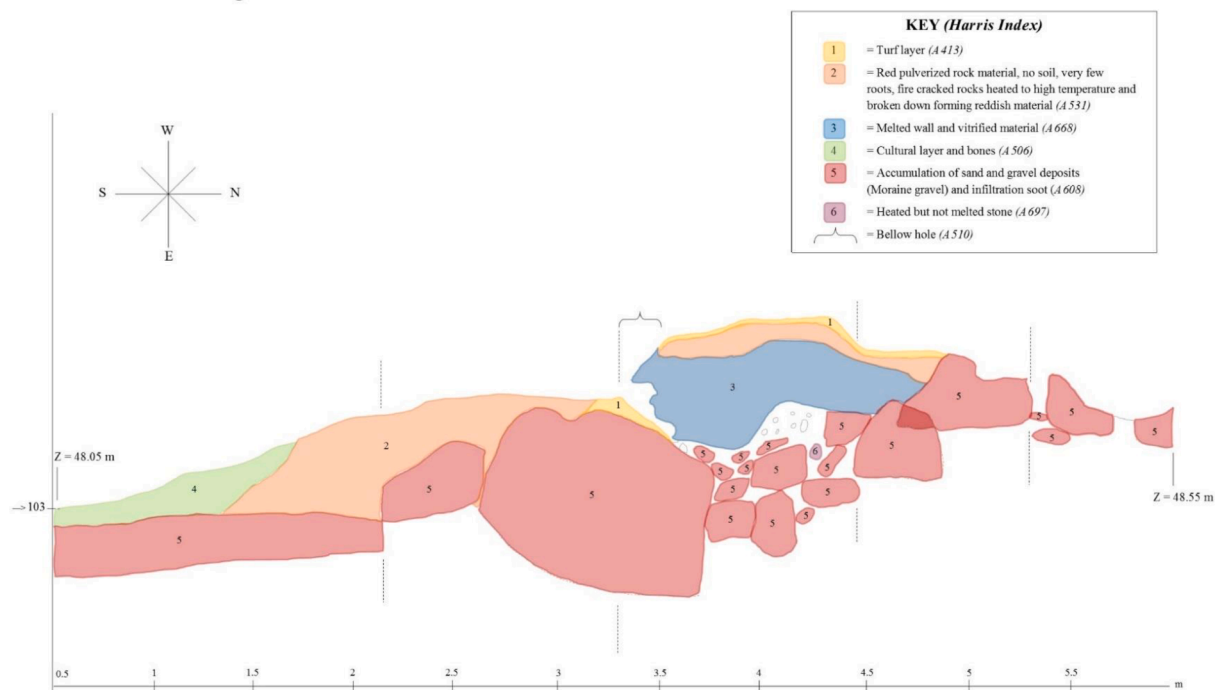
West Section - Broborg Hillfort Excavation October 2017

Fig. 5b. Drawing of the cross section of the inner wall at Broborg. Profile to the west. Areas labelled no 5 also contained cobble and boulder size material, cf. Fig. 4. The excavation was carried out in October 2017. This figure is very similar to Figure 10 in (Englund 2018a, Englund 2018b) in which also further information on the excavation can be found.
