Effects of Roof Age on Asphalt Shingle Performance During High Wind Events

To appear in: *Journal of Building Engineering*

This manuscript aims to examine whether roof age affects the level of roof cover damage observed under relatively similar hurricane wind speeds. This manuscript reports the results of an observational study of damaged asphalt roof shingles after Hurricane Laura in 2020. Damage to roof covers was subjectively estimated in percentage ranges through the use of post-hurricane aerial imagery, while roof age was estimated using roof cover damage from Hurricane Rita in 2005 or the year built after 2005, using readily available online databases. Results show that age is a clear factor in the level of roof cover damage for areas of similar peak wind speeds obtained from estimates of the wind field (i.e.,  $H*Wind$ ). A 'break' in age is found to occur centered around the 8-year mark, where damage notably increases. However, this value should be interpreted as an empirical breakpoint in this dataset rather than a general threshold. Investigating other factors, such as roof shape, shows relationships with age as well, including older hip roofs sustaining notably more da

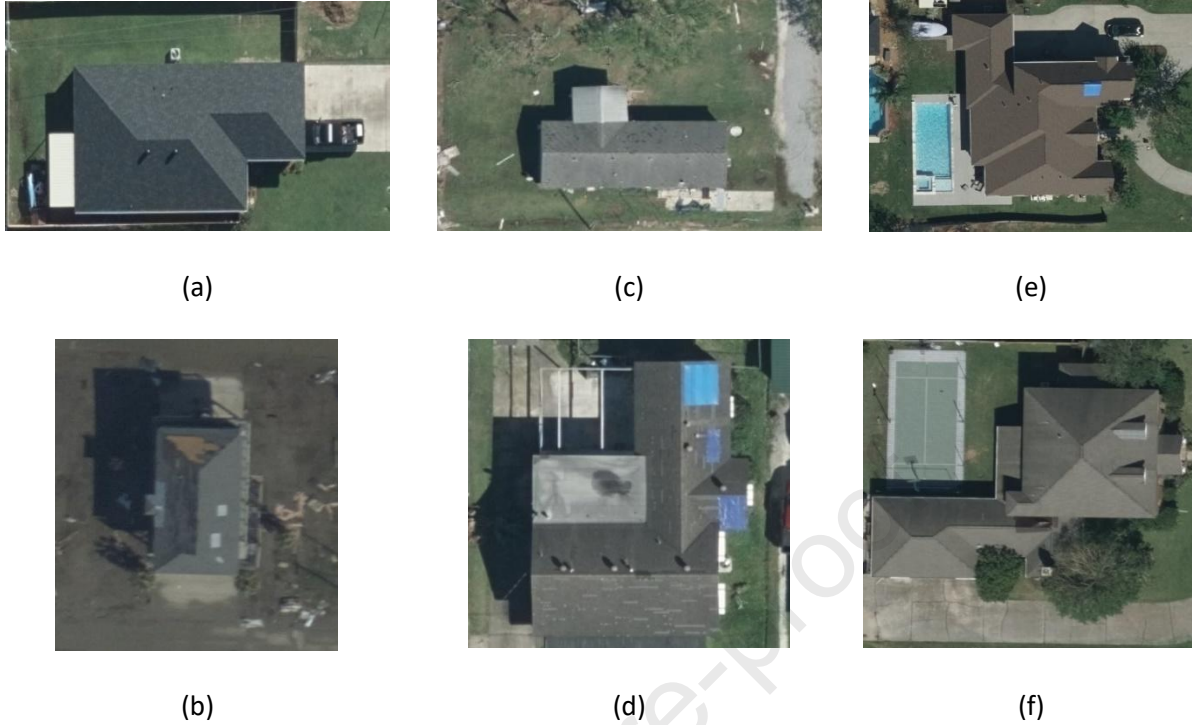
**Figure 4.** Examples of each roof shape. (a) and (b) are hip roofs, (c) and (d) are gable roofs, and (e) and (f) are complex roofs.

For all homes, the roof shape was determined from Zillow and aerial imagery and was categorized as hip, gable, or complex. The hip category consisted of homes with simple hip and hip and valley type roofs; the gable roofs were separated in the same manner. Within the complex roof category are the homes with both hip and gable features, as well as unique characteristics such as dormers and multi-level roofs. Figures 4(a) and 4(b) are representative of hip roofs, Figures 4(c) and 4(d) are representative of gable roofs, and Figures 4(e) and 4(f) are representative of complex roofs.

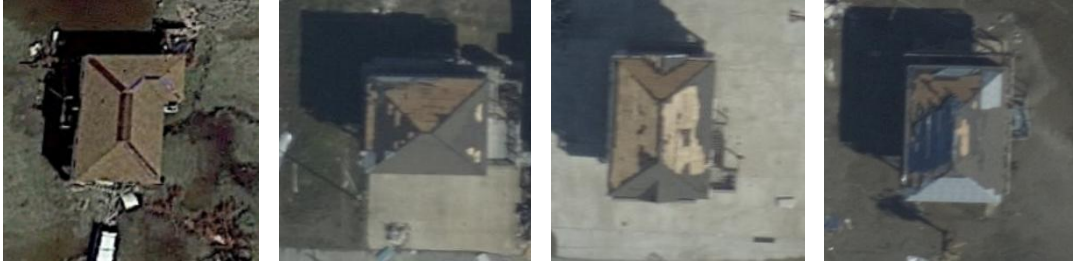
**Figure 6.** Examples of each roof cover damage state. From left to right:  $\leq 25\%$  damaged,  $>25\text{-}50\%$  damaged,  $>50\text{-}75\%$  damaged,  $>75\%$  damaged. Imagery obtained from NOAA aerial imagery.

The level of roof cover damage caused by Hurricane Laura was visually estimated for each home using the post-Hurricane Laura NOAA aerial imagery [22] following the methodology of [11]. Each home was classified with one of five roof cover damage severities: no damage,  $\leq 25\%$  damaged,  $>25-50\%$  damaged,  $>50-75\%$  damaged, or  $>75\%$  damaged. Examples of the damage categories (not including the ‘no damage’ category) are provided in Figure 6. The 25% interval in damage levels was used because it is consistent with the damage level approach used in previous remote sensing wind-damage studies [11,23,27] and because aerial imagery can support reliable classification into damage ranges rather than precise percentage estimates. The levels provide a repeatable visual scale for comparing relative roof cover damage severity across a large post-hurricane damage dataset.

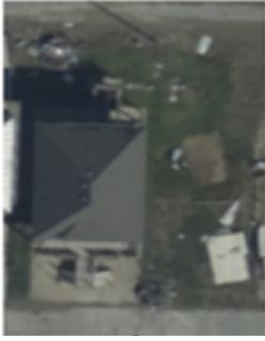
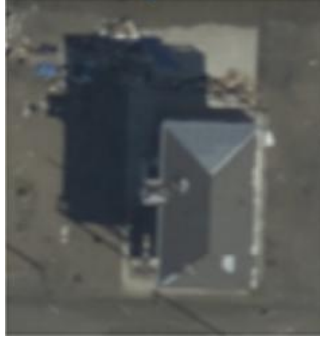
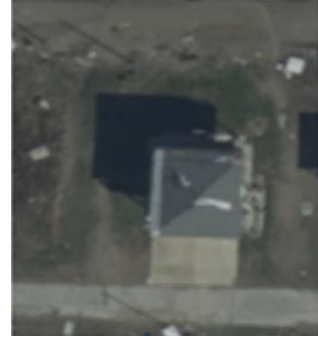
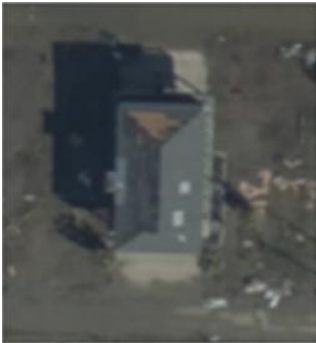
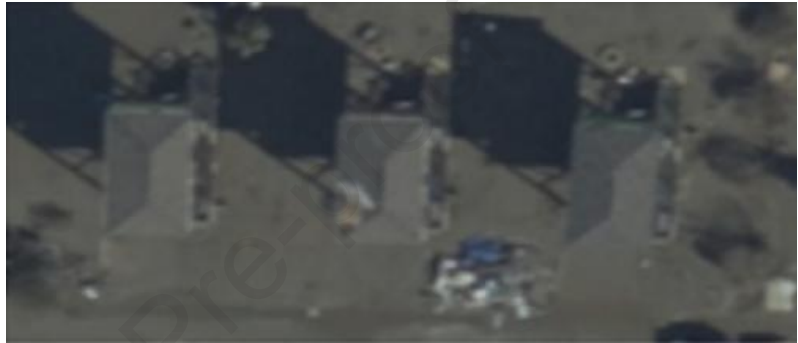
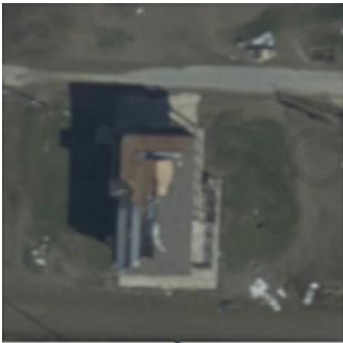
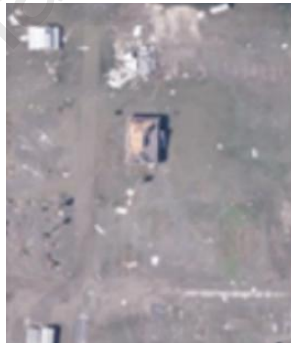
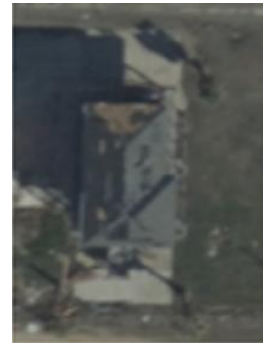
**Figure 7.** Examples of each roof cover damage state by roof age for homes in close proximity in Holly Beach, LA (coastal region). (a) Roof age: 2 years, (b) Roof age: 3 years, (c) Roof age: 5 years, (d) and (e) Roof age: 8 years, (f) Roof age: 10 years, (g) and (h) Roof age: 11 years.

A database was developed to record the location, roof cover age, estimated peak wind speed, and roof cover damage severity category, to allow for analysis. An example of roof cover damage by age in the coastal region of the dataset is shown in Figure 7, which illustrates the relative increase in visible roof cover damage with increasing roof cover age across an area with similar wind speeds. The percentages of homes in each roof age bin for a given roof cover damage level are shown in Table 1 and for homes with roofs older than one year in Figure 8 which includes all homes in the study.
