**NIST NCSTAR 1-1C**

**Federal Building and Fire Safety Investigation of the  
World Trade Center Disaster**

# **Maintenance and Modifications to Structural Systems**

David A. Fanella  
Arnaldo T. Derecho  
S. K. Ghosh

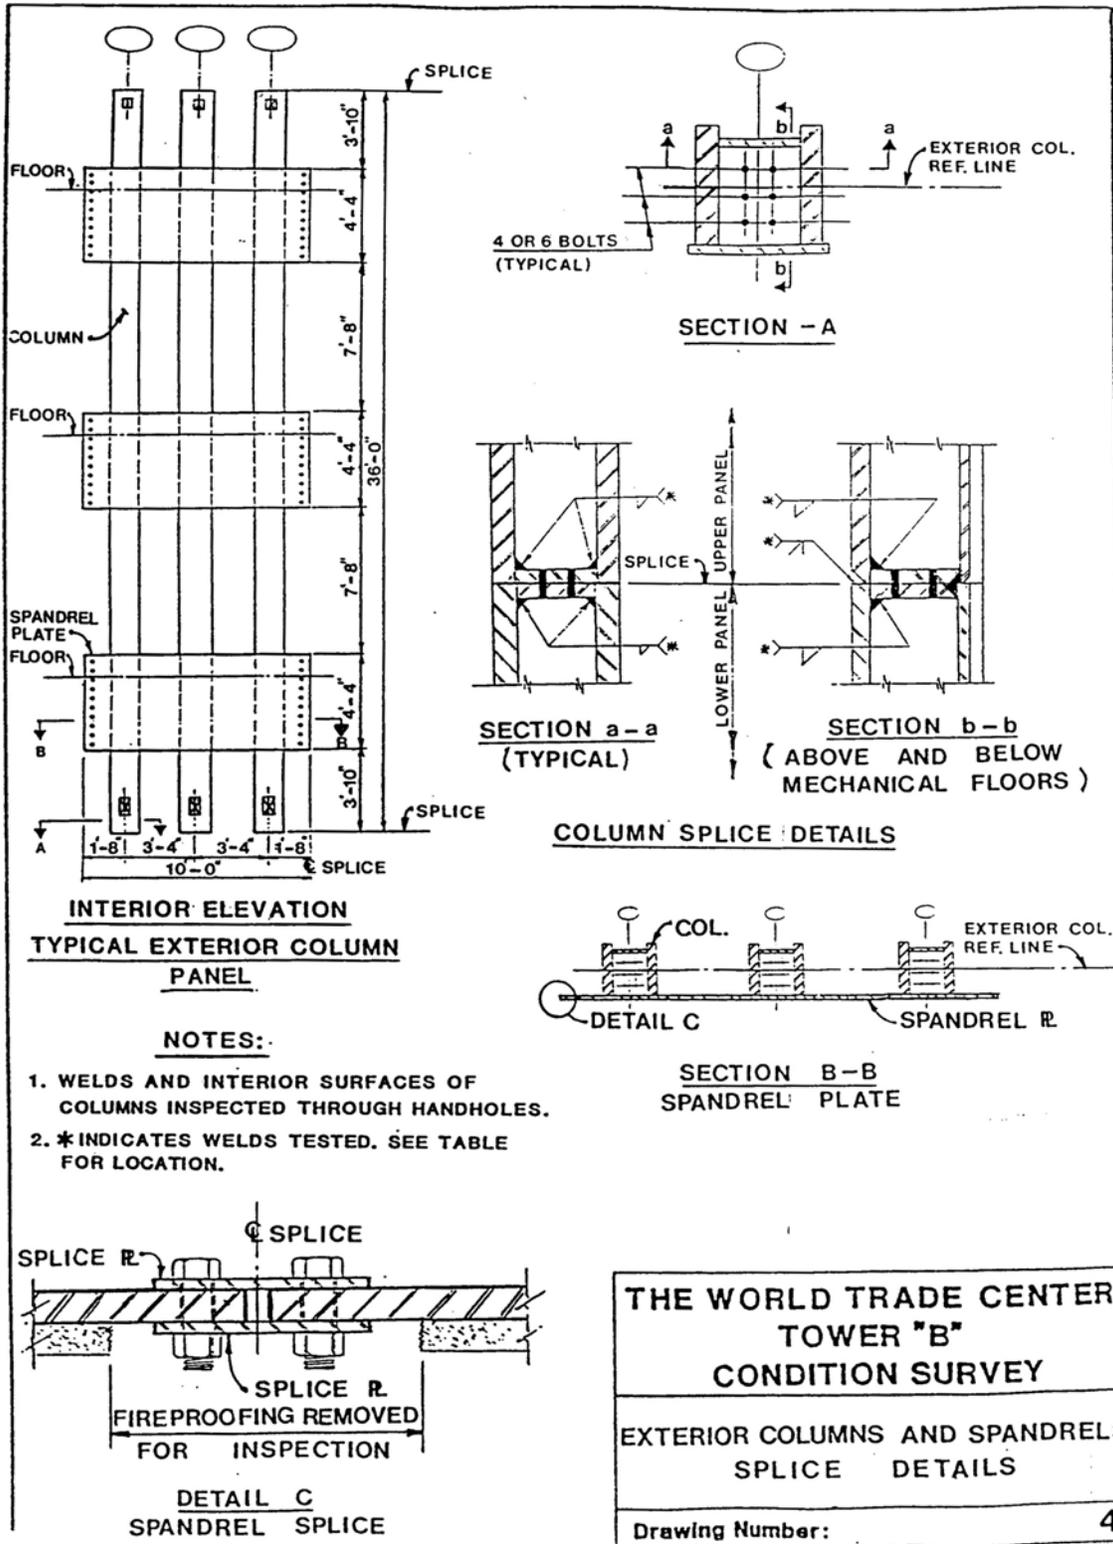
Figure 3-2. Splice details at typical inspection locations of exterior wall per the 1990 Condition Survey Report of WTC 2.
