NIST NCSTAR 1-3

**Federal Building and Fire Safety Investigation of the
World Trade Center Disaster**

Mechanical and Metallurgical Analysis of Structural Steel

September 2005

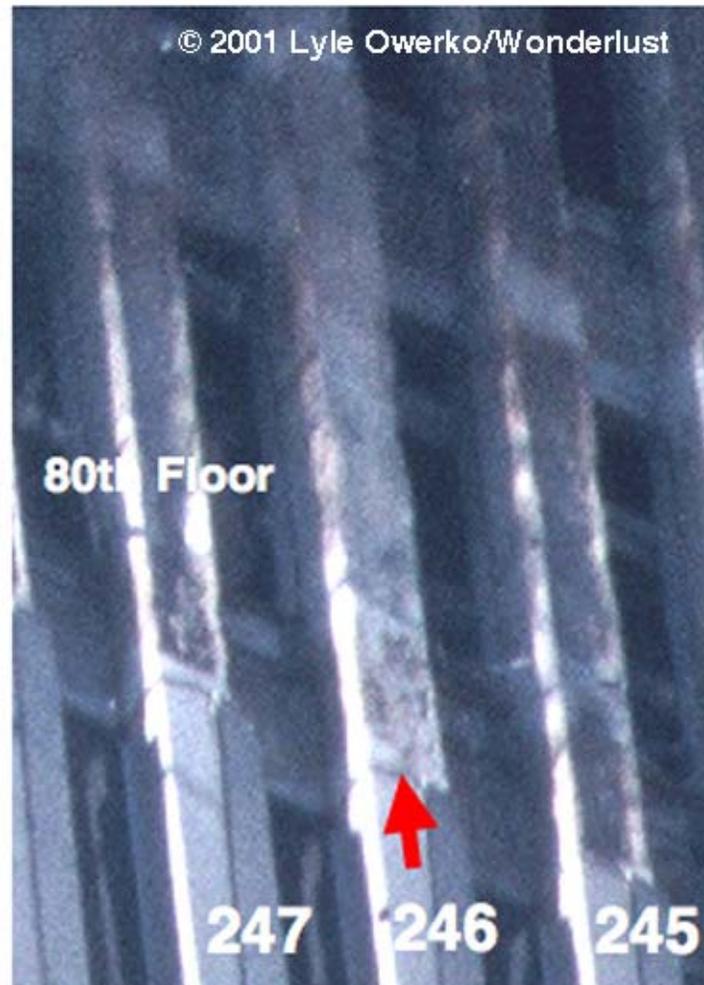
Figure 6–7. Fireproofing that had been applied to the exterior columns. The depression formed by the outer web and the flange tips are completely filled in with fireproofing at the arrow. North face of WTC 2.

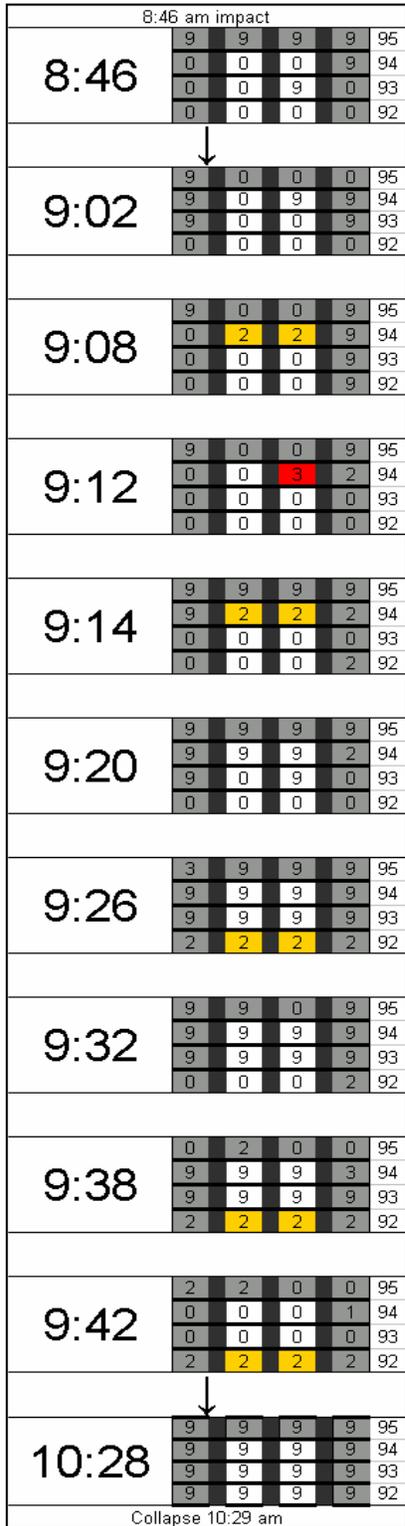
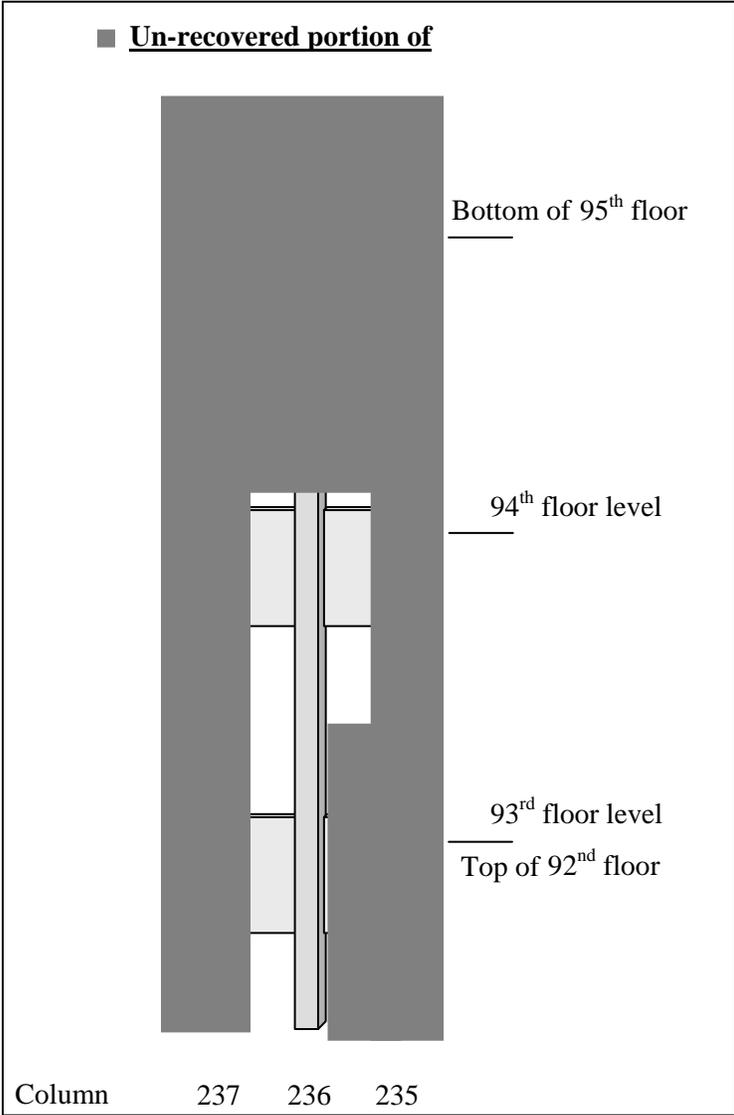
NIST Name: K-2
Panel ID: A236: 92-95
Panel location: WTC 1, East face

Figure 6–13. Time-fire exposure map for panel K-2 (A236: 92-95). Fire can be observed on the 92nd and 94th floors of the panel.

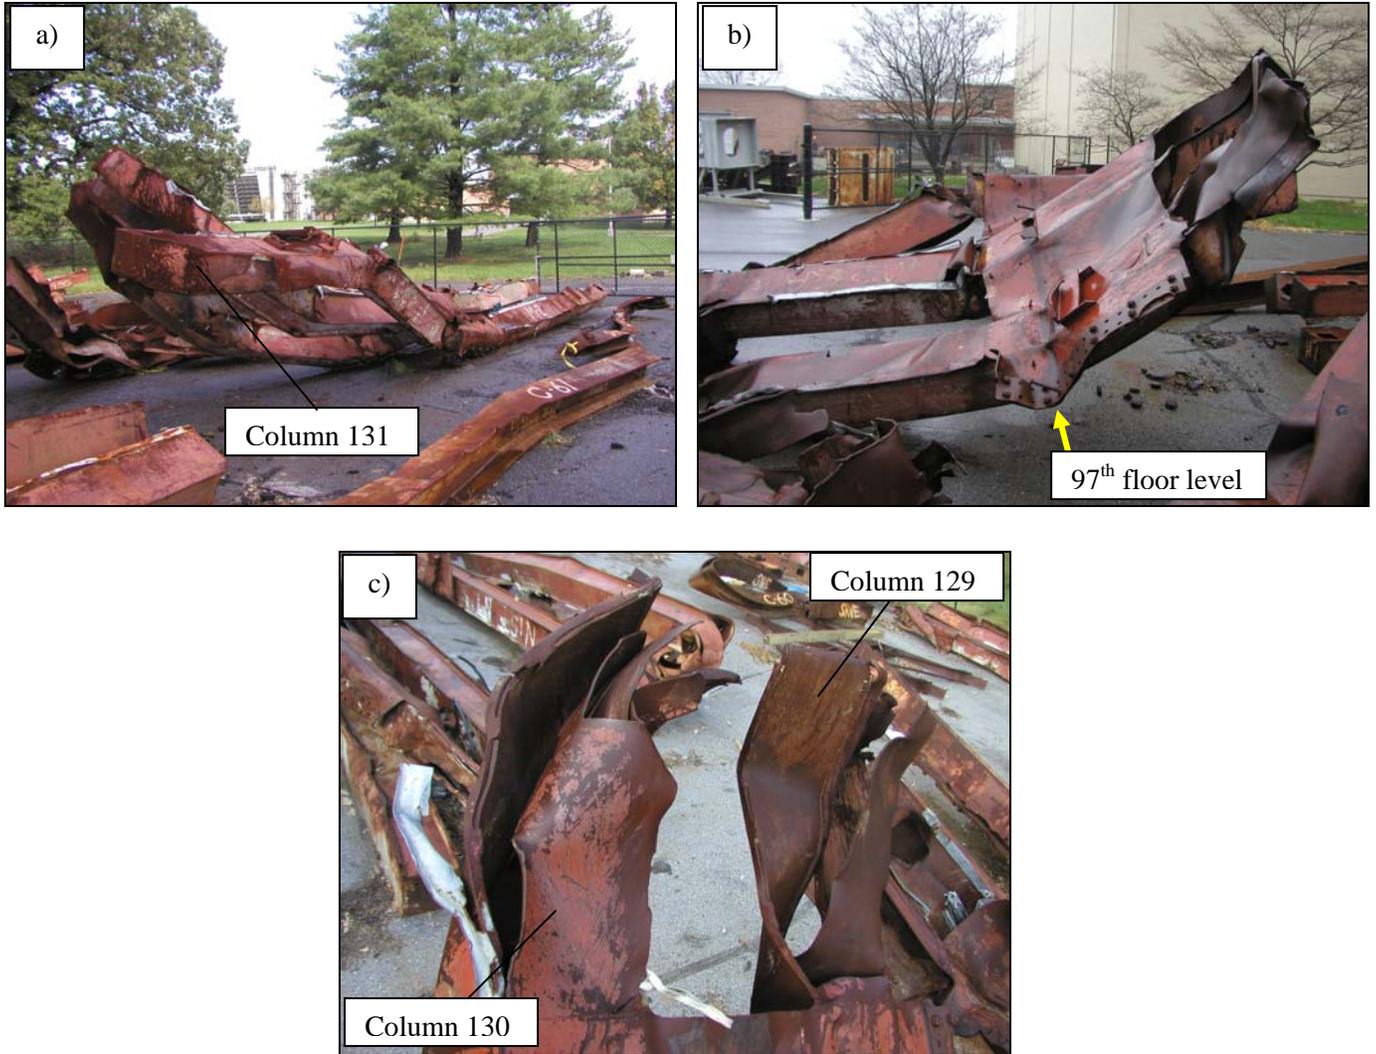
Damage to the lower portion of panel M-2 (WTC 1, column line 130, floors 96 to 99) was clearly associated with impact, which led to the missing endplates for columns 129 and 130. The inner and outer web plates of both columns have thinned in this area due to plastic deformation, Fig. 6-23a. The fracturing of the plates propagated as a 45 degree slant crack, oscillating between positive and negative 45 degrees with respect to the normal of the plate. The necking (thinning) of the outer web plate, plotted in Fig. 6-23b, indicates significant ductility, even at the high-strain rates associated with impact. Large buckles were observed on both flanges for columns 129 and 130 with some splitting occurring in the base material of the flanges (Figs. 6-24a and 6-24b) and spandrels (Fig. 6-24c). However, the welds found near this bending point remained intact (Fig. 6-24d).

Figure 6–22. a) Overall view of panel M-2 (A130: 94-97). Bottom of panel is on the left-hand side of the picture and the outside of the panel is facing down, b) major bend in panel located at the 97th floor level, and c) splayed bottoms of columns 129 and 130.

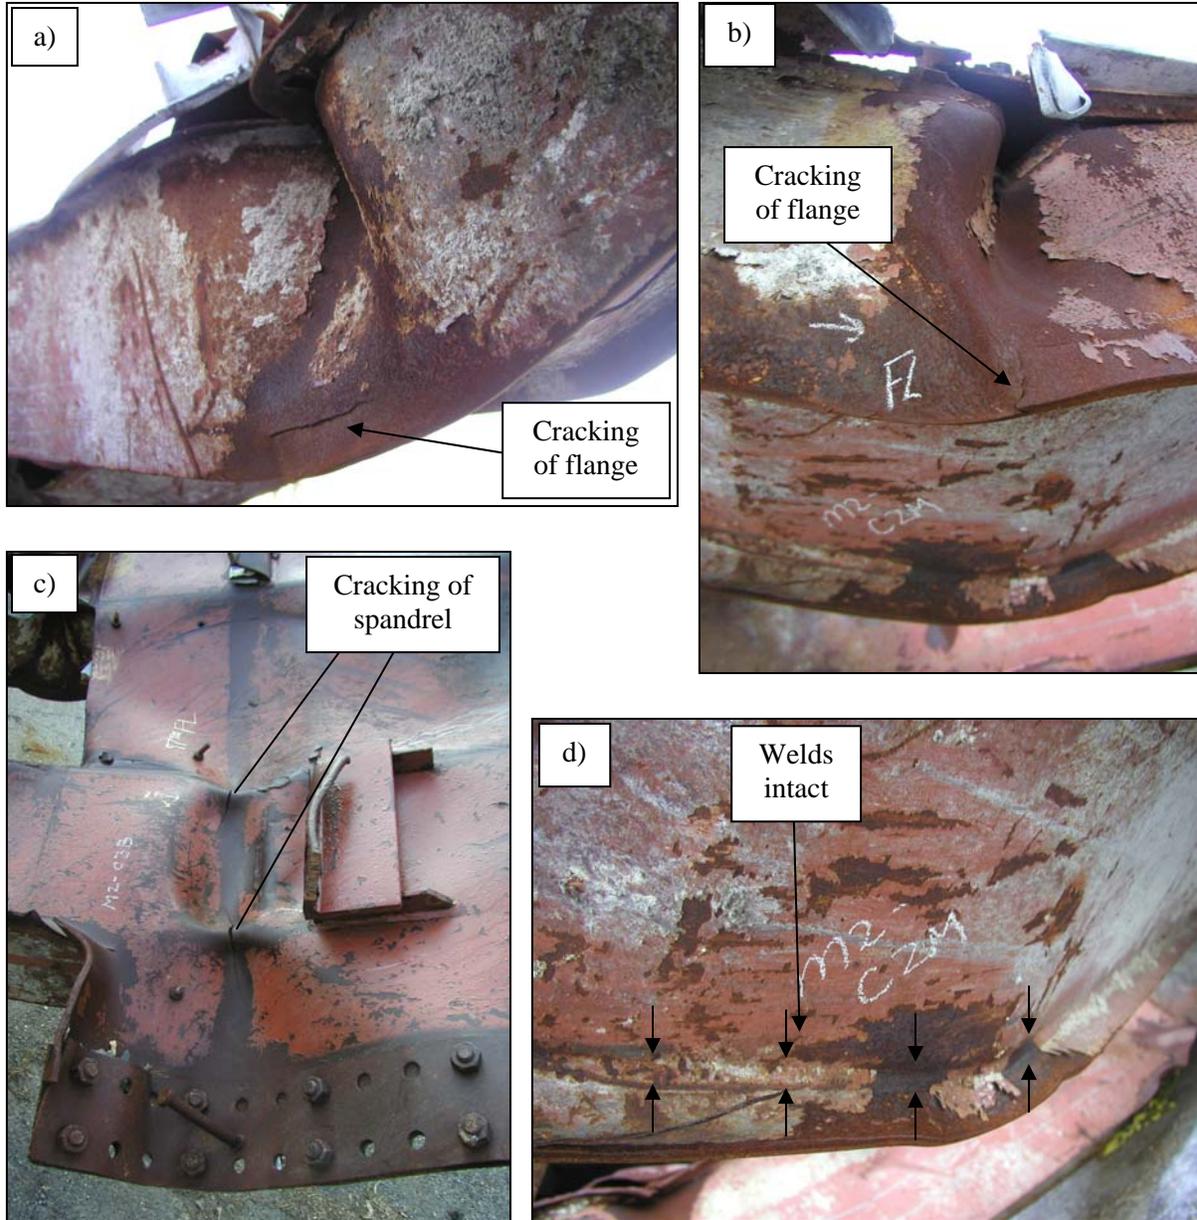
Figure 6–24. Damage images from sample M-2 (A130: 96-99). a) Large buckles observed on the flange plates of column 130, b) cracking of the flange plates on column 130, c) cracking of spandrel at 97th floor level, and d) no cracking of the welds in this area on column 130.

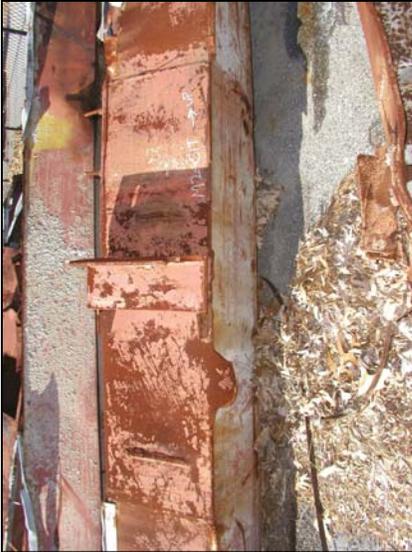
M2-C1T

Column 131, 99th floor

Failure mode: Type 4a, fracture of spandrel

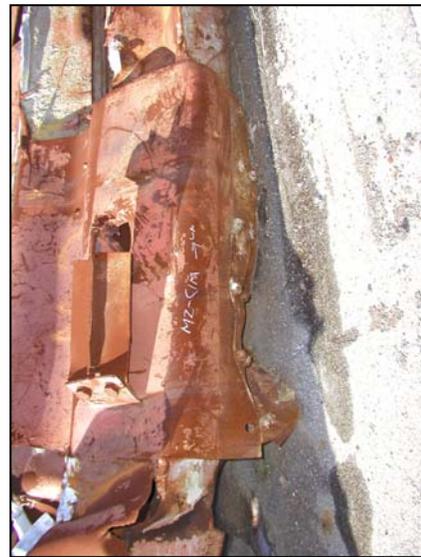
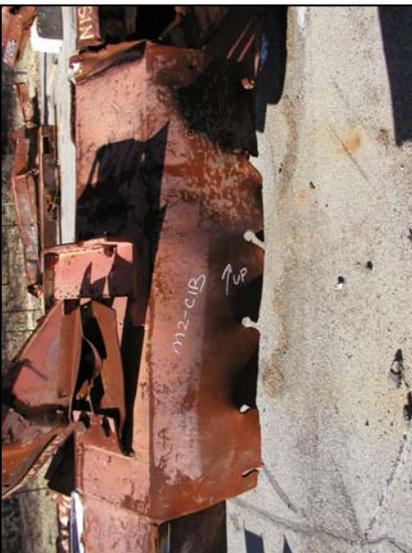
M2-C1B

As the entire panel M-2 (A130: 96-99) was recovered, all six spandrel connections were available for inspection. From pre-collapse photographs, it appears that both connections located on floor 97 failed upon impact of the airplane. Both failures were associated with tearing of the bolt holes (Fig. 6–25); the connection associated with column 131 had bolt hole tear out, and the connection nearest column 129 still retained the splice plate without the neighboring spandrel plate. The connections associated with floor 99 appeared intact, and failure may have occurred upon collapse. Those connections located on the 98th floor were obstructed by smoke, and the condition could not be determined prior to collapse. Their failures were associated with bolt hole failure, as well as fracture of the spandrel plate.

Column 131, 97th floor

Failure mode: Type 1a, bolt hole tear out

Figure 6–25. Photographs of recovered spandrel connections from sample M-2 (A130: 96-99).

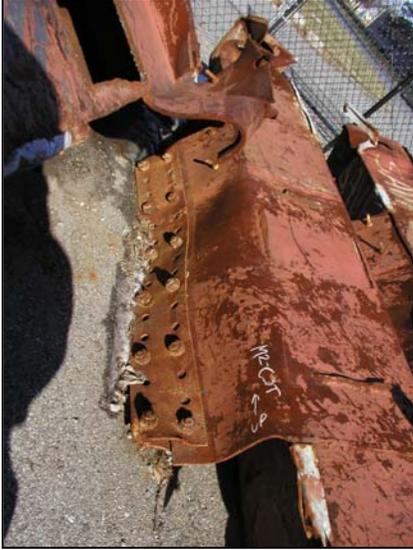
M2-C3T

Column 129, 99th floor

Failure mode: Type 1b, bolt hole tear out

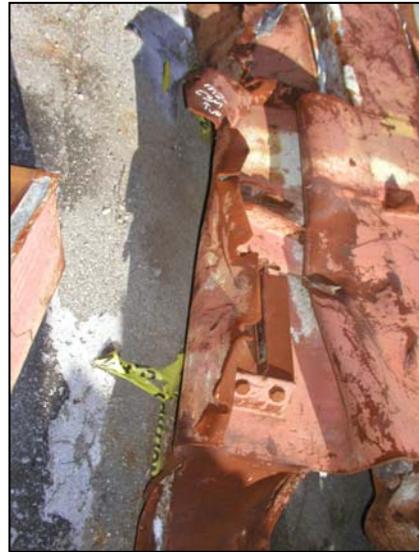
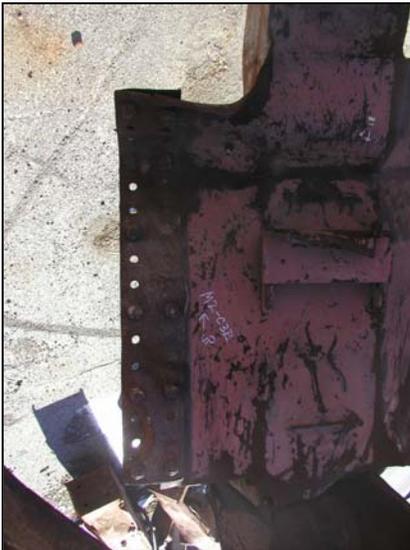
M2-C3B

Column 129, 97th floor

Failure mode: Type 1b, bolt hole tear out

Figure 6–25. Photographs of recovered spandrel connections from sample M-2 (A130: 96-99) (continued).

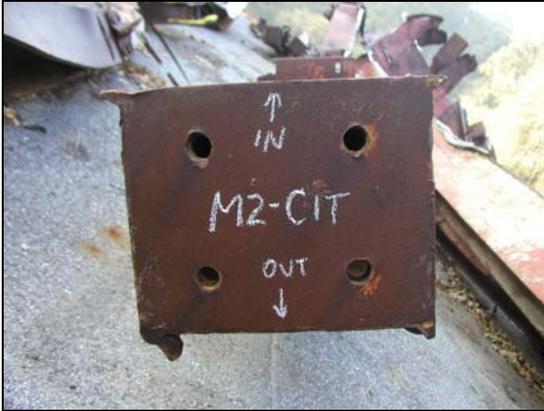
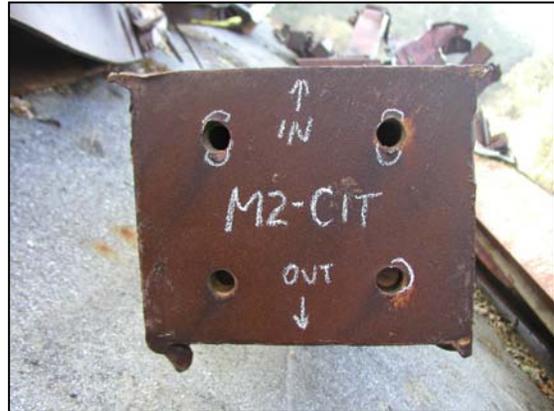
M2-C1T
WTC1
Col 131
F1 99

Figure 6–26. Photographs of recovered end plate connections from sample M-2 (A127: 97-100). Both ends of column 131 had bolt failure that resulted in deformation of the bolt holes in the end plates.

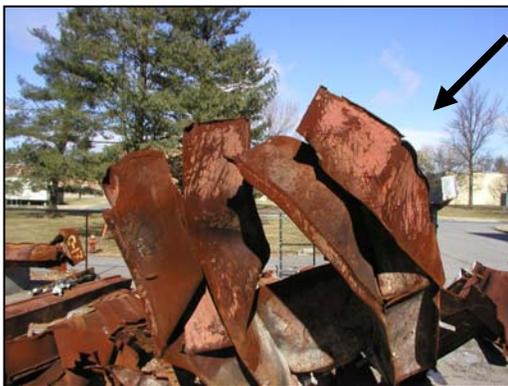
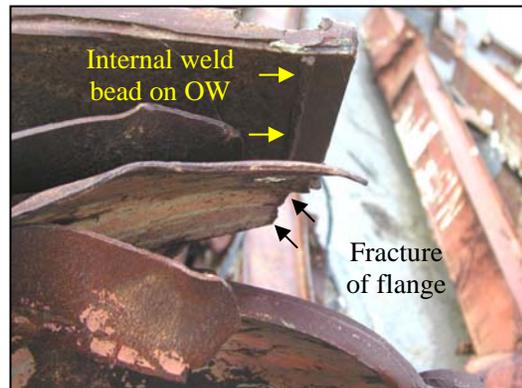
M2-C2B
WTC1
Col 130
F1 96

The state of the recovered bottom portion of columns 129 and 130 was nearly identical to the condition after the impact for panel M-2 (A130: 96-99). Both end plates were ripped completely out of the column, Fig. 6–26. Failure was a mixture of fracture in the base plates (portion of the flange/web still attached to the end plate) and clean separation of the end plate from the flange/web (complete flange/web recovered with internal weld bead visible). Bolt hole deformation for column 131 indicated that the connection was broken by bending inward of the lower column of the connection. Finally, while bolt failure was observed at the 99th floor splice of column 129, it can be noted that some separation existed between the flange plates of the column and the endplate.

Figure 6–26. Photographs of recovered end plate connections from sample M-2 (A127: 97-100). The upper end plate experienced bolt hole failure. The bottom end plate of column 130 was ripped out upon impact of the airplane. Failure was found to be a mixture of fracture in the base plates (portion of the flange/web still attached to the end plate) and clean separation of the end plate from the flange/web (complete flange/web recovered with internal weld bead visible) (continued).

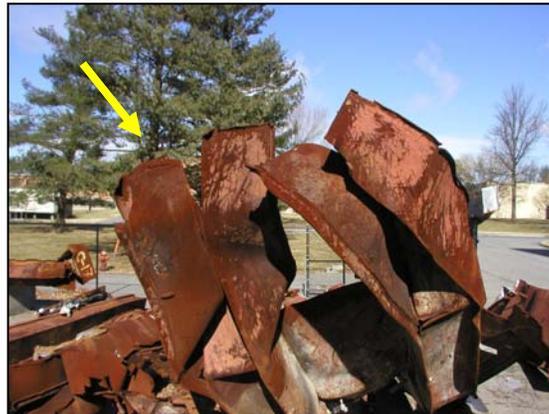
M2-C3B
WTC1
Col 129
F1 96

Separation between flange plates and butt plate

Figure 6–26. Photographs of recovered end plate connections from sample M-2 (A127: 97-100). The upper end plate experienced bolt hole failure. The bottom end plate of column 129 was also ripped out upon impact of the airplane. Failure was found to be a mixture of fracture in the base plates (portion of the flange/web still attached to the end plate) and clean separation of the end plate from the flange/web (complete flange/web recovered with internal weld bead visible) (continued).

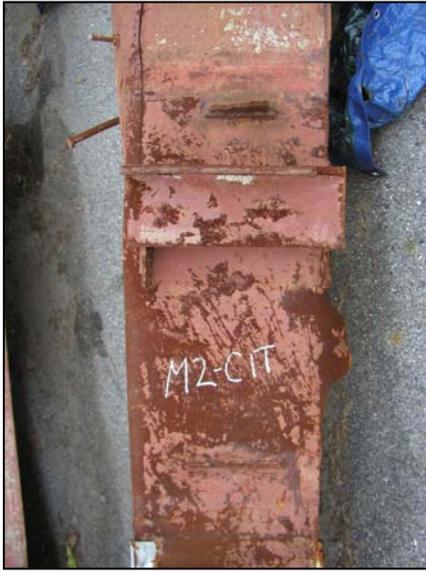
M2-C1T (Co 131, Fl 99)

1 standoff plate remains, seat and other standoff plate ripped off at welds;

Gusset plate with damper unit intact, bent up.

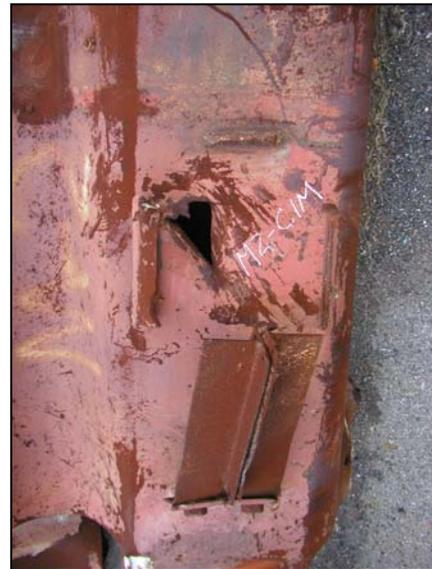
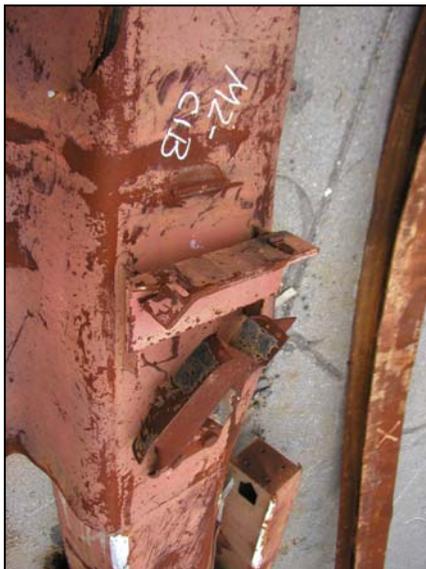
M2-C1B (Co 131, Fl 97)

Panel M-2 (A130: 96-99), Fig. 6–27, is shown as an example of perimeter wall truss connections. Of the six truss seats on the panel, four were damaged but intact (e.g., bending up/down, bolt hole failure), and the other two were completely ripped off of the column. The center column of this panel also had three gusset plates, used to anchor diagonal bracing straps to provide horizontal shear transfer between the floor slab and exterior wall, as well as out-of-plane bracing for the perimeter columns not directly supporting the floor trusses. Only portions of the gusset plates remained on the middle column of the panel with the diagonal bracing straps ripped from these plates.

Figure 6–27. Floor truss connectors for panel M-2 (A130: 96-99).

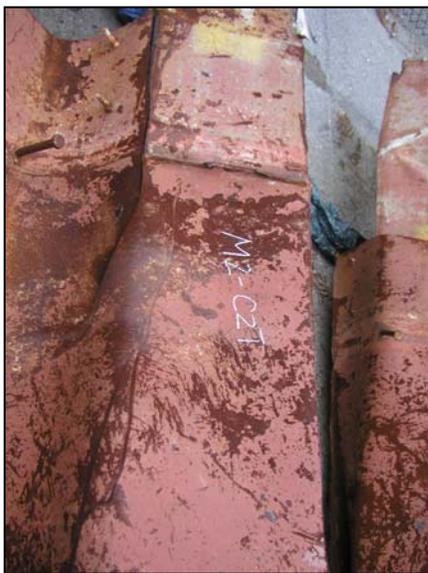
M2-C2T (Co 130, F1 99)
Type C
Seat Detail: 5210
Tab plate ripped off at weld.

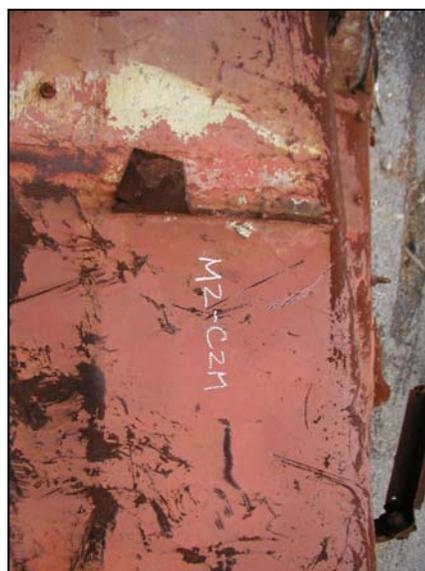
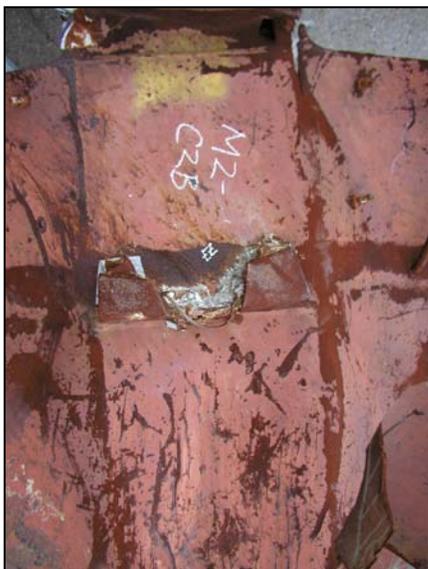
M2-C2M (Co 130, F1 98)
Type C
Seat Detail: 5210
Portion of tab plate remains, bent up.

M2-C2B (Co 130, 97)
Type C
Seat Detail: 5210
Tab plate remains, bent up.

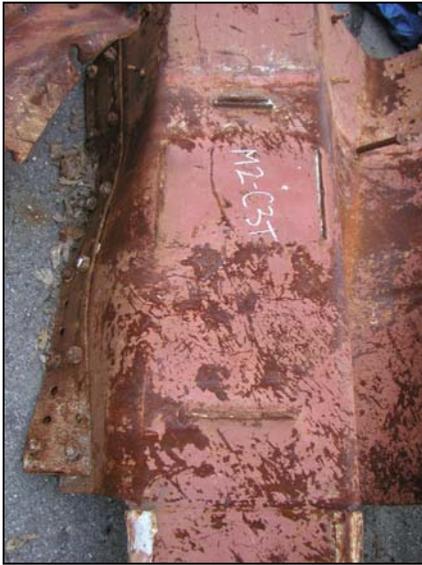
M2-C3T (Co 129, FI 99)
Type A
Seat Detail: 1411
Tab plate ripped off at weld;
Standoff plates ripped off at welds;

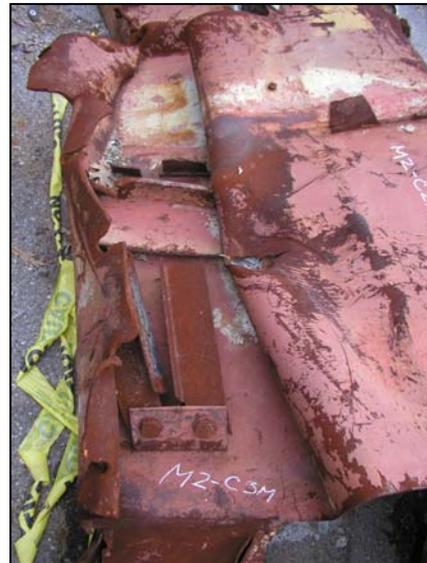
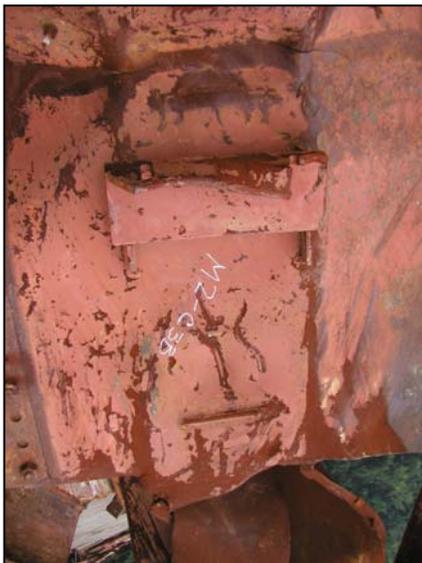
M2-C3B (Co 129, FI 97)

M2-C3M (Co 129, FI 98)

Type A
Seat Detail: 1411
Tab plate remains;
Seat intact, bent down, 1 bolt hole remains intact with bolt, other ripped out;

Type A
Seat Detail: 1411
Tab plate ripped off at weld;
Seat intact, bent down, 1 bolt hole remains intact, other ripped out;

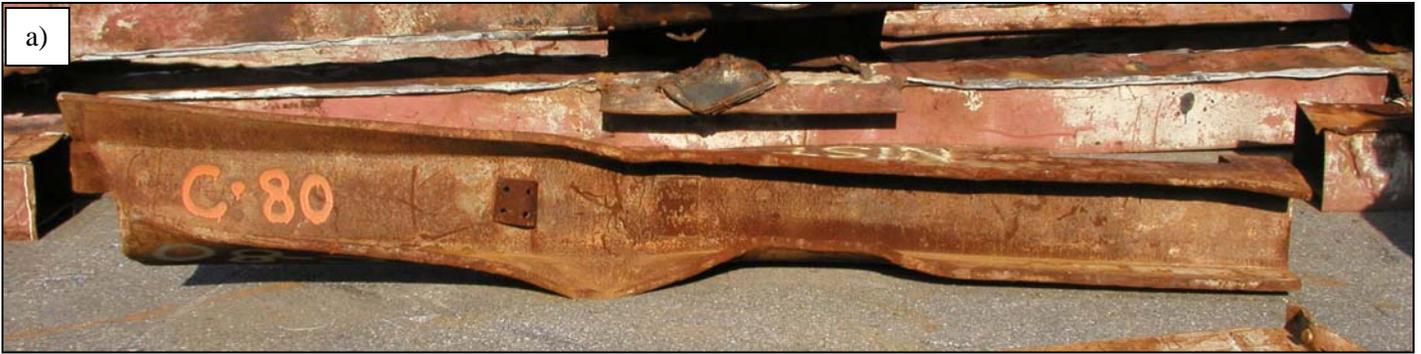
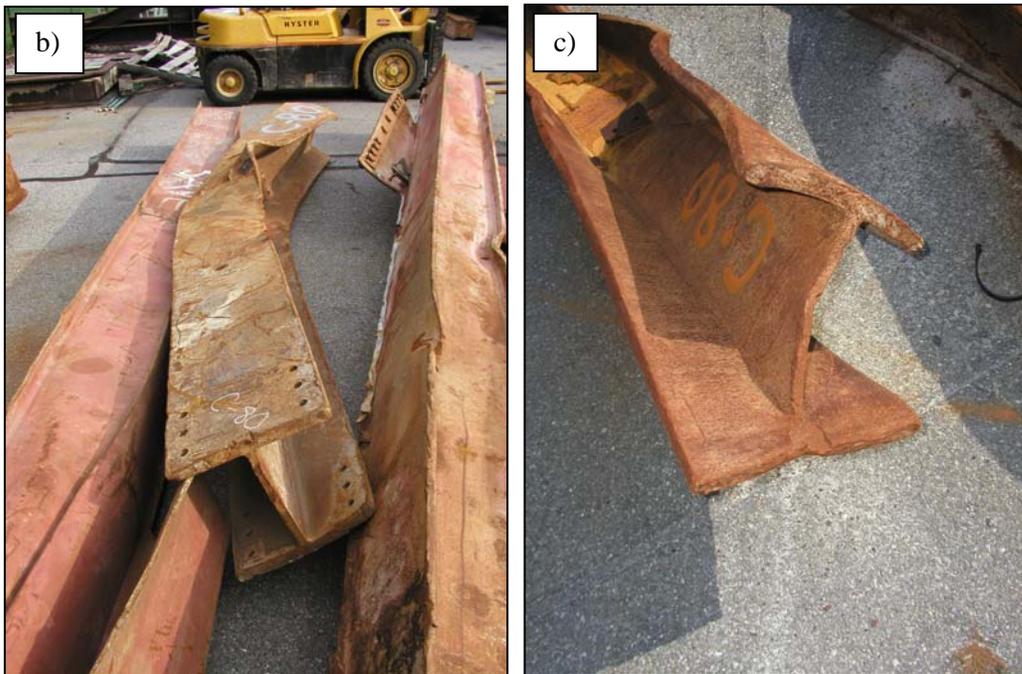
Sample C-80 (Fig. 6–30a), from WTC 1, was a 36 ksi wide-flange located in the middle of the second row of core columns along the north face. Only the lower third of the column was recovered (approximately 13 ft). The location of the column indicated that it did not sustain impact damage. Consistent with the column’s position, modeling results indicated that this column was not in the path of the aircraft debris (NIST NCSTAR 1-2). Different failure modes were observed for each end (Figs. 6–30b and 6–30c). Bolt fracture occurred at the lower portion of the column (92nd floor region), while the upper portion of the wide-flange was torn through its section (near the 93rd floor region). No visible necking (localized reduction in area) was observed in the immediate vicinity of the fracture.

Figure 6–30. Core column C-80 (603A: 92-95). a) Overall view of recovered column, b) view of connection in the 92nd floor region, failure as a result of bolt fracture, and c) torn end of column near the 94th floor region.

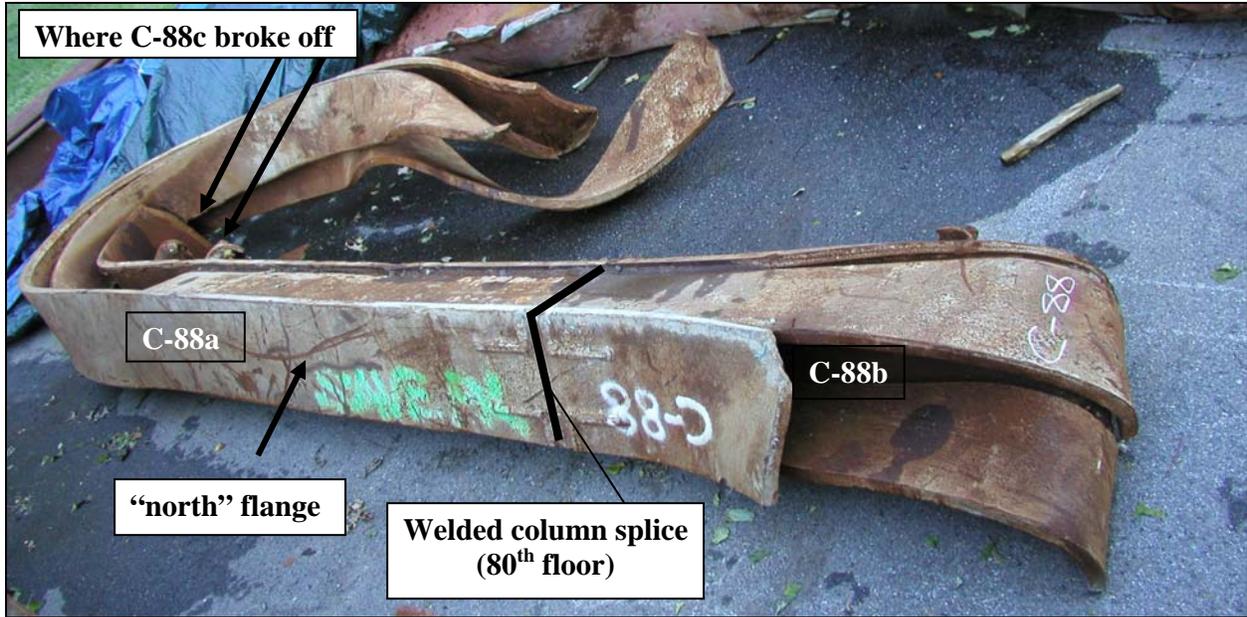
Core columns C-88a and C-88b, from WTC 2, were unique among the recovered core elements in that the columns were still connected at the welded column splice, Fig. 6–31. Both columns were 42 ksi built-up box columns with their shared splice in the 80th floor level. The lower 16 ft of C-88a was recovered (floors 80 through 82), whereas the upper 8 ft of C-88b was still attached (primarily within the 80th floor). The location of the column C-88b suggested that impact damage may have been sustained. Both webs and the “south” flange were severely bent to the east and had flame cut ends, Fig. 6–32. The bends occurred just below the connector for the channel associated with the 80th floor. The “north”

Figure 6–31. Overall view of recovered core columns C-88a (801B: 80-83) and C-88b (801B: 77-80).

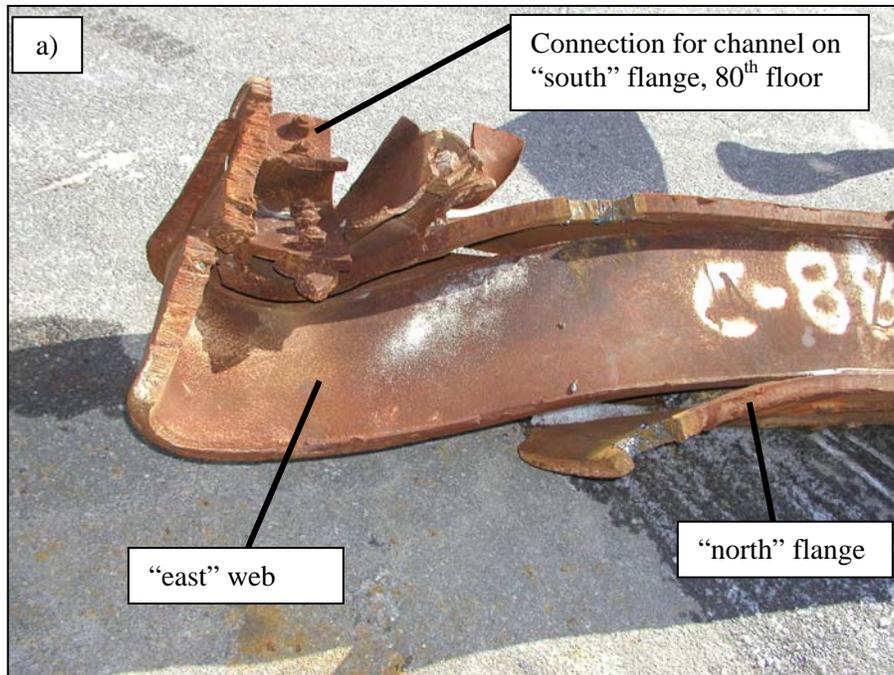
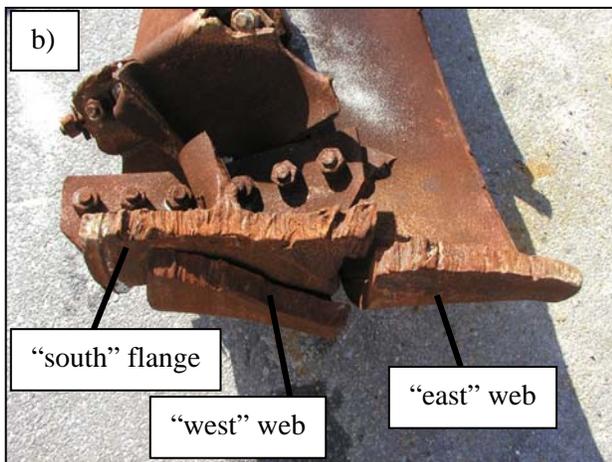
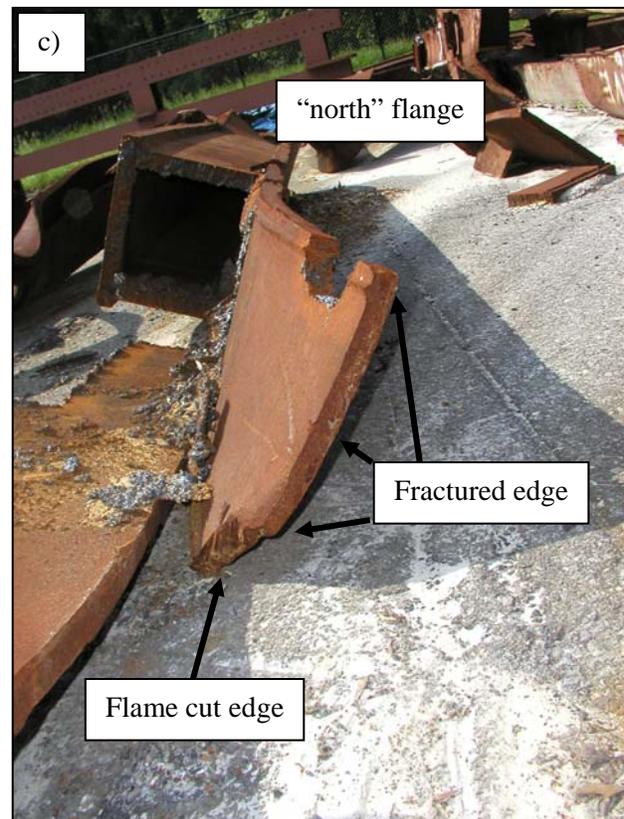
Figure 6–32. Damage associated with core column C-88b (801B: 77-80). a) Overall view of failed end, b) bottoms of “south” flange and both webs bent towards the east just below the 80th floor level, ends were flame cut, and c) “north” flange bent towards the north, majority of plate was fractured with some flame cutting.

flange had a less significant bend toward the north, with approximately 80 percent of the failed end of the plate as a fracture. There was no visible necking of the plate in the area of failure, with the remaining portion of the plate having been flame cut during the recovery effort. This flange was fractured roughly 2 ft below the splice in the 80th floor level. The fracture surfaces were too corroded for analysis. It was believed that the damage of the south flange and the two webs occurred during collapse of the building as the direction of bending was not consistent with the travel of the airplane. However, the damage to the north flange may have been a result of impact damage, as the severity and location of the plate failure was different from the other three plates of the column, and the direction of the bend was consistent with the travel of the airplane. The baseline analysis of the damage model indicated that this core column was not damaged as a result of the impact (NIST NCSTAR 1-2). However, another analysis with parameters set to increase the amount of damage indicated that impact damage was sustained. Core column C-88a did not sustain impact damage as (1) the damage (81st floor level) was above the floors of impact in this region (79th floor level), (2) the columns were bent downward indicating overloading of the column from above, and (3) the bending direction of the plates was opposite to the direction of the travel of the plane. This is also consistent with the modeling results (NIST NCSTAR 1-2).

Core column C-88b (801B: 77-80) may have sustained damage as a result of the airplane impact; however, the welded splice to the column above survived intact.

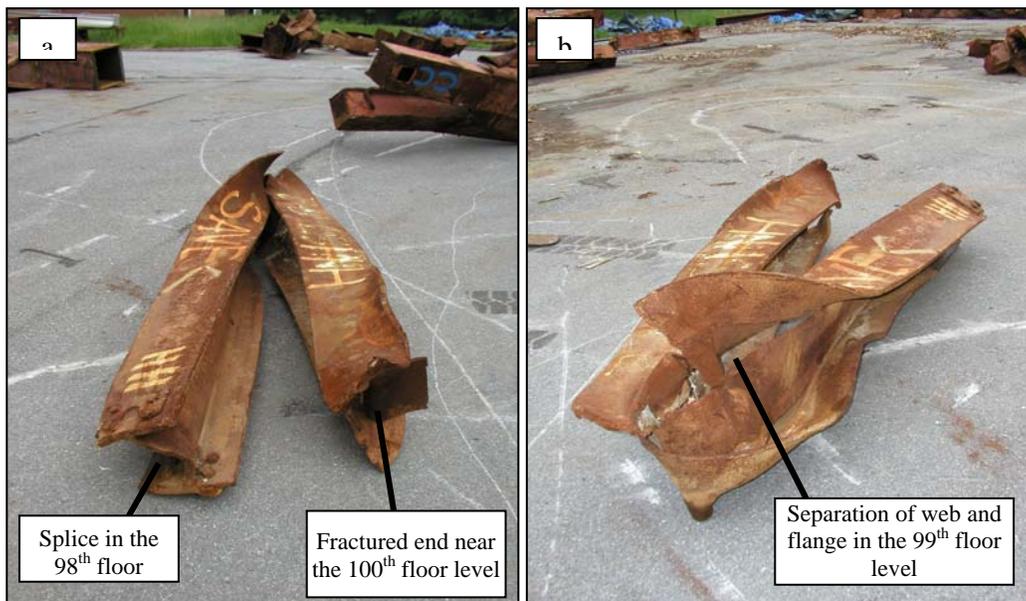
Aside from the three columns discussed above, only one other core column was recovered from within the fire region. Sample HH from WTC 1, Fig. 6–33, was a 42 ksi wide-flange positioned near the middle of the second row of core columns along the north face. The bottom half of the column was recovered (approximately 16 ft). The location of the column was such that damage could not have occurred during the impact. This was corroborated by the modeling results that indicated the core column was not hit during the impact (NIST NCSTAR 1-2). The failure mode of each end was different (Fig. 6–33a). Fracture of the plates used in the bolted connection occurred at the lower portion of the column (98th floor region), while the upper portion was torn through the material (100th floor region). Additionally, the sample was nearly bent in half (99th floor region), with complete fracture of one flange. Figure 6–33b shows that the flanges have become separated from the web in the region of the bend.

Figure 6–33. Core column HH (605A: 98-101). a) Fracture at both ends and b) separation between flange and web in the 99th floor region.

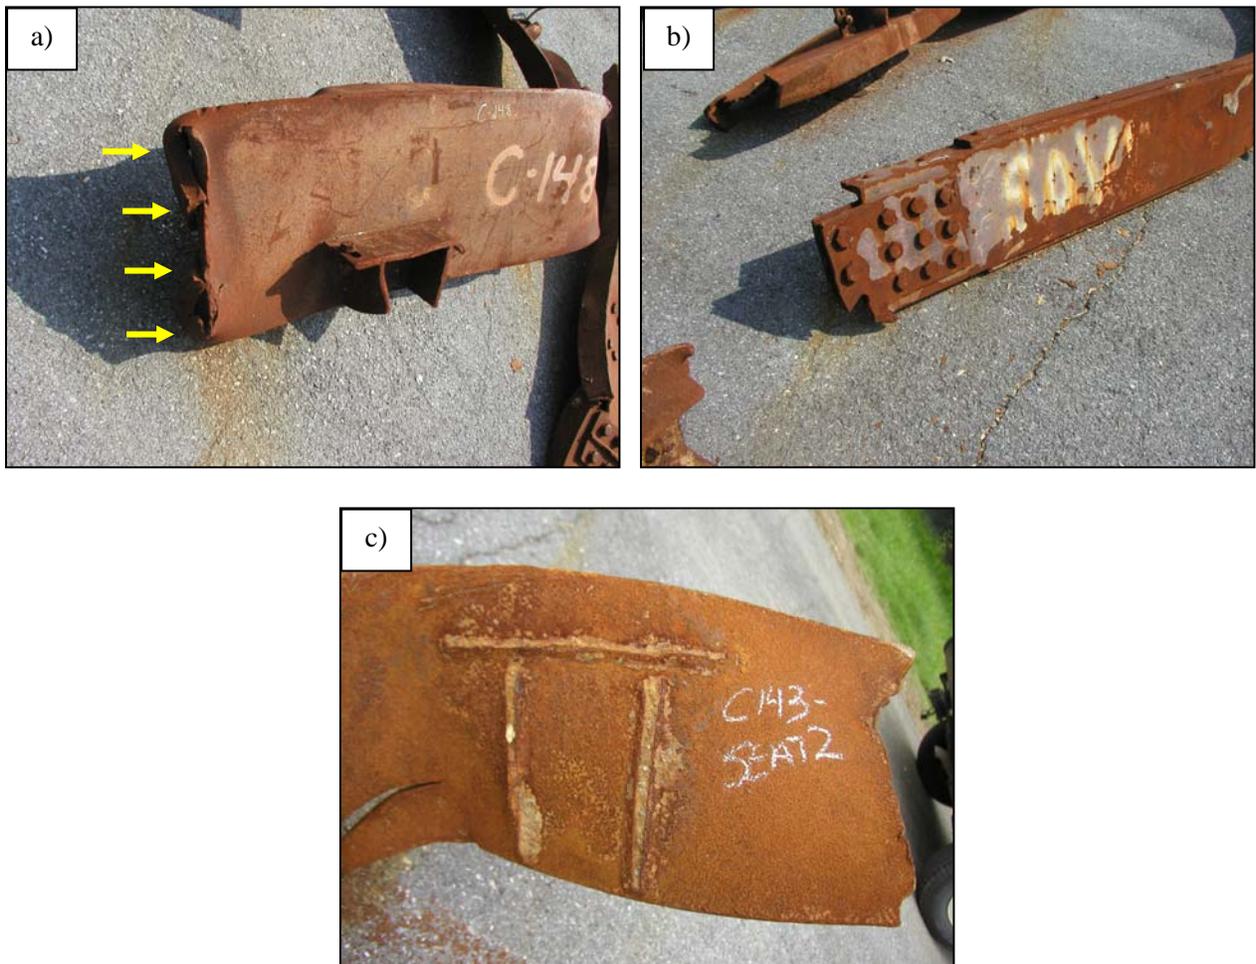
An analysis was conducted to evaluate the failure modes of the recovered channel material and the condition of the core truss seats. Of the 24 channels used to support the floor trusses, half failed at both ends within the channel itself, Fig. 6–34a, while the others failed at one or both of the end connectors, Fig. 6–34b. Twenty-one pieces of channel had seats or remnants of seats attached. Over 90 percent of the seats (31 total) were still intact with the majority of these somewhat deformed. Only two seats had been ripped completely from the channel at the welded joint between the seat and the channel, as shown in Fig. 6–34c. Half of the retained seats were observed to have both bolt holes still intact, while the other half had at least one bolt hole ripped out.

Figure 6–34. Failure modes of core channels. a) Fracture through channel as indicated by arrows, b) failure associated with end connector, and c) seat ripped off at welded connection to channel.

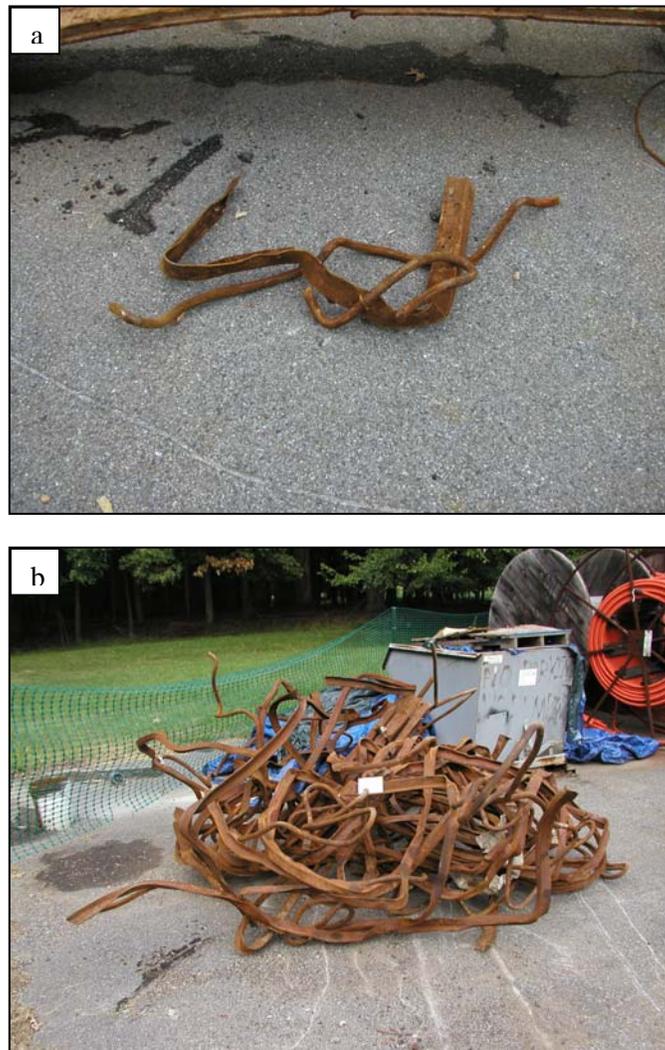
Samples received at NIST were either small sections (less than 3 ft to 4 ft in length) of chord and rod material (Fig. 6–35a) or large, entangled masses in the form seen in Fig. 6–35b. According to Structural Engineers Association of New York (SEAoNY) volunteer members involved in the recovery effort, it was necessary to “ball up” any truss pieces of significant size to facilitate removal from the WTC site and subsequent handling in the recovery yards. This was necessary since the primary and bridging trusses for a given floor were welded together into huge grids. During the collapse, these lightweight floor sections were severely damaged and could not be easily removed. Thus, it is unknown when specific damage features occurred. Further, it is likely that sections of multiple trusses were “balled” together and labeled as a single unit rather than that NIST labeled samples consisting of just one pre-fabricated truss unit.

Figure 6–35. Examples of recovered floor truss material. a) Small sections of rod and chord (sample C-53) and b) “balled-up” sections of rod and chord (C-137f).

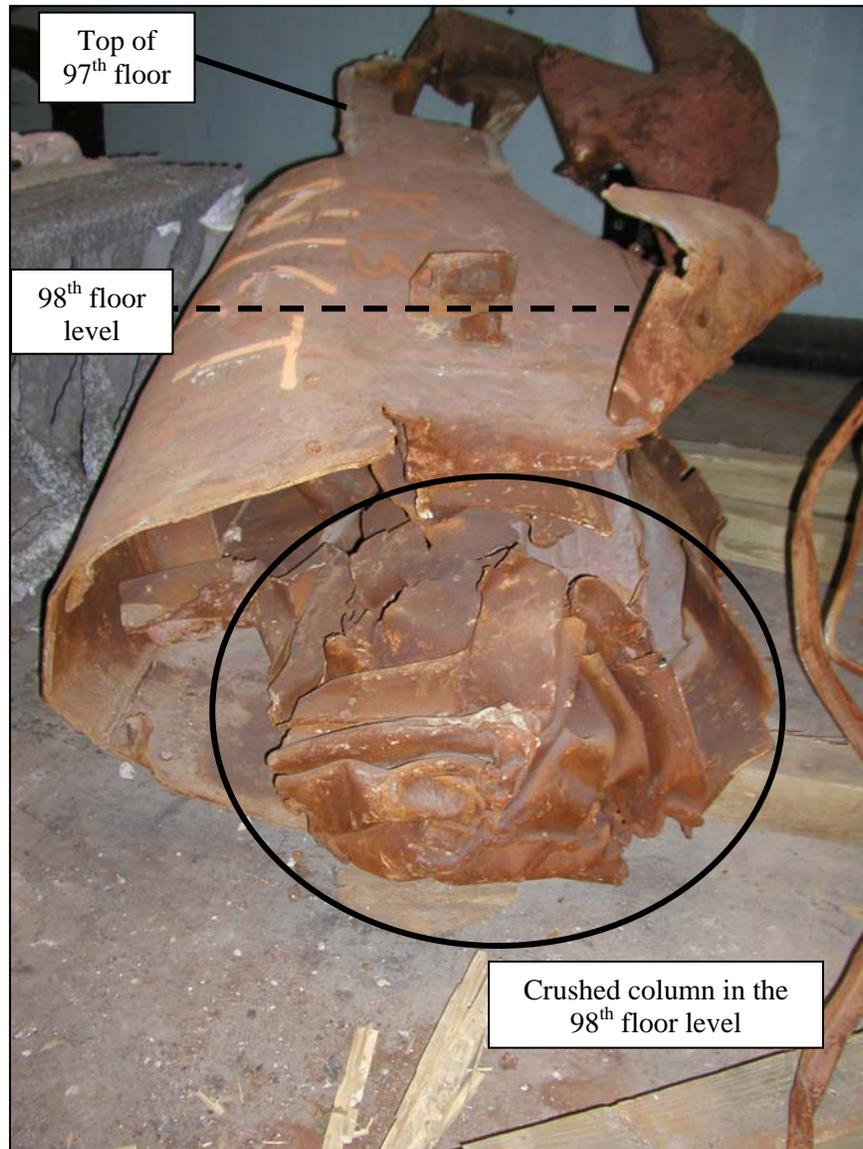
1. Panel K-1, WTC 1, column 210, flange and inner web of 98th floor region. Prior to the collapse of WTC 1, the panel was observed to have experienced varying degrees of fire exposure for a minimum of 31 cumulative minutes in this area. A unique feature of this panel is that the upper portion of the column was crushed while generally maintaining concentric axial alignment with the lower portion of the column, Fig. 6–36. This suggests that deformation occurred at the onset of collapse, while the lower portion of the column was still constrained due to the bolted splice (endplates).

Figure 6–36. Crushed portion of column 210 in the area of the 98th floor (from sample K-1, A209: 97-100). Paint had mud cracking characteristic in this region.

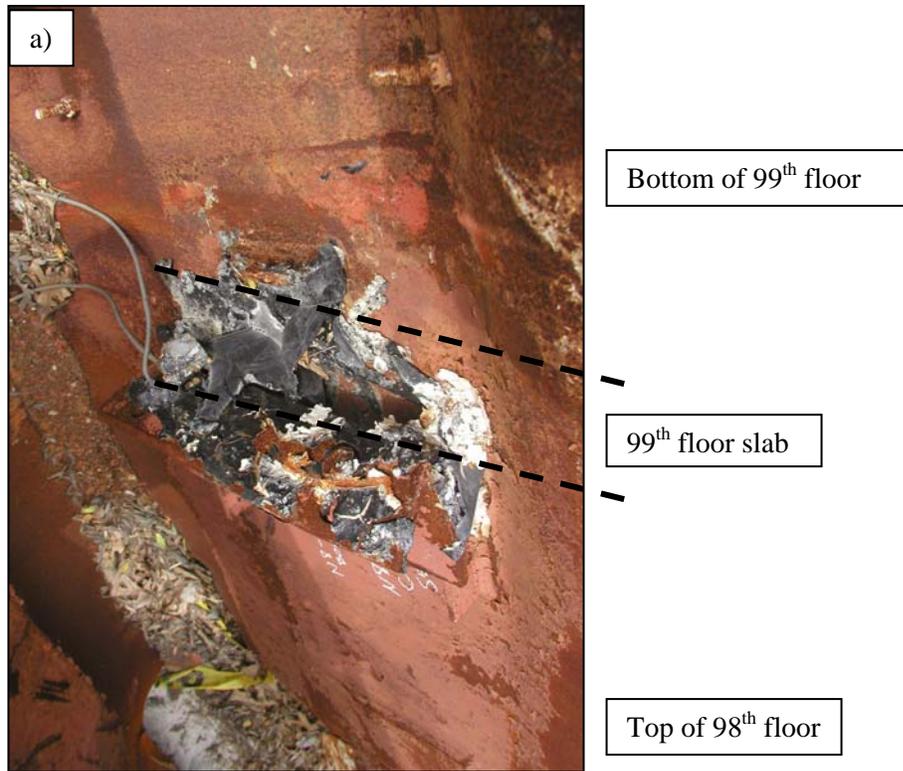
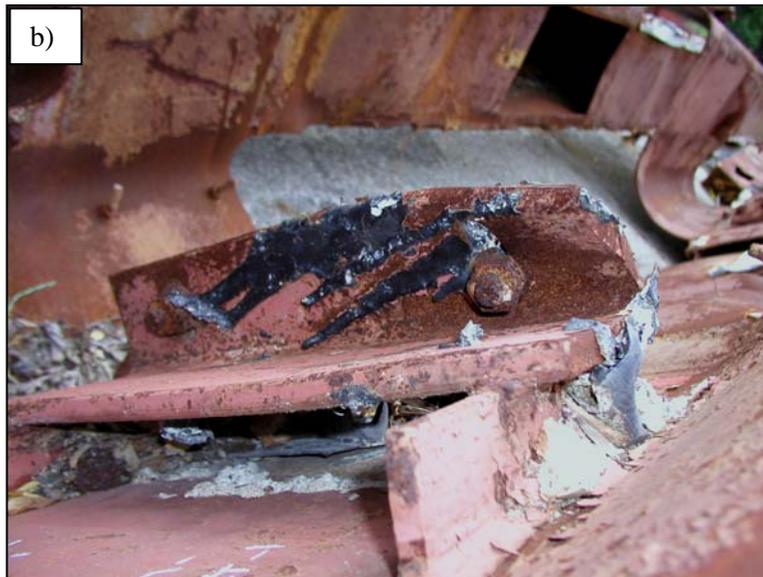
3. Panel N-8, WTC 1, column 143, seat and standoff plates of the 99th floor. This seat (Fig. 6–38) was exposed to fire for a minimum of 18 cumulative minutes before collapse. Mud cracking was not observed on the spandrel plate to which the seat was welded.

Figure 6–38. Truss seat of the 99th floor on column 143 of sample N-8 (A142: 97-100). a) Top view showing the re-solidified black plastic with embedded papers, most likely a binder of some type and b) bottom view showing the drip pattern. It was unknown when the high-temperature excursion may have occurred.
