NIST NCSTAR 1-3

**Federal Building and Fire Safety Investigation of the
World Trade Center Disaster**

Mechanical and Metallurgical Analysis of Structural Steel

September 2005

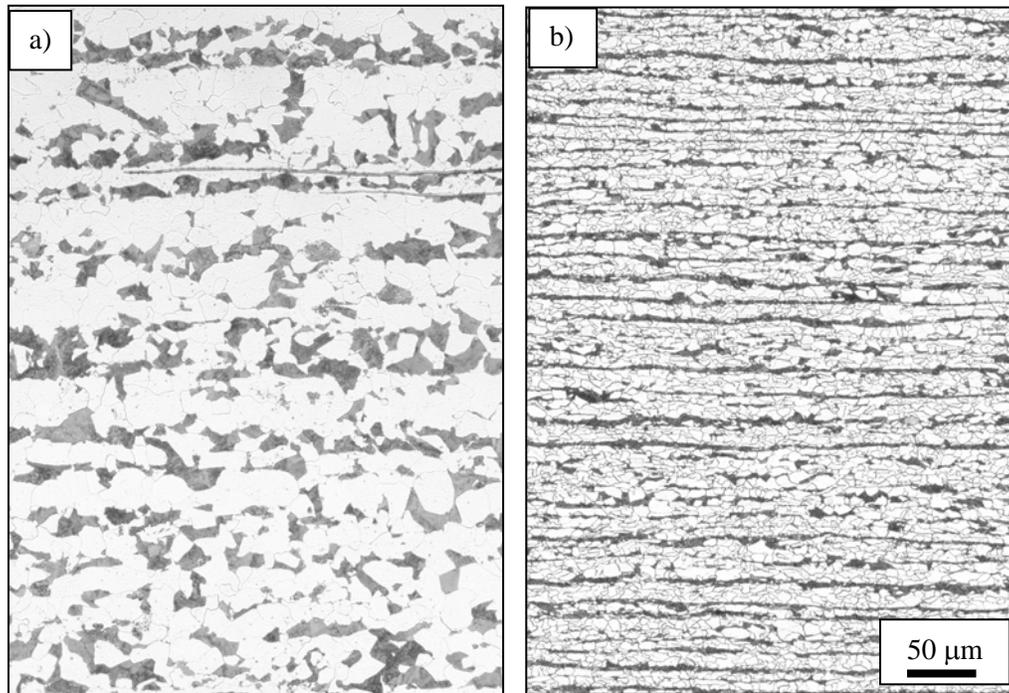
For the exterior panel sections, two different microstructural types were observed. Flange, web, and spandrel plates with specified minimum yield strengths less than 70 ksi were ferrite-pearlite (Fig. 8–1). Additionally, inner webs with F_y of 70 ksi and 75 ksi were ferrite-pearlite. For the Yawata produced plates (flange, outer web, and spandrel), this type of microstructure was expected given the measured plate thickness and specified minimum yield strength (refer to NIST NCSTAR 1-3A). Plates with F_y less than 70 ksi were typically hot rolled unless the following sizes were exceeded for a given F_y : 0.5” for 65 ksi, 1.25” for 60 ksi, and 1.5” for 55 ksi. For these specified plates, as well as those with minimum yield strengths equal to or greater than 70 ksi, “quenched-and-tempered” microstructures were observed (Fig. 8–2).

Figure 8–1. Microstructure of ferritic-pearlitic WTC perimeter column flange plate steels. a) $F_y = 45$ ksi (unidentified perimeter column with “45” flange stamping) and b) $F_y = 60$ ksi (WTC 1, column 126, 97th floor).

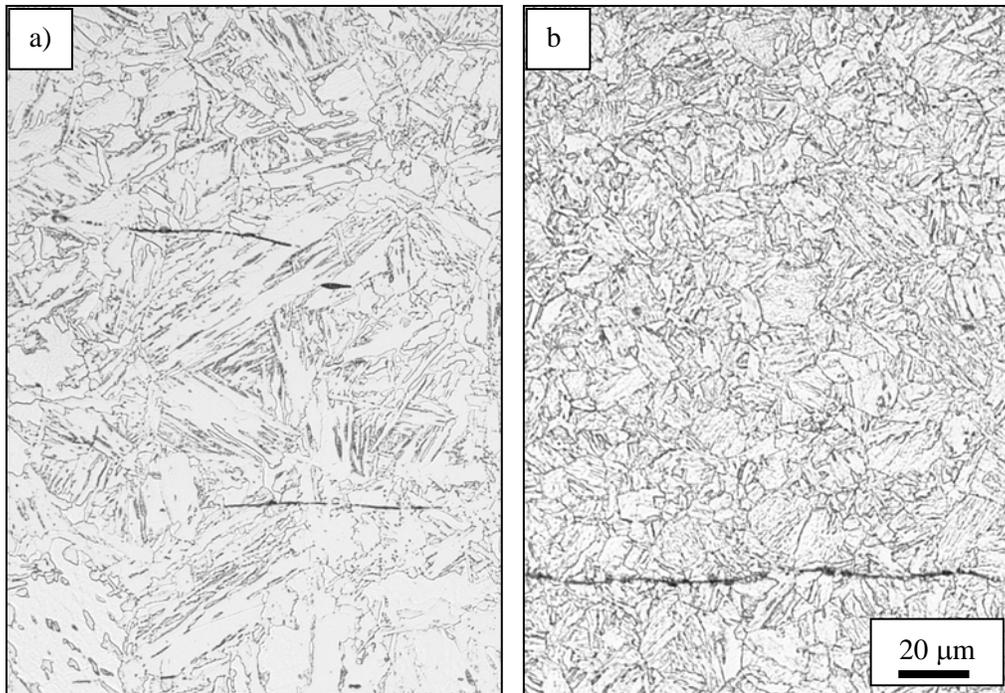
Microstructure varied within each of the two structure types, depending on product type, gauge, and strength level. Ferrite-pearlite steels had variations in ferrite grain size, ferrite grain shape, pearlite lamellar spacing, and banding of microstructural constituents with a change in specified F_y and gauge of the plate. Examples of these microstructures are shown in Fig. 8–1. Similarly, the quenched and tempered steels had variations with F_y . Plates with $F_y = 70$ ksi had a coarse Widmanstätten morphology of ferrite with coarse cementite precipitates while the higher strength plates had what appeared to be a tempered martensitic structure, as shown in Fig. 8–2.

Figure 8–2. Examples of “quenched and tempered” WTC perimeter column flange steel. a) $F_y = 70$ ksi (WTC 1, column 224, 94th floor) and b) $F_y = 80$ ksi (WTC 1, column 207, 89th floor).

For each of the designated minimum yield strengths, the type of structures observed was expected for steels of that era. While the microstructural features may have varied from plate to plate, there was no indication that the practices followed to produce the plates were improper.
