# **Deterioration of Iowa Highway Concrete Pavements: A Petrographic Study**

Paul E. Stutzman

December, 1999

Building and Fire Research Laboratory  
National Institute of Standards and Technology  
Gaithersburg, MD 20899

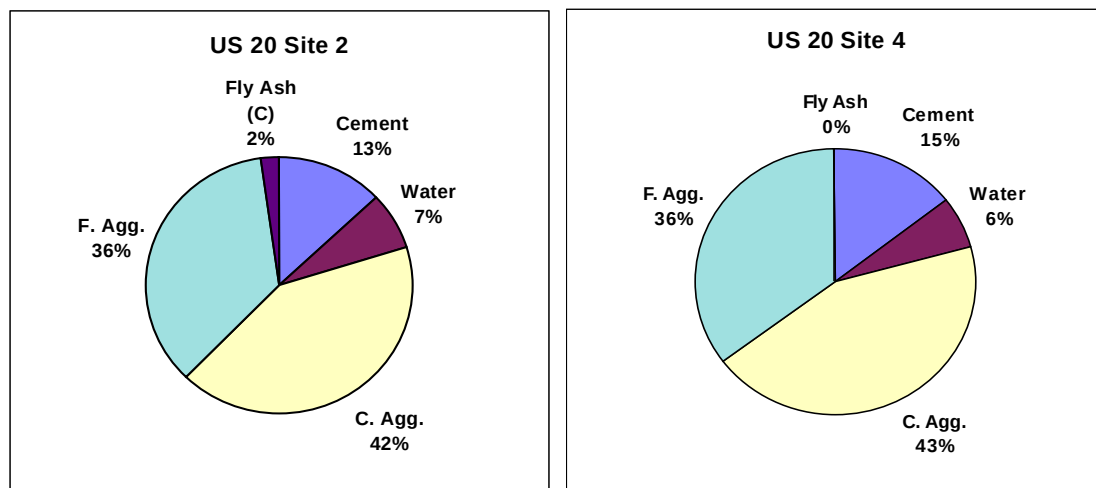
Figure 4 gives the concrete materials proportions from US 20 for mixes with and without fly ash while Figure 5 indicates the gap grading of the aggregates. Evaluation of the mix design by two separate internationally recognized engineers [18,19] found agreement in that the high sand content and gap-grading probably led to difficulties in workability and consolidation, and may have resulted in drying shrinkage problems. The aggregate distributions plotted on a Shilstone Coarseness Factor Chart [20] fall in a region reflecting gap-graded concrete and where workability difficulties may be present (Figure 6). The parallel blue lines on this chart define a region of optimum grading for low water demand and optimum response to vibration. While the potential difficulty in workability were not unexpected to the Iowa Department of Transportation staff [21], it is significant in that it may also affect the development of the entrained air void system during mixing. Failure to develop an adequate entrained air void system appears to be contributory to the deterioration of these pavements.

Figure 4. Concrete materials proportions, by mass, for selected sections of Iowa US 20.

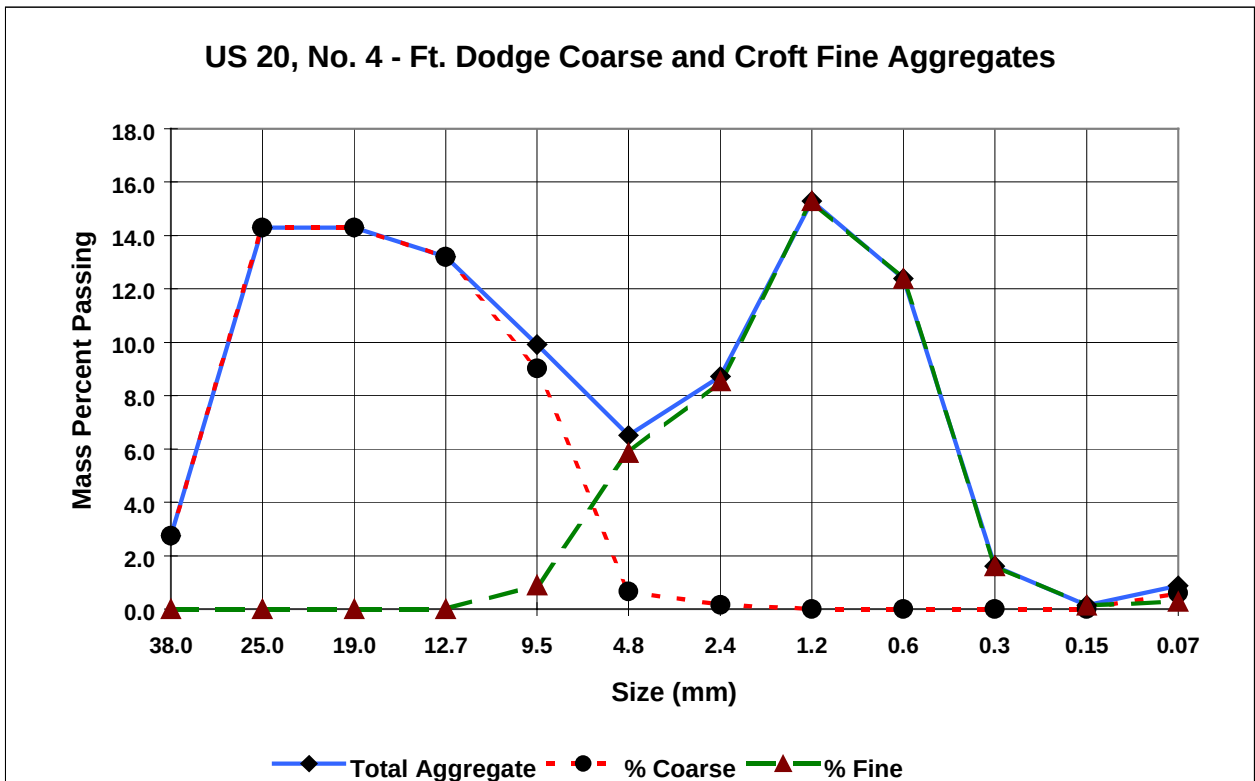
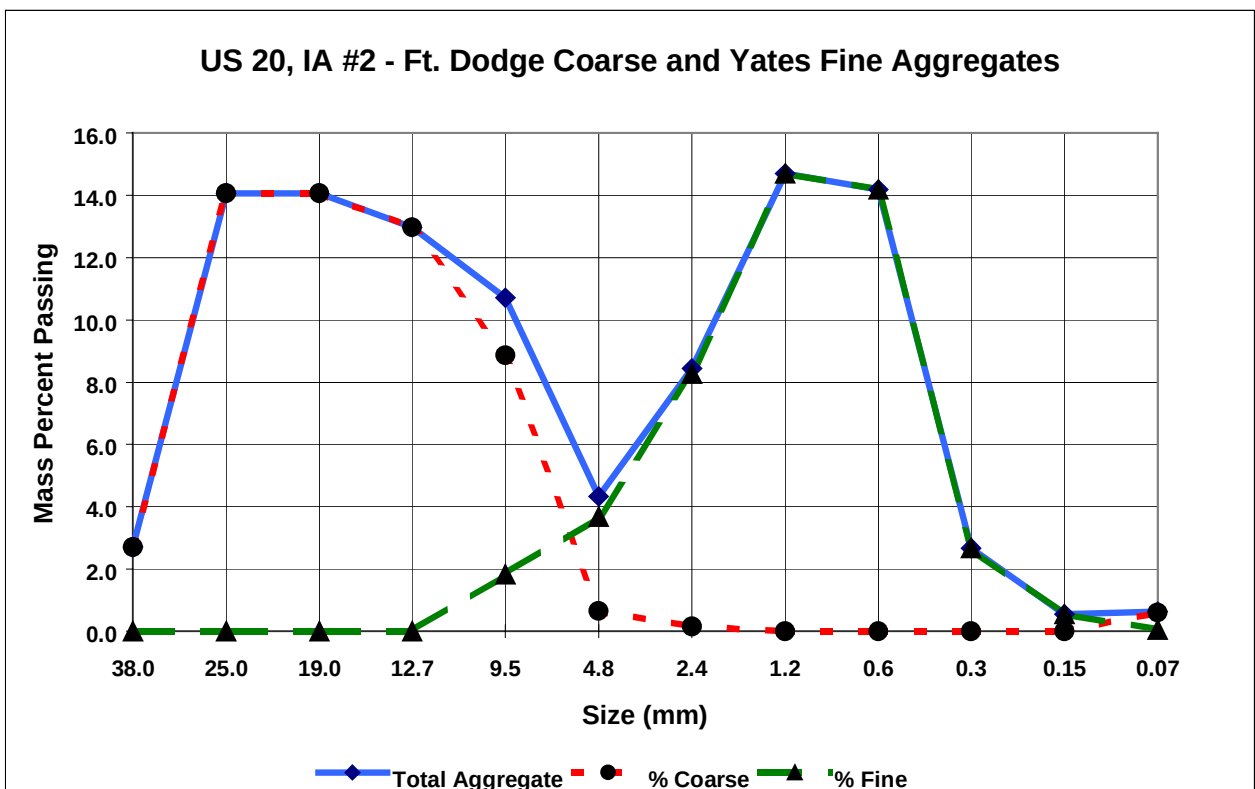
Figure 5. Aggregate gradation plots showing coarse, fine, and combined aggregate gradation and the lack of particles in the intermediate size range.

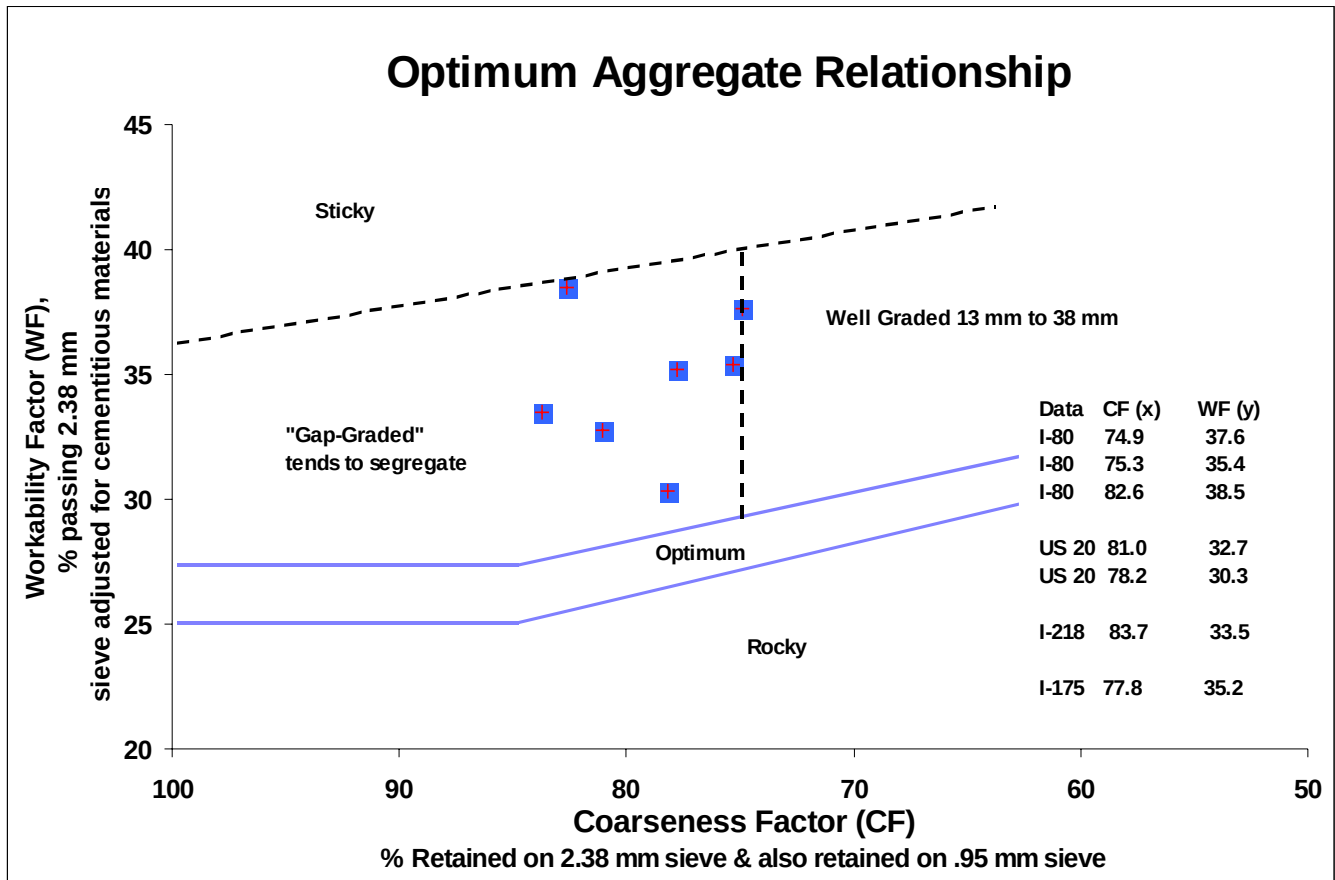
Figure 6. Optimum aggregate chart plots of Iowa pavement mix designs fall into the gap-graded region and indicate likely difficulties in workability [20].

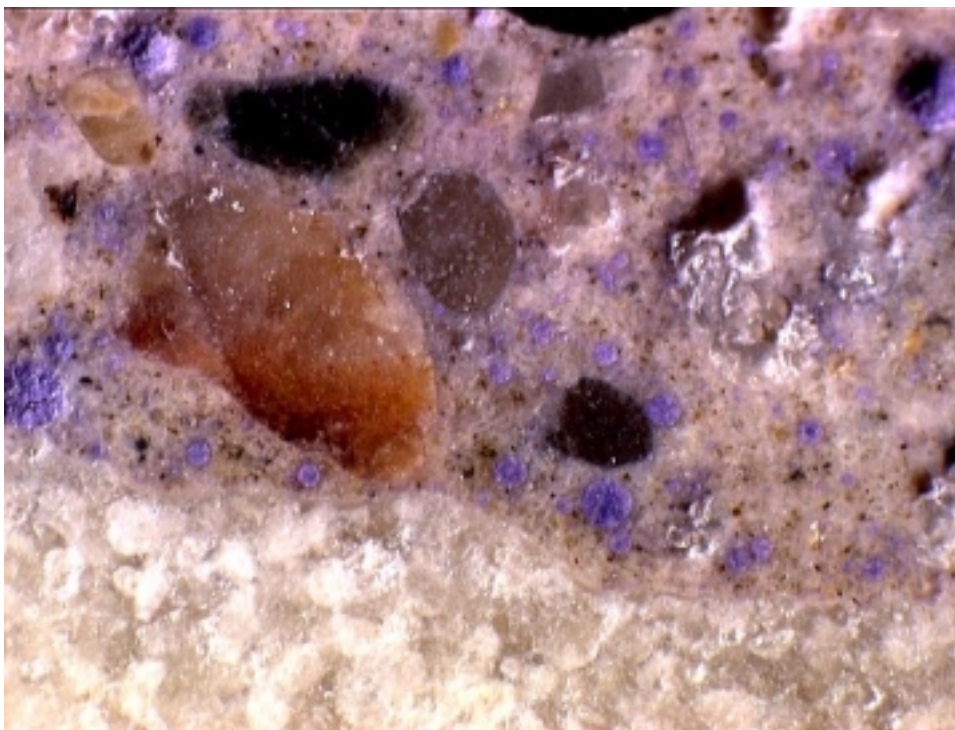
Figure 8. Potassium permanganate and barium chloride staining colors sulfate phases purple facilitating their identification. This allows discrimination of both the original and effective entrained air void systems.

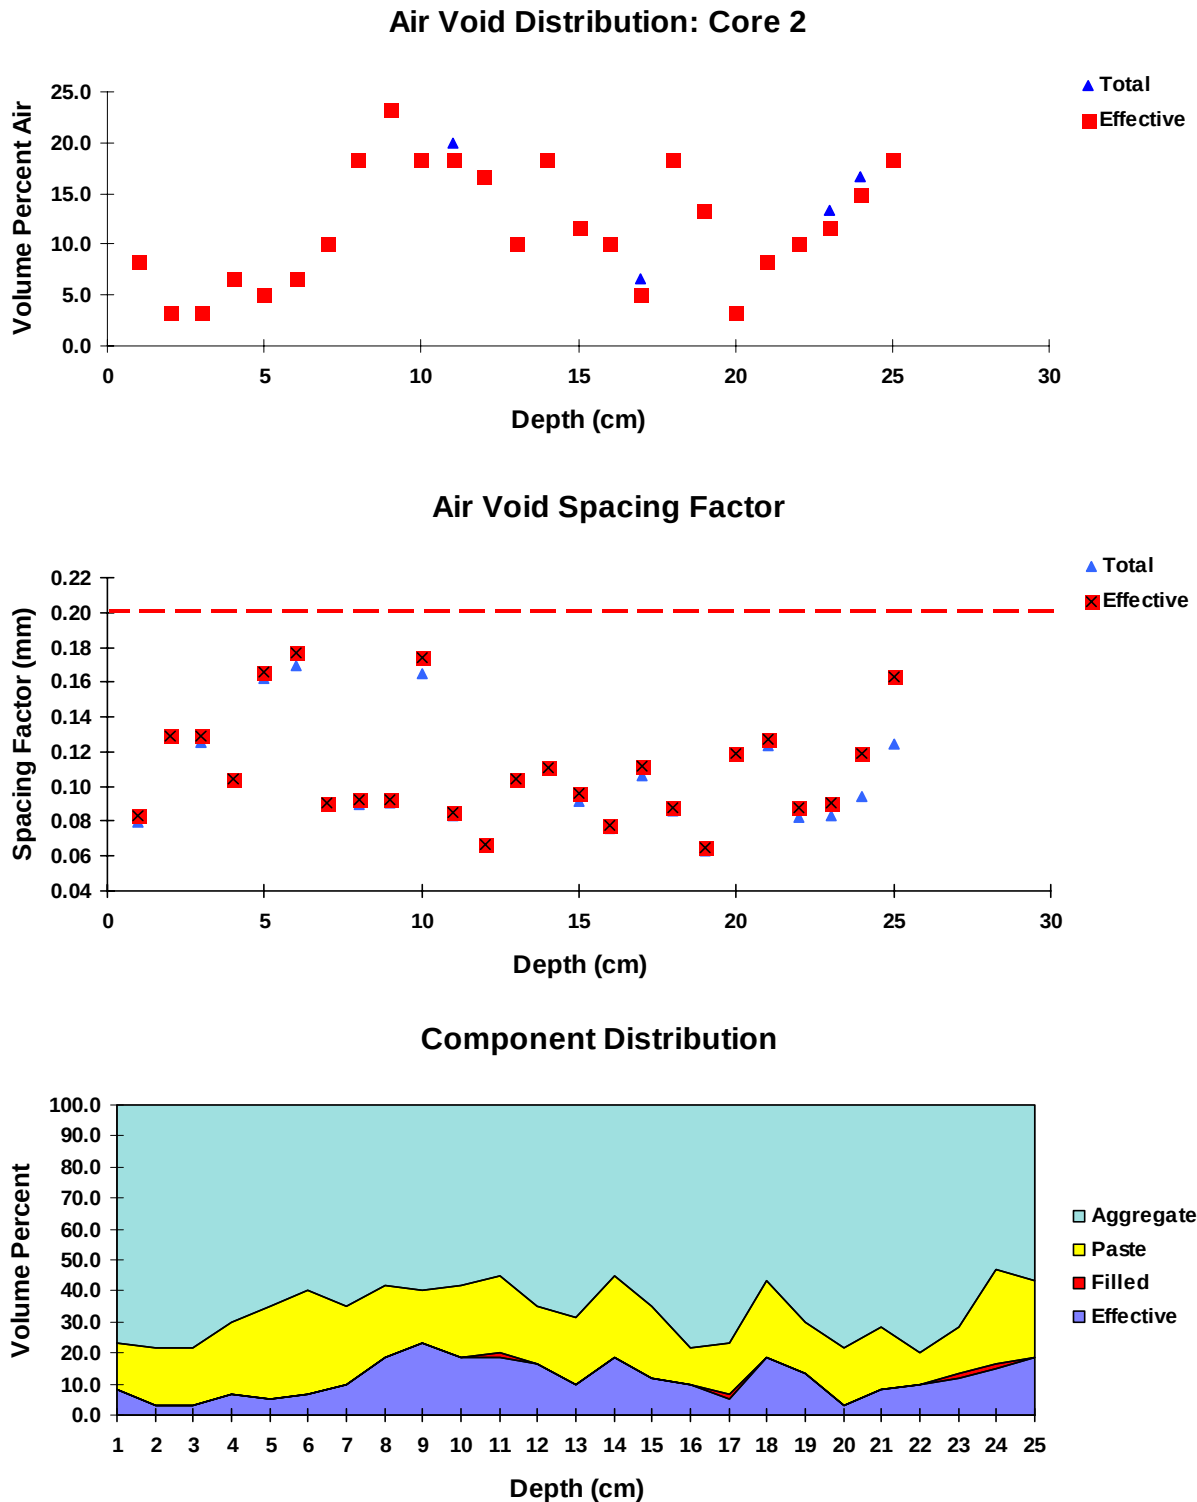
Figure 13. Iowa 175 Core 2 air void and materials distribution plots. A decrease in air near the surface may reflect the loss of entrapped air. The blue triangles represent an air void parameter estimate for the original concrete; the red box represents that value as affected by void filling, if present.

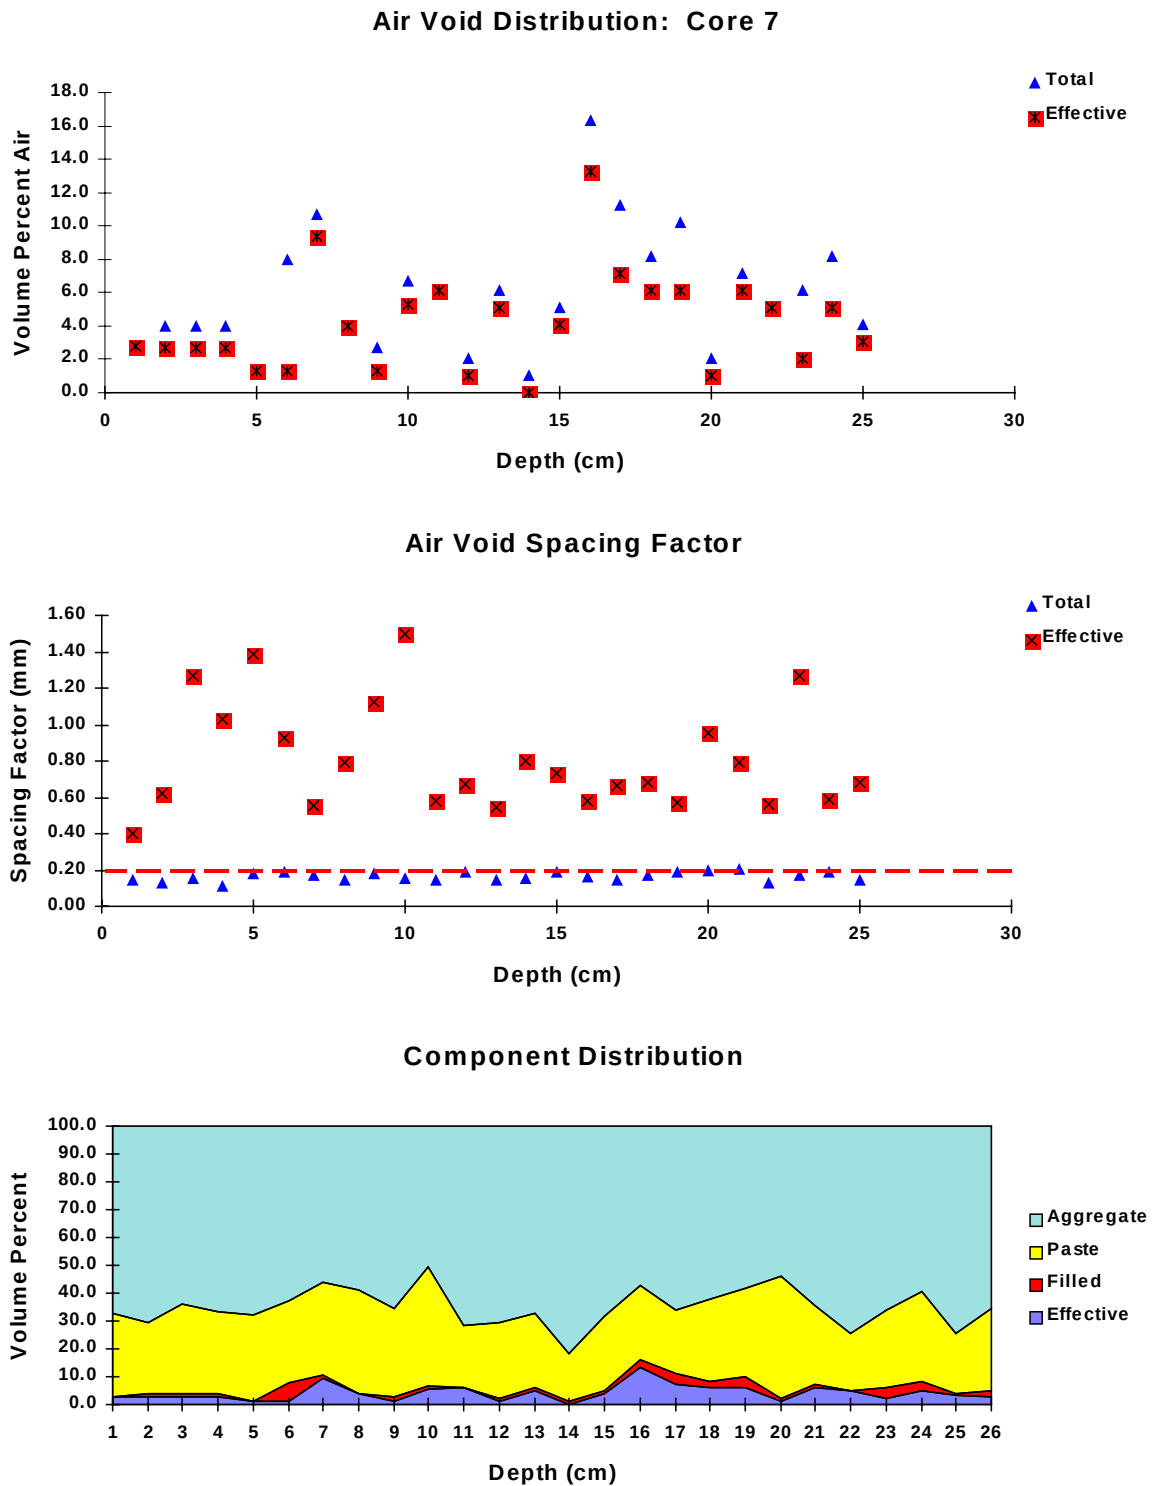
Cores 7 and 8 exhibit a white exudation from some large shale fragments indicating some alkali-aggregate reaction, though no significant cracking was observed. Large (to 30 mm) entrapped air voids were common. The top surface appears rough with uneven tining grooves. The paste appears strong and cuts cleanly, and the paste / aggregate bond appears strong. The coarse aggregate is a crushed limestone that exhibits some internal cracking, and the sand is silicious and angular. The larger-sized sand particles appear more rounded and contain some shale grains. Segregation is common with a lack of coarse aggregate in the upper third of the core (Figures 14, 15). The partial loss of the core in the upper image of Figure 14 resulted from the core transecting a joint dowel (circular void). Surface cracking terminating in both limestone aggregate and paste is common (Figure 16). These cracks were empty and closed, and were identified through a subtle change in paste coloration due to carbonation along the crack plane. Entrained air void system analysis indicates a lower volume of air near the concrete surface and a significant loss of entrained air void capacity due to filling with ettringite (Figure 17, Table 2). The total air volume decreased from 5.9 % to 4.6 % while the spacing factor has increased from 0.12 mm to 0.26 mm. The loss of the smaller entrained air voids is reflected by the change in specific surface from  $35 \text{ mm}^{-1}$  to  $21 \text{ mm}^{-1}$ . The increased spacing factor is in excess of that recommended in ACI 201 for freeze-thaw protection.

Graphical representation of the total air, spacing factors, and component distribution (Figure 18, Figure 19) illustrates the alteration of the air void system resulting from the ettringite filling. Air distribution, as measured by total air volume, appears uniform from the core top to base. Core 7 may show a slight decrease in air in the upper 50 mm, possibly reflecting the elimination of entrapped air in the upper-most portion of the concrete. This also indicates that, outside the immediate regions of the immersion vibrators, the air void spacing factors do not appear to be adversely affected. The decrease in ettringite precipitation near the surface (upper 5 mm) may reflect the influence of surface drying. At greater depths, filling of voids appears uniform from both a total air void volume and loss of spacing factor. Component distribution appears uniform indicating no apparent vertical segregation of materials due to vibration.

Figure 18: Air void distribution, spacing factors, and concrete component distribution versus depth for Core 7. The red boxes represent the current value, the blue triangle, the original value, and the red line in the spacing factor plot denotes the ASTM C 457 recommended limit for freeze-thaw protection.

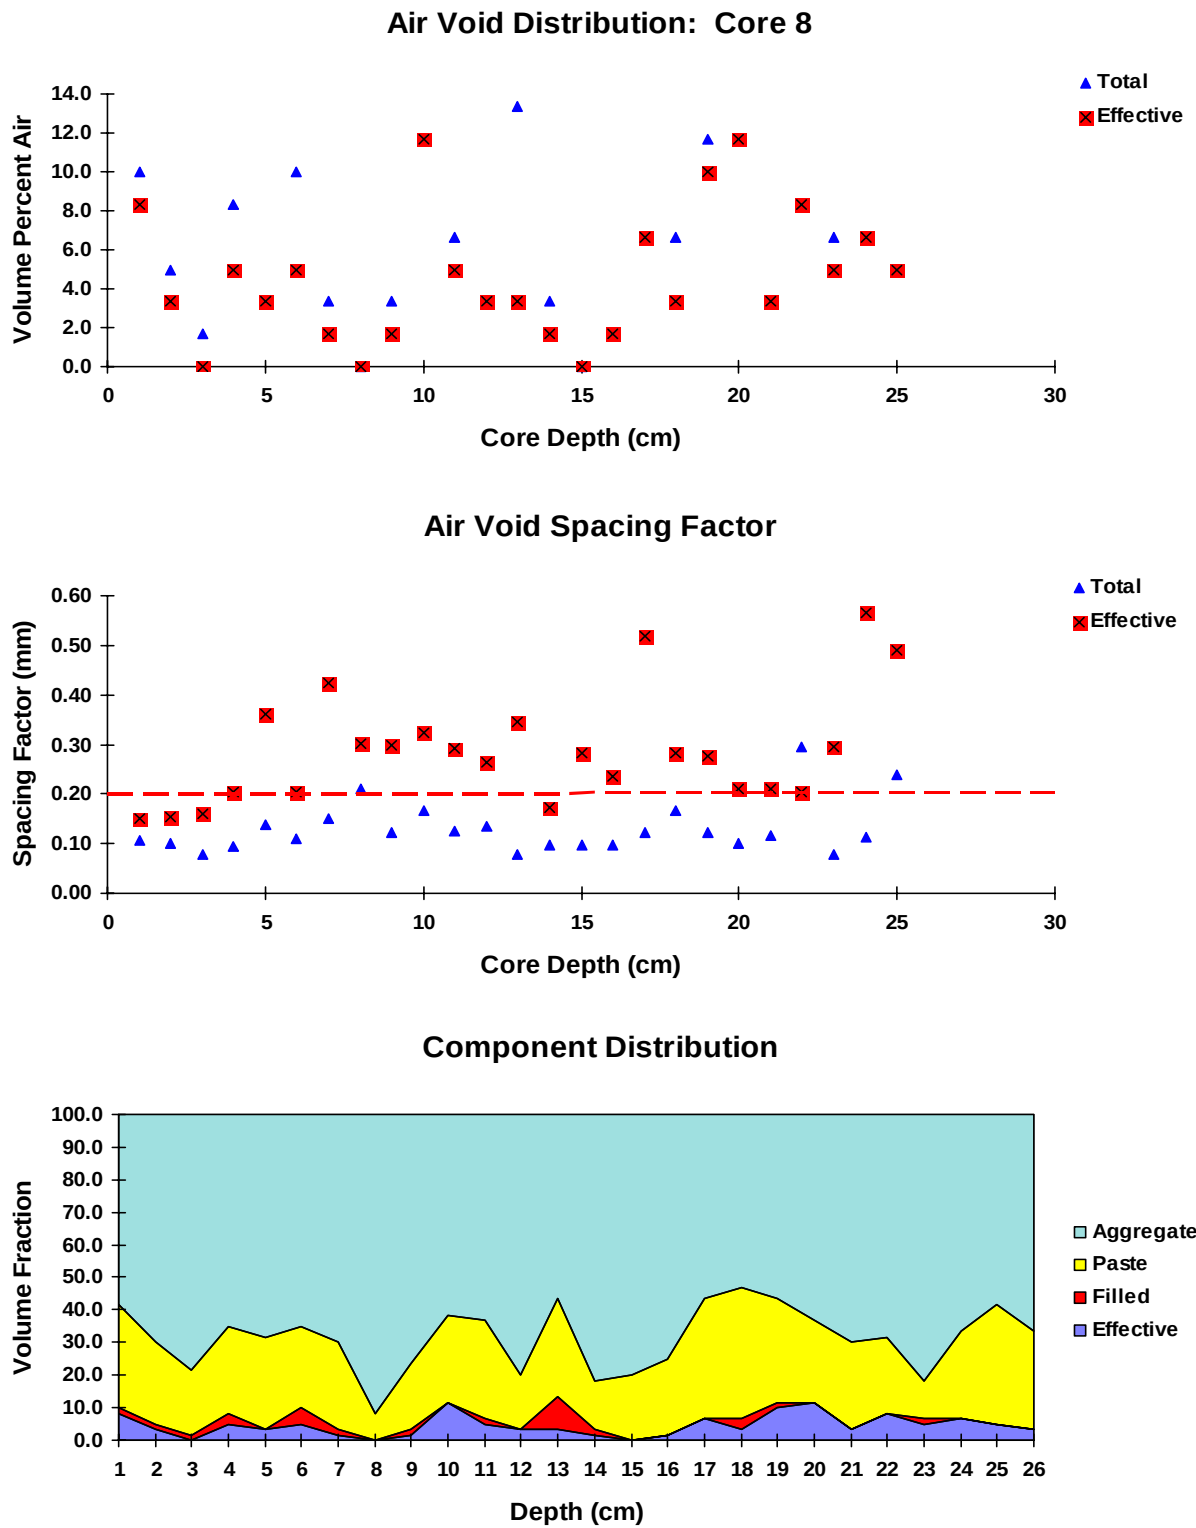
Figure 19: Air void distribution and spacing factors versus depth, and concrete component distribution for Core 8, mid-panel.

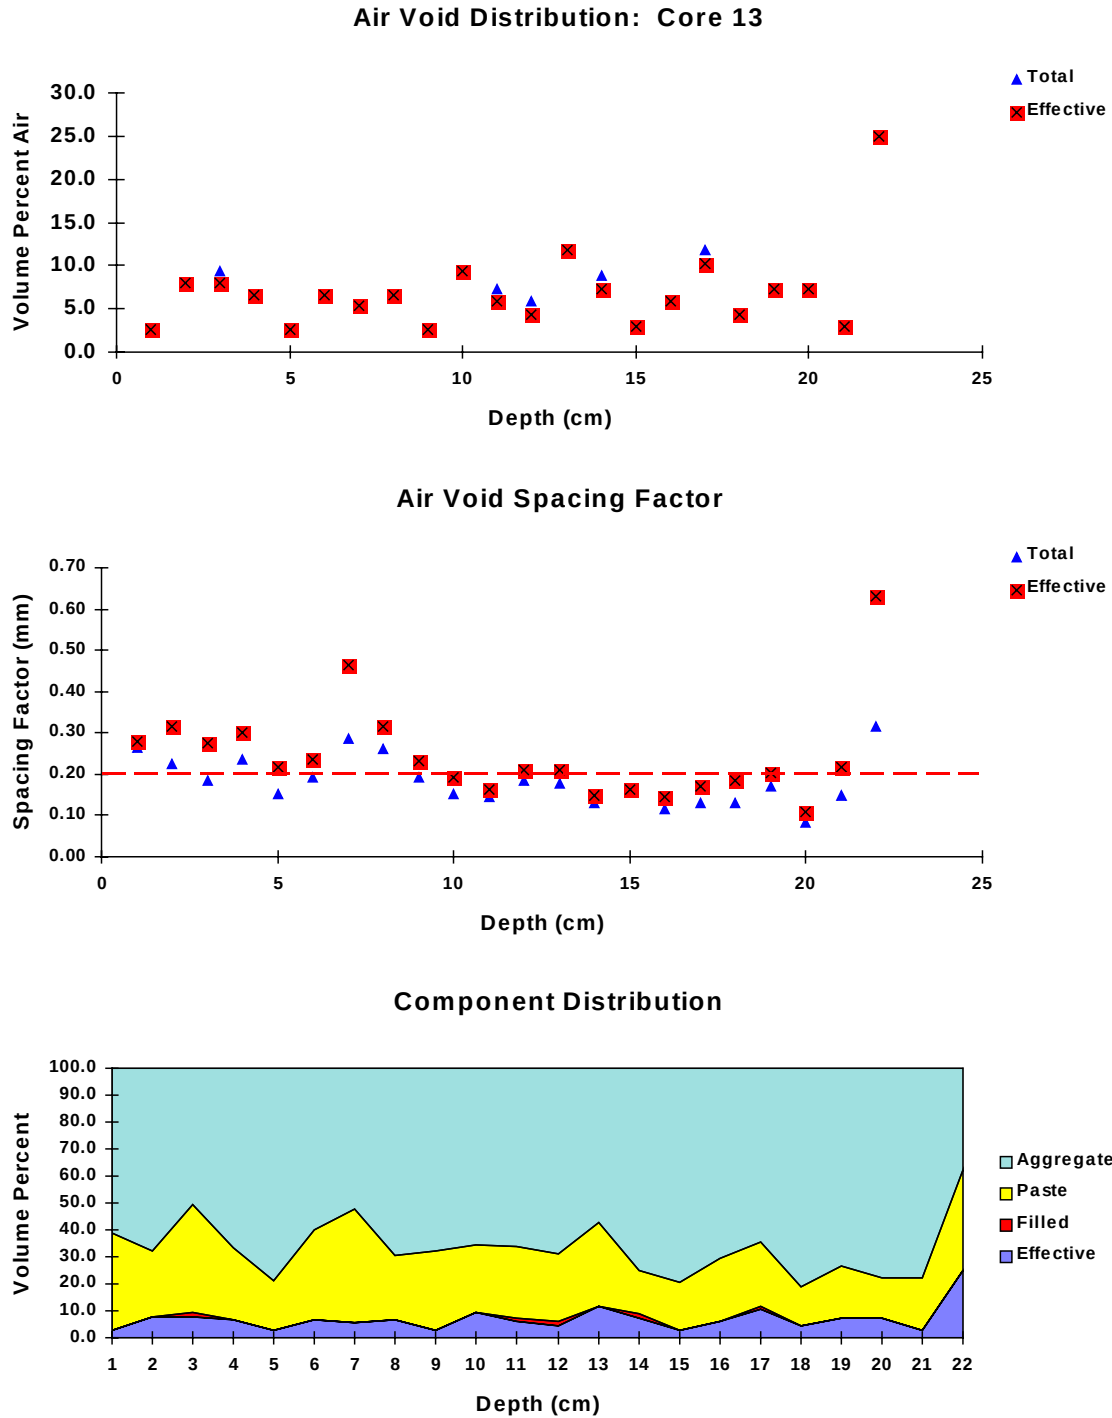
Figure 25. Air void distribution and spacing factors versus depth, and concrete component distribution for Core 13. The air volume appears uniform with depth while the spacing factor appears substandard in the upper 100 mm. Filling has resulted in a slight increase in the spacing factor.

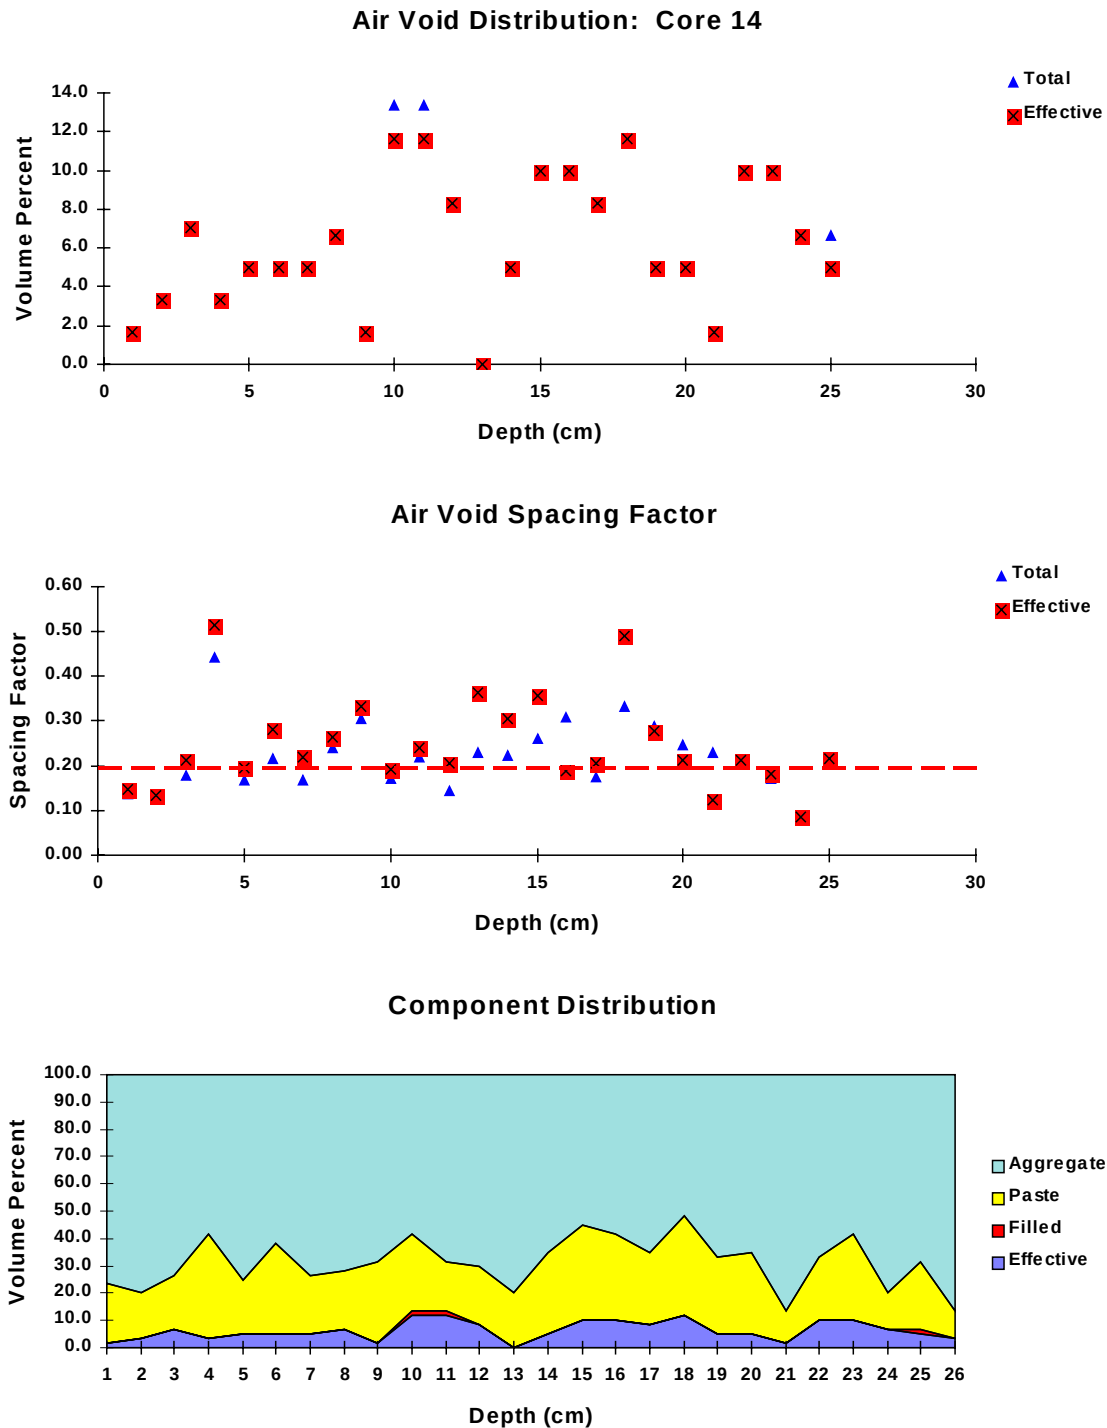
Figure 26. Air void distribution and spacing factors versus depth, and concrete component distribution for Core 14. The total air volume appears similar to that of Core 13 from the joint and appears uniform with depth (deviations from the median probably reflect entrapped air voids). The spacing factor appears marginal to sub-standard at depths below 6 cm, and filling of the smaller entrained air voids has resulted in an increase in void spacing factor.

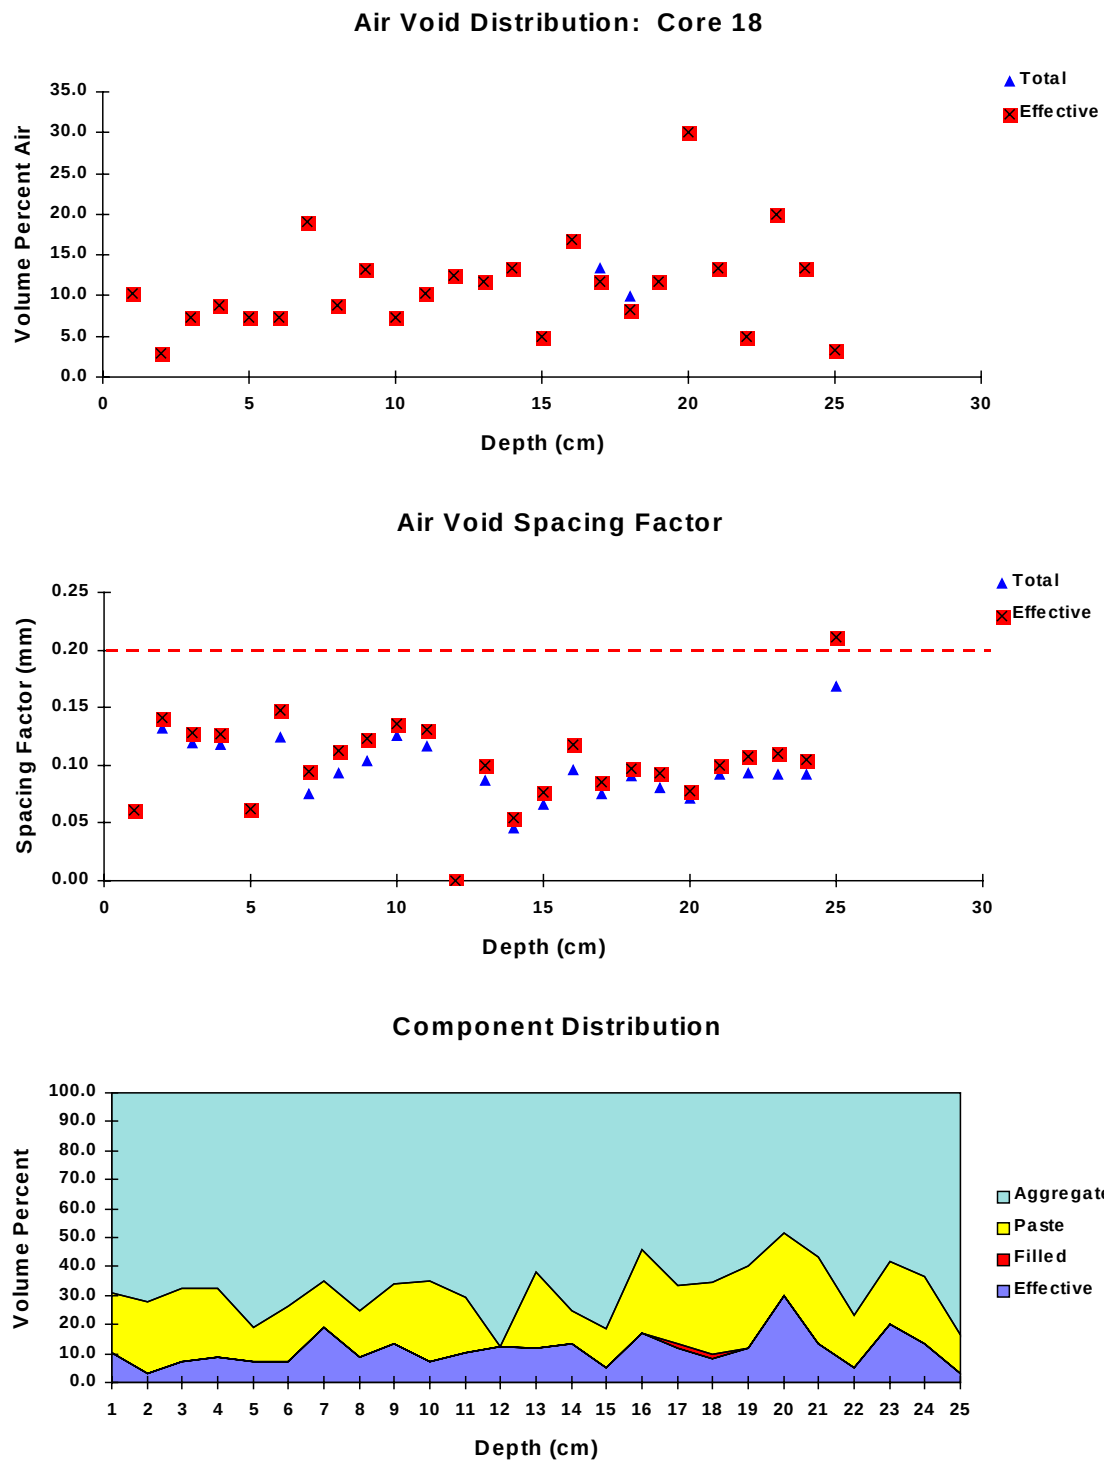
Figure 28. Air void and component distribution plots for core 18. Little loss of air void volume is evident with only a slight, uniform loss of air void spacing factor. Component distribution appears uniform from top to bottom.

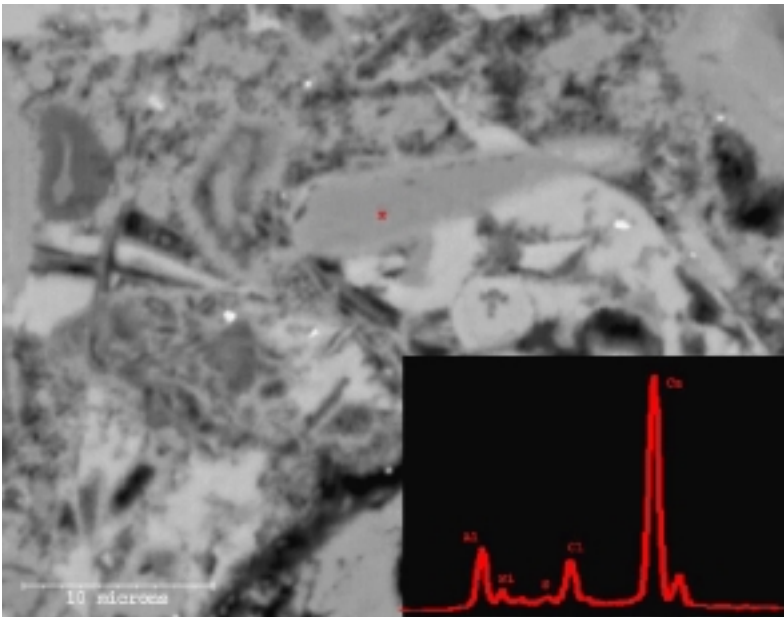
Figure 30. Friedel's salt in hardened paste is identified here using X-ray microanalysis. It appears to be a primary hydration product in the paste throughout the cores, suggesting that it may be a result of the presence of chlorides in the original mix as opposed to the infiltration of road salts.

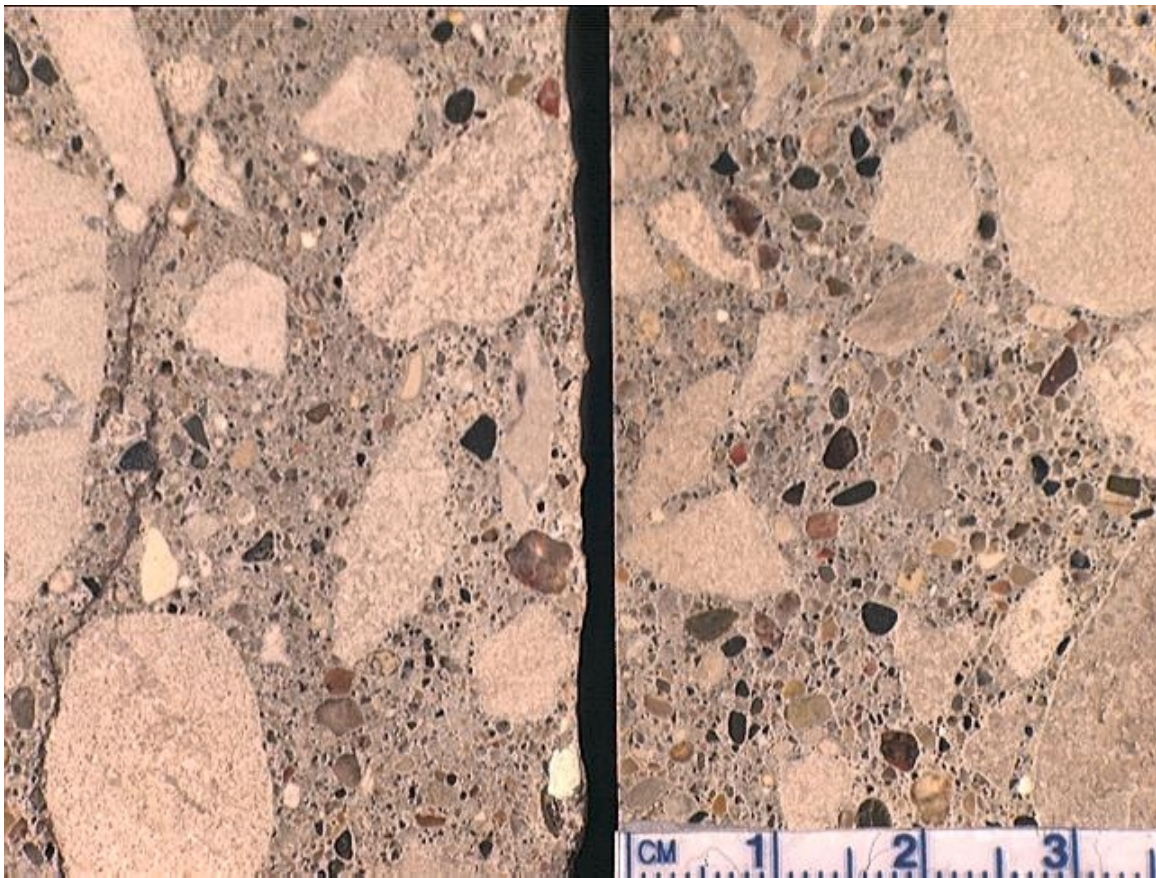
Visual examination of Cores 18 and 19 found a likely difference in aggregate grading (Figure 35) with Core 18 appearing to have a more uniform, and perhaps smaller, aggregate gradation. The apparent change in aggregate gradation may have affected the development of the higher-volume entrained air void system in Core 18. However, specific surface values indicate a coarse air void size distribution.

Figure 35. Core 19 (left) appears to have a finer-sized sand and possibly a larger maximum coarse aggregate size when compared to Core 18 (right).

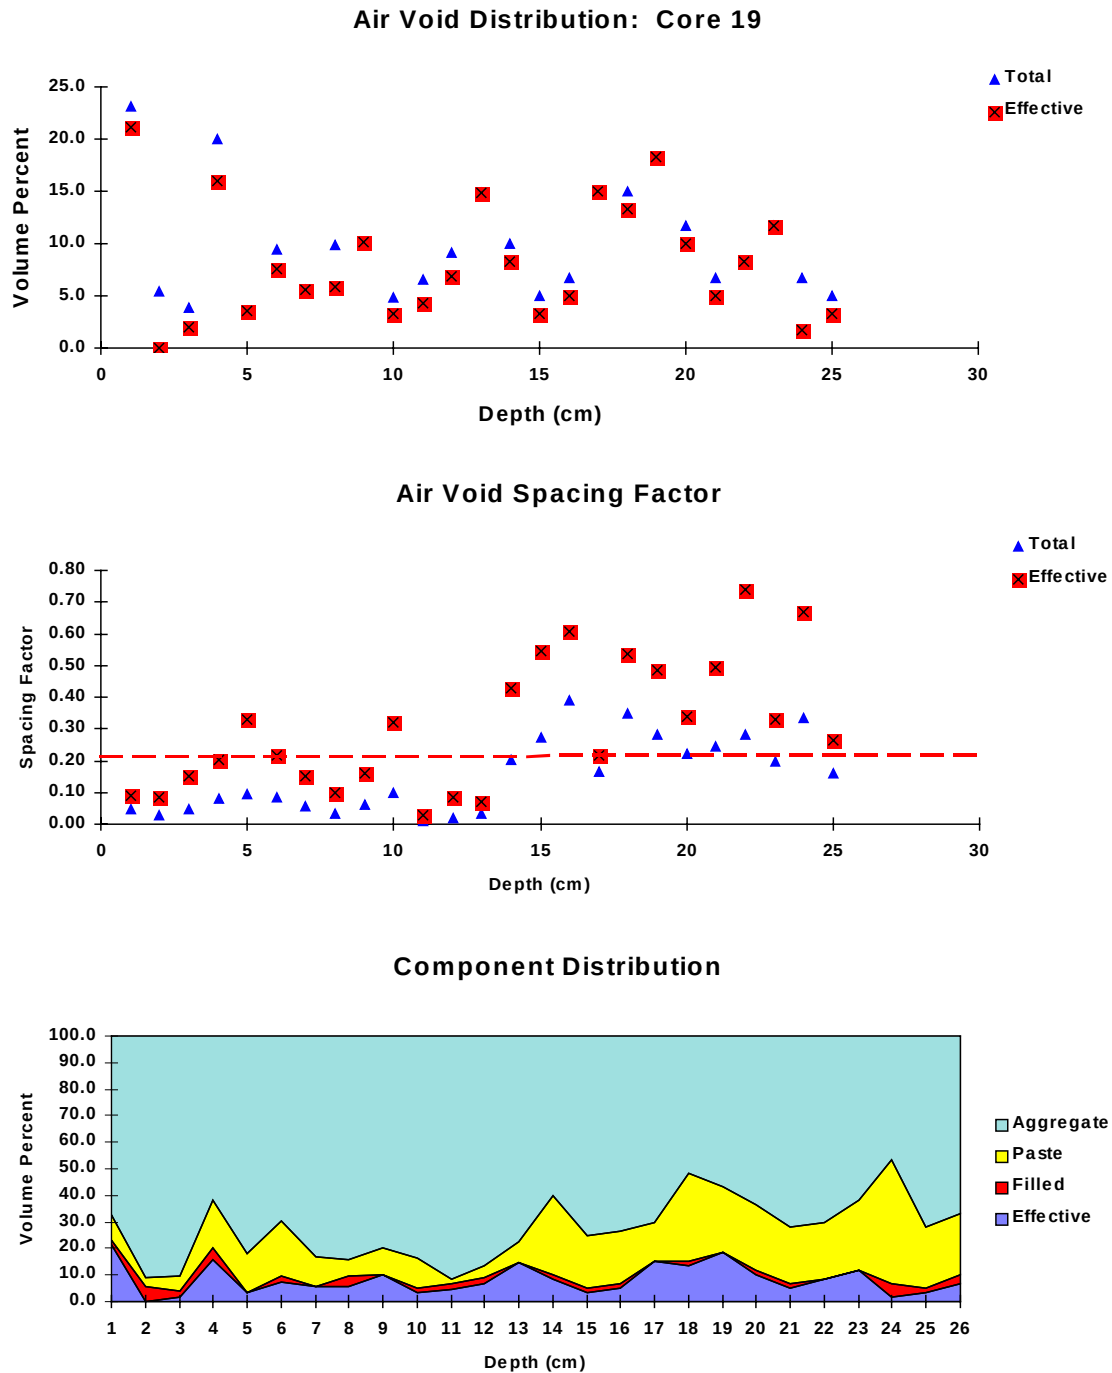
Graphical representation of the air void and component distributions indicates a decrease in spacing factor and an increase in cement paste content with depth (Figure 36). The spacing factors for both the total (original) and effective systems fall beyond that necessary for frost protection at depths greater than 150 mm.

Figure 36. Core 19 data show a decrease in spacing factor with depth and possibly a trend to an increased loss of spacing factor with depth. The component distribution plot shows a possible increase in aggregate and decrease in paste in the upper half of the core.

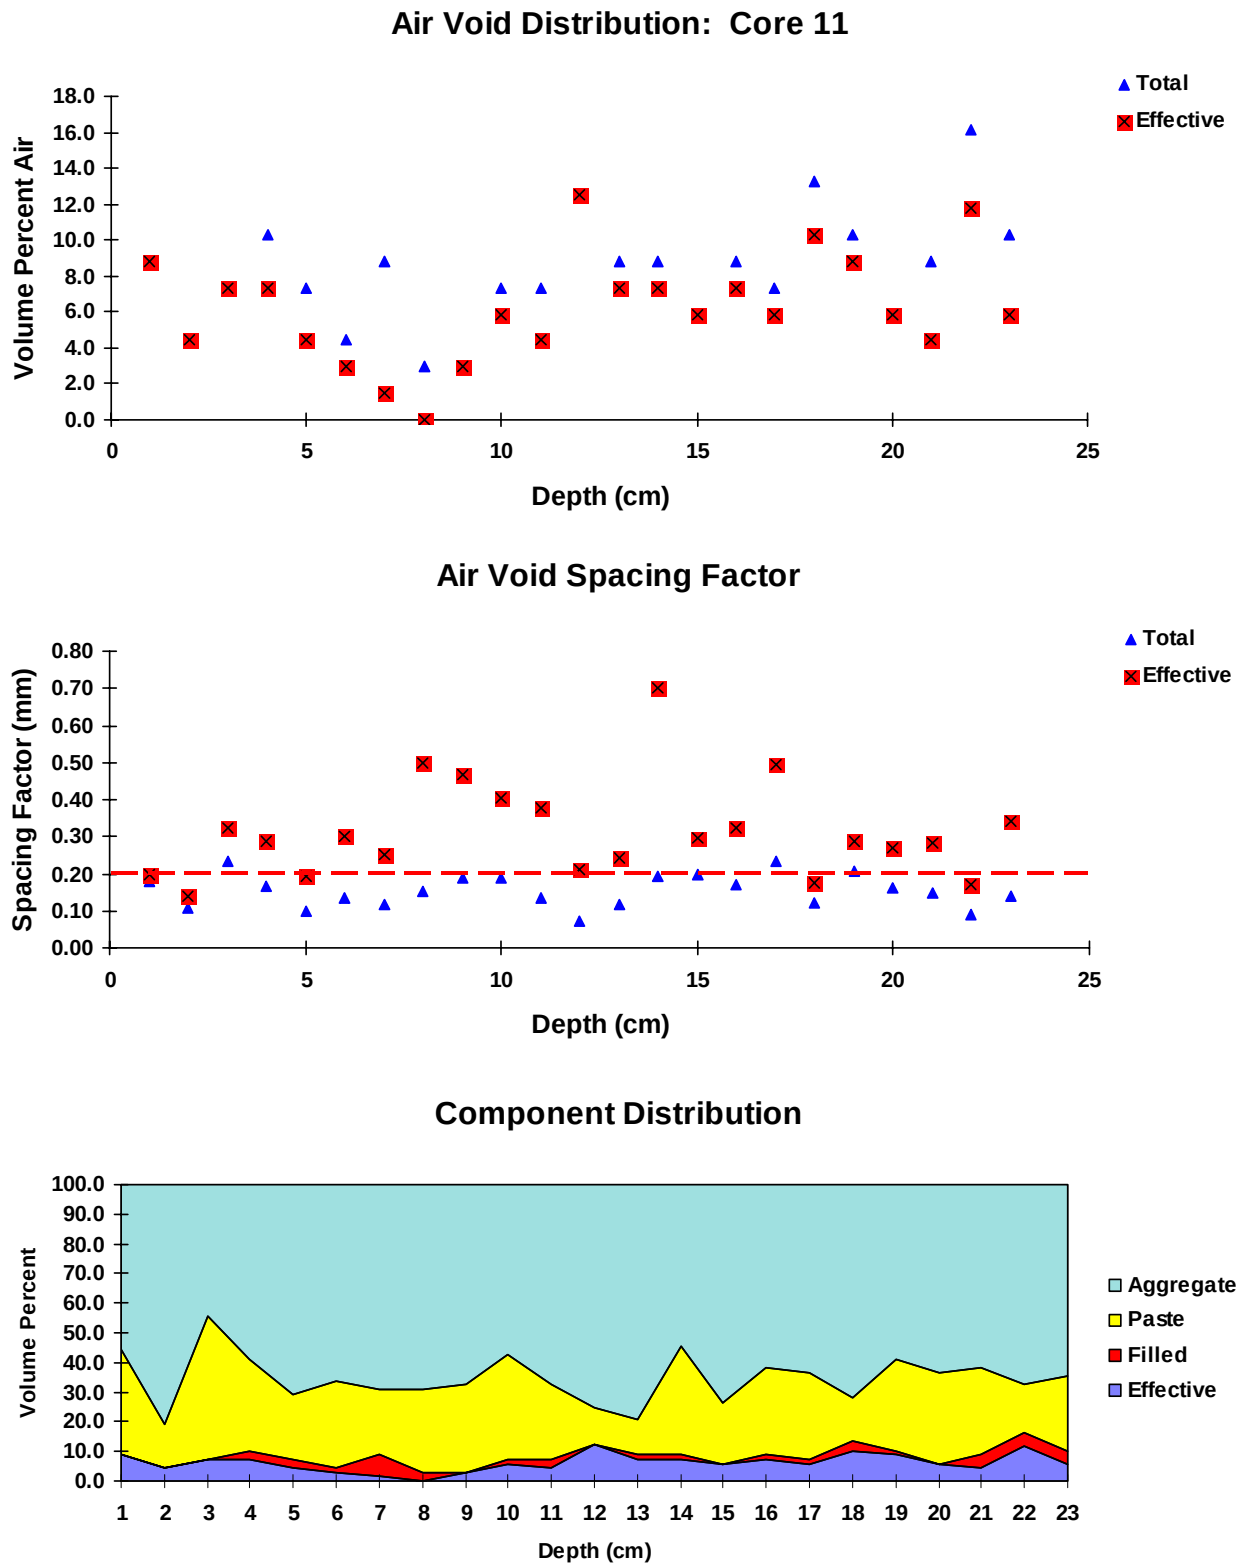
Figure 41: Core 11 air void parameters and component distribution show a loss of air void spacing yet relatively uniform air void volume and materials distribution.
